On-scene Investigation / Vehicle to Vehicle  
Dynamic Science, Inc. / Case Number: DS02012  
2003 Toyota Matrix XR five door hatchback  
California  
May, 2002

1. Report No. <b>DS02012</b>	2. Government Accession No.		3. Recipient Catalog No.	
4. Title and Subtitle <b>In-Depth Accident Investigation</b>		5. Report Date

**Dynamic Science, Inc.**  
**Accident Investigation**  
**Case Number: DS02012**

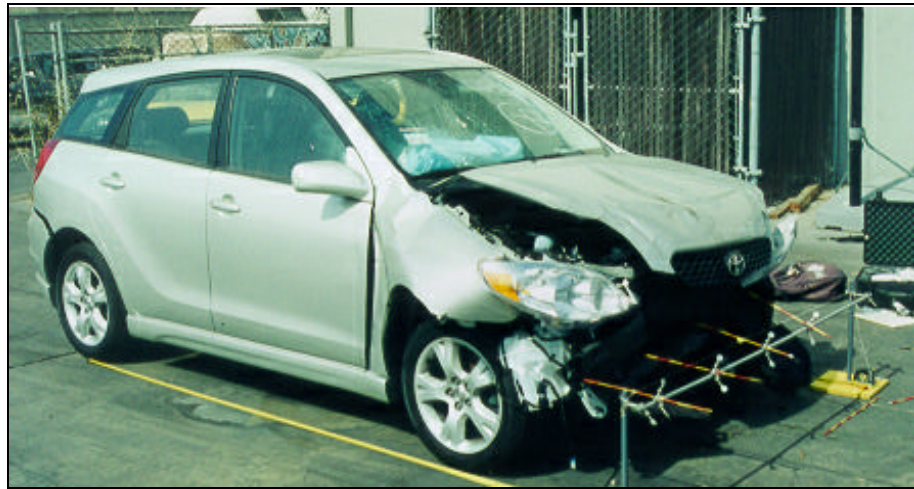
**Figure 2.** Front right, case vehicle

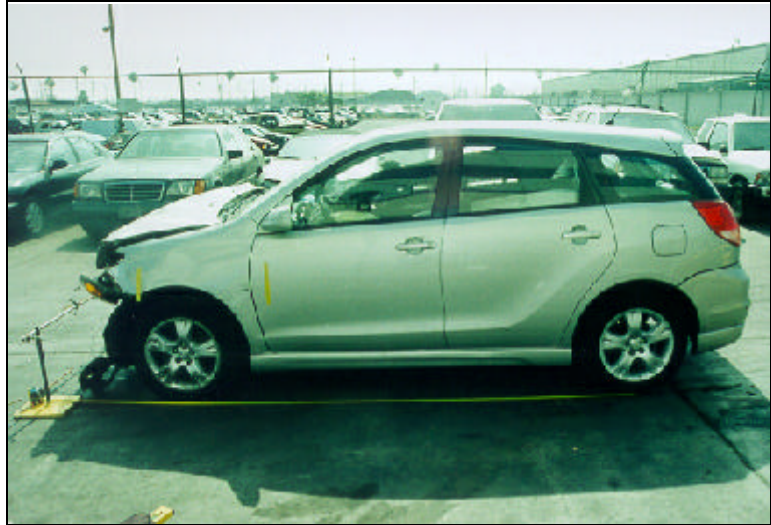
vehicle. The other vehicle tried to change lanes to the right. As soon as the other vehicle moved to the right, the driver felt a hard impact to the left. The right side of the other vehicle contacted the left front tire/fender area of the case vehicle (09LFEW1). The damage appears to have come from the tire of the other vehicle. The driver of the case vehicle steered to the right and lost control. The case vehicle began a clockwise rotation, left the roadway on the right and struck a concrete barrier on the right side of the freeway with its front end (10FDEW2). The maximum crush on the bumper was 31 cm (12.2 in) at C1. The total velocity change calculated by barrier algorithm of the WinSmash collision model was 33.0 km/h (20.5 mph). The longitudinal and lateral delta V components were -21.2 km/h (-13.2 mph) and 25.3 km/h (15.7 mph), respectively. Both front air bags deployed at this point. Both front seat pretensioners also fired. The case vehicle rotated in a clockwise direction and lightly brushed the rear bumper (09BLLS1) against the concrete barrier before coming to rest.

**Figure 3.** Left side, case vehicle, initial impact

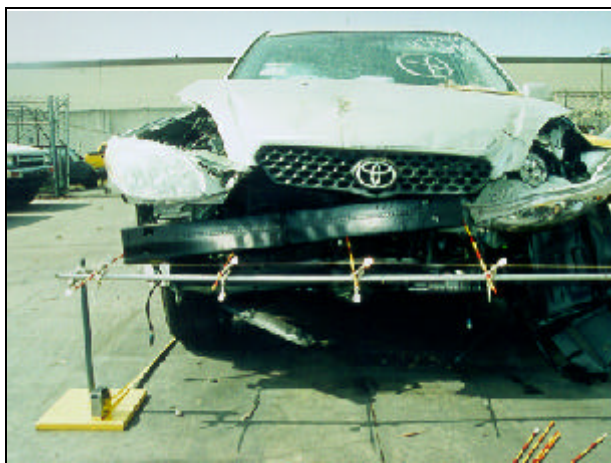
**Figure 5.** Front, case vehicle

The case vehicle sustained 67 cm (26.4 in) of direct contact to the left fender area from the initial impact with the unknown vehicle. The principle direction of force was within the 9 o'clock sector and was an estimated 280 degrees. As a result of the impact with the barrier, the vehicle sustained 160 cm (63 in) of direct contact along the bumper fascia. Measurements were taken to the bumper reinforcement bar. The maximum crush was 31 cm (12.2 in) and was located at C1. The principle direction of force was within the 10 o'clock sector and was an estimated 310 degrees. The impact energy was managed by the forward structures of the vehicle. The damaged components included the bumper fascia and reinforcement bar, lower radiator, and grille. As a result of the second impact to the barrier, the vehicle sustained 42 cm (16.5 in) of direct contact to the left rear bumper. This was a swiping type contact. The principle direction of force was within the 9 o'clock sector and was an estimated 270 degrees. There was no measured change in the wheelbase dimensions. The windshield was cracked by the deploying passenger air bag. There was no additional glazing damage and all the doors remained closed and operational.

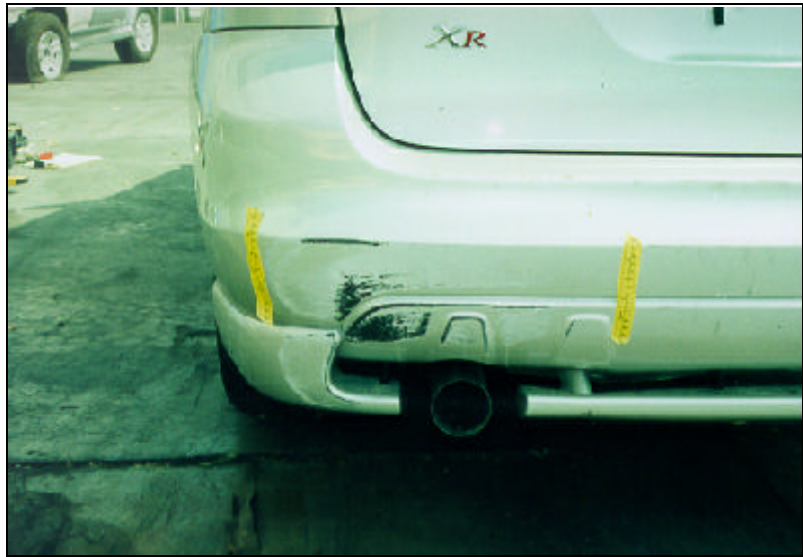
**Figure 6.** Rear bumper contact

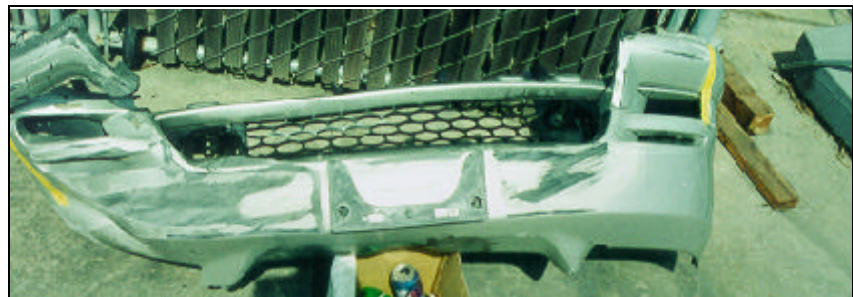
**Figure 7.** Front bumper, case vehicle

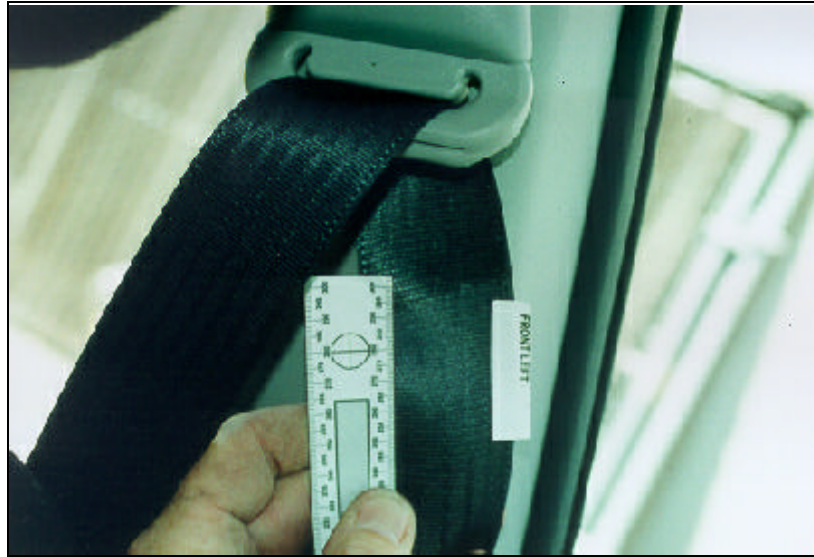
The front seat belt pretensioners at both outboard seats also fired at this time. Scuffing was found on the belts at the location where they loop into the D rings. The trim panels for both B-pillars were displaced laterally.

**Figure 10.** Loading marks, front left seat belt

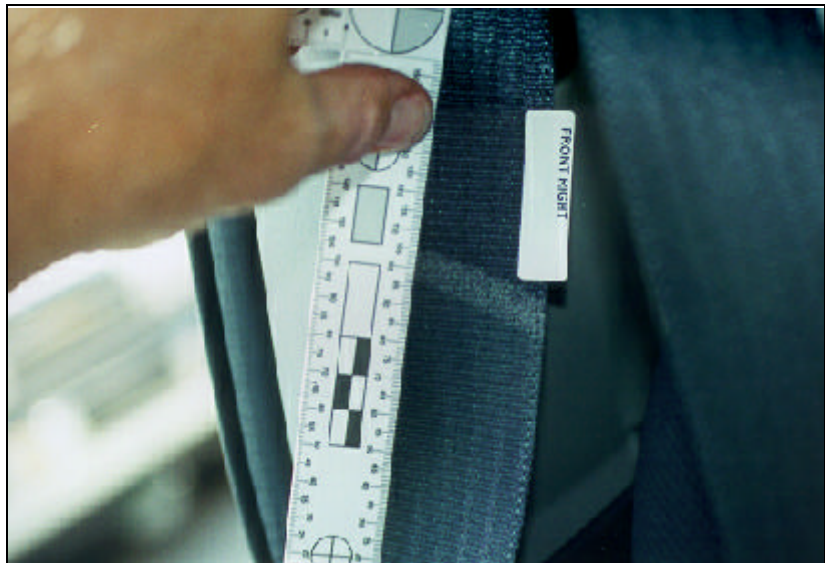
**Figure 11.** Loading marks, front right seat belt
