**CALSPAN REMOTE REDESIGNED AIR BAG VEHICLE CRASH
INVESTIGATION**

CASE NO: CA02-015

VEHICLE: 2001 PORSCHE BOXTER

CRASH DATE: MARCH 2002

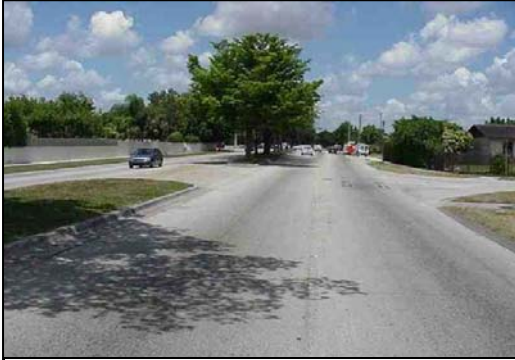
Figure 2 - Northbound approach of 2001 Porsche Boxter.

The 32-year old male driver of the 2001 Porsche Boxter S was traveling northbound on the right outside lane approaching a T-intersection with no traffic controls for north/south traffic (**Figure 2**). The Porsche drifted into the inside lane through the intersection and mounted the forward edge of the center median. There was no physical evidence at the scene indicating any pre-crash evasive maneuvers such as steering or braking inputs.

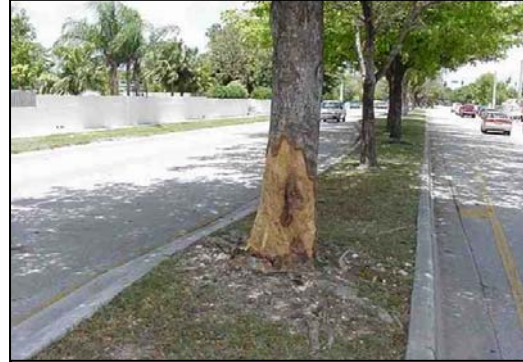
Figure 1 - Point of impact - hardwood tree.

Both left side tires were damaged as the Porsche mounted the curbed median. The front right corner of the Porsche then impacted a large hardwood tree that was located approximately 2.5 m (8') inboard from the curbed grassy median (**Figure 3**). The direction of force for the Porsche was 12 o'clock. The impact resulted in severe damage to the Porsche and was sufficient to deploy the frontal air bag system. The damage-only routine of the WinSMASH program calculated a total delta-V of 37 km/h (23 mph). The specific longitudinal and lateral changes in velocity were -37 km/h (-23 mph) and 0 km/h, respectively. The WinSMASH results were based on the frontal crush profile of the Porsche and were measured along the bumper level. Considering that a significant amount of the actual crush was outside the frame rails, the results are underestimated and should not be considered representative of this crash.

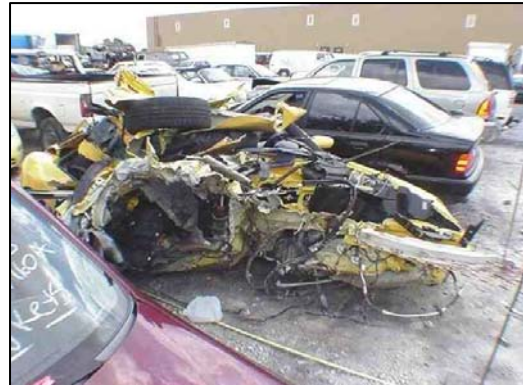
The 2001 Porsche Boxter sustained severe frontal damage as a result of the impact with the large diameter hardwood tree (**Figures 4 and 5**). The CIREN vehicle inspection revealed that the direct damage began at the front right bumper corner and extended 20 cm (7.9") to the left. The maximum crush was located at the front right bumper corner and measured 65 cm (25.6") in depth. The combined direct and induced damage encompassed the entire front end and measured 67 cm (26.4") across the compressed front bumper. The Collision Deformation Classification (CDC) for this frontal impact was 12-FREE-6. Six equidistant measurements were documented across the full width of the bumper and were as follows: C1 = 0 cm, C2 = 6 cm (2.4"), C3 = 22 cm (8.7"), C4 = 37 cm (14.6"), C5 = 46 cm (18.1"), C6 = 65 cm (25.6").

Energy was translated down the right side of the vehicle resulting in a CIREN-reported front right door opening. The compromised area appears to be the door structure as the latch and striker appear to have maintained their integrity; however, no photographic documentation of

Figure 3 – Right lateral view of the damage profile.

these components was provided to substantiate this finding. The CIREN investigation did attribute the opening to door support failure due to damage with the EDS portion of the case. Due to the severity of the impact, the windshield was holed and the front right tempered-glazing was shattered.

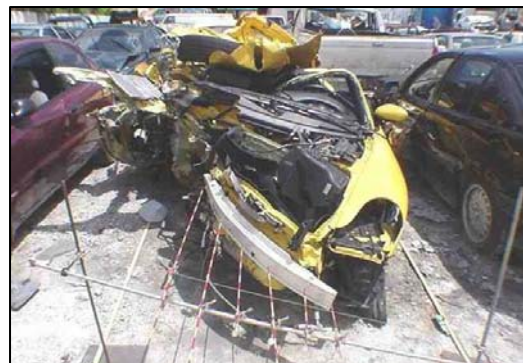
Figure 5 - Damaged 2001 Porsche Boxter

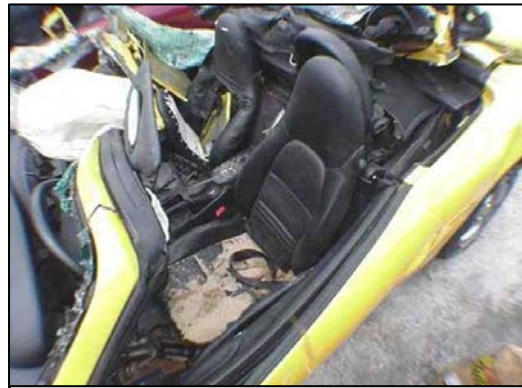
Passenger compartment intrusions of the windshield header and front right instrument panel were documented by the CIREN investigator. This SCI review of their finding determined that the front right door intruded as well. Although the front right door was altered from its original placement, damage to the right side of the front right bucket seat exhibits a damage pattern often seen with door panel intrusion (**Figure 6**). It is likely

Figure 4 - Driver's seating position, stretched webbing of shoulder belt, deformed front right seat.

The 2001 Porsche Boxter was equipped with manual 3-point lap and shoulder belts for the front outboard seats. Both belts were configured with sliding latch plates, fixed D-rings and Emergency Locking Retractors (ELRs). The driver's belt in its relaxed state exhibited severe stretching of the webbing indicative of driver loading (**Figure 6**).

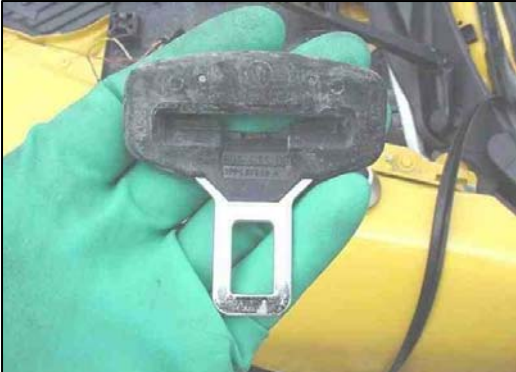
Additionally, a wear mark pattern demonstrating historical usage was visible on the sliding latch plate (**Figure 7**).

Figure 5 - Driver's latch plate.

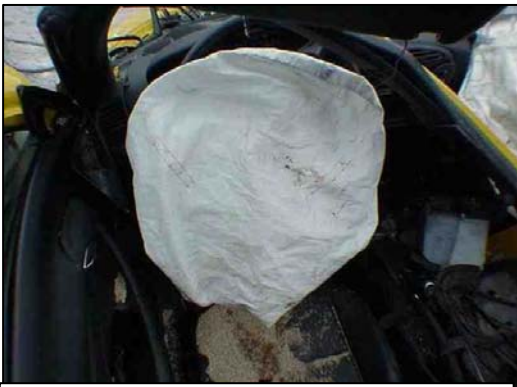
The 2001 Porsche Boxter was equipped with redesigned frontal air bags for the driver and front right passenger positions. The driver and front right air bags deployed as a result of the frontal impact with the hardwood tree. The driver’s air bag deployed from the steering wheel hub that was configured with asymmetrical H-configuration module cover flaps. The upper flap measured 23 cm (9.1”) in width and 23 cm (9.1”) in height. The lower flap measured 18 cm (7.1”) in width and 10 cm (4”) in height. The driver’s air bag (**Figure 8**) measured 50 cm (19.7”) in diameter and was vented by a single circular port at the 12 o’clock aspect on the rear of the air bag. The air bag was not tethered. The CIREN investigator reported no occupant contact evidence on the air bag. However, as illustrated in **Figure 8**, transfers from an unknown origin are present on the right half of the air bag.

Figure 8 - Driver's air bag.

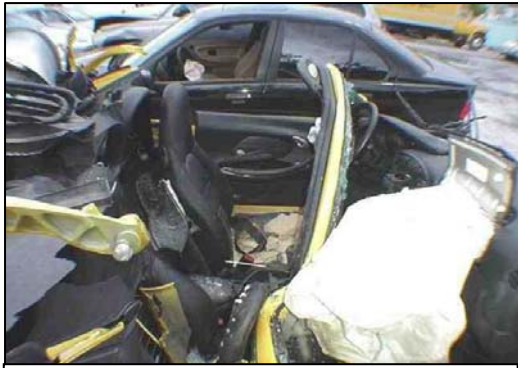
The front right passenger’s air bag (**Figure 9**) deployed from a mid-mount cover flap on the right instrument panel that measured 29 cm (11.4”) in width and 15 cm (5.9”) in height. The deployed front right air bag measured 50 cm (19.7”) in width and 50 cm (19.7”) in height. The air bag was not tethered and was vented by a single port located in the 1 o’clock position on the back of the air bag. There was no damage or contact evidence to the bag.

Figure 9 - Deployed front right air bag.

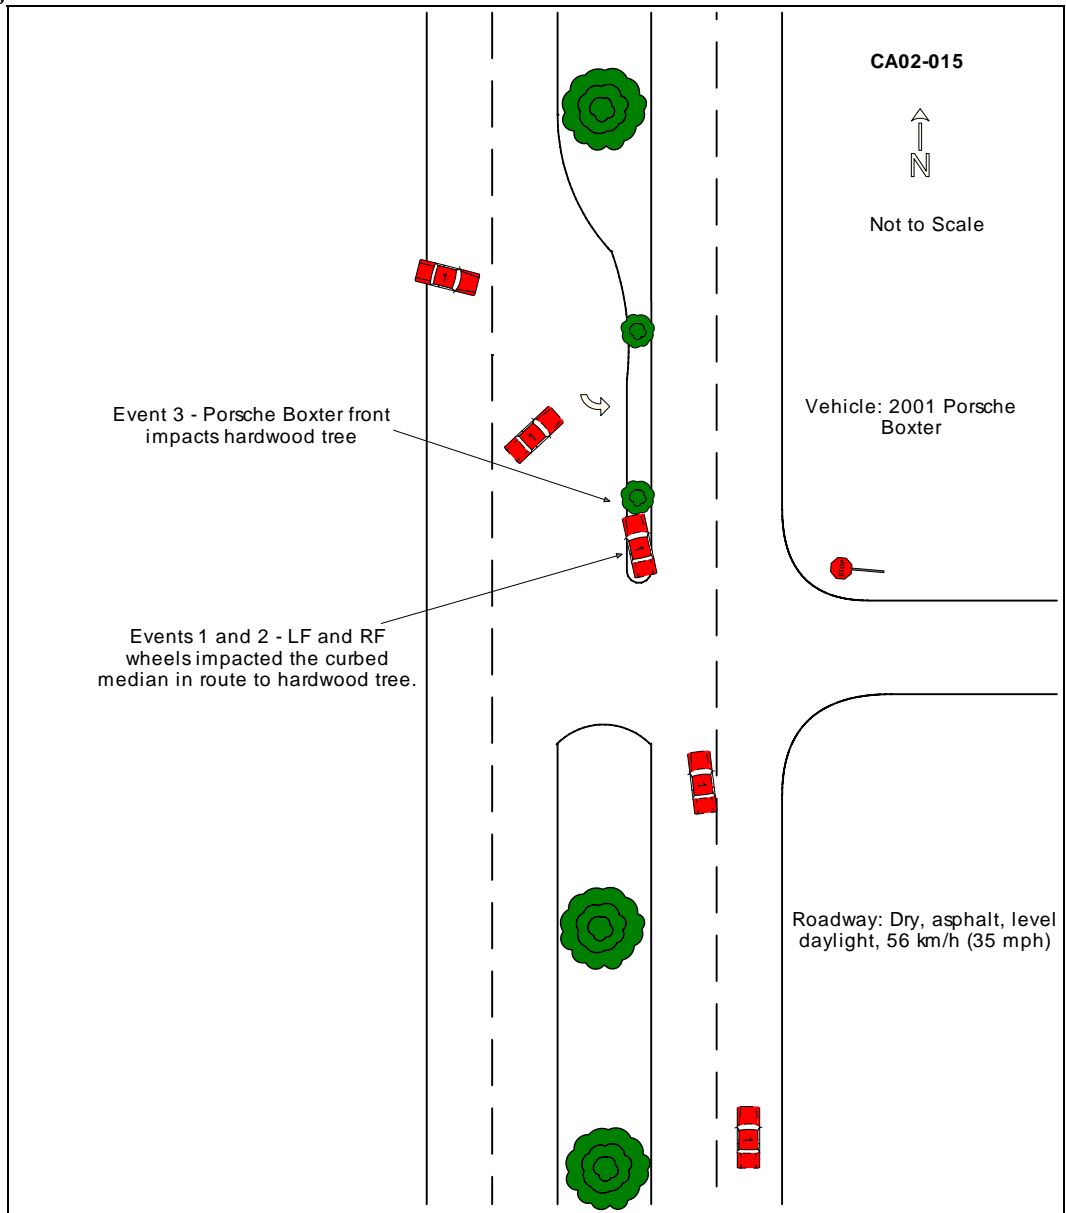
Figure 10 – Scene Schematic

Following the impact, the Porsche rotated clockwise and exited the left aspect of the median, crossed both southbound lanes, and came to final rest straddling the west roadside facing in an eastbound direction
