On-Site Advanced Occupant Protection System Investigation
Dynamic Science, Inc. / Case Number: DS02015
2003 Toyota Corolla S
Washington
June, 2002

Dynamic Science, Inc.
Crash Investigation
Case Number: DS02015

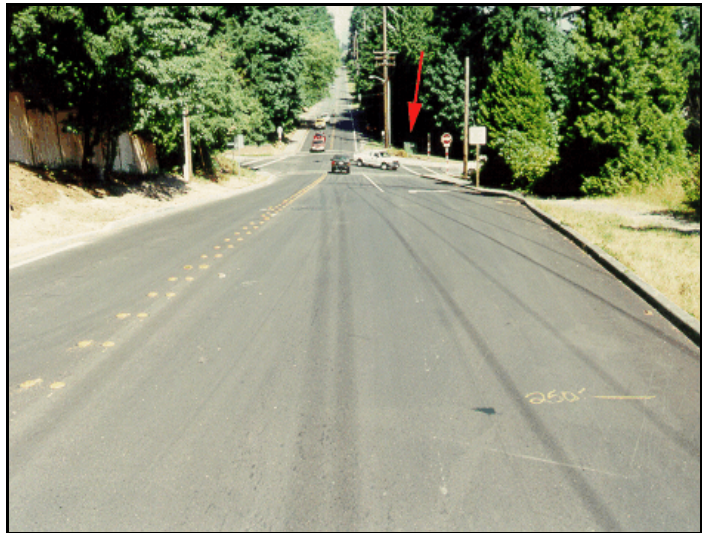
This single vehicle crash occurred in June, 2002 at 2252 hours in the state of Washington. The crash occurred within the confines of a four leg intersection of a residential roadway. The divided westbound approach to the intersection is comprised of one eastbound through lane, one westbound right turn lane, and one eastbound travel lane. The eastbound dry, bituminous roadway is straight and approximately 61 m (200 ft) from the north/east corner the westbound roadway has a -16% downhill grade. All other roadways leading to the intersection were dry, bituminous, straight and level surfaces.

Figure 1. Downhill grade leading to impact areas

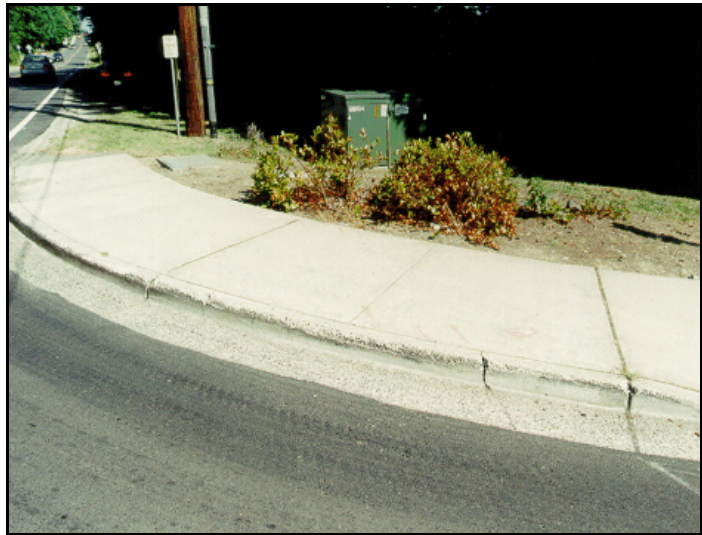
The front right (12FRWN3) and rear right (12FRWN9) tire rims were damaged by impacts with the 16.5 cm (6.5 in) high concrete curbs.

Figure 2. Impacts 1 and 2 with concrete curbs

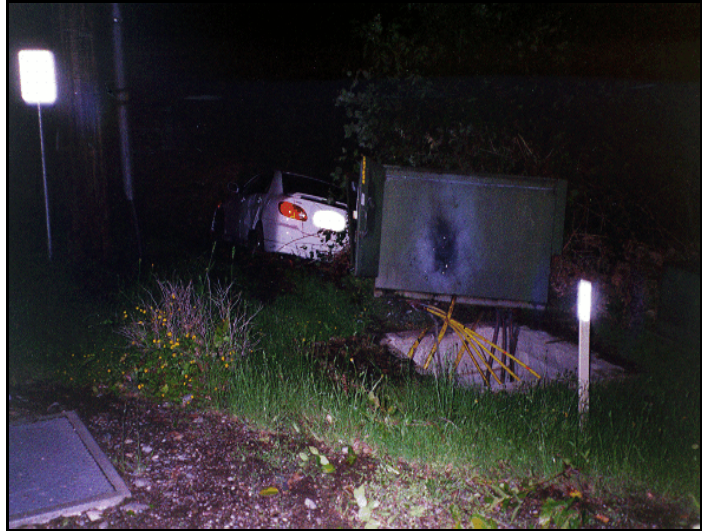
The case vehicle continued moving forward in a southeast direction off the roadway away from the southeast corner. The front right corner (12FREE5) of the case vehicle crashed into a steel power transfer box, knocking the power box forward several feet of its concrete base. The case vehicle sustained a maximum crush of 34.2 cm (13.5 in) at C6. The total velocity change as

Figure 3. Impact with power box and final rest

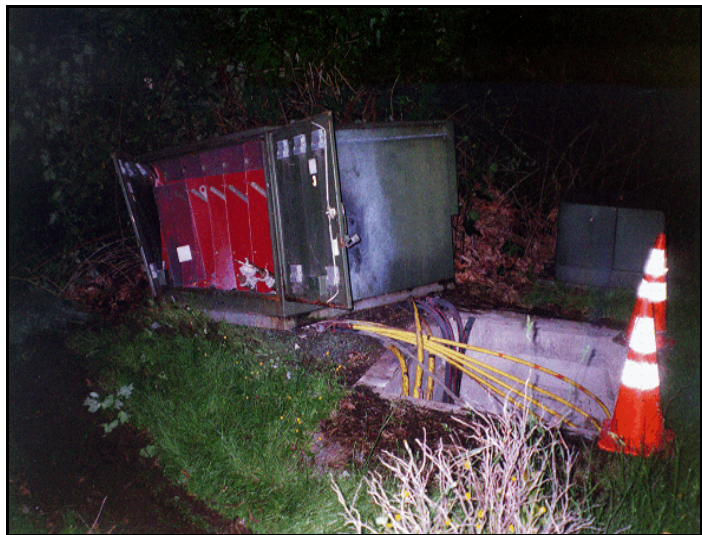
Figure 4. Damaged power transfer box

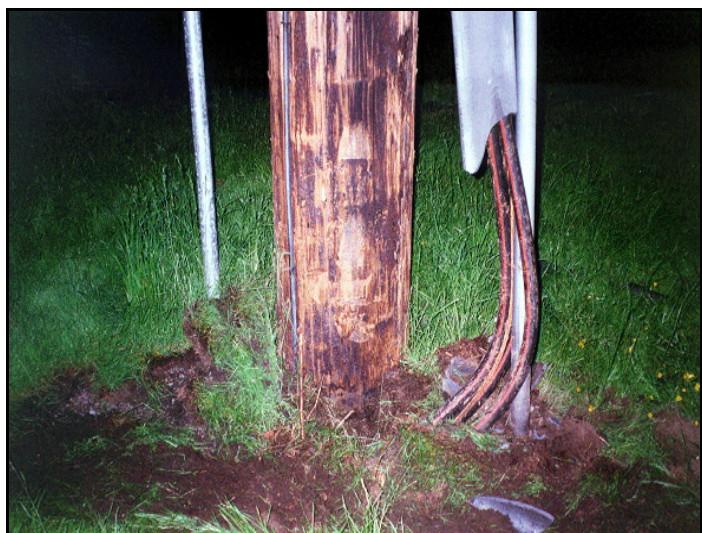
After impact with the power box, the case vehicle rotated clockwise and continued moving forward. The left rear door and rear panel struck (12LZES1) a high voltage wooden power pole and power lines that were sheathed in a plastic tube running up along side the power pole. The case vehicle sustained a maximum crush of 3.0 cm (1.2 in) at C4.

Figure 5. Damage to pole and electrical cabling

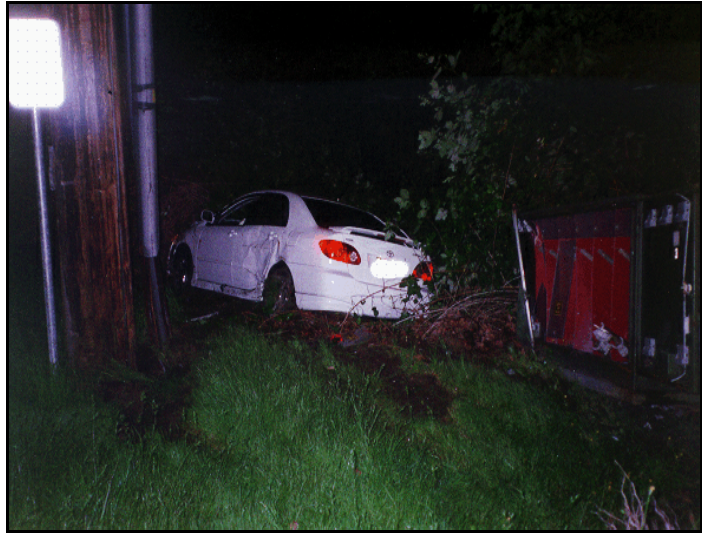
The case vehicle was redirected to clockwise and continued moving forward. The case vehicle came to final rest on all four wheels heading east, several feet east of impact 4 with the high voltage power pole. Electrical power in the area was interrupted for more than two hours.

Figure 6. Final rest area

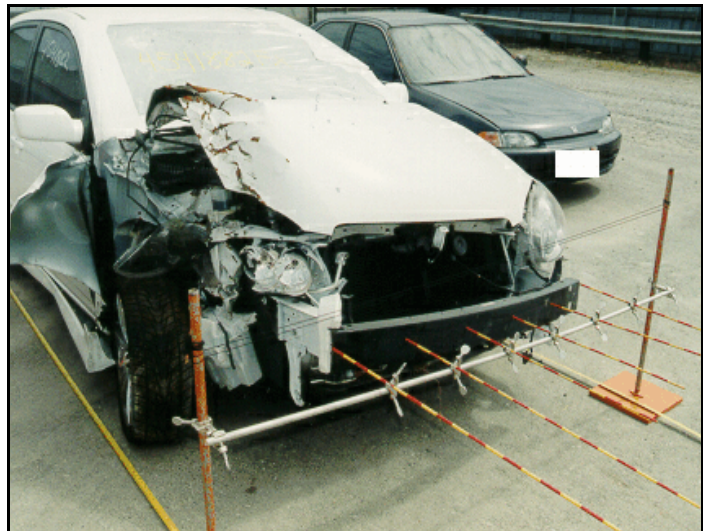
Damage Description: Major damage to front right bumper corner, and front fender. The front bumper fascia cover was off the vehicle. The front right tire was pushed rearward into the vehicle frame. The right wheelbase was shortened 13.3 cm (5.2 in). The front hood, and grille areas also sustained damage. There was damage to the left rear door that extended rearward.

Direct and induced damage from Impact 3 (Steel power transfer box) began at the front right bumper corner. It measured 113.0 cm (44.5 in) and extended laterally to the left. The bumper fascia had been removed prior to the vehicle inspection. Two sets of crush measurements were taken. One at the front bumper backing bar and the second above the bumper. These two sets of crush measurements were averaged and the resultant crush is as follows: C1= 6.8 cm (2.7 in), C2= 0.0 cm (0.0 in), C3=7.6 cm (3.0 in), C4=10.5 cm (4.1 in), C5=12.2 cm (4.8 in), C6=34.2 cm (13.5 in).

Figure 7. Front exterior damage to case vehicle

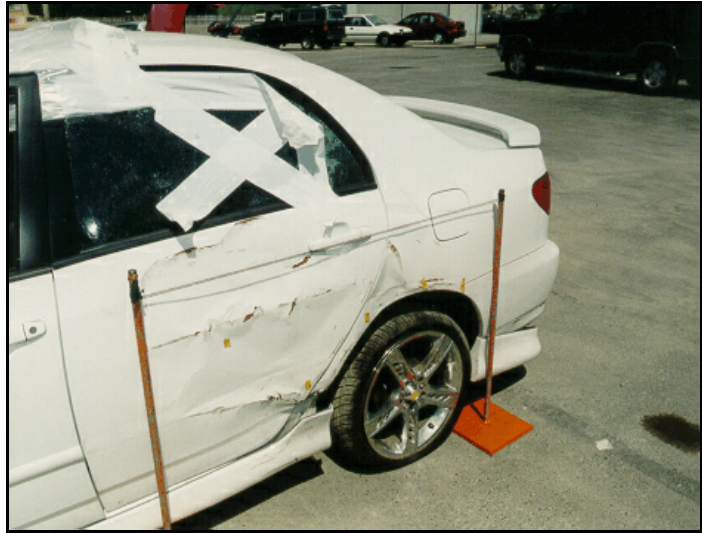
Direct and induced damage from Impact 4 (Power pole/power lines) began 14.0 cm (5.5 in) rearward of the rear left axle. It measured 111.0 cm (43.7 in) and extended rearward. Six crush measurements were taken at the mid-door level and measured: C1= 0.0 cm (0.0 in), C2= 1.5 cm (0.6 in), C3=1.0 cm (0.4 in), C4=3.0 cm (1.2 in), C5=2.8 cm (1.1 in), C6=0.0 cm (0.0 in).

Figure 8. Left rear damage to case vehicle

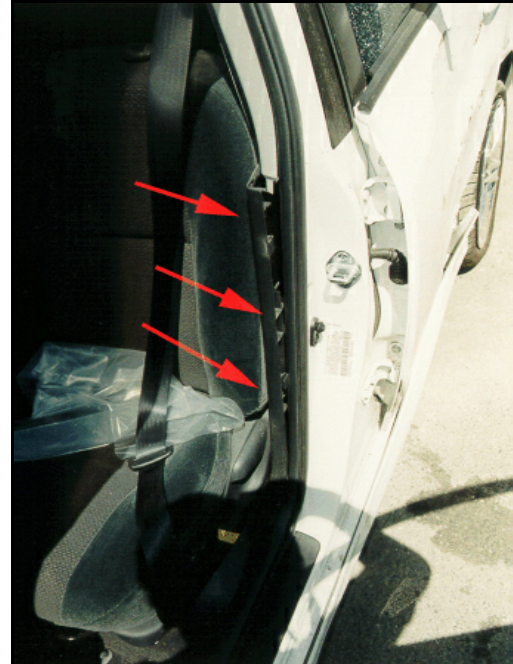
The case vehicle was configured with manual restraint systems at all five seating positions which consisted of a continuous 3-point lap and shoulder safety belts with sliding latch plates. Both front belts restraints were equipped with pretensioners and force limiters, in addition to adjustable shoulder belt anchorages. Both front adjustable shoulder belt anchorages were adjusted to the full up position. The driver's manual restraint was configured with an emergency locking retractor (ELR) located in the B-pillar. The front right seat and all three rear seat positions were equipped with switchable emergency/automatic locking retractors (ELR/ALS). Both front seat belt pretensioners actuated as a result of the impact with the steel power box (impact 3). Both the driver's and front right passenger's lap and shoulder safety seat belts were locked in the extended positions.

Figure 9. Driver's seat belt actuated pretensioner and retractor displaced

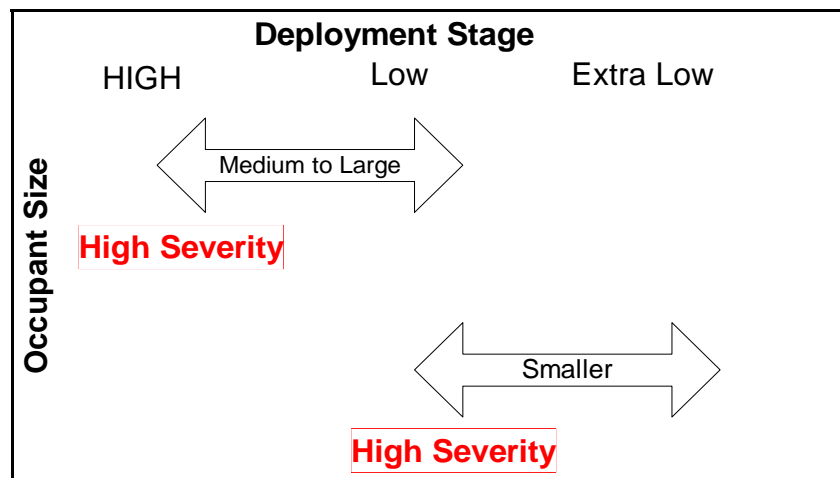
The case vehicle was also equipped with multi-stage driver and front right passenger air bags. The driver's air bag has a three-stage deployment sequence based on impact severity and the position of the driver's seat. A seat position sensor judges the size of the occupant based on the seat position. The driver's air bag will deploy at a faster rate (high stage) or slower rate (low stage) for medium and large size occupants, depending on impact severity. The driver's air bag will deploy at low stage, or extra-low stage for smaller occupants, depending on impact severity. Based on the known seat track position (between middle and rear most position), the air bag should have deployed at a low to high stage with the latter being the most likely.

Figure 10. Driver's air bag deployment logic

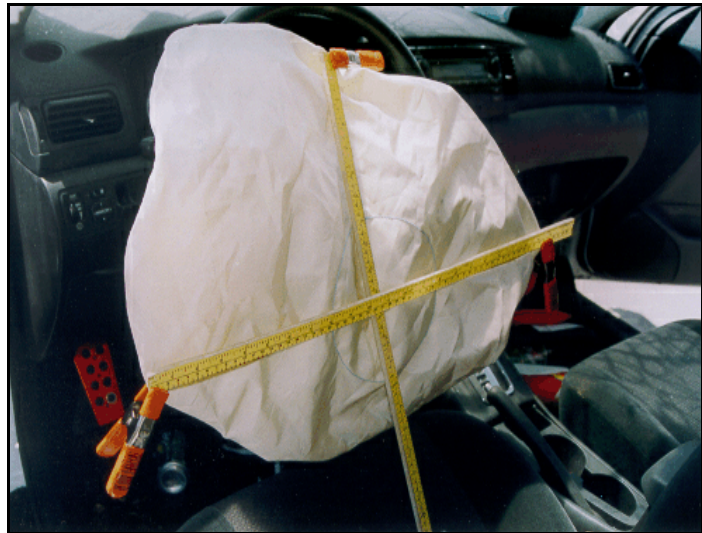
Both front air bags deployed as a result of impact with the steel power box. The circular driver's front air bag was mounted in the steering wheel hub and measured 52.0 cm (20.5 in) in diameter in its post deflated state. The air bag had a maximum excursion of 26.0 cm (10.2 in). There was no evidence of driver contact, but there was what appeared to be light grease about the front face and back of the air bag fabric. The air bag was equipped with two vents ports—located at the 11 and 1 o'clock positions-- and two tethers sewn to the face of the air bag. The driver's module cover flap consisted of an inverted, triangular, curvilinear-shaped cover that contained three asymmetrical flaps. The top and largest flap was somewhat semicircular in design while the left and right lower flaps were obliquely oriented. The top flap measured 15.0 cm (5.9 in) horizontally and 9.0 cm (3.5 in) vertically. The two lower flaps were mirror imaged and each measured 9.0 cm (3.5 in) diagonally. The inspection of the air bag's module cover flaps revealed that the cover flaps opened at the designed tear points and there was no damage to the covers. There was no steering wheel rim deformation.

Figure 11. Driver's deployed air bag

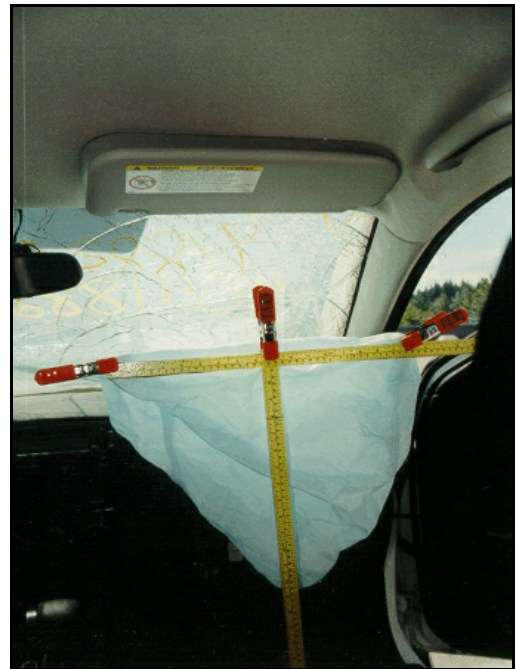
The front right passenger's air bag was a top-mount design located in the right aspect of the instrument panel. The deployed air bag was rectangular and measured 42.0 cm (16.5 in) in width and 45.0 cm (17.7 in) in height. The air bag had a maximum air bag excursion of 49.0 cm (19.3 cm). The air bag was not tethered and was vented by two circular ports that were located at the 10 and 2 o'clock positions. There were two symmetrical "H" configuration, modular cover flaps. The cover flaps both measured 20.0 cm (7.9 in) wide by 6.0 cm (2.4 in) high. Inspection of the cover module flaps and the air bag revealed no occupant contacts to either the cover flaps nor the air bag. There was also no damage to the cover flaps nor the air bag. The deployment of the front right air bag cracked the windshield.

Figure 12. FR occupant's deployed air bag

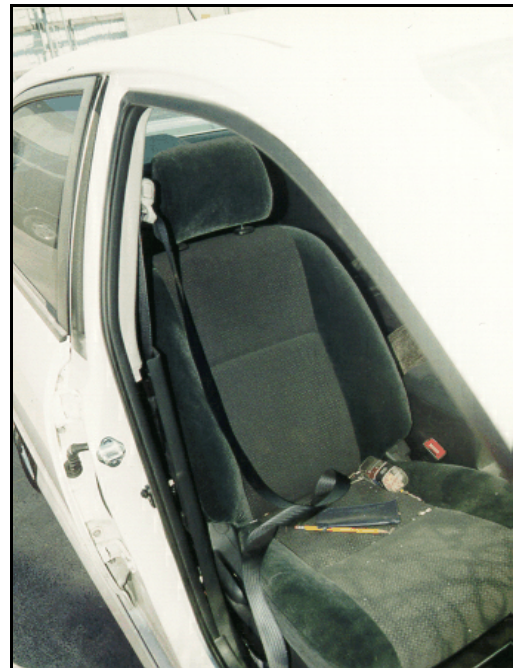
Figure 13. FR occupant's actuated pretensioner and retractor cover displaced

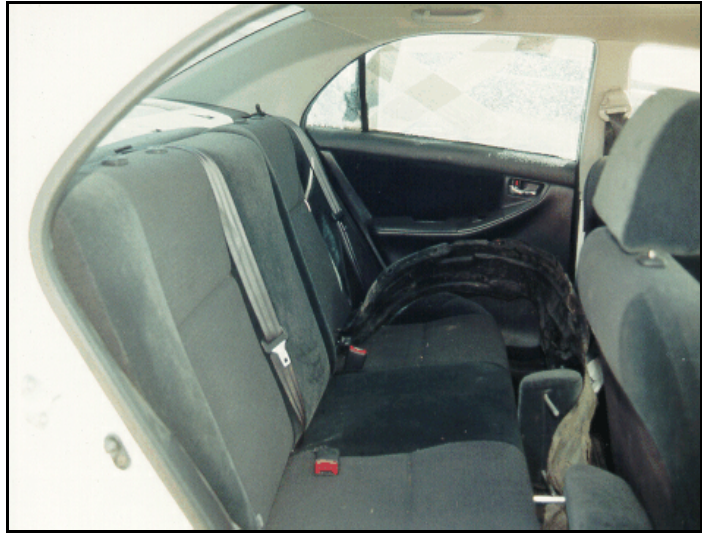
There were three additional occupants in the rear seat as reported by the police. Additionally, there were three other occupants that left the scene prior to the arrival of the police. It is presumed that these three occupants were likely seated in the rear seat, possibly on the laps of the other occupants. The rear seat is a fabric covered bench seat with a 60/40 split folding seat back. There were lap and shoulder safety seat belts with sliding latch plates available to all three seat positions. While there was evidence of historical usage, there no evidence of loading which indicated that none of the rear occupants were using the lap and shoulder belts.

Figure 14. Rear seat area
