INDIANA UNIVERSITY

TRANSPORTATION RESEARCH CENTER

ON-SITE ADVANCED OCCUPANT PROTECTION SYSTEM INVESTIGATION

CASE NUMBER - IN-02-017
LOCATION - TEXAS
VEHICLE - 2002 CHEVROLET TAHOE
CRASH DATE - November 2002

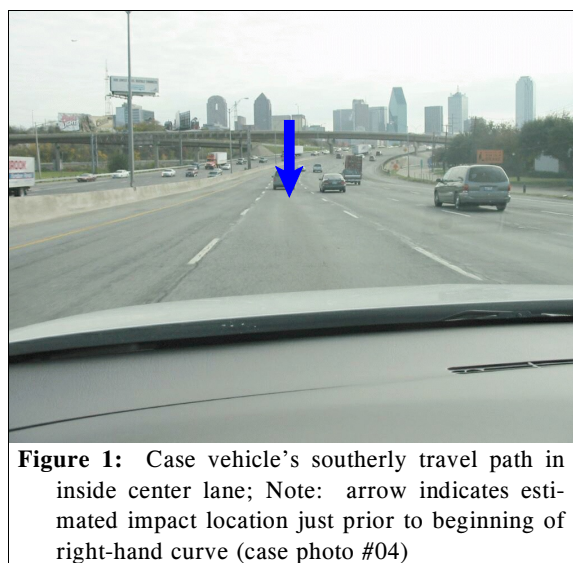
Figure 1: Case vehicle's southerly travel path in inside center lane; Note: arrow indicates estimated impact location just prior to beginning of right-hand curve (case photo #04)

Pre-Crash: The case vehicle was traveling in a southerly direction in the inside center through lane of the southern roadway and intended to proceed straight ahead (**Figure 1**). The Jeep was disabled (i.e., stopped), heading south-southeast in the inside center lane of the same southern roadway. According to his interview, the case vehicle's driver braked and, based on the offset nature of the impact, most likely steered slightly to the left, attempting to avoid the crash. The crash occurred in the inside center southerly lane of the southern roadway.

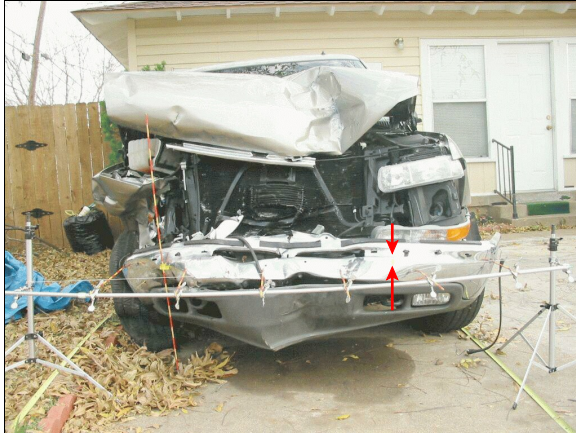
Figure 2: Case vehicle's frontal damage with contour gauge present at bumper level; Note: rightward shift to hood, slight upward rotation of front bumper, and yellow tape (arrows) marks width of direct damage on bumper (case photo #06)

Exterior Damage: The case vehicle's contact with Jeep involved the entire front with the damage distributed all the way across (**Figures 2 and 3** above). Direct damage began at the front right bumper corner and extended 130 centimeters (51.2 inches) inward along the front bumper (**Figure 11**). Crush measurements were taken on the bumper and along the upper radiator support

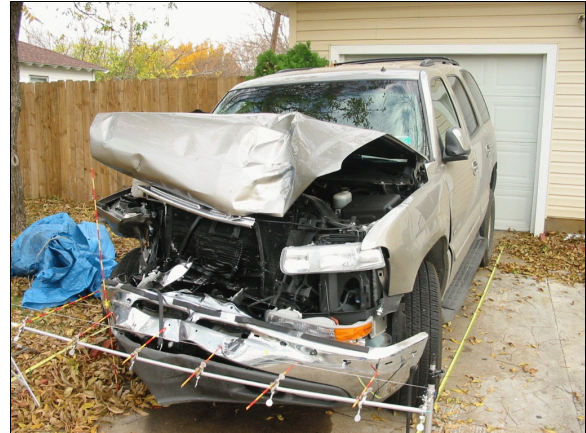
Figure 3: Case vehicle's frontal damage viewed from left of front with contour gauge present at bumper level; Note: rightward offset nature of impact, resulting in rightward shift of hood and more crush to front right corner (case photo #15)

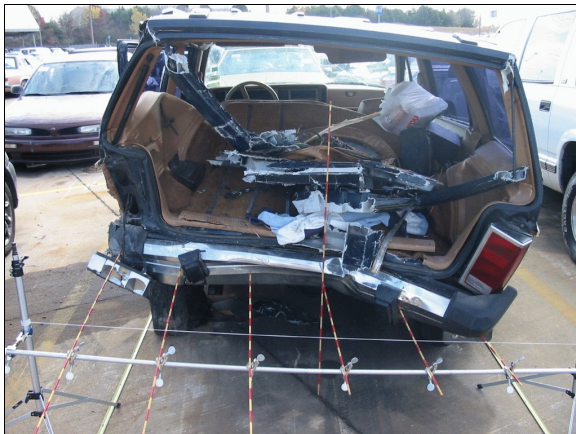
Figure 4: Jeep's back damage with contour gauge present at bumper level; Note: crush to left "D"-pillar and obliterated liftgate and backlite (case photo #72)

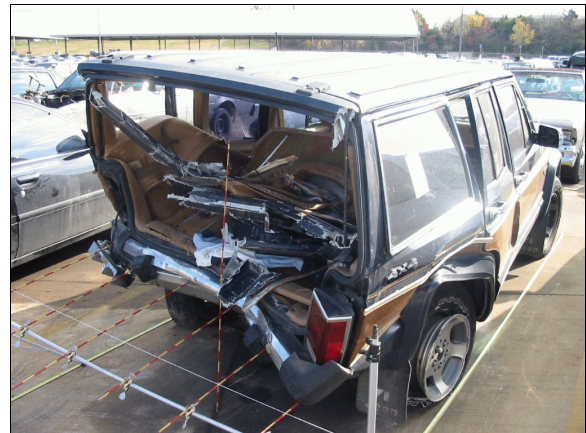
Figure 5: Jeep's back damage viewed from right of back with contour gauge at bumper level showing leftward offset nature of impact, greater crush to back left corner, and damaged left "D"-pillar (case photo #73)

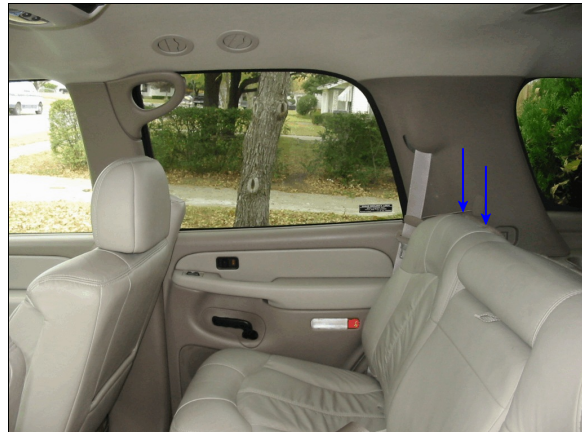
Figure 6: Case vehicle's second seating area showing missing adjustable head restraint (see arrows) for right-most seating position and non-integral safety belt system (case photo #55)

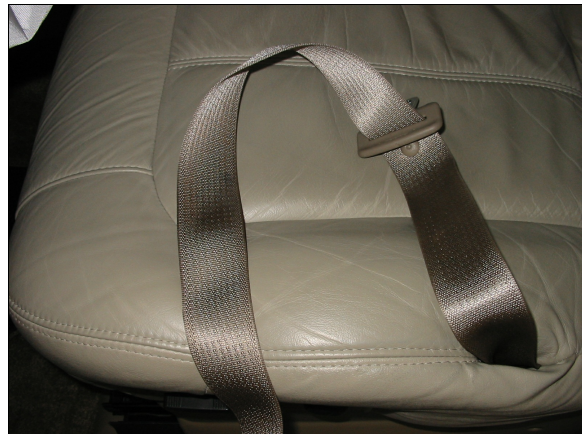
Figure 7: Lap portion of case vehicle's driver integral safety belt anchored within seat cushion (case photo #39)

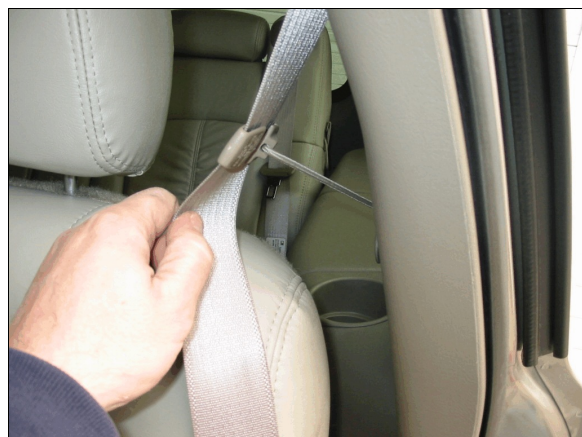
Figure 8: Tether attached to torso portion of Case vehicle's second seat left safety belt; Note: integral safety belt for back left seating position in background (case photo #56)

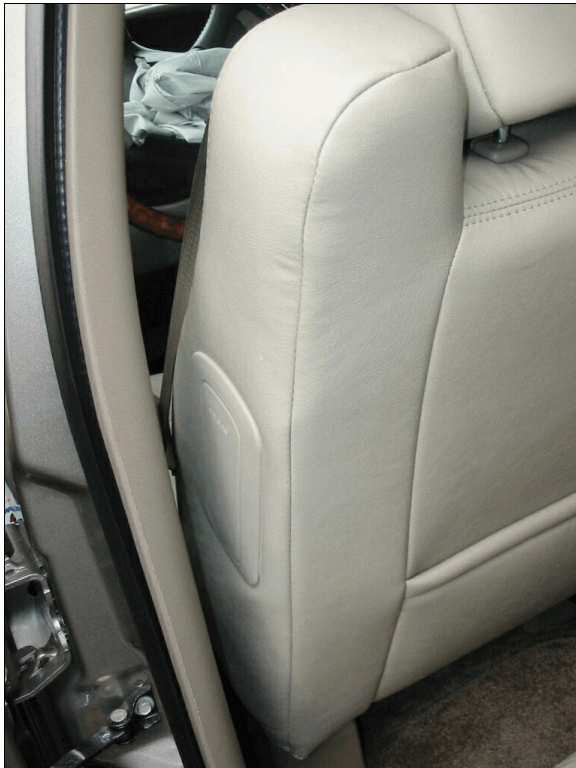
vehicle was equipped with knee bolsters for both the driver and front right seating positions, and neither of which showed evidence of contact or deformation. Automatic restraint was provided by a Supplemental Restraint System (SRS) that consisted of a redesigned frontal air bag for the driver and front right passenger seating positions. In addition, the vehicle was equipped with front, seat back-mounted, side impact air bags. Both frontal air bags deployed as a result of the case vehicle's frontal impact with the Jeep. Neither of the front seat back-mounted side impact air bags deployed as a result of the case vehicle's frontal impact with the Jeep (**Figures 9 and 10**).

Figure 9: Case vehicle's non-deployed left front seat back-mounted side impact air bag (case photo #37)

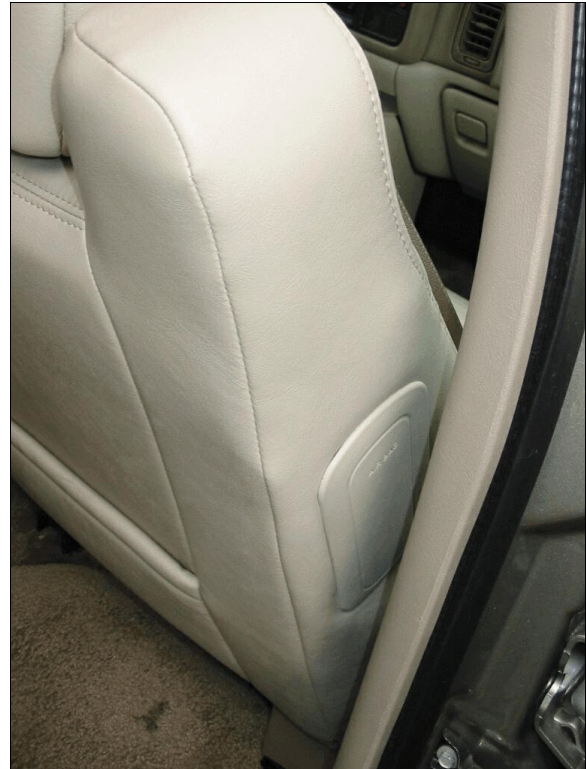
Figure 10: Case vehicle's non-deployed right front seat back-mounted side impact air bag (case photo #36)

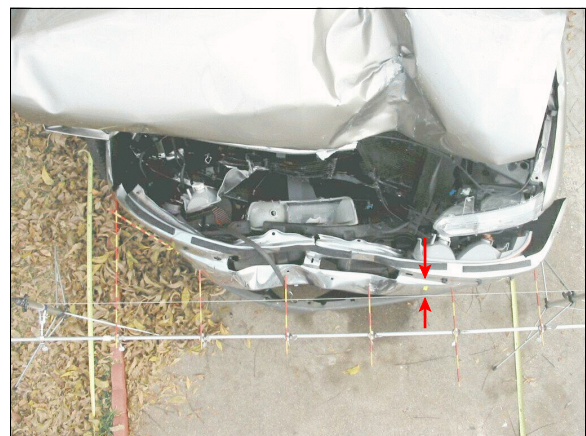
Figure 11: Overhead view of case vehicle's frontal damage with contour gauge present at bumper level; Note: yellow tape (arrows) marks width of direct damage, rightward shift of hood, more extensive crush to front right corner, and imprint in hood—most likely from Jeep's left "D"-pillar (case photo #09)

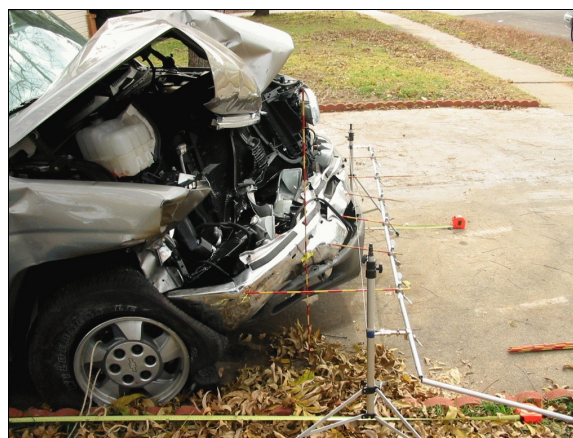
and, where appropriate, the values were averaged. Residual maximum crush at the bumper was measured as 28 centimeters (11.0 inches) at C₆ (**Figure 12**). Above the bumper the residual maximum crush was measured as 50 centimeters (19.7 inches) at C₆. The average residual maximum crush at C₆ was 39 centimeters (15.4 inches). The table below shows the case vehicle’s crush profile.

Figure 12: Case vehicle’s frontal damage viewed along reference line from right; Note: crush more extensive to front right corner (case photo #07)

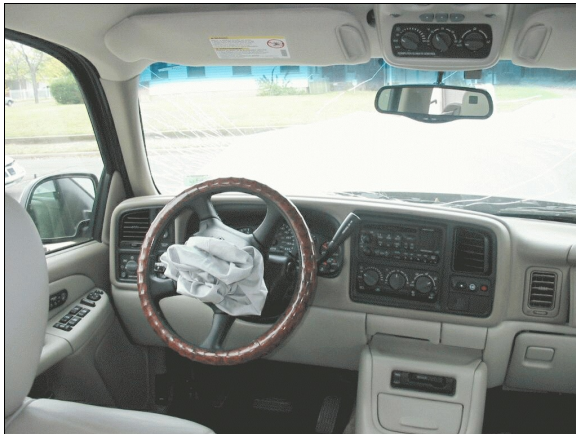
Vehicle Interior: Inspection of the case vehicle's interior revealed that there was no evidence of occupant contact on the interior surfaces of the case vehicle (**Figures 13** and **14**). In addition, there was no evidence of intrusion to the case vehicle's interior, no evidence of compression to the energy absorbing shear capsules in the steering column, and no deformation to the steering wheel rim.

Figure 13: Case vehicle's driver seating area showing no apparent occupant contact evidence on steering wheel, instrument panel, or greenhouse areas (case photo #30)

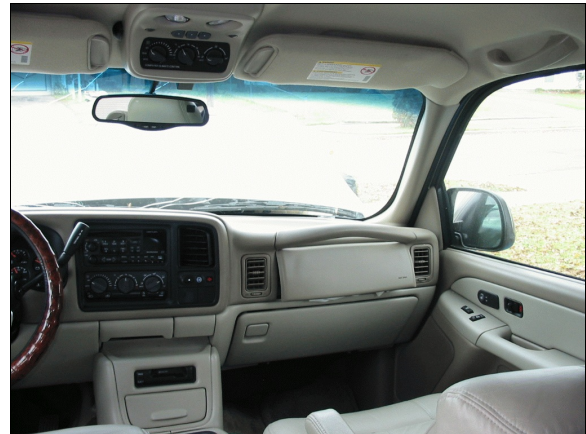
Figure 14: Case vehicle's front right seating area showing no apparent driver contact evidence to center console, instrument panels, or greenhouse areas (case photo #32)

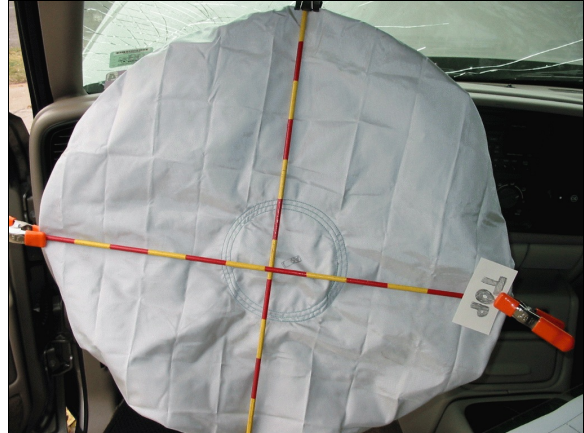
positions. The deployed driver's air bag was round with a diameter of 63 centimeters (24.8 inches). An inspection of the driver's air bag fabric revealed no contact evidence readily apparent on the air bag's fabric (**Figure 15**).

Figure 15: Front surface of case vehicle's deployed driver air bag showing no apparent evidence of occupant contact; Note: steering wheel rim is rotated approximately 90 degrees clockwise (case photo #41)

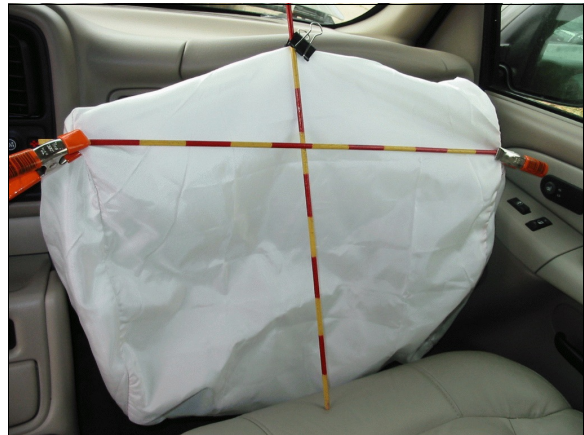
The front right passenger's air bag was located in the middle of the instrument panel. There was a single, essentially rectangular, modular cover flap. The cover flap was made of a semi-pliable vinyl. The flap's dimensions were 39 centimeters (15.4 inches) at the lower horizontal seam and 14 centimeters (5.5 inches) along both vertical seams. The profile of the case vehicle's instrument panel was flush with the leading edge of the cover flap. The distance between the mid-center of the front right seat back, as positioned at the time of the vehicle inspection, and the front surface of the air bag's fabric at full excursion was 22 centimeters (8.7 inches). An inspection of the front right air bag module's cover flap and the air bag's fabric revealed that the cover flap opened at the designated tear points, and there was no evidence of damage during the deployment to the air bag or the cover flap. The front right passenger's air bag was designed without any tethers. The front right air bag had two vent ports, approximately 4 centimeters (1.6 inches) in diameter, located at the 9:30 and 2:30 clock positions. The deployed front right air bag was rectangular with a height of approximately 54 centimeters (21.3 inches) and a width of approximately 57 centimeters (21.7 inches). An inspection of the front right passenger's air bag fabric revealed no contact evidence readily apparent on the front right air bag's fabric (**Figures 16 and 17**).

Figure 16: Front surface of case vehicle's front right passenger air bag showing no apparent evidence of occupant contact (case photo #48)

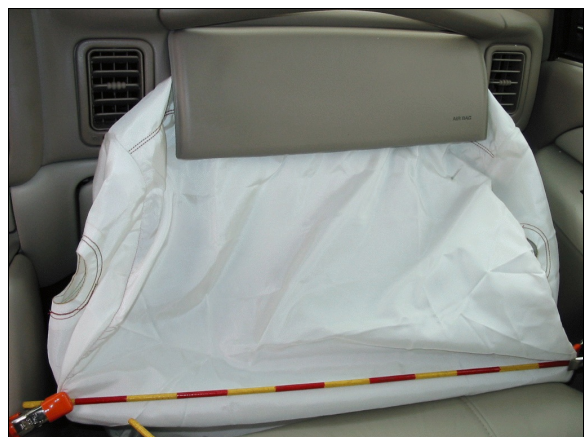
Figure 17: Top surface of case vehicle's deployed front right passenger air bag showing no apparent evidence of occupant contact to top surface or air bag module's cover flap (case photo #49)

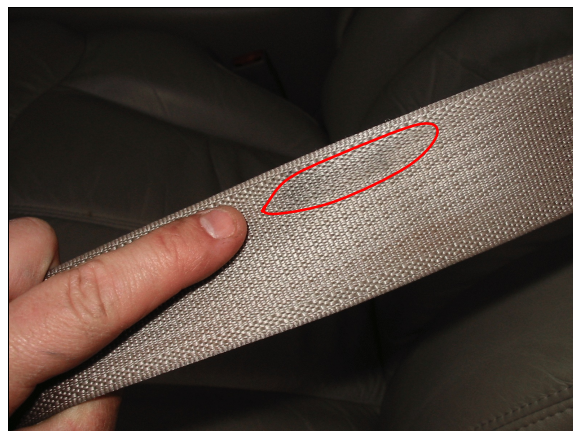
Based on this contractor's vehicle inspection and supported by the **EDR** data, the case vehicle's driver was restrained by his available, active, three-point, integral lap-and-shoulder, safety belt system. Furthermore, the inspection of the driver's seat belt webbing, shoulder belt guide, and latch plate showed trace evidence of loading (i.e., a very slight scuff/burn to the webbing—**Figure 18**).

Figure 18: Slight scuff/burn on webbing of shoulder belt portion of case vehicle's driver safety belt (case photo #38)

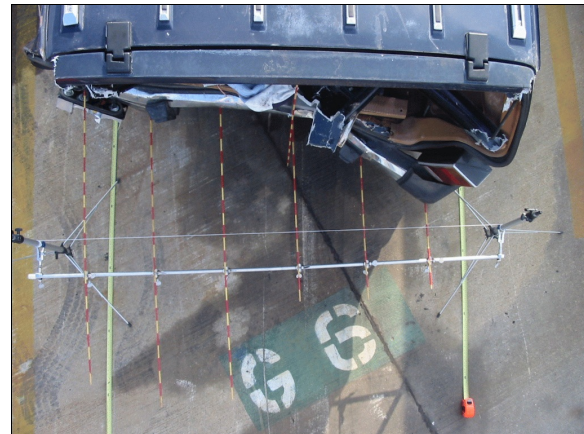
Exterior Damage: The Jeep’s contact with the case vehicle involved the entire back with the damage distributed all the way across (**Figure 19**). Direct damage began at the back left corner and extended inward a distance of 141 centimeters (55.5 inches) along the back bumper. Residual maximum crush was measured as 61 centimeters (24.0 inches) at C₁ (**Figure 20**). The table below shows the Jeep’s crush profile.

Figure 19: Overhead view of Jeep’s back damage with contour gauge present at bumper level; Note: crush more extensive to back left corner (case photo #71)

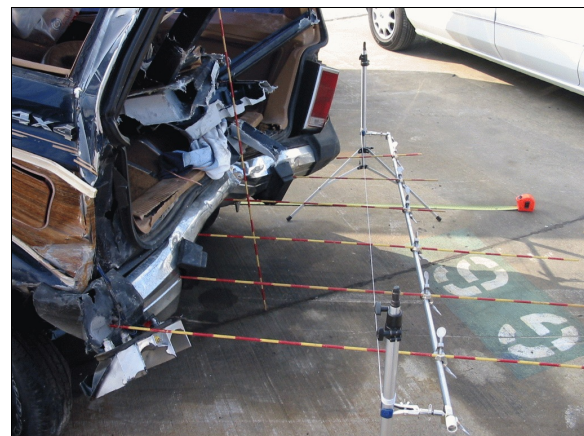
Figure 20: Jeep’s back damage viewed along reference line from left with contour gauge present at bumper level showing crush profile; Note: crush more extensive to back left corner (case photo #69)

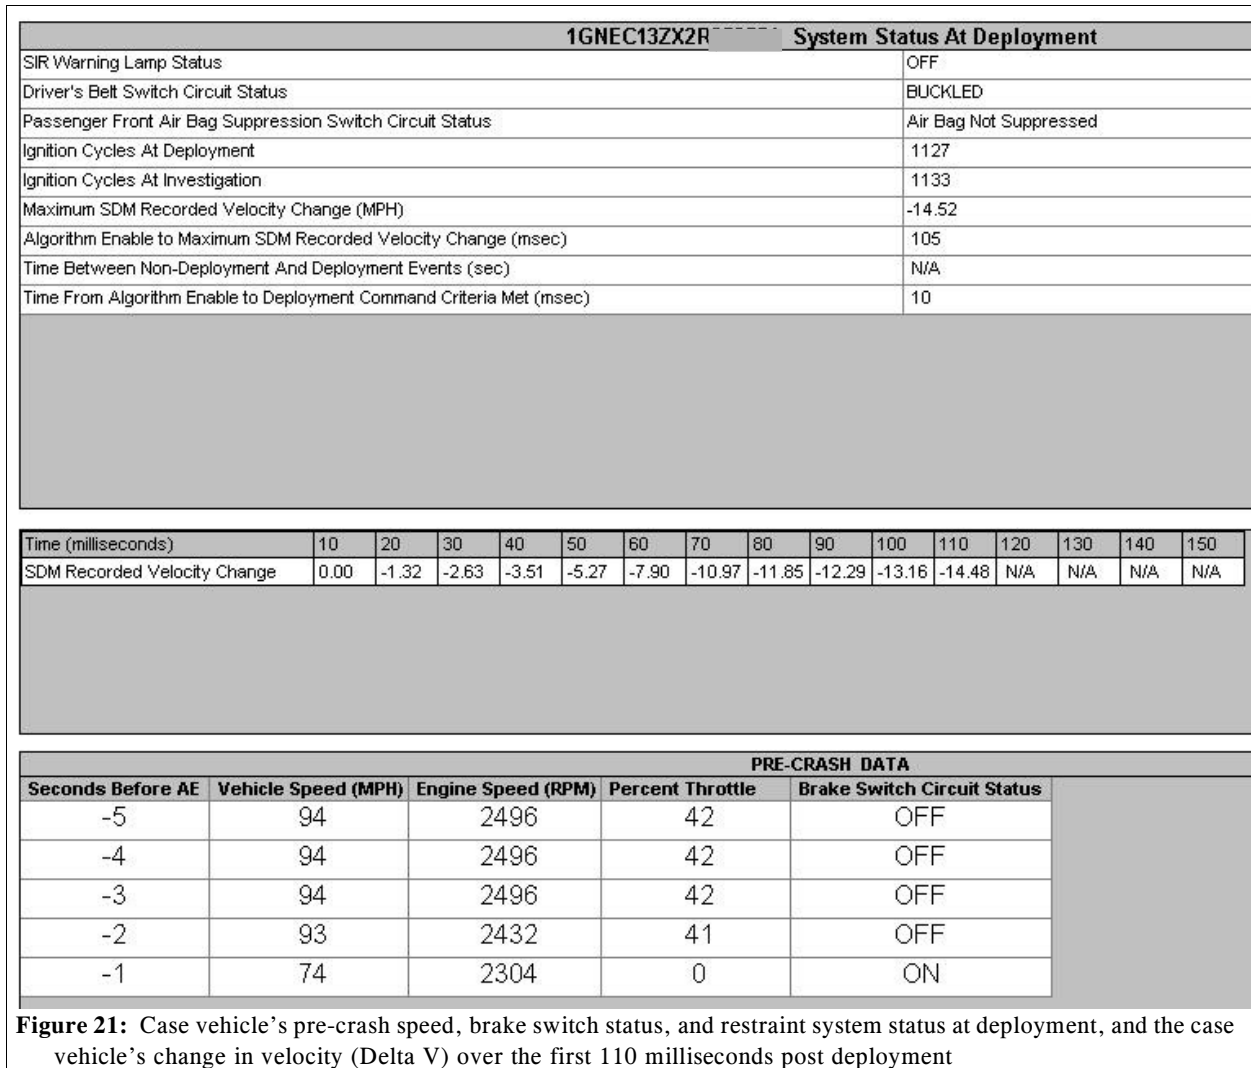
velocity change (i.e., Delta V). Downloaded data of interest indicated the following. The case vehicle was traveling at a speed of 151 km.p.h. (94 m.p.h.), the driver's seat belt status showed it was buckled, and the Delta V had reached a value of 23.3 km.p.h. (14.5 m.p.h.) at the 110 millisecond mark of recorded data; see **EVENT DATA RECORDER DATA (Figures 21 through 23)** below. This contractor believes that the recorded Delta V seems reasonable considering the amount of deformation to both vehicles and the limitations on the **EDR's** recording time.

Figure 21: Case vehicle’s pre-crash speed, brake switch status, and restraint system status at deployment, and the case vehicle’s change in velocity (Delta V) over the first 110 milliseconds post deployment

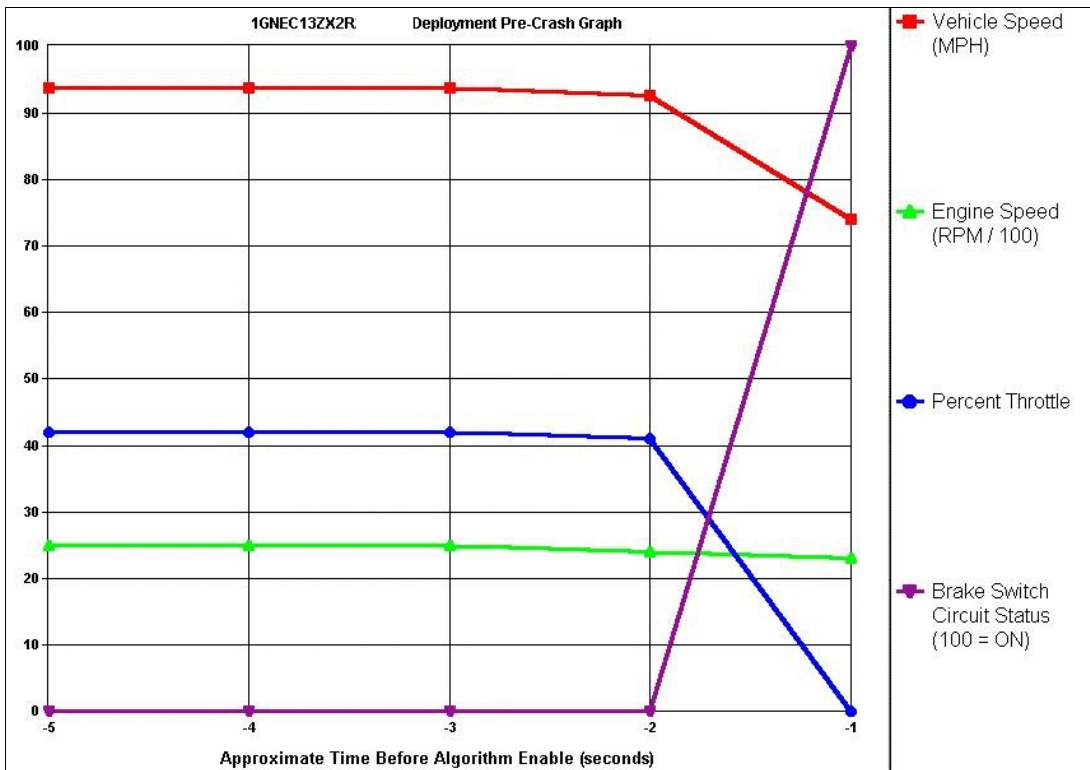
Figure 22: Case vehicle's pre-crash speed and brake switch circuit status showing that the vehicle's speed was recorded at 151 km.p.h. (94 m.p.h.) when the brake was activated approximately 2 seconds prior to algorithm enable.

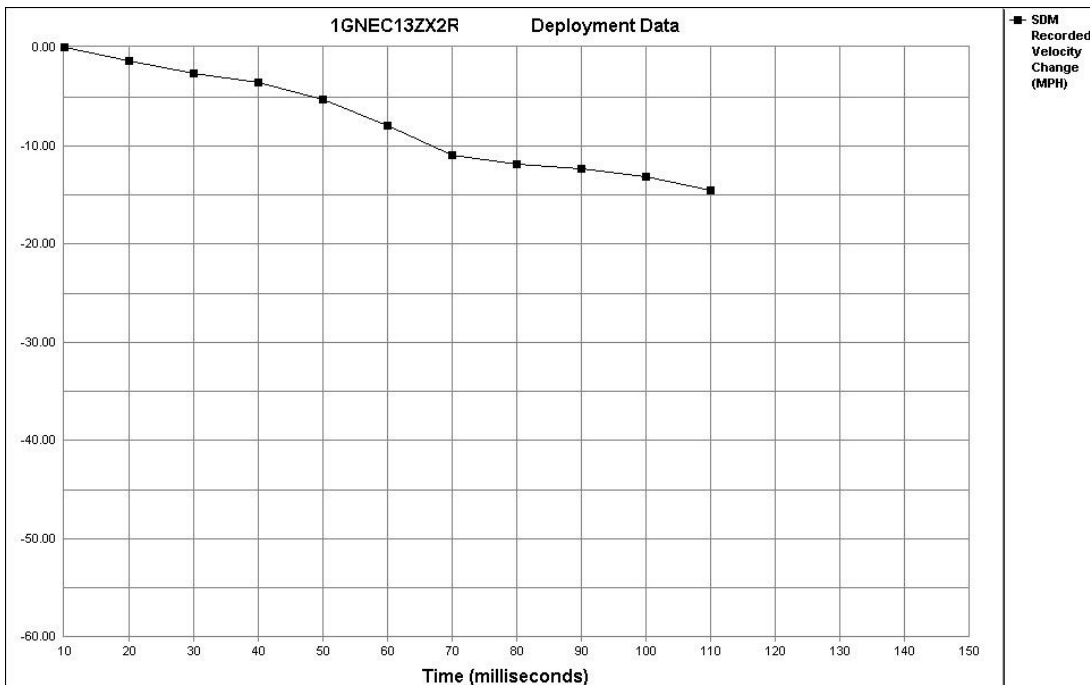
Figure 23: The case vehicle sustained a velocity change of approximately 23.3 km.p.h. (14.5 m.p.h.) during the first 110 milliseconds after the algorithm was enabled; maximum velocity change was recorded as 14.52 km.p.h. (23.37 m.p.h.) at 105 milliseconds
