**ON-SITE ADVANCED OCCUPANT PROTECTION SYSTEMS/CHILD SAFETY SEAT
CRASH INVESTIGATION
SCI TECHNICAL SUMMARY REPORT**

VERIDIAN CASE NO. CA02-018

VEHICLE - 2002 DODGE CARAVAN

CRASH DATE - MARCH 2002

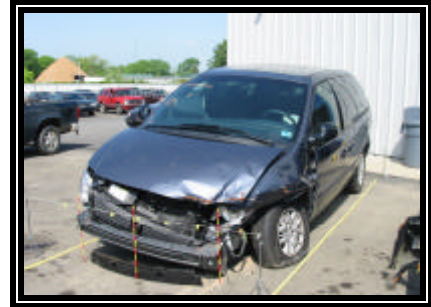
This on-site investigation focused on a two-vehicle crash that involved a 2002 Dodge Caravan (**Figure 1**) that was equipped with an Advanced Occupant Protection System (AOPS) and a 1989 Honda Accord. The Dodge Caravan was occupied by a restrained 36-year-old male driver, a restrained 35-year-old female front right passenger, a 3-year-old male restrained in a forward-facing child safety seat (CSS) on the second seat right position, and a 7-year-old male who was unrestrained and lying across the third seat. The 18-year-old female driver of the Accord failed to negotiate a right curve and crossed the centerline into the opposite travel lanes. The vehicles impacted in an off-set head-on configuration. The impact was sufficient to deploy the frontal air bag system and seat belt buckle pretensioners in the Caravan. The occupants of the Caravan initiated forward trajectories in response to the frontal impact force and loaded the manual restraint systems. The driver sustained seat belt-related contusions, a right knee contusion, and a left wrist sprain. The front right passenger sustained seat belt-related contusions and a left knee contusion. The 3-year-old child in the CSS was not injured. The 7-year-old child sustained a lower back contusion. The occupants of the Caravan were evaluated by rescue personnel at the scene, but were not transported to a medical facility. They sought evaluation from a family physician the following day.

Figure 1. Damaged 2002 Dodge Caravan

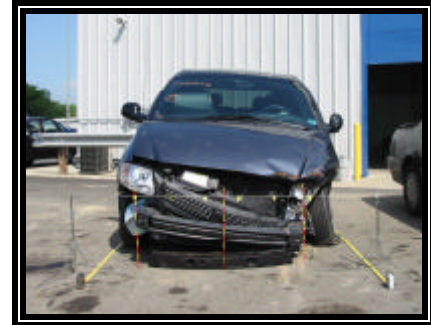
The 2002 Dodge Caravan sustained moderate frontal damage as a result of the impact with the Honda Accord (**Figure 4**). The direct damage began 34.9 cm (13.8") left of the centerline and extended 43.2 cm (17.0") left to the front left corner. The leading edge of the hood was abraded and crushed and the left front fender was crushed rearward and displaced slightly inward from direct contact. The left headlight assembly was separated from the vehicle. The entire bumper fascia and foam filler were separated from the Caravan and the plastic fascia was not available at the time of the vehicle inspection. The foam filler was fractured 49.5 cm (19.5") left of center from direct contact and was fractured 53.3 cm (21.0") to the right of center from induced damage. The combined direct and induced damage measured the entire frontal width of the Caravan. The entire hood was displaced slightly to the right. The top aspect of the grille was fractured 10.2 cm (4.0") to the right of center and entire grille was displaced from induced damage. The left headlight assembly was slightly displaced. The left front wheel was displaced rearward from direct and induced damage, which resulted in the reduction of the left wheelbase by 3.8 cm (1.5") (**Figure 5**). The left front tire was deflated and the left front wheel cover sustained multiple abrasions. The left corner of the bumper beam was crushed rearward and displaced downward, which resulted in the induced displacement of the entire bumper beam. The Collision Deformation Classification (CDC) for the impact with the Honda Accord was 12-FLEW-1. Six crush measurements were taken along the bumper beam. At the time of this PCS, free space had not been obtained and the crush measurements were approximated as follows: C1 = 15 cm (6"), C2 = 13 cm (5"), C3 = 8 cm (3"), C4 = 3 cm (1"), C5 = 3 cm (1"), C6 = 0 cm.

Figure 4. Frontal damage to the Dodge Caravan

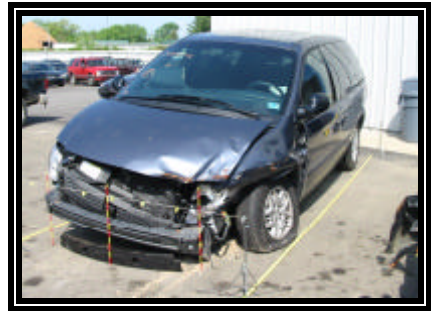
Figure 5. View of left front/left side damage to the Dodge Caravan

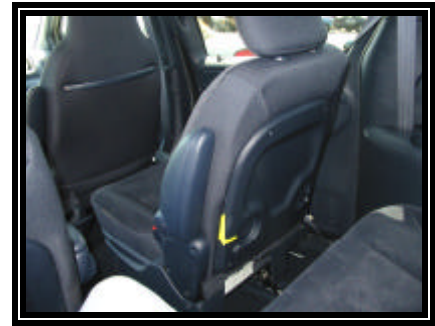
Interior damage to the 2002 Dodge Caravan was minor and attributed to occupant contact. The windshield laminate and vehicle glazing were intact and did not sustain damage. Both front doors were operational and slightly restricted due to the rearward displacement of the front fenders. A scuff which measured 5.7 cm (2.3") in width and 3.2 cm (1.3") in height was located on the knee bolster under the center aspect of the steering column which resulted from contact with the driver's knee. Occupant contact was also identified on the rear inboard aspect of the second row, right side bucket seat (**Figure 6**). The plastic seat back exhibited a scuff which measured 5.7 cm (2.3") in width and 7.6 cm (3.0") in height from contact with the unrestrained 7-year-old child. The rear view mirror appeared to have been displaced, although it was unknown if by occupant contact.

Figure 6. Scuff on the rear aspect of the second row right seat back

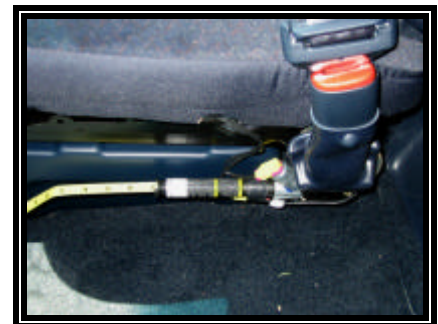
All outboard seating positions in each row of the Caravan were configured with manual 3-point lap and shoulder belts with emergency locking retractors (ELR). The center position of the third row split bench seat was configured with a manual 2-point lap belt. There were no seat belt failures and all seat belts were in working order at the time of the vehicle inspection. The driver's belt was equipped with a sliding latch plate and the remaining lap and shoulder belts were equipped with cinching latch plates. Both front seat adjustable D-rings were adjusted to 7.6 cm (3.0") below the full-up positions. The driver's seat belt webbing exhibited a lateral crease 125.0 cm (49.0") above the lower anchor from probable latch plate loading. Minor stretch marks were located on the upper aspect of the shoulder belt and faint abrasions were present on the driver's D-ring and latch plate from occupant loading. The front right passenger's seat belt displayed minor stretch marks located 108.6 cm (42.8") above the lower anchor and a crease from latch plate loading 116.2 cm (45.8") above the lower anchor. Both front seat belts were configured with buckle pretensioners which deployed as a result of the crash. The driver's pretensioner stroke was 5.1 cm (2.0") and the front right pretensioner stroke was 3.6 cm (1.4") (**Figure 7**).

Figure 7. Front right buckle pretensioner

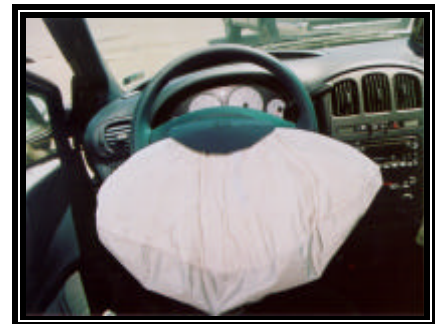
The 2002 Dodge Caravan was equipped with dual-stage air bags for the driver and front-right positions that deployed as a result of the impact with the Honda Accord. The driver’s air bag module was located in the steering wheel hub and configured with a single cover flap design hinged at the top aspect. The cover flap measured 20.6 cm (8.2”) in width and 11.4 cm (4.5”) in height and was contoured in a semi-circular fashion along the bottom aspect (**Figure 8**). The driver’s air bag was circular in shape and measured 61.0 cm (24.0”) in diameter (**Figure 9**). The air bag was tethered by two internal straps located at the 3 and 9 o’clock positions and the circular tether stitching in the center of the air bag face measured 22.9 cm (9.0”) in diameter. There were no external vent ports.

Figure 8. Driver’s air bag cover flap

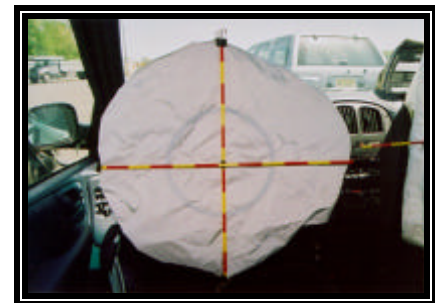
Figure 9. Deployed driver’s air bag

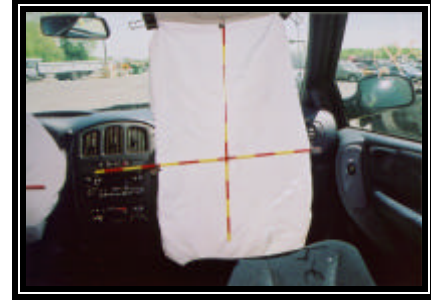
The front right passenger's air bag deployed from a mid-mount module hinged at the top aspect. The rectangular module cover flap measured 30.5 cm (12.0") in width and 22.2 cm (8.8") in height. The cover flap was plastic construction with a vinyl outer surface that was blended with the vinyl on the instrument panel surface, with no obvious tear seams prior to deployment. The side and bottom aspects of the cover flap separated from the instrument panel as the air bag deployed.

Figure 10. Deployed front right passenger's air bag

The front right passenger's air bag measured 40.6 cm (16.0") in width and 71.1 cm (28.0") in height (**Figure 10**). There were no external vent ports or internal tether straps.
