Advanced Occupant Protection System Crash Investigation / Vehicle to Vehicle
Dynamic Science, Inc. / Case Number: DS02020
2003 Toyota Corolla CE four door
Washington
August, 2002

1. Report No. DS02020		2. Government Accession No.		3. Recipient Catalog No.	
4. Title and Subtitle Advanced Occupant Protection System Crash Investigation				5. Report Date October 8, 2003

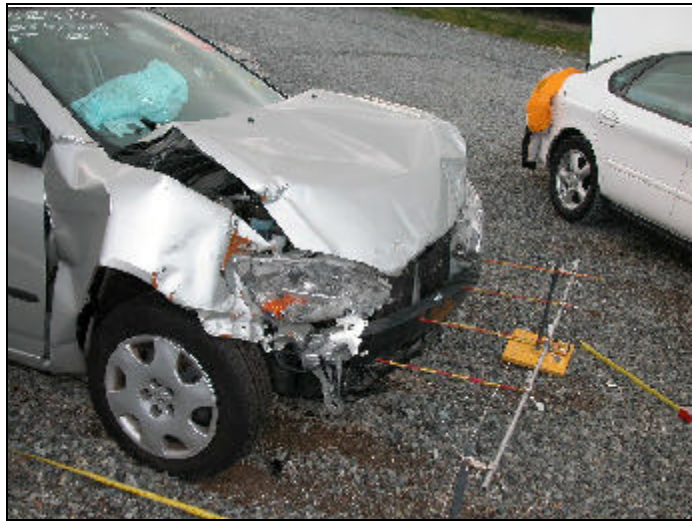
Figure 3. Front right, case vehicle

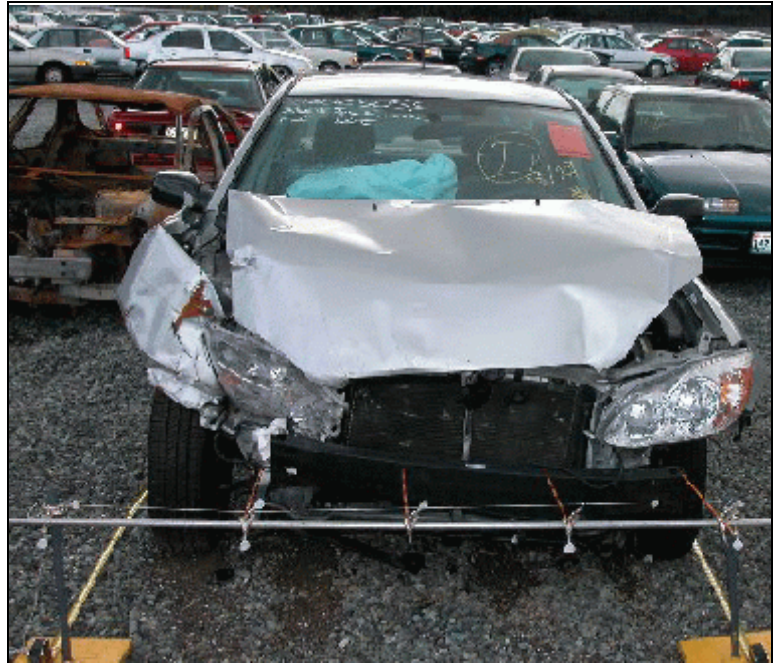
The case vehicle sustained 118 cm (46.5 in) of direct contact damage that started at the front right and extended to the left. The residual crush measured along the bumper reinforcement bar was as follows: C1=12.0 cm (4.7 in), C2=15.0 cm (5.9 in), C3=21.5 cm (8.5 in), and C4=27.5 cm (10.8 in). The maximum crush was located at C4. The reinforcement bar had been shifted to the left by approximately 30 cm (11.8 in). The principle direction of force was within the 1 o'clock sector and was an estimated 30 degrees. The impact energy was managed by the forward structures of the vehicle. The damaged components included the bumper fascia and reinforcement bar, the radiator supports, hood, and both fenders. The right wheelbase had been shortened by 1 cm (0.4 in). There was a single fracture to the right side of the windshield that occurred as a result of the front right air bag deployment. The right rear door was jammed shut. The right front door and left doors all remained closed and operational.

Figure 5. Front, case vehicle

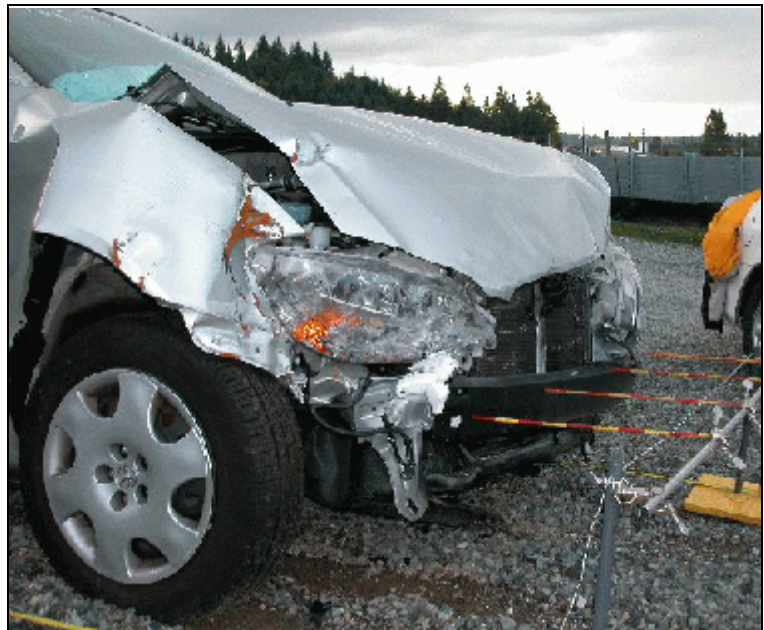
Figure 6. Right side, crush depth

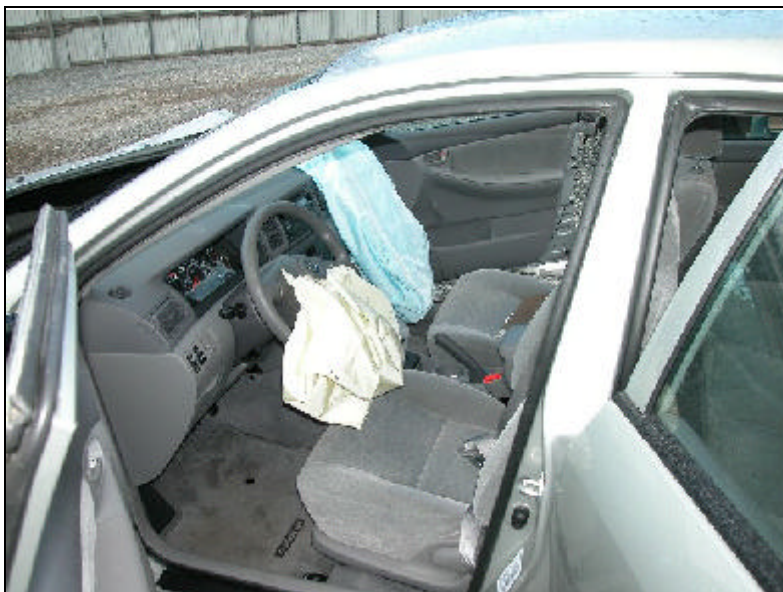
Figure 7. Driver's seated position showing deployed air bags

steering wheel hub and measured 60 cm (24 in) in diameter. The air bag was equipped with two vents—located at the 10 and 2 o'clock positions-- and one tether. The “Y” type module cover opened at the designed tear points and there was no damage to the cover. There was no damage to the air bag nor any occupant contacts found. There was no steering wheel rim deformation nor any steering column movement.

The rectangular front right air bag was mounted in the top of the instrument panel and measured 42 cm (17 in) wide by 53 cm (21 in) high. The air bag was equipped with two vents—located at the 3 and 9 o'clock positions. The dual module cover flaps opened at the designed tear points and there was no damage to the covers. There was no damage to the air bag nor any occupant contacts found.

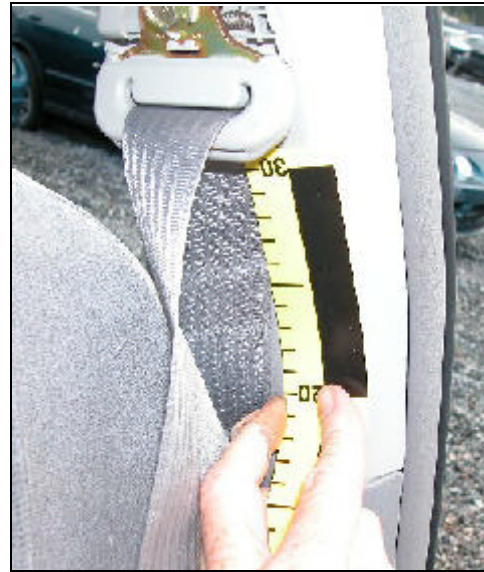
Figure 9. Scuffing to driver's seatbelt

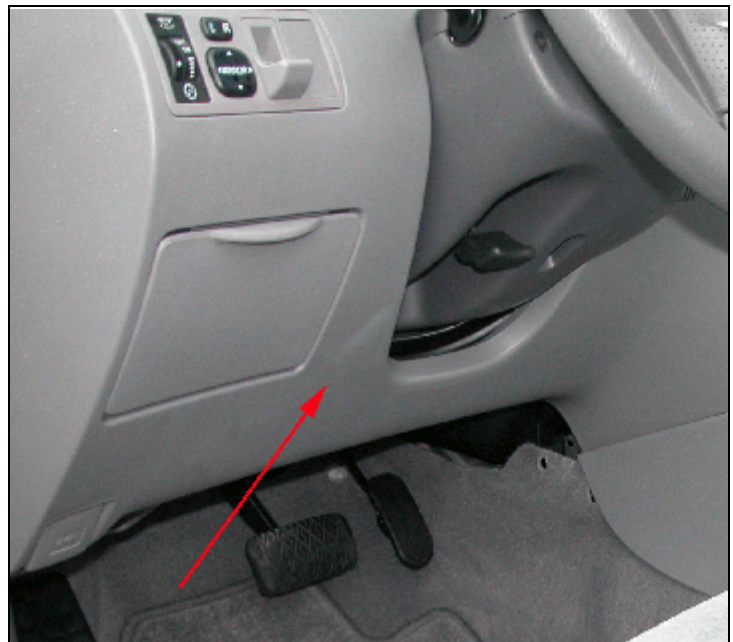
The 23-year-old female driver of the case vehicle was seated in a fabric covered bucket seat that had been adjusted to the forward most track position. She was seated in a normal, upright fashion, and was facing straight ahead with her hands at the 10 and 2 o'clock positions on the steering wheel rim. She was using the available lap and shoulder belts with the shoulder belt upper anchorage adjustment in the full down position. She was wearing metal framed sunglasses and contact lenses. Prior to impact, the driver began braking and steering to the left. The braking motion likely began loading the seatbelt. Upon impact, both front pretensioners actuated and the frontal air bags deployed. The driver responded to the 1 o'clock direction of force by exhibiting a forward and slightly right trajectory and loading the pretensioned and locked manual restraint system. Her upper torso contacted the deployed driver air bag and her knees contacted the lower instrument panel. The driver sustained contusions to both knees from the instrument panel contact. She also sustained chest and middle abdomen contusions from contact with the seatbelt.

Figure 11. Knee contact (scuff)
