Child Safety Seat Fatality/ Vehicle to Object
Dynamic Science, Inc. / Case Number: DS02024
1998 Honda Accord
California
September, 2002

**Dynamic Science, Inc.
Crash Investigation
Case Number:DS02024**

This on-site investigation focused on two child safety seats that were installed in the rear seat of a 1998 Honda Accord. This single vehicle, rollover type collision occurred in California in September, 2002 at 0242 hours. The crash occurred on the roadside of an interstate highway. The case vehicle is a 1998 Honda Accord four door sedan that was driven by a 23-year-old male. The front right seat was occupied by a 21-year-old female. The 2nd row left seat position was occupied by a 20-month-old male seated in a forward facing child safety seat. The 2nd row right seat position was occupied by a 6-week-old female that was seated in a rear facing child safety seat. The case vehicle was traveling southbound and for an unknown reason drove off the interstate, into the right shoulder area. It struck a metal/wood guardrail and rolled over. The vehicle then struck a concrete bridge abutment with its roof/top (see Figure 1). The case vehicle was equipped with a driver and a front right pas

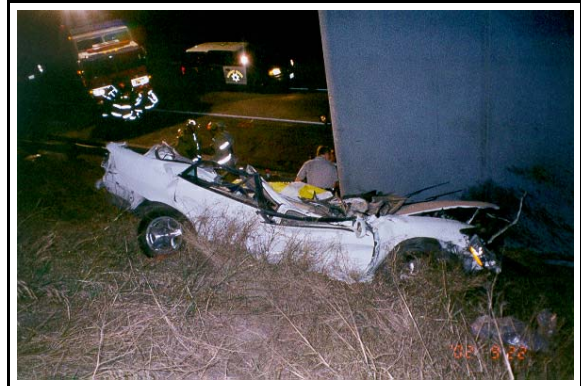
Figure 1. Case vehicle at final rest.

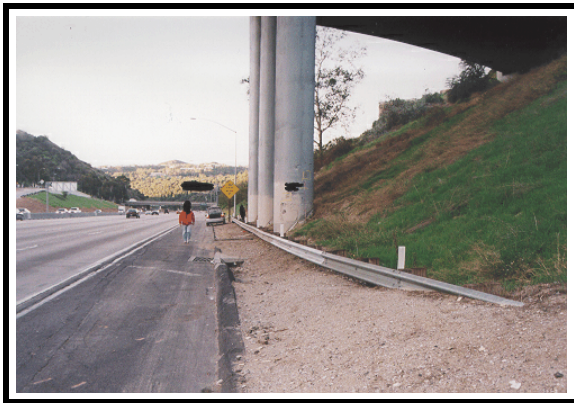
Figure 3. Point of impact

The Honda Accord mounted the west curb and its front end traveled over the turned down end of the west guardrail. The left rear tire contacted the west curb mounting the curb. The center of the undercarriage of Honda slid across the west guardrail (Impact 1). The Honda continued over the guardrail and traveled southwest along the uphill embankment. The left side of the Honda then struck the initial concrete bridge abutment of a bridge over pass (see Figures 3 and 4). The left rear side of the Honda struck the abutment leaving a tire strike mark from the rear left tire. The second row left occupant struck the bridge abutment with his head leaving a mark of blood and brain matter. The Honda then rolled longitudinally to its left about the abutment crossing in its roof (Impact 3). The Honda rotated counterclockwise around the bridge abutment on its roof. The Honda then rolled longitudinally to its right and onto its wheels where it came to final rest facing southeast.

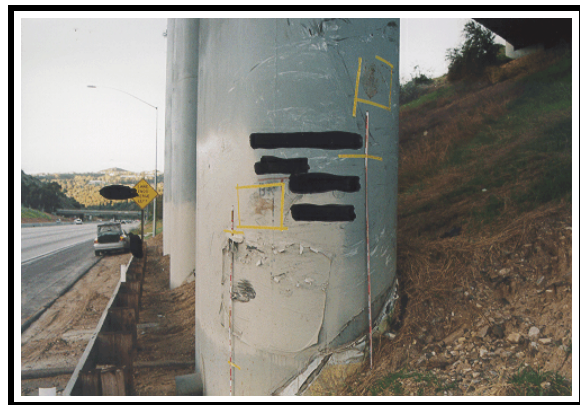
Figure 4. Struck concrete abutment. Occupant contacts are marked in boxes.

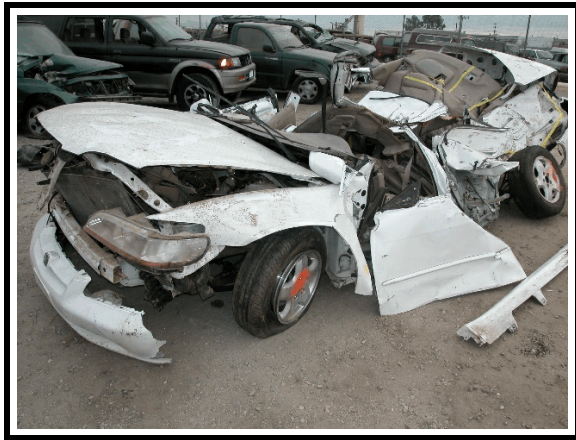
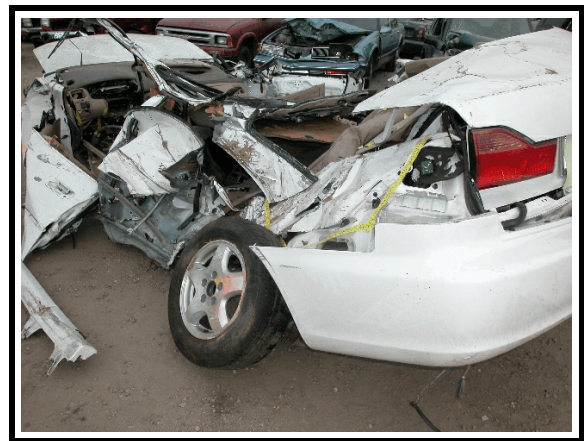
The 1998 Honda Accord sustained extensive damage during this crash (see Figures 5 and 6). The first impact was to the undercarriage as the vehicle overrode the guardrail. The second impact was to the left side as the vehicle initially contacted the bridge abutment. The direct damage began 19.0 cm (7.5 in) rear of the left rear axle and extended 165.0 cm (64.9 in) forward along the left side plane. Six crush measurements were documented along the left side as follows: C1=8.0 cm (3.1 in), C2=35.5 cm (13.9 in), C3=48.0 cm (18.9 in), C4=44.0 cm (17.3 in), C5=14.0 cm (5.5 in), C6=23.0 cm (9.0 in). The Collision Deformation Classification (CDC) for the initial abutment impact was 09LZEW3. The third impact was to the top of the vehicle as it rotated and pitched into the abutment. The entire roof area was essentially crushed to the hood/trunk lid area. The CDC for this impact was 00TPDW5.

Figure 5. Front left, Honda Accord

Figure 6. Rear left, Honda Accord

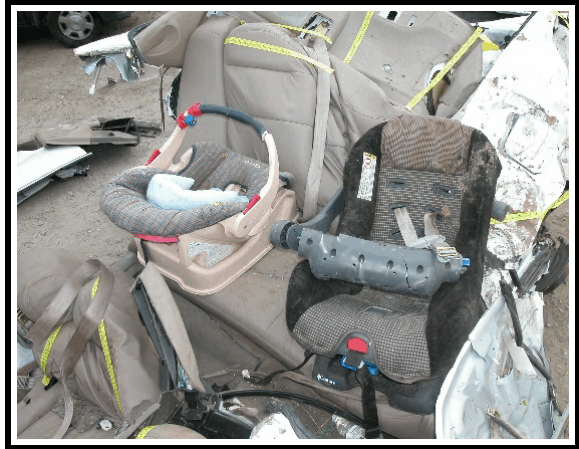
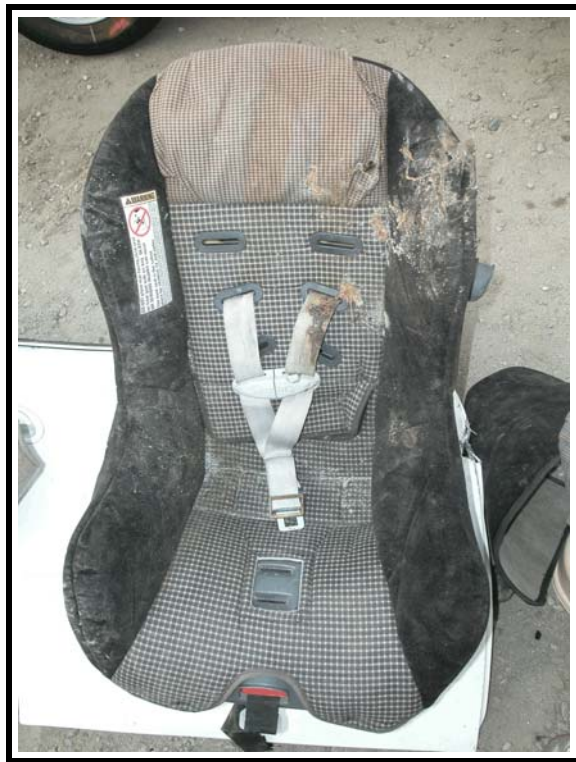
A Century Encore convertible child safety seat was positioned in the left rear seat of the Honda Accord (see Figures 7 and 8). The model number was 4466 and the date of manufacture was May 9, 2001. The convertible CSS was configured with an overhead shield harness system. The manufacturer recommends that the seat be used in the rear facing mode for children from birth to 13.6 kg (30 lbs). Infants from birth to 9.0 kg (20 lbs) MUST use rear-facing mode. Infants or toddlers 9-13.6 kg (20-30 lbs) MAY use rear-facing mode. The manufacturer recommends that the seat be used in the forward-facing mode for children weight 9-18 kg (20-40 lbs). Toddlers who weigh 9-13.6 kg (20-30 lbs) who are capable of sitting upright unassisted may be forward-facing. Toddlers weighing 13.6-18 kg (30-40 lbs) and up to 102 cm (40 in) in height MUST use the forward-facing mode. The seat was being used in the forward facing mode during this crash. The 20-month-old child occupant weighed 13 kg (28 lbs) and was 81 cm (32 in) tall. The child met the forward-facing mode guidelines. The child seat was anchored to the vehicle using the available lap and shoulder belt. It is not known if the switchable retractor had been switched to the ALR mode during installation or not. At the time of the inspection, the harness straps were routed through the middle set of harness slots. According to the instruction manual, when the seat is being used in the forward-facing mode, the harness straps MUST be in the top set of slots. The overhead shield was damaged due to lateral intrusion resulting in the latchplate and harness system pulling through the plastic of the tray shield. Blood and body tissue was found on the upper left portion of the seat back.

Figure 7. Second row child seat configuration

Figure 8. Century Encore child safety seat

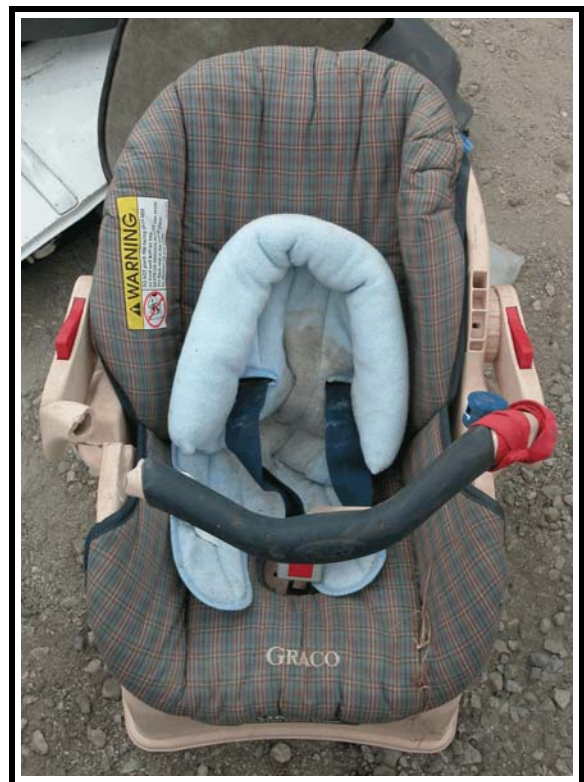
A Graco LiteRider System infant seat was positioned in the right rear of the Honda Accord (see Figure 9). The model number was 8444 and the date of manufacture was November 3, 1999. The rear-facing infant safety seat was configured with a five-point harness system. The manufacturer recommends that the seat be used only for children who weigh 9 kg (20 lbs) or less and who were 66 cm (26 in) in height or less. The 6-week-old child weighed 5 kg (11 lbs) and was 53 cm (21 in) tall. The infant seat was appropriate for a child of this height and weight. The infant seat was anchored to the vehicle using the available lap and shoulder belt. It is not known if the switchable retractor had been switched to the ALR mode during installation or not.

Figure 9. Graco 8444 infant safety seat

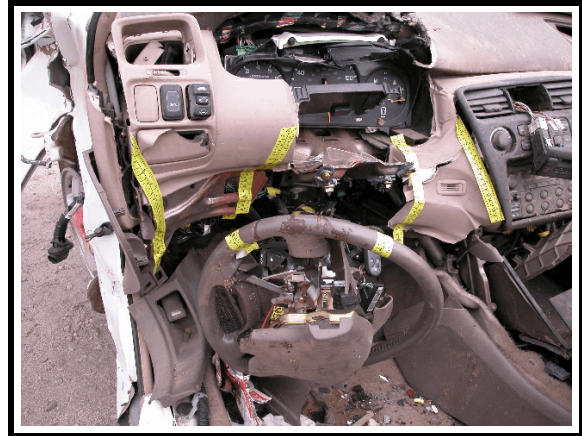
Figure 10. Driver position

The 23-year-old male driver was seated in an upright posture and restrained by the 3-point manual lap and shoulder belt (see Figure 10). The seat track was adjusted to the rear most position. As the vehicle began its clockwise rotation, the driver likely pitched to the left in response to the rotational forces. The effect of the vehicle overriding the guardrail was likely negligible. At impact with the bridge abutment, the driver pitched sharply to the left and slightly forward in response to the 9 o'clock direction of force. The driver sustained numerous injuries related to contacts to the steering wheel rim, left instrument panel, and left door; including: spleen laceration, multiple rib fractures, left tibia/fibula fractures, left humerus fracture, kidney lacerations, and a liver laceration. As the vehicle pitched onto its roof, and the roof intruded into the passenger compartment, the driver sustained major injuries related to the roof contact, including: a transverse skull fracture, and a T-8 spinal fracture.

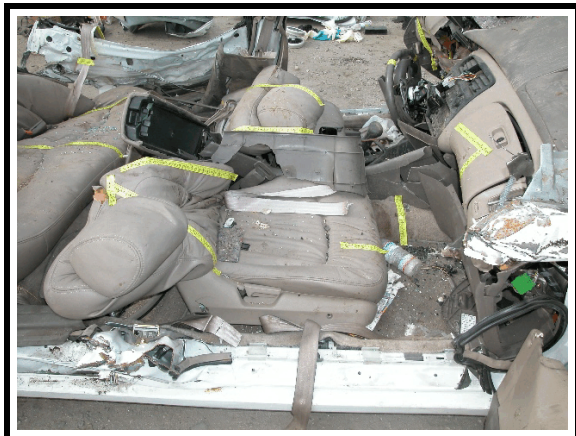
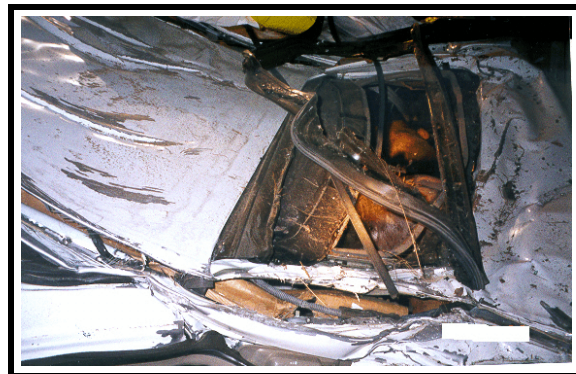
The 21-year-old female front right occupant was seated in an upright posture restrained by the 3-point manual lap and shoulder belt (see Figure 11). The seat track was adjusted to the rear most position. As the vehicle began its clockwise rotation, this occupant pitched to the left in response to the rotational forces. The effect of the vehicle overriding the guardrail was likely negligible. At impact with the bridge abutment, this occupant pitched sharply to the left and forward in response to the 9 o'clock direction of force. She engaged the center console and the driver's seat back—causing a humerus fracture and multiple left side abrasions and contusions. She also engaged the right lower instrument panel—causing multiple lower leg injuries. As the vehicle overturned and the roof was crushed, she sustained multiple skull fractures, spinal fractures, and facial fractures. These injuries occurred in combination with this occupant's head also striking the concrete abutment through the sun roof (see Figure 12).

Figure 11. Front right occupant seated position

Figure 12. Overhead view showing front right occupant through the sun roof.

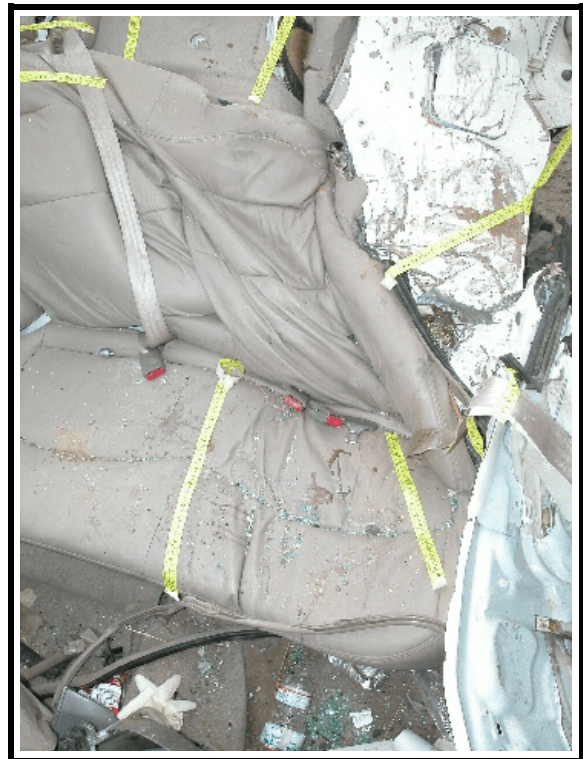
Figure 13. Second row left occupant seated position

The 20-month-old male child was restrained in a forward facing convertible child safety seat by the overhead shield. The child seat was anchored in the second row left seat position with the vehicle's manual 3-point safety belt. As the vehicle began its clockwise rotation, this occupant pitched to the left in response to the rotational forces. The effect of the vehicle overriding the guardrail was likely negligible. At impact with the bridge abutment, this occupant pitched sharply to the left and forward in response to the 9 o'clock direction of force. His lower legs sustained fractures due to the intruding door panel as it came into the lower part of the child seat. The child's head came into contact with the bridge abutment during the initial impact—causing multiple skull and facial fractures. The seat in this position was deformed to the right (see Figure 13) and this occupant and the child seat came into contact with the child seat in the second row right position. There were a number of contusions and abrasions related to this contact.

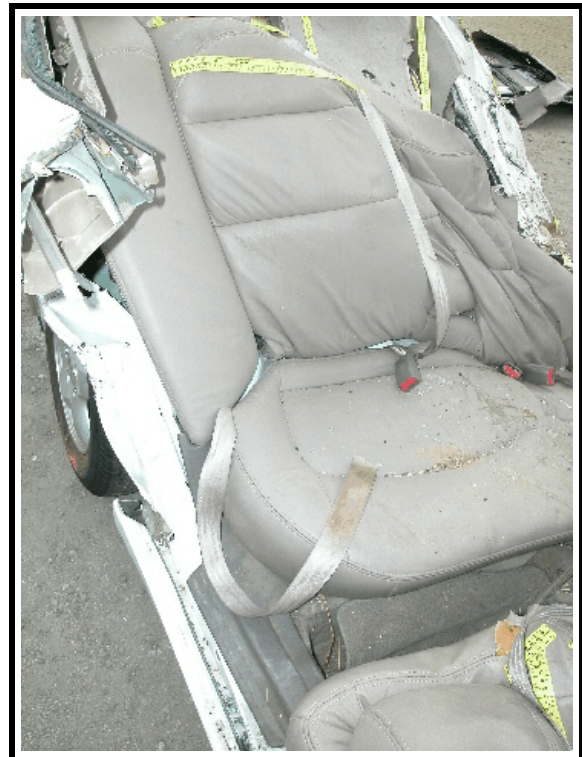
Figure 14. Second row right passenger area

The 6-week-old female child was restrained in the rear-facing infant seat by the five point harness. The child seat was anchored in the second row right seat position with the vehicle's manual 3-point safety belt (see Figure 14). As the vehicle began its clockwise rotation, this occupant pitched to the left in response to the rotational forces. The effect of the vehicle overriding the guardrail was likely negligible. At impact with the bridge abutment, this occupant pitched sharply to the left and forward in response to the 9 o'clock direction of force. She contacted the second row left child seat as it was being pushed to the right by vehicle intrusion. She sustained a left femur fracture from this contact, as well as numerous abrasions and contusions. As the vehicle overturned, and the roof was crushed, the intruding roof contacted this occupant's head causing multiple calvarial fractures.
