**TRANSPORTATION SCIENCES
CRASH DATA RESEARCH CENTER**

**ON-SITE SIDE IMPACT INFLATABLE OCCUPANT PROTECTION
INVESTIGATION**

GENERAL DYNAMICS CASE NO: CA02-029

VEHICLE: 2002 VOLKSWAGEN PASSAT

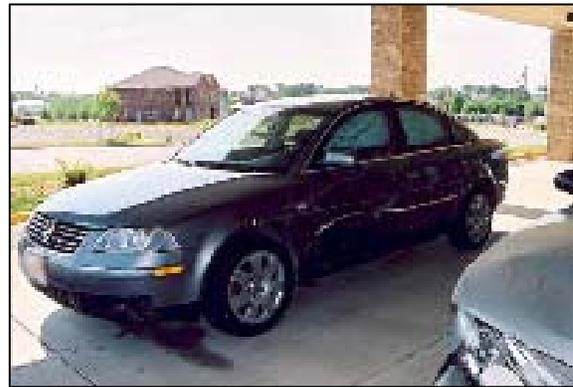
Figure 1. Left side of the 2002 Volkswagen Passat with the deployed side curtain.

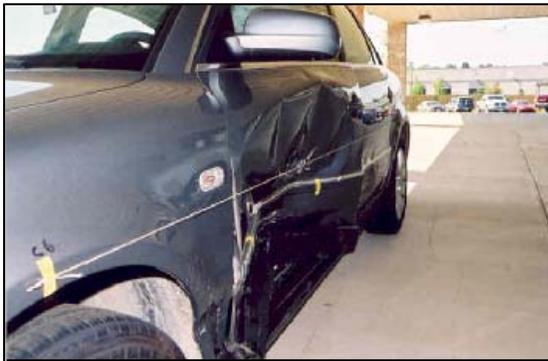
The Volkswagen Passat sustained moderate severity left side damage. The direct contact damage began on the left front alloy wheel at the axle position and extended 310 cm (122") rearward onto the left doors and quarter panel, terminating 38 cm (15.1") rearward of the left rear axle on the wheel opening. This damage pattern, although continuous, involved the initial impact with the left door area (**Figure 4**) by the front left corner of the Escort then continued to a sideswipe engagement as the Passat rotated CCW. Maximum crush was 16 cm (6.4") in depth and was located on the left front door (**Figure 5**), 8 cm (3.0") below the rub strip and 175 cm (67.9") forward of the left rear axle. The crush profile over the length of the damage was as follows: C1 = 0 cm, C2 = 0 cm, C3 = 2 cm (0.8"), C4 = 10 cm (3.4"), C5 = 5 cm (2.1"), C6 = 0 cm. The Collision Deformation Classification (CDC) for this event was 10-LYEW-1.

Figure 4. Damage to the left side of the Passat.

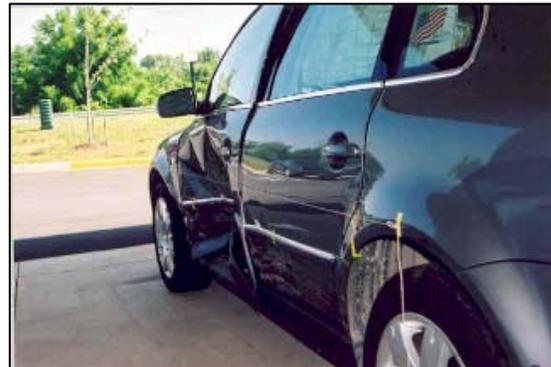
Figure 5. Continuation of damage on quarter panel.

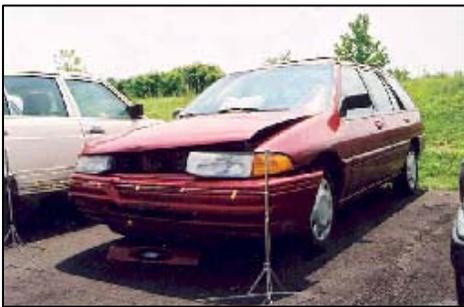
Figure 6. Frontal view of the Escort's damage.

The exterior of the Ford Escort sustained moderate severity damage that was limited to the frontal plane (**Figure 6**). Maximum crush was 13 cm (5.25") located at the right corner of the front bumper. The direct contact damage began 30 cm (12.0") left of center and extended 102 cm (40.0") to the right bumper corner. The impact deformed the full width of the

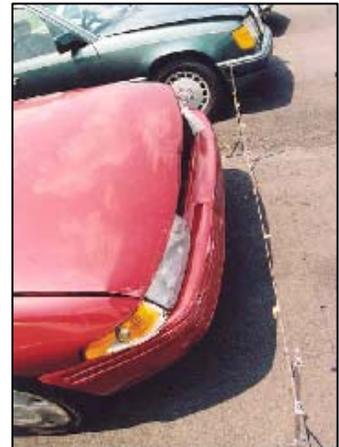
Figure 7. Right profile view of the frontal crush.

bumper system resulting in a combined direct and induced damage length of 144 cm (56.5"). The crush profile at bumper level (**Figure 7**) was as follows: C1 = 13 cm (4.0"), C2 = 11 cm (2.4"), C3 = 12 cm (3"), C4 = 15 cm (4"), C5 = 15 cm (4"), C6 = 17 cm (5.25"). The CDC for this event was 01-FDEW-1.

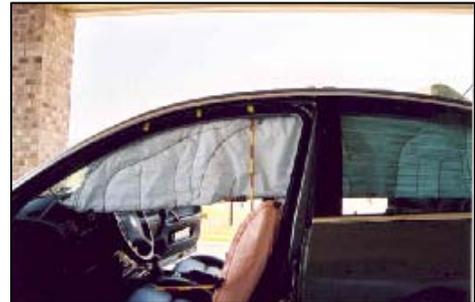
The side impact air bag system utilized seat back mounted air bags that provided abdominal/thoracic protection for the driver and front right passenger positions and side curtain air bags that provided head impact protection to the four outboard seated positions (**Figure 8**). The left side impact air bag and left side curtain air bag deployed as a result of the side impact sequence with the Ford Escort.

Figure 8. Deployed side impact air bag and side curtain.

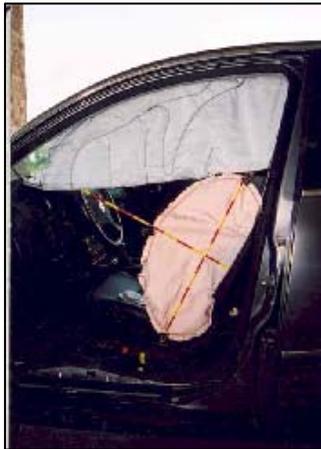
Figure 9. Exterior view of the deployed front left side air bag.

The seat mounted side impact air bag membrane was oval-shaped (**Figure 9**) with a vertical length of 52.1 cm (20.5") and a width of 29.2 cm (11.5") that extended from the inflator to the mid point of the bag. The bag, which extended to the full height of the seat back (**Figure 10**), was vented by a single port at the forward aspect of the peripheral seam. The peripheral stitching was positioned 1.9 cm (0.75") inboard of the edge of the membrane. A break in the stitching formed a vent port that was located 14.0-17.8 cm (5.5-7.0") above the bottom aspect of the bag. The side impact air bag was not tethered internally. Although the driver probably contacted the side impact

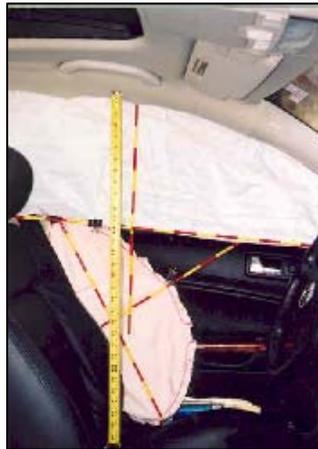
Figure 10. Interior view of the front left air bags.

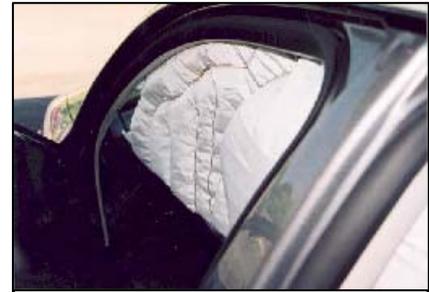
Figure 11. Inflated chamber for the driver's head position.

The side curtain was stitched to form a series of chambers. The primary chamber that offered head protection to the driver (**Figure 11**) measured 52.1 cm (20.5") horizontally at the bottom edge and tapered rearward to approximately 15.2 cm (6.0"). The vertical height of the chamber was 29.2 cm (11.5").

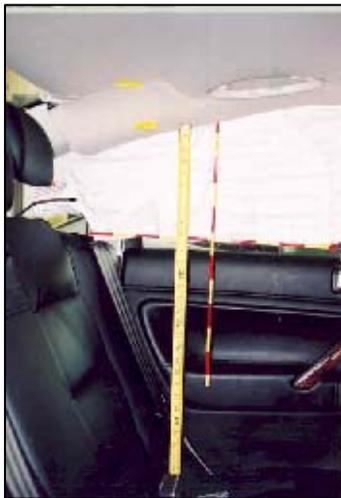
Figure 12. Vertical profile of the rear left side curtain.

The side curtain air bag for the left rear occupant position extended vertically downward from the side rail 31.8 cm (12.5") at the rear aspect of the B-pillar to 22.9 cm (9.0") forward of the C-pillar (**Figure 12**). The vertical height from the of the belt line to the side rail at these points were 36.8 cm (14.5") and 26.7 cm (10.5") respectively. The stitched chamber that provided head protection to a rear seated occupant (**Figure 13**) measured 33.0 cm (13.0") horizontally across the side rail, 21.6 cm (8.5") horizontally at the level of the belt line (bottom of curtain), and 24.1 cm (9.5") vertically.

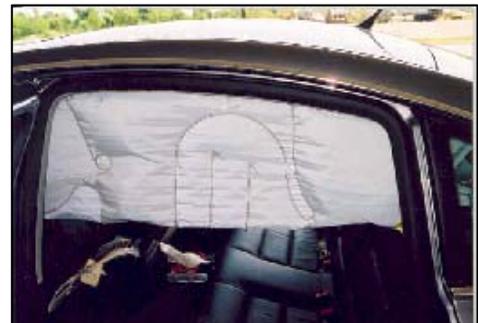
Figure 13. Inflated rear left side curtain.

During the on-site SCI investigation, a small hole was cut into the membrane of the side curtain air bag and the bag was inflated with an available air supply. Although, the bag could not reach peak inflation pressure due to air loss through the bag fabric and the inflator, all chambers of the bag did inflate to various depths.
