On-site Child Safety Seat Investigation / Single vehicle rollover
Dynamic Science, Inc. / Case Number: DS02031
1993 GMC Sierra extended cab pickup
Colorado
November, 2002

1. Report No. DS02031		2. Government Accession No.		3. Recipient Catalog No.	
4. Title and Subtitle On site Child Safety Seat Investigation				5. Report Date September 3, 2003

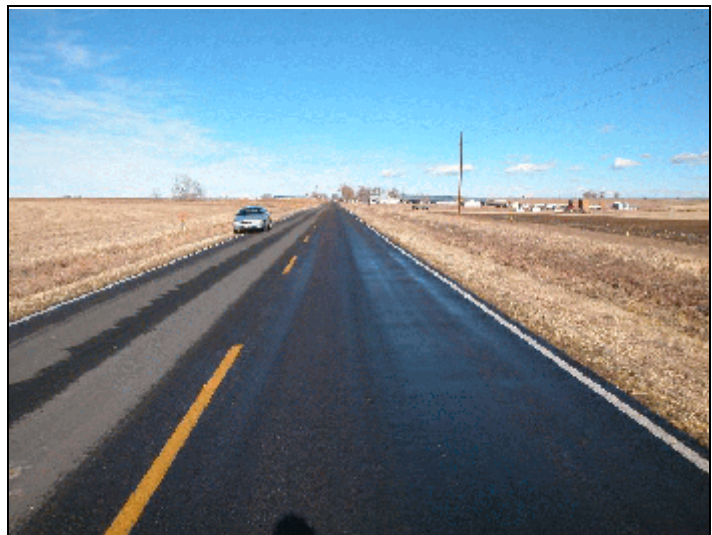
Figure 1. Approach to area of rollover, facing north

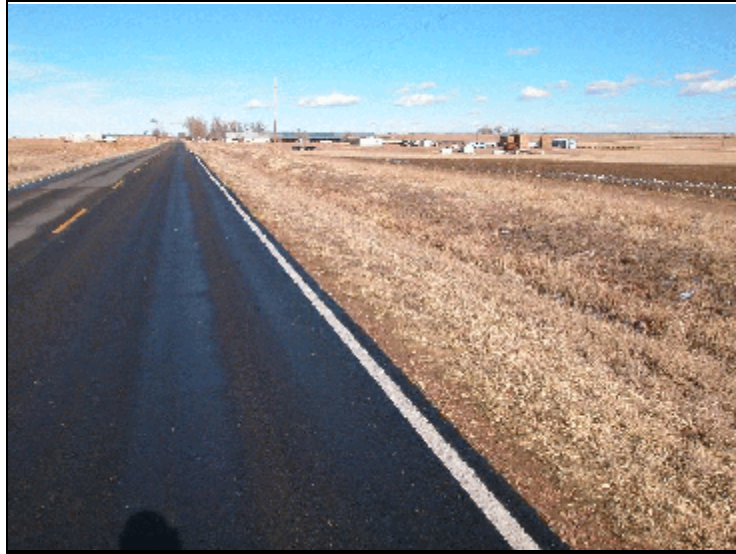
The case vehicle traveled off the right side of the roadway. The driver steered left and returned to the roadway. The vehicle continued into the opposing travel lane. The driver steered right and traveled off the right side of the roadway. The driver steered again to the left, but the two right side tires tripped and the vehicle began a right side leading rollover about the longitudinal axis (00TDDO2). Police report that the vehicle rolled two complete turns before coming to rest on its wheels facing west.

Figure 2. Area of rollover

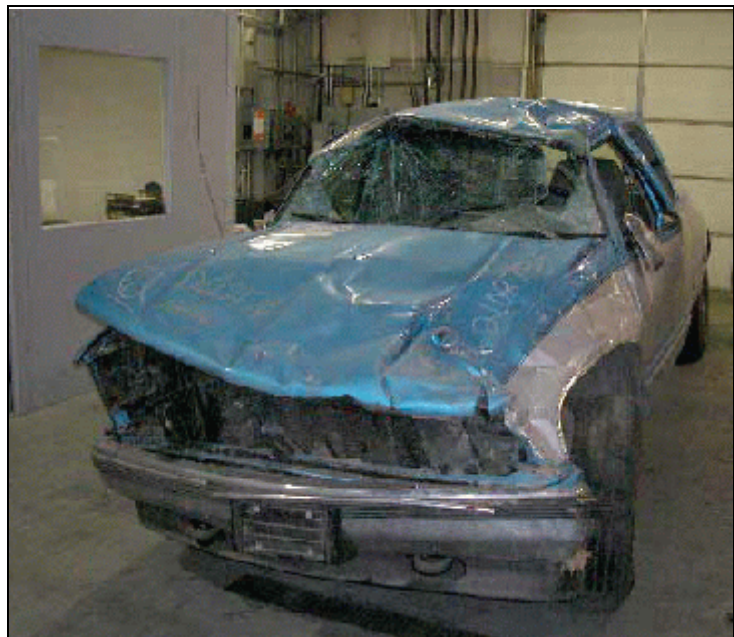
Figure 3. Front left, case vehicle

The case vehicle sustained major damage to the roof and left side. There was intrusion to the roof, left A pillar, and left roof rail. Both left side windows disintegrated. The driver's door was bowed outward due to occupant loading.

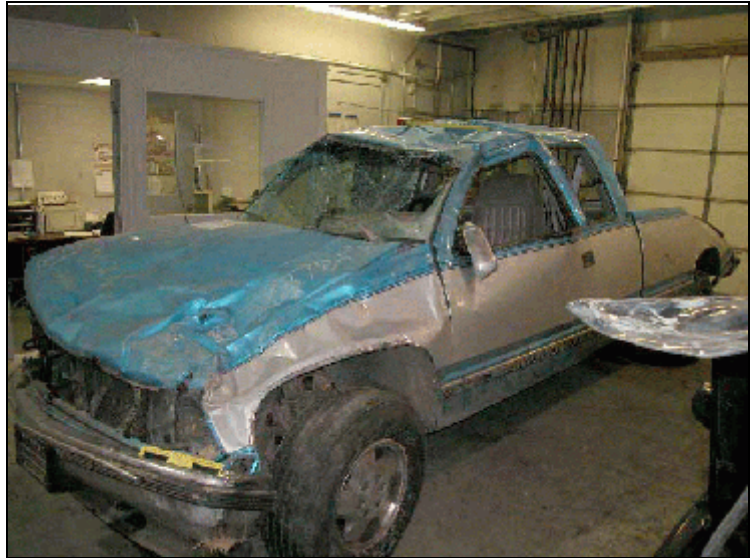
Figure 4. Left side, case vehicle

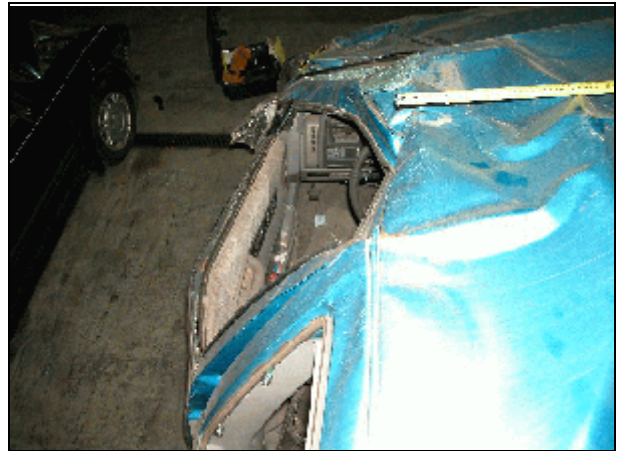
The driver of the case vehicle was ejected from the vehicle through the driver's window. She engaged the left side door panel and bowed it outward as she was ejected. She sustained serious injuries that included: a concussion (with loss of consciousness), a left collar bone fracture, 10 left side rib fractures, a punctured left lung, and fractures to the thoracic spine (@ T3, T11, and T12). She was hospitalized for an unknown length of time. At the time of the interview, she was out of the hospital and was wearing an upper body cast. She was mobile and there was no paralysis.

Figure 5. Top view, showing lateral crush to roof rail and outward bowing of the driver's door

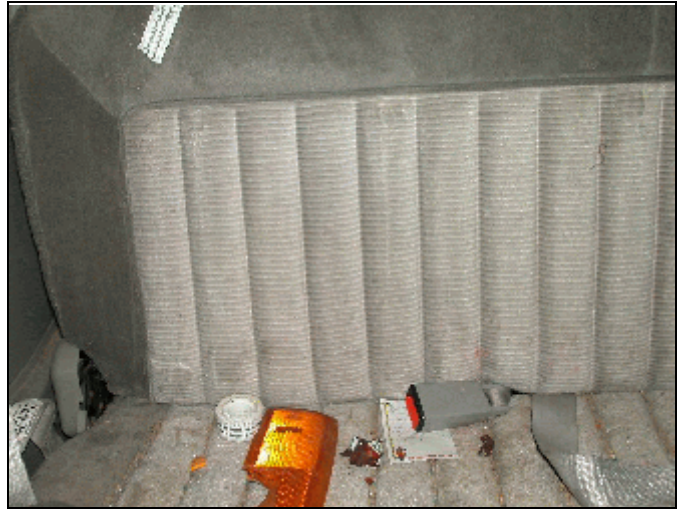
Figure 7. Right rear seat

The rear seat outboard manual restraint system consisted of a continuous loop 3-point lap and shoulder belts with locking latch plates. Both belts were found to be locked into the spooled out position at the time of inspection. It is presumed that during the rollover the pawl in the retractor had somehow become locked with the ratchet.

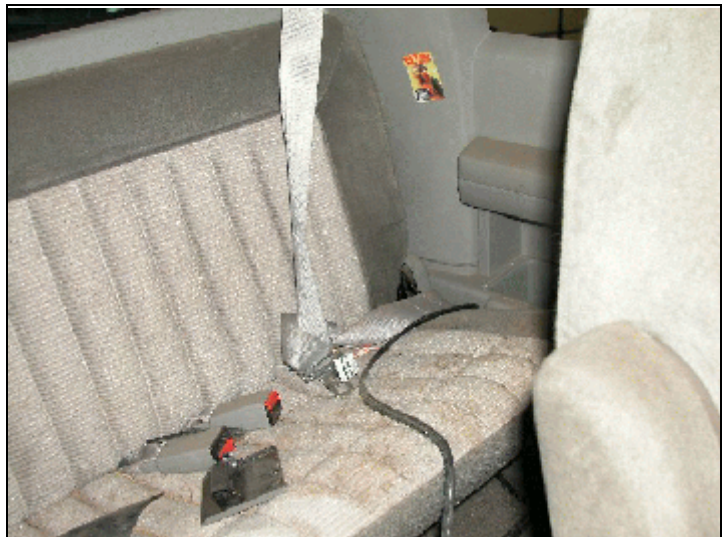
Figure 6. Left rear seat

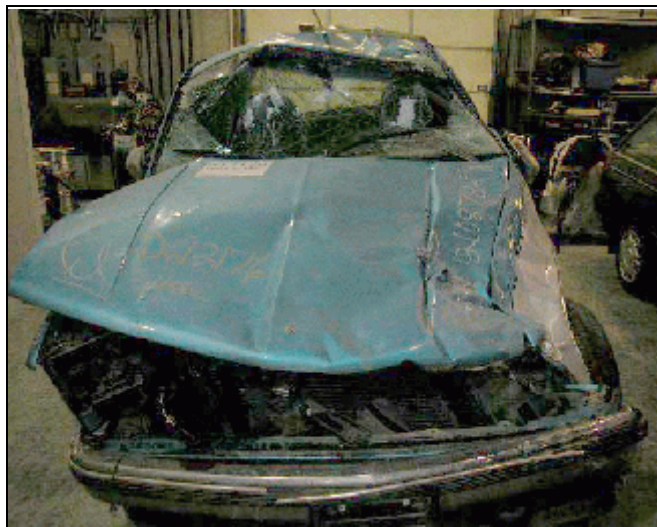
Description:	1993 GMC Sierra extended cab pickup	
VIN:	2GTEK19K8P1xxxxxx	
Odometer:	Unknown (electronic display)	
Engine:	5.7L/V8	
Reported Defects:	None	
Cargo:	Two child seats	
Damage Description:	Major rollover damage to roof, left side, truck bed. Vehicle towed from scene due to damage. Vehicle declared a total loss by insurance company.	
CDC:	00TDDO2	
Delta V:	Total	Unknown
	Longitudinal	Unknown
	Latitudinal	Unknown
	Energy	Unknown

Figure 9. Front, case vehicle

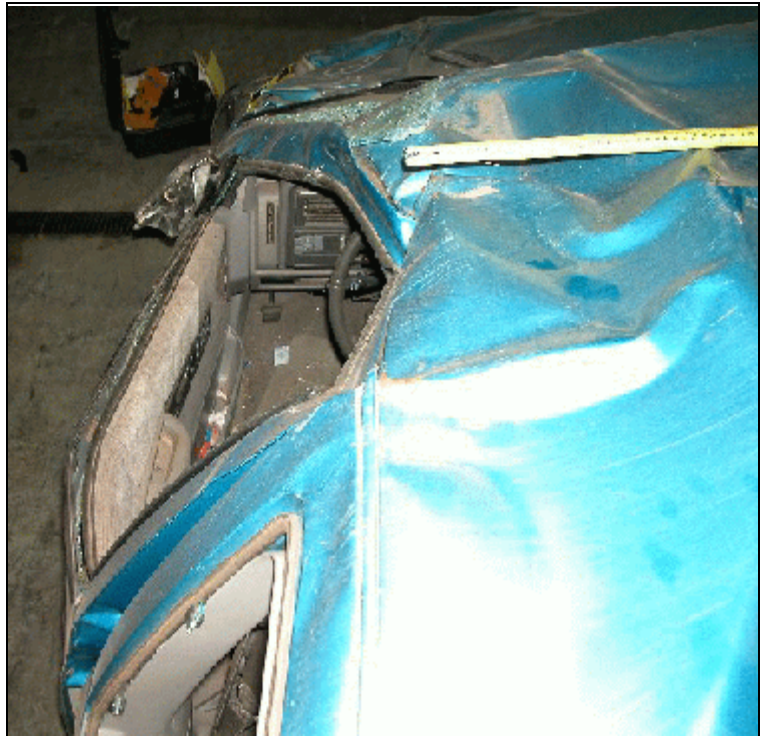
The 28-year-old female driver of the case vehicle was unrestrained just prior to the crash. She was seated in a fabric covered bucket seat. The seat had been adjusted to the middle track position. Both of her hands were on the steering wheel and she was actively steering first to the left and then more sharply to the right. Her right foot was on the brake; the left was on the floorboard. As the vehicle went into a counterclockwise rotation—just prior to tripping, the driver would have been shifting to the right. As the vehicle tripped, it completed a 3/4 roll and struck the ground with its left side. This contractor believes that the driver shifted sharply to the left, struck and loaded the left door—scuffing the inside door panel and deforming the door outward—and was then ejected through the left side glass.

Figure 10. Top view, shows occupant loading to left door
