**VERIDIAN ON-SITE SIDE IMPACT INFLATABLE OCCUPANT PROTECTION
INVESTIGATION
SCI TECHNICAL SUMMARY REPORT**

CASE NO. CA02-048

VEHICLE – 2001 SAAB 9-5

CRASH DATE – OCTOBER 2002

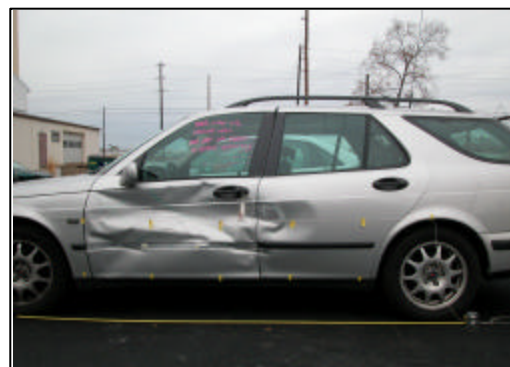
The Saab 9-5 sustained minor left side damage as a result of the impact with the Ford F-150. The direct contact damage began 1.3 cm (0.5") aft of the forward aspect of the left front door and extended 121.9 cm (48.0") rearward along the left side (**Figure 4**). Paint transfers and abrasions were present on the left front and left rear door panels. The outline of the Ford F-150's front bumper could be seen above the left door trim. The maximum crush was located 56.0 cm (22.1") aft of the leading edge of the left front door and

Figure 4. Left side damage to the 2001 Saab 9-5

measured 9.5 cm (3.8"). The combined direct and induced damage began at the leading edge of the left front door and extended 219.7 cm (86.5") rearward along the left front and left rear doors. The left rear door was displaced slightly rearward. Six crush measurements were taken along the left side plane at the mid-door level and were as follows: C1 = 0.0 cm, C2 = 0.6 cm (0.3"), C3 = 3.2 cm (1.3"), C4 = 7.6 cm (3.0"), C5 = 8.9 cm (3.5"), C6 = 0.0 cm. The Collision Deformation Classification (CDC) for the impact with the Ford F-150 was 10-LPEW-2.

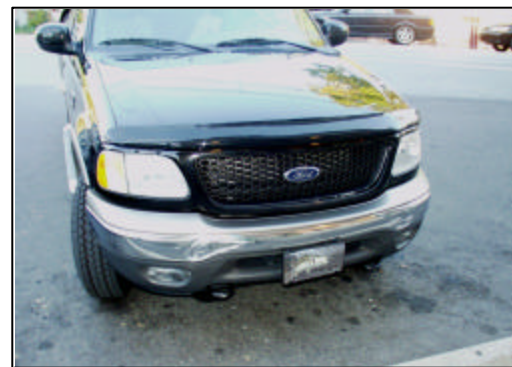
The 2002 Ford F-150 sustained minor frontal damage as a result of the impact with the Saab 9-5. The damage to the F-150 was based on police photographs (**Figure 5**), as an on-site inspection could not be obtained from the owner. The direct damage began approximately 8 cm (3") from the left front corner and extended laterally approximately 122 cm (48") across the front bumper. The damage consisted of paint transfers from the Saab and minor abrasions on the bumper. There was no measurable crush to the bumper. The CDC for the impact with the Saab was 12-FDEW-1.

Figure 5. Police photograph of damaged Ford F-150

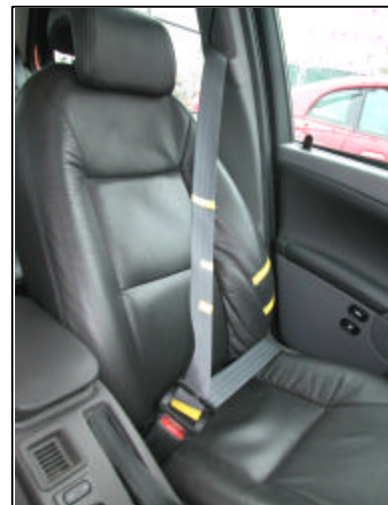
Figure 6. View of driver's seat belt

The driver's plastic latch plate exhibited a minor abrasion from the seat belt webbing from occupant loading. The abrasion measured 1.0 cm (0.4") in width and was located on the upper forward corner of the plastic latch plate in the buckled position. The latch plate also exhibited a small gouge that was located 7.6 cm (3.0") above the bottom aspect of the latch plate on the left aspect of the plastic housing. The gouge measured 1.3 cm (0.5") in length and 0.6 cm (0.3") in depth.

The left B-pillar exhibited a faint, curved, linear abrasion forward of the slot for the automatic height adjuster. The abrasion measured 3.8 cm (1.5") in length and was located 1.9 cm (0.8") above the bottom aspect of the height adjuster slot. The forward aspect of the plastic slot exhibited a small, faint abrasion/gouge at the center aspect.

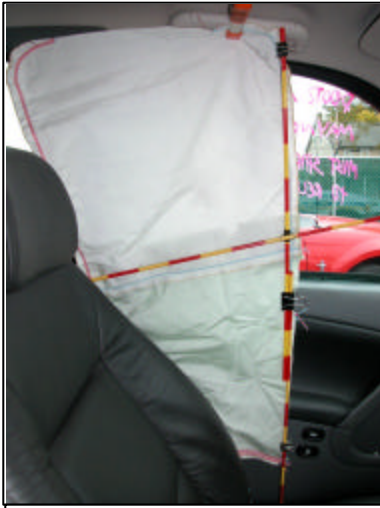
Figure 8. View of inboard aspect of the driver's side impact air bag

The side impact air bag was a single-chamber bag that provided protection for the head and torso of the occupant (**Figures 8 and 9**). The air bag measured 76.2 cm (31.0") in height, 30.5 cm (12.0") in width at the bottom aspect, and 38.1 cm (15.0") in width at the top aspect. The air bag was constructed of two separate fabric patterns for the upper and lower aspects, which were stitched together by a seam located 38.1 cm (15.0") below the top aspect of the air bag. The top portion overlapped the bottom portion by 7.6 cm (3.0"). A vertical line of break-away stitching was present on the forward inboard aspect of the air bag that began 2.5 cm (1.0") below the center seam and extended to the bottom aspect of the air bag (**Figure 10**). The stitching appeared to have restricted the initial inflation of the torso portion of the air bag, which allowed the head portion of the air bag to inflate first. As the head portion of the air bag inflated, the stitching tore to allow the torso portion of the air bag to inflate completely.

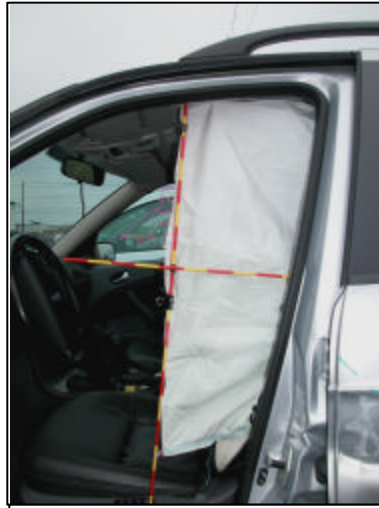
Figure 9. View of outboard aspect of the driver's side impact air bag

The driver's side impact air bag was vented by one external port that was located on the outboard aspect of the air bag 25.4 cm (10.0") aft of the forward aspect of the air bag and 30.5 cm (12.0") above the bottom aspect. The vent measured 1.9 cm (0.8") in diameter.

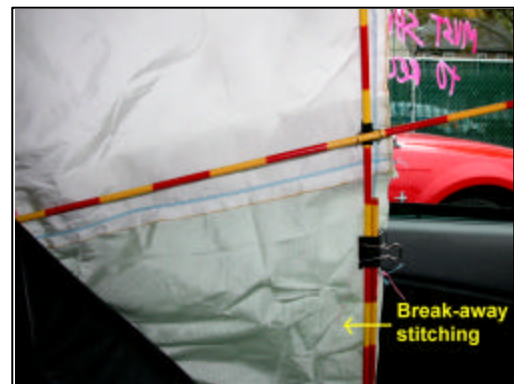
Figure 10. View of center seam and vertical break-away stitching

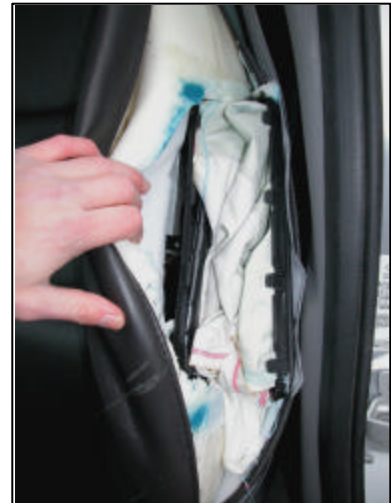
The air bag was housed in the driver seat back in a plastic module behind the outboard aspect of the seat back fabric (**Figure 11**). The module cover flap measured 26.7 cm (10.5”) in height and 10.2 cm (4.0”) in width. The module flap was configured with four plastic tabs on the forward aspect which separated from the inboard module housing as the air bag deployed.

Three minor linear scuff marks were present on the outboard aspect of the driver’s seat 15.2 cm (6.0”), 24.1 cm (9.5”), and 25.4 cm (10.0”) above the seat back that measured 5.1 cm (2.0”), 8.9 cm (3.5”), and 3.8 cm (1.5”), respectively. There was no corresponding evidence on the air bag fabric.

Figure 11. View of plastic air bag module housing located behind the seat back tear seam
