**SCI-1 ON-SITE CHILD SAFETY SEAT CRASH INVESTIGATION  
SCI TECHNICAL SUMMARY REPORT**

**CASE NO. CA02-049**

**VEHICLE – 1998 VOLKSWAGEN BEETLE**

**CRASH DATE – OCTOBER 2002**

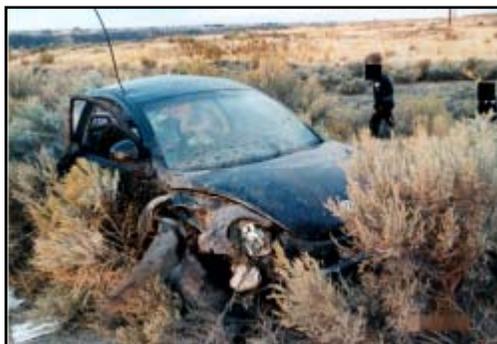
**Figure 1. On-scene photograph of the 1998 Volkswagen Beetle at rest**

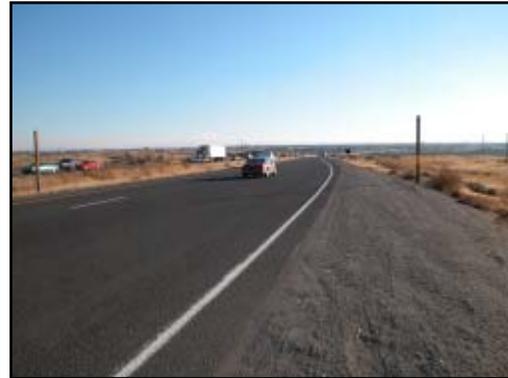
The 24-year-old female driver was operating the vehicle in a southbound direction on the state roadway during the nighttime hours (**Figure 2**). Police reported that the driver was operating the vehicle under the influence of alcohol. As the vehicle approached the crash site, the driver failed to negotiate the left curve and traveled onto the roadside in a tracking motion. Police estimated the vehicle's pre-crash speed to be 106 km/h (66 mph). The Volkswagen Beetle traveled in a south direction along the roadside for approximately 52 m (170'). The driver attempted to regain control by steering left. She overcorrected which caused the vehicle to initiate a counterclockwise (CCW) yaw for approximately 47 m (154').

**Figure 2. Southbound approach for the Volkswagen Beetle**

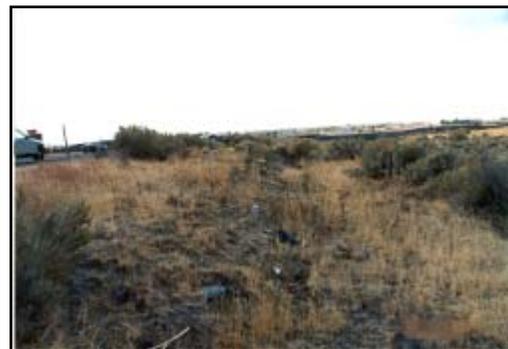
The right side tires furrowed into the roadside, which tripped a rollover with the right side leading. The vehicle rolled eight quarter-turns over a distance of approximately 57 m (186') and came to rest upright facing northeast on the roadside (**Figure 3**). The unrestrained driver was ejected through the backlight during the rollover event. Miscellaneous clothes and store-bought items that were present in the vehicle were also ejected and deposited along the vehicle's rollover trajectory (**Figure 4**). The vehicle's final rest position was behind tall sagebrush, which made it difficult to detect the vehicle from the roadway. The driver came to rest 6.4m (21.0') south of the vehicle's final rest position and 11.3 m (37.0') west of the roadside.

**Figure 3. Southbound view of the rollover trajectory**

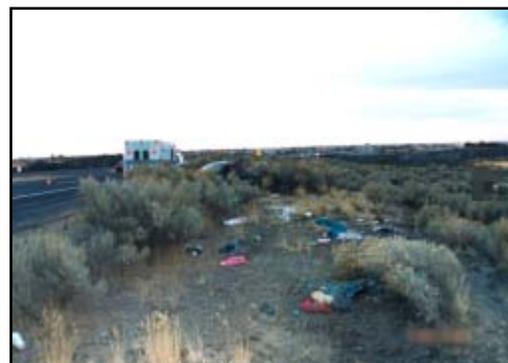
**Figure 4. Miscellaneous contents ejected from the vehicle**

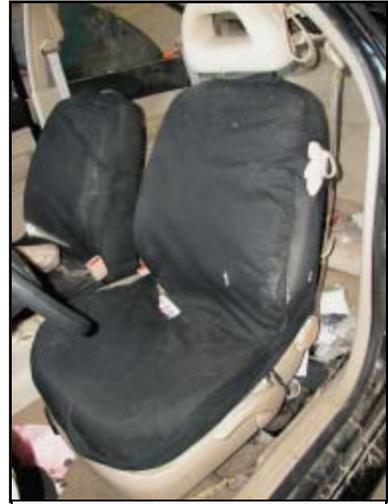
Both front seat backs were configured with after-market seat covers (**Figure 5**). There were no identifying labels on the seat covers indicating the manufacturer. It appeared that the outboard aspects of the covers were cut to gain access to the release levers on the upper outboard aspects of the seat backs. The covers were installed over the seat back from the top and subsequently pulled over the seat cushion. Elastic loops were present on the inboard and outboard aspects of the seat covers near the rear aspect of the cushion, but were not secured at the time of the vehicle inspection. The underside of the seat cover revealed a clear plastic pouch with plastic hooks for the elastic loops, however, the plastic pouch had not been opened and the hooks were not in use. A content label was also present on the underside of the seat cover adjacent to the hooks and instructions that included a warning that read “Warning: Not recommended for use on seats equipped with air bags.” In addition, a warning label was present

**Figure 5. View of driver's aftermarket seat cover**

on the forward aspect of both B-pillars that read, “ATTENTION-SAFETY INFORMATION! This vehicle is equipped with SIDE-AIRBAG in the seats. DO NOT USE SEAT COVERS. For further IMPORTANT INFORMATION see OWNER’S MANUAL.”

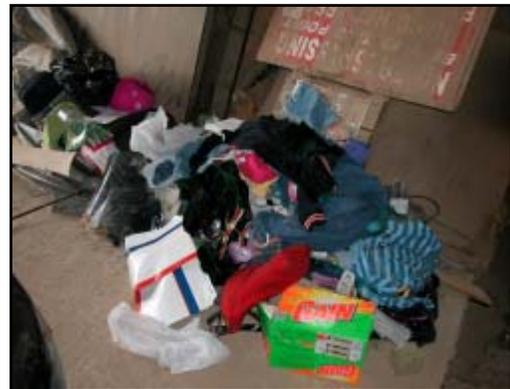
Additional cargo in the vehicle at the time of the crash included numerous plastic bags of new clothing, a large box of powder laundry detergent, a television game system, quarts of motor oil, bags of snack foods, audio tapes, video tapes, and a pizza (**Figure 6**).

**Figure 6. Additional cargo items found in the vehicle**

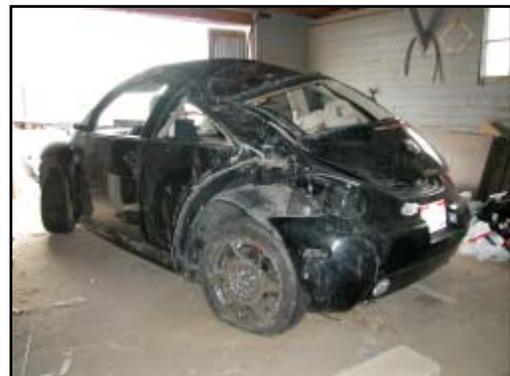
The 1998 Volkswagen Beetle sustained moderate damage as a result of the rollover (**Figure 7**). The front bumper fascia and both head lamp assemblies were separated from the vehicle. The left mirror was separated. Heavy abrasions from ground contact were present on the upper left A-pillar, left roof side rail, upper left B-pillar, and upper left C-pillar. Minor diagonal abrasions were present on the left front fender, left door, and left rear quarter panel. The left rear fender was fractured and separated. Grass was deposited in the left front door area and the left rear window frame. The left front and left rear alloy wheels were abraded. The left front wheel was turned inward

**Figure 7. Damaged 1998 Volkswagen Beetle**

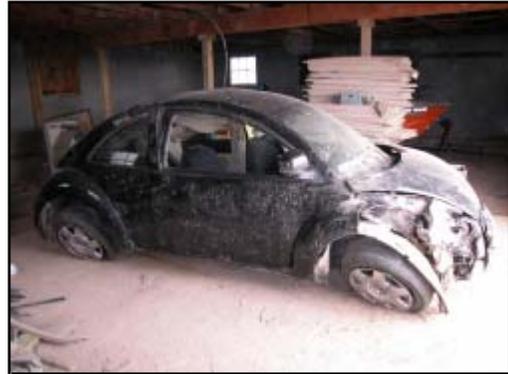
approximately 30 degrees and the left rear wheel was displaced slightly rearward. The left C-pillar and left rear aspect of the roof were crushed vertically with a lateral component due to the rollover. The maximum roof crush was located at the left C-pillar area. The roof exhibited lateral abrasions. The rear hatch was displaced. The right roof side rail and right C-pillar sustained moderate abrasions. The top aspect of the right door was displaced outward which created a gap between the top aspect of the door frame and the roof side rail that measured 17.8 cm (7.0"). The right front fender was fractured and separated. The right sill sustained lateral crush that measured 10.2 cm (4.0") and was located 78.7 cm (31.0") rear of the right A-pillar.

**Figure 8. Right side view of damaged Volkswagen Beetle**

The right front and right rear alloy wheels were abraded and the right rear wheel was fractured. The right side suspension components were damaged as a result of the CCW yaw and resistance from the right side tires. The damage to the suspension components resulted in inward lateral deflection of the lower aspects of the right side wheels (**Figure 8**). The Collision Deformation Classification for the rollover event was 00-TDDO-3.

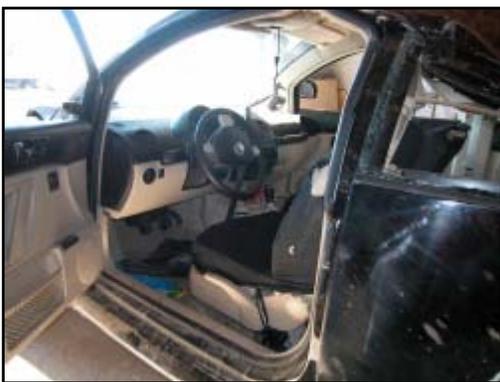
The interior damage to the 1998 Volkswagen Beetle was attributed to passenger compartment intrusion and occupant contact. Both side doors were operational. The rear hatch was displaced and jammed. The windshield laminate exhibited a minor fracture on the right aspect. The left door glazing, right door glazing, left rear glazing, and backlight glazing disintegrated from impact forces. The bottom half of the steering wheel rim was deformed forward 2.5 cm (1.0") from occupant contact and there were no identifiable contacts to the knee bolster (**Figure 9**). The rear view mirror assembly was separated from the roof and hanging by the wiring harness. The driver's head restraint was deformed slightly CW, but exhibited no contact evidence. The front right head restraint was completely separated from the seat back. Heavy body fluid transfers (blood) were present on the head restraint fabric, and it appeared to have pulled vertically out of the seat back during the rollover (**Figure 10**). Two heavy lateral dirt transfers were present above

**Figure 9. View of deformed steering wheel rim and knee bolster**

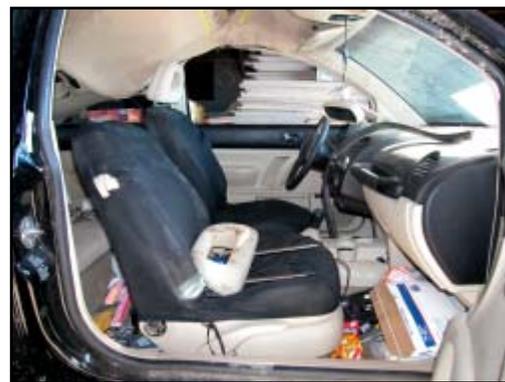
**Figure 10. View of front right seat and separated front right head restraint**

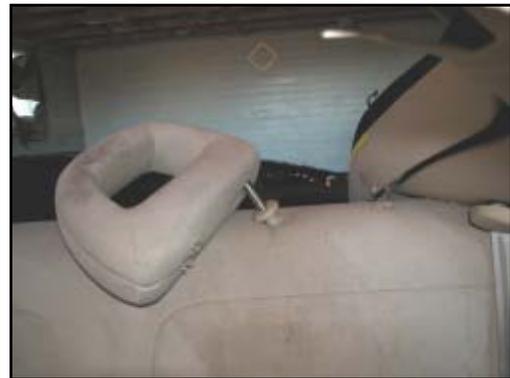
The rear left head restraint was displaced as a result of the lateral left C-pillar intrusion and subsequent ejection of the driver (**Figure 11**). The head restraint rotated CCW approximately 170 degrees, based on the on-scene photographs, and the outboard stainless steel post was completely separated from the head restraint and seat back. The inboard post was displaced and partially separated from the seat back. Scuff marks were present on the interior trim panel of the left C-pillar from probable contact with the driver during the ejection.

**Figure 11. Damaged rear left head restraint**

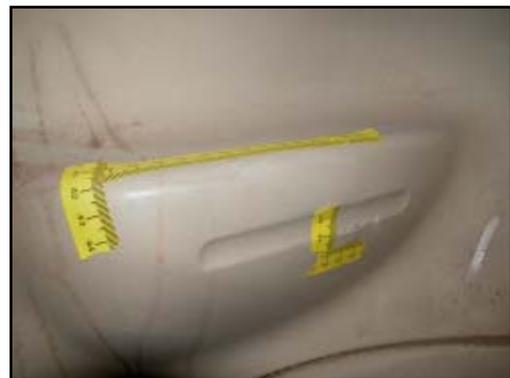
The right rear interior plastic panel/armrest sustained a 14.6 cm (5.8") long scuff on the top aspect from contact with the CSS. A small tear was present 4.4 cm (1.8") below the top aspect of the armrest. The tear began 12.7 cm (5.0") aft of the forward aspect of the armrest and measured 1.6 cm (0.6") in length (**Figure 12**).

**Figure 12. View of abrasion and laceration on right rear armrest**

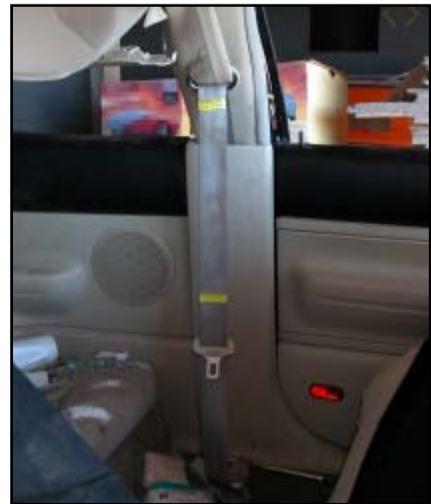
The 1998 Volkswagen Beetle was configured with manual 3-point lap and shoulder belts with sliding latch plates and fixed D-ring anchors for each outboard seating position. The rear seat was not configured with a center seat position, and was not equipped with a manual restraint. The lap portions of the front seat restraints were anchored to steel bars mounted longitudinally along the inboard lower sill areas. The bars measured 27.9 cm (11.0") in length and 1.0 cm (0.4") in diameter. The driver's seat belt was configured with an Emergency Locking Retractor (ELR) and the remaining seat belts were configured with switchable ELR/Automatic Locking Retractors (ALR). Retractor pretensioners were present for the driver and front right passenger seat belts, but it could not be determined if they fired as a result of the rollover. The driver's seat belt was found in the stowed position at the time of the vehicle inspection, and was not utilized by the driver in the crash (**Figure 13**). In its stowed position, the driver's seat belt webbing exhibited minor body fluid (blood) transfers that were consistent with a body fluid pattern on the adjacent interior B-pillar panel. The driver's latch plate showed signs of minor historical usage.

**Figure 13. View of post-crash driver's seat belt**

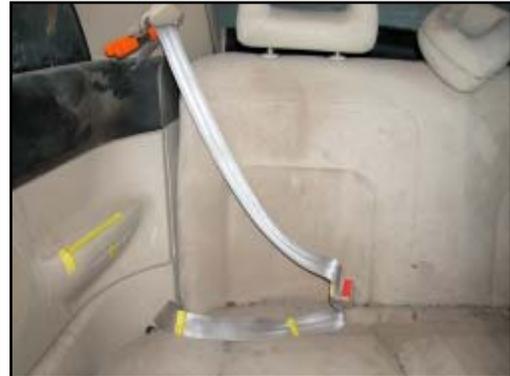
The rear right seat belt (**Figure 14**) was found buckled and routed through the forward-facing belt path of the CSS during the vehicle inspection. In the buckled position, the length of the shoulder belt webbing measured 62.2 cm (24.5") between the D-ring and the latch plate. The lap belt portion measured 58.4 cm (23.0") between the latch plate and outboard anchor. The retractor was found to be in the locked mode. The Volkswagen's rear right latch plate showed no abrasions indicative of historical usage. The plastic housing on the latch plate was abraded due to the loading of the webbing during the rollover. Stretching of the webbing began at the stop button and extended 21.6 cm (8.5") upward. A black linear transfer that extended laterally across the webbing was adjacent to the stop button, which was a result of loading against the right side plastic surface of the CSS belt path.

**Figure 14. View of rear right seat belt**

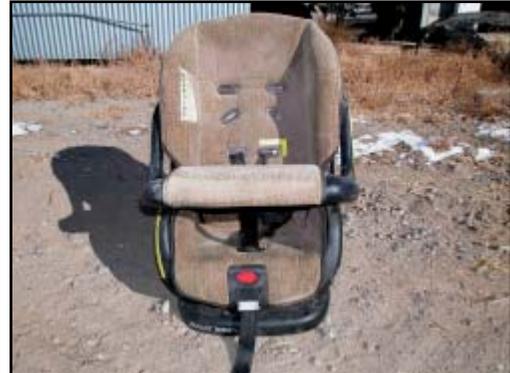
The Cosco Regal Ride (**Figure 15**) was a convertible CSS with a tray shield installed forward-facing in the rear right position of the Volkswagen Beetle. A locking clip was not required due to the use of the ALR, and the locking clip was found attached to the rear aspect of the CSS. The CSS manufacture date was June 2002 and the CSS was not listed on the NHTSA recall list. The 1998 Volkswagen Beetle was not equipped with lower anchors, but was configured with tether anchors on the rear outboard positions. Although the CSS was originally configured with a tether strap, it was not present on the CSS at the time of the inspection. The harness system was routed through the lowest harness slots that were intended for rear-facing use rather than through the top reinforced slots. The harness retainer clip was positioned 19.1 cm (7.5") above the latch plate.

**Figure 15. Cosco Regal Ride CSS**

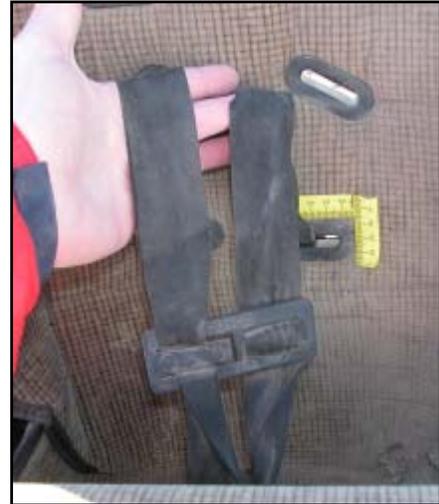
The left harness strap was permanently routed through the retainer clip and the right harness strap was inserted from the front aspect versus the rear aspect (**Figure 16**). Since the right harness strap was routed through the retainer clip from the front, it was not held in position by the plastic locking tab on the retainer clip. The left harness strap had two complete twists in the webbing between the rear harness bracket and the retainer clip. It had two additional complete twists between the retainer clip and the latch plate. The right harness strap had one complete twist between the rear harness bracket and the retainer clip and one complete twist between the retainer clip and the latch plate. It was not known how tight the harness straps were in relation to the child passenger, however, the harness adjustment webbing on the front aspect of the CSS was extended 35.6 cm (14.0"). The latch plate showed abrasions indicative of regular usage.

**Figure 16. View of harness straps and harness retainer clip**

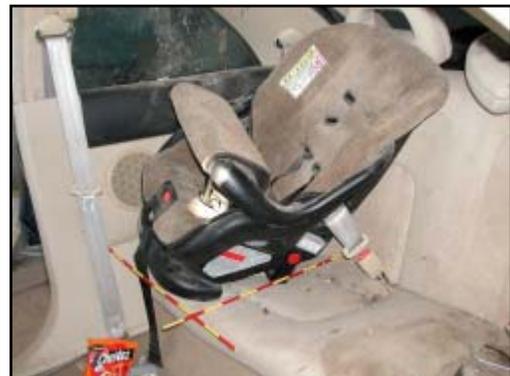
The CSS was found in the rear right seating position and installed forward-facing with the manual 3-point lap and shoulder belt (**Figure 17**). The vehicle seat belt was in the locked mode and was routed through the forward-facing belt path. At the time of the vehicle inspection, the CSS had not been moved since the time of the crash. The CSS was found leaning to the left toward the center of the vehicle at a 20 degree angle from vertical and rotated slightly CW within the vehicle seat belt. The right front aspect of the CSS was resting directly against the right rear interior panel. Although the vehicle seat belt was buckled, the CSS was able to move greater than 2.5 cm (1.0") side-to-side and fore-and-aft. The kickstand was in the down position for forward facing use. The distance between the seat back and kickstand measured 16.5 cm (6.5") on the left side and 2.5 cm (1.0") on the right side.

**Figure 17. Post-crash position of the CSS**

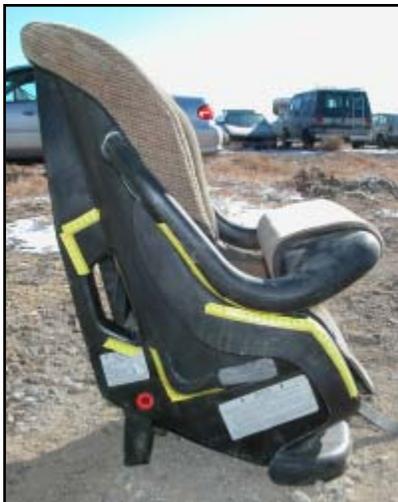
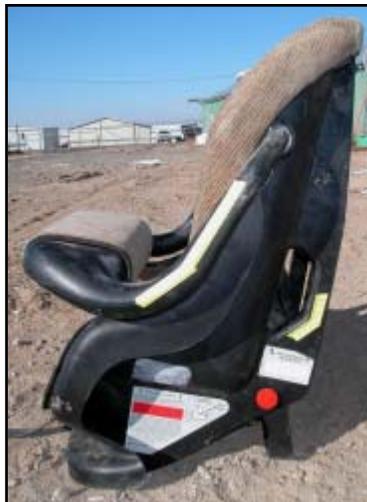
The Cosco convertible CSS sustained moderate damage as a result of the crash (**Figures 18 and 19**). Abrasions on the left outboard aspect of the tray shield began 11.4 cm (4.5”) below the pivot point and extended 17.8 cm (7.0”) forward along the left arm of the tray shield. A heavy abrasion from loading against the vehicle seat belt webbing was present on the left outboard aspect of the forward-facing belt path that measured 7.6 cm (3.0”) in width along the contour of the belt path and 0.6 cm (0.3”) in length (**Figure 20**). The right outboard aspect of the belt path was moderately abraded on the top aspect from loading against the shoulder belt and on the bottom aspect from loading against the lap belt. The shoulder belt abrasion measured 3.8 cm (1.5”) in width and the lap belt abrasion measured 5.1 cm (2.0”) in width. A large “V”-shaped abrasion was located below and forward of the forward-facing belt path on the right side of the CSS as a result of engagement against the plastic right rear side panel of the Volkswagen Beetle. The abrasion measured 7.6 cm (3.0”) in height and 7.0 cm (2.8”) in width. Contact with the plastic right side panel of the vehicle interior also resulted in scuffs on the right outboard aspect of the tray shield that measured 20.3 cm (8.0”) along the tray shield arm and scuffs on the right front side plane of the CSS that measured 19.1 cm (7.5”) in length.

**Figure 18. View of right side damage on the CSS**

**Figure 19. View of left side damage to the CSS**

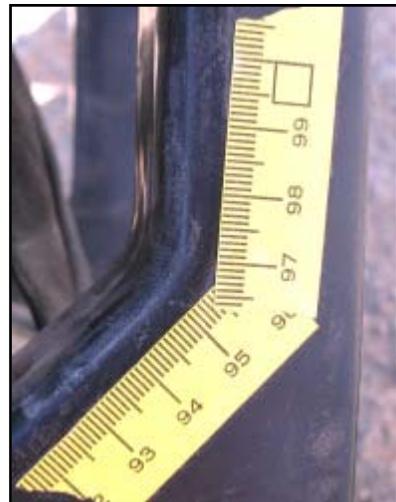
**Figure 20. Close-up of left side seat belt scuff**

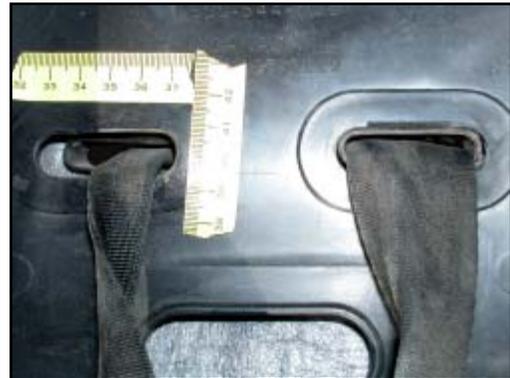
There was no loading evidence on the right harness strap, however minor stretching of the left harness strap was present above the harness retainer clip as a result of the child's loading to the harness system. Plastic sleeves were secured in each harness slot by plastic tabs on the rear upper and rear lower aspects of the sleeves. Due to the loading of the left harness strap, the lower left plastic sleeve was displaced forward from the harness slot 1.3 cm (0.5"). **Figure 21** depicts the displaced left plastic sleeve.

**Figure 21. Close up of displaced left plastic sleeve and harness straps**

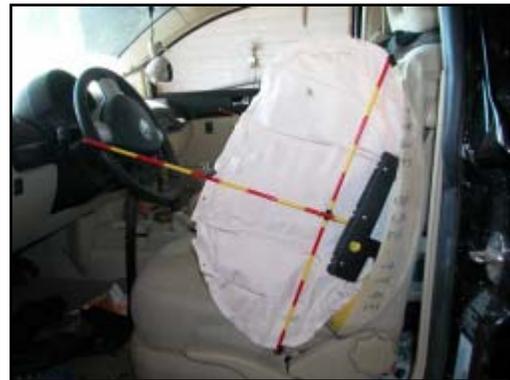
The 1998 Volkswagen Beetle was equipped with seat back-mounted side impact air bags that deployed as a result of the rollover crash. The side impact air bags were designed to offer torso protection. The deployment of the side impact air bags was impeded due to the after-market seat covers that were installed on the front bucket seats.

**Figure 22. Deployed driver's side impact air bag**

The side impact air bags deployed forward from the respective seat backs through a vertical tear seam on the forward aspect of the seat backs. The tear seam measured 57.2 cm (22.5") in height. The side impact air bag was housed in a plastic module surrounded by Styrofoam filler within the seat back. The interior plastic cover flap measured 22.9 cm (9.0") in height and 10.2 cm (4.0") in width and exhibited three small tabs on the forward aspect (**Figure 22**).

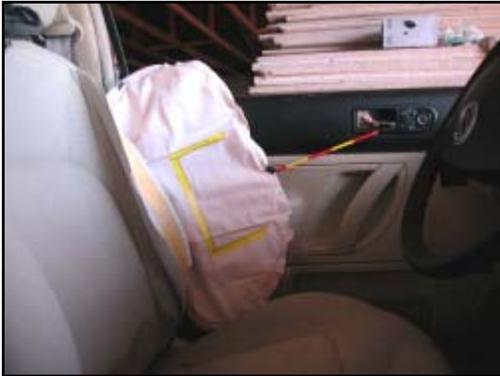
The side impact air bags measured 55.9 cm (22.0”) in height and 33.0 cm (13.0”) in width and extended vertically from the seat cushion to the top of the seat back. The air bags were not tethered and were vented back through the module. The inboard aspect of the driver’s side impact air bag exhibited an area of light abrasion that measured 19.7 cm (7.8”) in height and 10.2 cm (4.0”) in width (**Figures 23 and 24**). The abrasion was a result of engagement against the outboard aspect of the interior seat back due to the impeded deployment caused by the seat cover.

**Figure 23. Area of abrasion on the driver's side impact air bag**

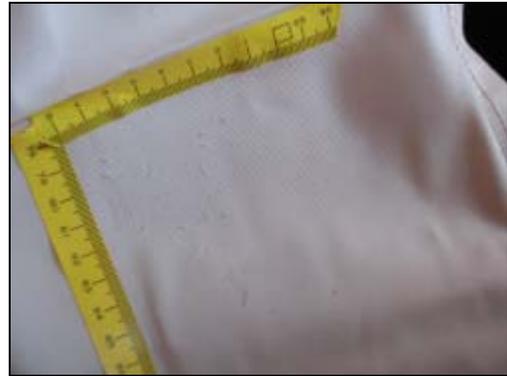
**Figure 24. Close-up of the abraded area on the air bag**
