**CALSPAN ON-SITE VEHICLE COMPATABILITY
CRASH INVESTIGATION**

CASE NO: CA02-057

**VEHICLE: 2002 TOYOTA TUNDRA
1990 DODGE GRAND CARAVAN**

LOCATION: MARYLAND

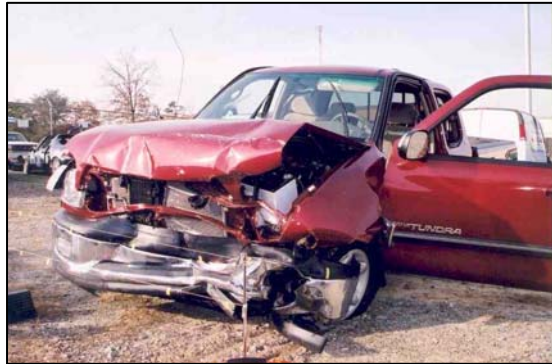
Figure 1 - Damaged 2002 Toyota Tundra.

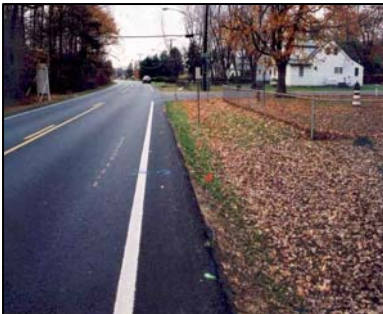
The 62-year old female driver of the 2002 Toyota Tundra pickup truck was traveling on the southbound lane of a two-lane roadway and was negotiating a left curve (**Figure 2**). The 55-year old male driver of the 1990 Dodge Caravan was traveling northbound on the same roadway and was negotiating a right curve (**Figure 3**). The Toyota drifted off the right roadside evidenced by visible furrow marks on the west roadside grass.

Figure 2 - Southbound approach of Toyota.

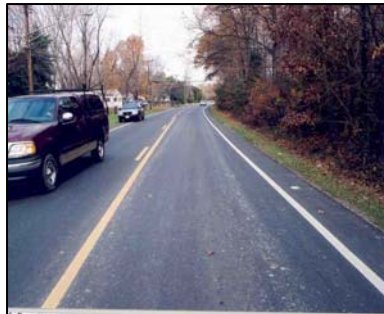
Figure 3 - Northbound approach of Dodge.

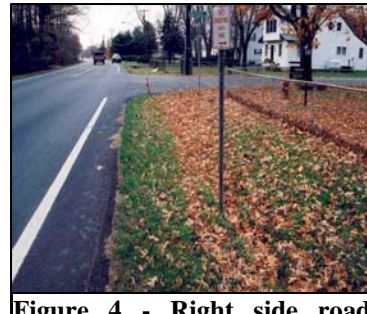
As the Toyota exited the right side of the roadway, the vehicle sideswiped a road sign located approximately 1 m (3.3') outboard of the roadway on the west roadside (**Figure 4**). After the initial impact, the driver of the Toyota applied a left steering input, attempting a corrective action. The Toyota reentered the roadway, crossed the roadway's centerline, and entered the northbound traffic lane. The Toyota left visible tire marks illustrating its trajectory to the point of impact with the Dodge Caravan. The front plane of the Toyota contacted the front center and left aspect of the Dodge in off-set configuration on the northbound travel lane. The directions of force for the Toyota and Dodge were in the 01 o'clock and 12 o'clock sectors, respectively. The impact resulted in frontal damage to both vehicles and was sufficient to deploy the frontal air bags of the Toyota. The damage algorithm of the WinSMASH program calculated a total delta-V of 41 km (25.5 mph) for the Toyota and 45 km (28 mph) for the Dodge. The specific longitudinal and lateral components were -39 km (-24.2 mph) and -14 km (-8.7 mph) for the Toyota and -44 km (-27.3 mph) and 8 km (5 mph) for the Dodge.

Figure 4 - Right side road departure and impacted street sign.

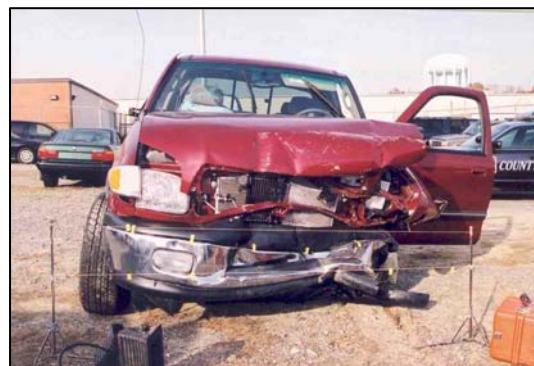
The 2002 Toyota Tundra (**Figure 5**) sustained moderate damage as a result of the impact with the 1990 Dodge Caravan. The direct damage for the third and highest severity impact began 39 cm (15.3") right of the vehicle's centerline and extended 122 cm (48") to the left front bumper corner. The direct damage terminated at the left front bumper corner. The maximum crush was located at the left front bumper corner and measured 58 cm (22.8") in depth. The

Figure 5 - Damaged 2002 Toyota Tundra.

combined direct and induced damage encompassed the entire front end of the vehicle and measured 157 cm (61.8") in length. The crushed bumper contacted the left front wheel deflating the tire and compressing the left side wheelbase 22 cm (8.6"). The induced damage emanated down the left side and the inertial forces shifted the bed of the pickup 2.5 cm (1") to the left from the vehicle cab bodyline. The crush profile was measured to the vehicle's chrome bumper at six equidistant placements and was as follows: C1 = 58 cm (22.8"), C2 = 43 cm (17"), C3 = 41 cm (16.1"), C4 = 21 cm (8.3"), C5 = 0 cm, C6 = 0 cm. The Collision Deformation Classification (CDC) for this event was 01-FDEW-1

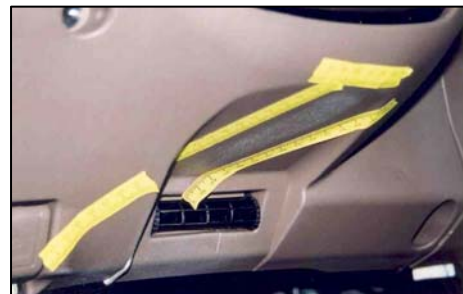
The 2002 Toyota Tundra sustained minor interior damage as a result associated with occupant contact and minor intrusion. Scuff marks coupled with blue fabric transfers were present at two locations on the left side knee bolster. The first transfer was located 55 – 60 cm (21.5 - 23.5") left of the vehicle's centerline and 43 – 48 cm (17 – 18.75") below the top of the instrument panel's brow. This contact was consistent with occupant loading. The second transfer was 43 – 51 cm (17- 20") left of the vehicle's centerline and 37 – 39 cm (14.5 – 15.3") below the top of the instrument panel's brow. Both transfers are illustrated in **Figure 6**. As the vehicle reached the point of maximum engagement, in addition to loading the restraint systems, the driver's lower torso loaded the front left seat cushion resulting in a frictional fabric abrasion (**Figure 7**). This abrasion ran parallel to the instrument panel and was located 1 – 15 cm (0.5 – 5.75") left of the vehicle's centerline and was 7 cm (2.75") in width at its widest point. The only discernable intruded component was the driver's toe pan which was displaced 8 cm (3.2") longitudinally.

Figure 6 - Contact evidence to left knee bolster.

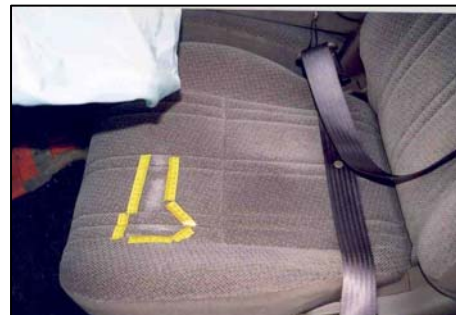
Figure 7 - Frictional abrasion to driver's seat cushion.

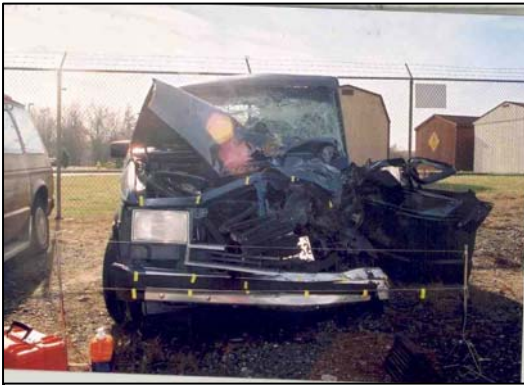
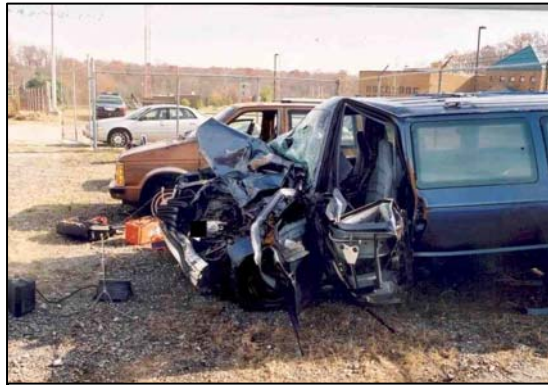
The 1990 Dodge Caravan (**Figures 8 and 9**) sustained severe damage as a result of the impact with the 2002 Toyota Tundra pickup truck. The direct damage began at the left front bumper corner and extended along the bumper 76 cm (30") to the right. The combined direct and induced damage encompassed the entire front bumper and measured 131 cm (51.5") in width. The maximum crush was located 39 cm (15.4") left of the vehicle's centerline and measured an averaged 68 cm (26.8") in depth. The crush profile was measured to the aluminum bumper and also to the upper radiator support. The averaged results of the crush profile were as follows: C1 = 65 cm (25.6"), C2 = 68 cm (26.8"), C3 = 59 cm (23.2"), C4 = 35 cm (13.8"), C5 = 9 cm (3.5"), C6 = 0 cm. The CDC for this impact was 12-FYEW-4.

Figure 8 - Damaged 1990 Dodge Caravan.

Figure 9 - Damaged 1990 Dodge Caravan (side view).

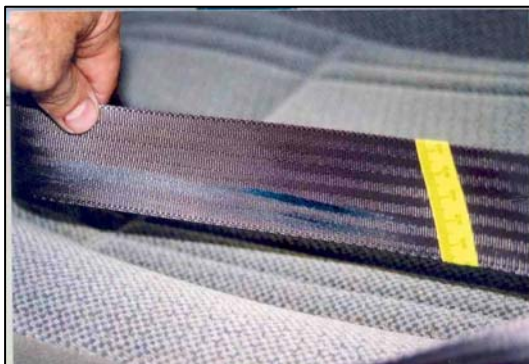
Figure 10 - Loading evidence on driver's shoulder belt webbing.

latch plate, Emergency Locking Retractor (ELR), and an adjustable D-ring, which was in the full-down position at the time of the SCI inspection. Loading evidence in the form of a blue fabric transfer was identified on the interior shoulder belt webbing (**Figure 10**). This transfer began 71 cm (28") above the belt's stop button and extended forward 26 cm

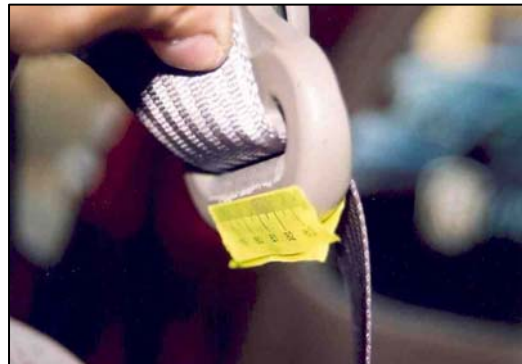
Figure 11 - Loading evidence on left front D-ring.

(10.2”). Additional loading evidence, attributed to the adjustable D-ring, was identified on the interior shoulder belt that began 118 cm (46.4”) above the stop button and extended 10 cm (3.9”) forward thereof. A correlating grey fabric transfer was present within the inside aspect of the D-ring (**Figure 11**). The driver’s belt was also equipped with a retractor pretensioner that fired during the third crash event. The ELR locked the belt webbing into the worn position, indicative of belt usage.

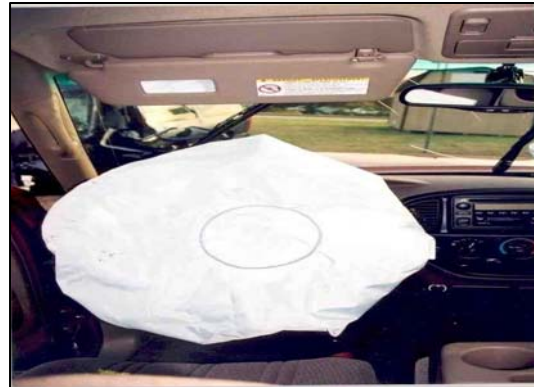
The 2002 Toyota Tundra was equipped with redesigned frontal air bags for the driver and front right seating positions. The frontal air bags deployed as a result of the impact with the 1990 Dodge Caravan. The driver’s air bag (**Figure 12**) deployed through asymmetrical H-configuration cover flaps. The upper flap was 17 cm (6.7”) in width and 10 cm (3.9”) in height. The lower flap was 17 cm (6.7”) in width and 8 cm (3.1”) in height. The air bag

Figure 12 - Driver's deployed air bag.

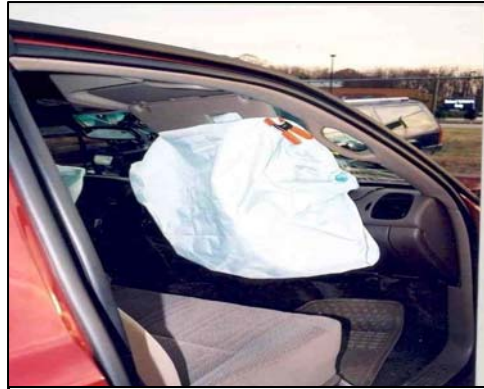
The top-mount front right passenger’s air bag deployed from a single rectangular cover flap that measured 37 cm (14.5”) horizontally and 17 cm (6.2”) vertically (**Figure 13**). The air bag membrane measured 71 cm (28”) horizontally and 64 cm (25”) vertically in its deflated state. The air bag’s maximum excursion was 50 cm (20”) from the mid

Figure 13 - Front right passenger's deployed air bag.

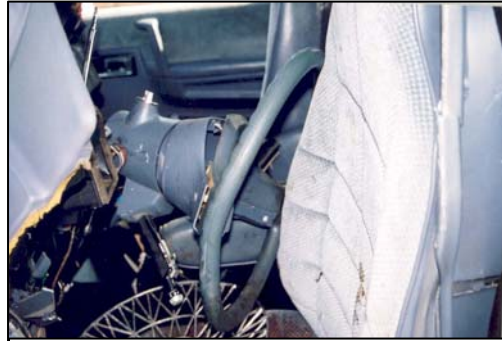
The 55-year old male driver of the 1990 Dodge Grand Caravan was seated in presumed upright position prior to the impact with the 2002 Toyota Tundra. The driver was reportedly unrestrained. The driver initiated a forward trajectory responding to the 12 o'clock direction of force and loaded the severely intruded steering assembly. This is evidenced by the deformed steering wheel rim and subsequent column separation (**Figure 14**). The driver sustained unspecified fatal injuries and was entrapped within the vehicle upon arrival of emergency personnel. After extrication procedures, emergency personnel removed the driver from the vehicle and transported the remains to the county medical examiner for autopsy. Repeated attempts to obtain copies of the autopsy report have been unsuccessful.

Figure 14 - 1990 Dodge Caravan steering assembly.

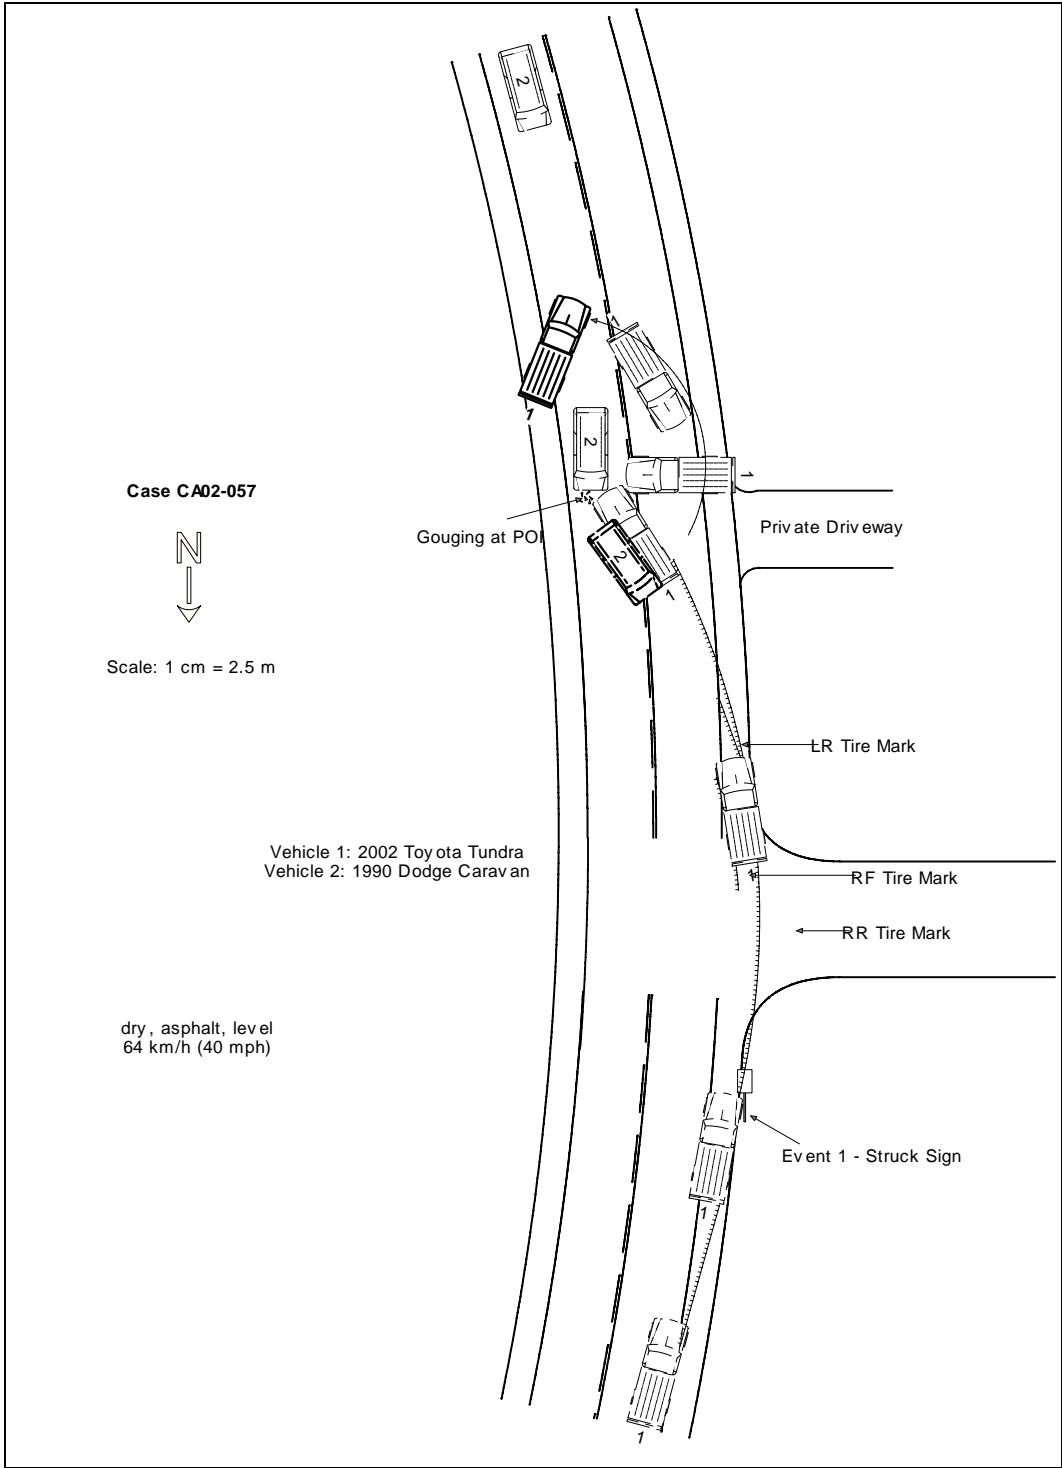
Figure 15 – Scene Schematic

fog lines were present outboard of both travel lanes. The roadside environment consisted of multiple private homes in a residential setting. A shallow ditch was present on the west roadside. The roadway characteristics included a pronounced curve (left curve for southbound traffic and right curve for northbound). The roadway was straight and level and had a posted speed limit of 56 km/h (35 mph). The crash schematic is included as **Figure 15** at the end of this narrative report.
