**VERIDIAN ON-SITE INFLATABLE SAFETY CANOPY  
CRASH INVESTIGATION  
SCI TECHNICAL SUMMARY REPORT**

**VERIDIAN CASE NO. CA02-059**

**VEHICLE: 2002 MERCURY MOUNTAINEER**

**CRASH DATE: NOVEMBER 2002**

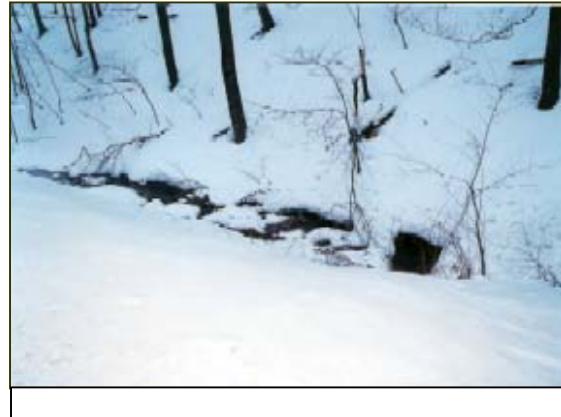
The Mountaineer overturned onto the negative embankment. At the onset of the rollover, the rollover canopy air bags deployed from the roof side rails, providing head protection to the driver and front right passenger. As the vehicle overturned onto its roof, the left D-pillar/backlight header area impacted a large rock, which crushed the roof to a maximum depth of 31.1 cm (12.25"). The Mountaineer rolled down the negative embankment that was sloped approximately 30 degrees. The embankment terminated in a shallow drainage ditch that was located approximately 8 m (25') outboard of the roadway. At this point, the Mountaineer had completed 4-quarter turns and was in a near upright attitude. The left front door and A-pillar area impacted a small diameter tree that was located on a positive slope on the backside of the ditch. This impact fractured the tree branches and produced minor damage to the vehicle. The Mountaineer came to rest on its wheels, straddling the drainage ditch facing opposite of its original direction of travel (**Figure 4**).

**Figure 4.** Struck tree and final rest area of the Mountaineer.

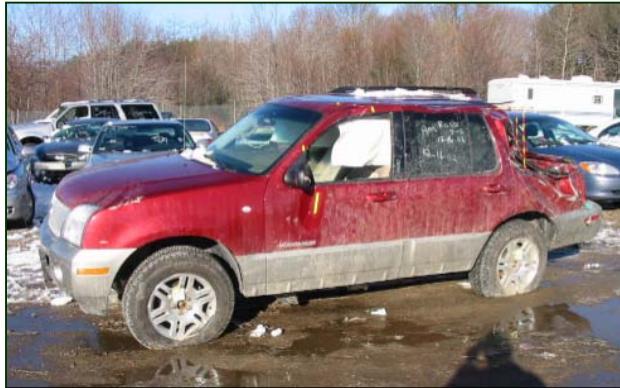
The Mercury Mountaineer sustained moderate damage as a result of the rollover and impact with the rock, and minor damage from impact with the tree that was located on the back side of the drain ditch. Rollover damage was noted to the left (**Figure 5**), top, and right side of the vehicle. In addition, all four alloy wheels were damaged from the rollover. This damage is identified in the table under the heading of *Tires and Wheels* that follows this *Exterior Damage* section.

**Figure 5.** Left side rollover damage to the Mountaineer.

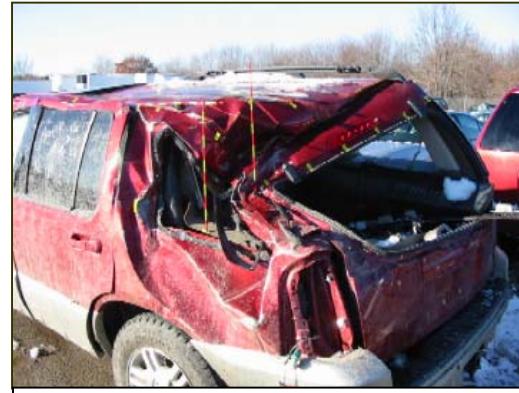
A large rock impact occurred to the top surface of the vehicle in the area of the upper left D-pillar, side rail, and roof juncture (**Figure 6**). The impact occurred during the rollover sequence which resulted in a non-horizontal impact force (00). The direct damage for this impact began 34.9 cm (13.75") left of the vehicle's centerline at the header and extended 24.1 cm (9.5') to the outboard corner. The impact crushed the backlight header and side rail area both downward and laterally right. The lateral damage length across the backlight header was 101.6 cm (40.0"). A crush profile was documented at the header and was as follows:

$C1 = 31.1 \text{ cm (12.25")}$ ,  $C2 = 29.2 \text{ cm (11.5")}$ ,  $C3 = 22.9 \text{ cm (9.0")}$ ,  $C4 = 15.6 \text{ cm (6.1")}$ ,  $C5 = 9.5 \text{ cm (3.75")}$ ,  $C6 = 3.8 \text{ cm (1.5")}$ . The juncture of the left corner of the backlight header and upper D-pillar was crushed forward 43.8 cm (17.25"). The CDC for this impact was 00-TBLN-4.

**Figure 6.** Rock impact damage to the roof, backlight header, D-pillar area of the vehicle.

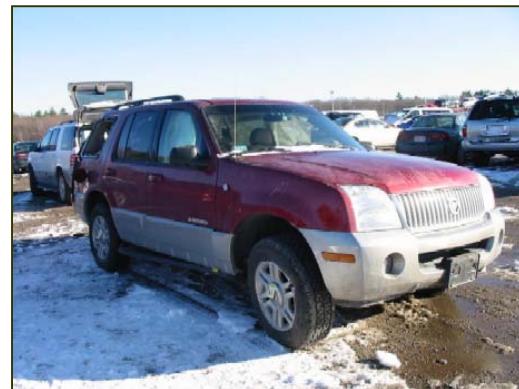
Isolated rollover damage was noted to the right side of the Mercury Mountaineer (**Figure 7**). The right rear corner of the bumper fascia was abraded. The right OEM running board was crushed laterally to a depth of 9.5 cm (3.75"), located 21.6 cm (8.5") rearward of the leading edge. There was 11.4 cm (4.5") of direct contact associated with this deformation. Superficial abrasions were noted to the mid and forward aspect of the right front fender. These abrasions were vertically oriented. A crack was noted on the fiberglass fender at the forward aspect of the wheel opening.

**Figure 7.** Rollover damage to the right to the right front fender, right running board, right rear quarter window, and D-pillar.

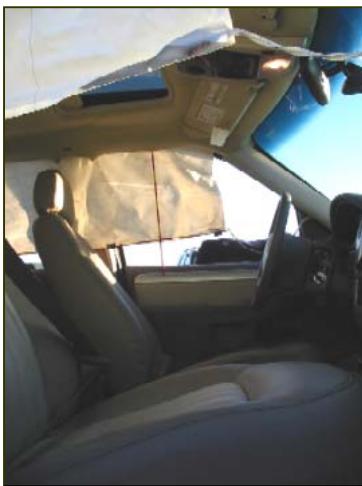
**Figure 8.** Deployed left side rollover canopy air bag.

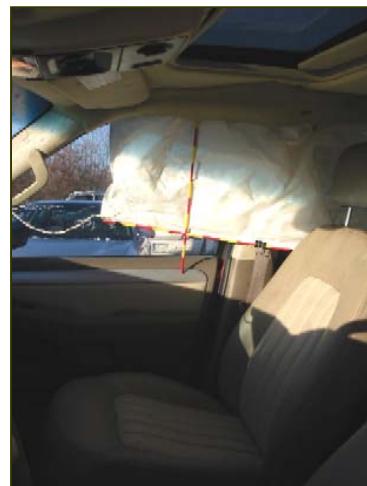
**Figure 9.** Deployed right side canopy air bag.

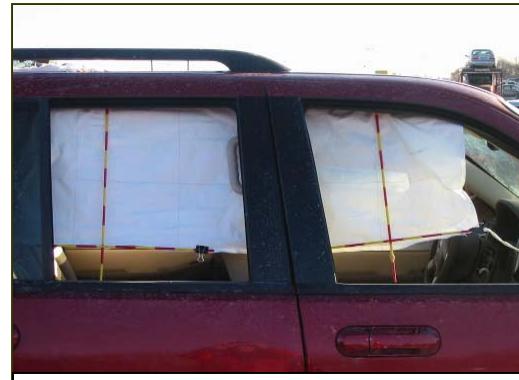
**Figure 10.** Overall view of the deployed right side rollover canopy air bag.

The canopy air bags were constructed of two panels that were fused together. The air bag panels were fused to form air chambers for occupant protection. There was no damage to

the bag fabric or separation of the fused seams. Several transfers were noted to the bag membrane, however, these transfers appeared to be related to parts that were placed in the vehicle prior to towing from the scene.

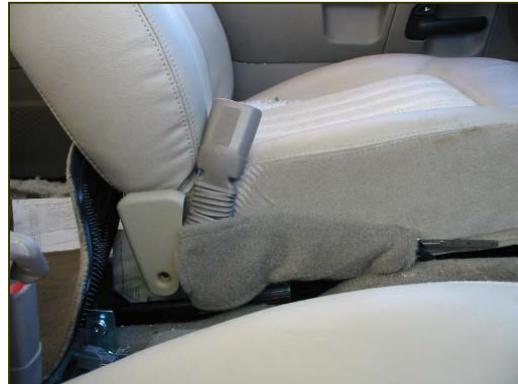
The front safety belt buckle pretensioners fired as a result of the deployment of the canopy air bag system. The front left pretensioner barrel length was measured at 6.0 cm (2.375") post-crash with equated to 4.8 cm (1.875") of piston travel. The seat cushion fabric adjacent to the pretensioner was abraded in a serrated pattern from the convoluted sleeve of the buckle assembly. The right pretensioner barrel measured 5.7 cm (2.25") which resulted in 5.1 cm (2.0") of piston travel. **Figure 11** is a view of the front left buckle pretensioner.

**Figure 11.** Front left buckle pretensioner.
