## SCI/NASS COMBINATION CASE REPORT

CASE NUMBER - NASS-2003-09-006C

VEHICLE - 2002 GMC ENVOY

CRASH DATE - January 2003

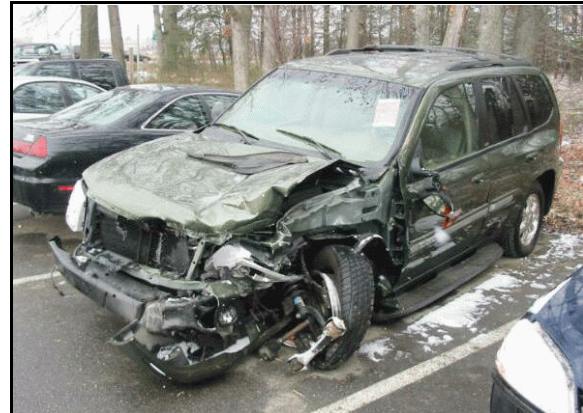
The case vehicle sustained direct contact damage at the front left corner, extending inward across the front and rearward along the left side. The left front wheel assembly was broken, with the wheel and tire pushed rearward and rotated outward approximately -60 degrees (**Figures 2 and 3**). The outer sheet metal of the left fender was torn away, with the inner structures and the left edge of the engine hood crushed inward. There was minor direct damage on the left A-pillar and driver's door. The left headlamp assembly and the entire grille were shattered and broken away, and the front bumper cover was torn off. The front left bumper corner, the left headlamp area and the left edge of the engine hood were crushed rearward. The wheelbase was shortened by 38 centimeters [14.9 inches] on the left and 6 centimeters [2.4 inches] on the right. Direct damage was measured as 49 centimeters [19.3 inches] wide, beginning at the front left bumper corner and extending inward, with induced damage extending across the entire front. Maximum crush was measured as 31 centimeters [12.2 inches] between C2 and C3. There was no glazing damage and all of the doors remained closed and operational. The CDC was determined to be **10-FYEW-2 (310)**. This impact is not eligible for the WinSMASH reconstruction program because the other vehicle is out of scope. The Barrier Equivalent Speed was calculated as 17 km.p.h. [10.6 m.p.h.], but this estimate seems low. The Event Data Recorder (discussed further, below) recorded a maximum longitudinal velocity change of -34.8 km.p.h. [-21.61 m.p.h.]. This was a crash of moderate severity ( 24 - 40 km.p.h. [15 - 25 m.p.h.]) for the case vehicle.

**Figure 2:** Case vehicle's front and left side

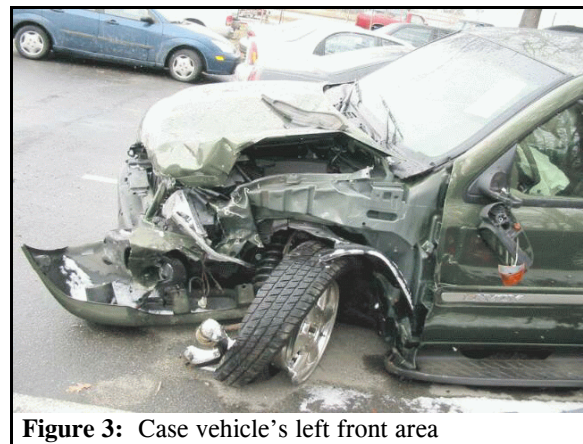
**Figure 3:** Case vehicle's left front area

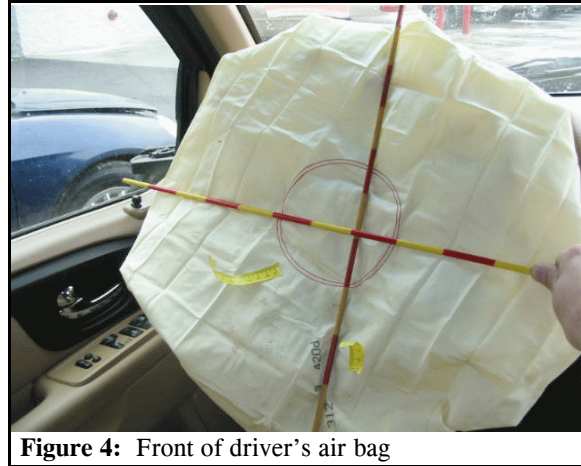
The driver's air bag was mounted in the steering wheel hub with cover flaps in the I-configuration. The center seam measured 12 centimeters [4.7 inches] vertically, with the upper and lower seams measuring 16 centimeters [6.3 inches] horizontally, centered on the vertical seam. The seams opened at the tear points and there was no evidence of damage to the cover flaps or the adjacent structures. The deployed driver's air bag was round with a diameter of 54 centimeters [21.3 inches]. The air bag had two vent ports, each with a diameter of 3 centimeters [1.2 inches], at the 11:00 and 1:00 o'clock positions, and had two tether straps near the center, each 13 centimeters [5.1 inches] wide. There was no evidence of damage to the air bag. There was an area of body fluid (mucus/saliva) in the lower left quadrant (**Figure 4**).

**Figure 4:** Front of driver's air bag

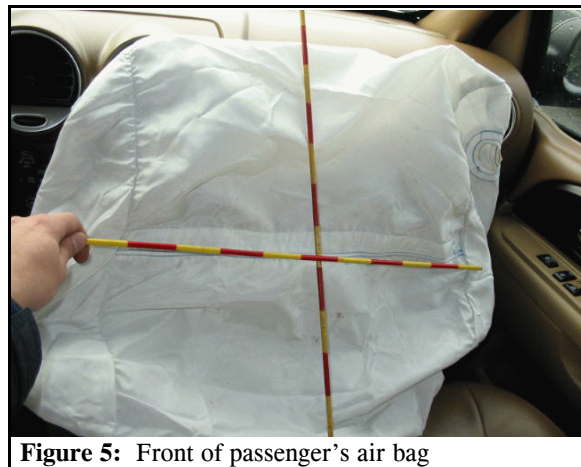
The front right passenger's air bag was mounted in the mid-instrument panel, with a single cover flap hinged at the top. The cover flap measured 33 centimeters [13.0 inches] horizontally and 14 centimeters [5.5 inches] vertically. The cover flap opened at the tear points and there was no evidence of damage to the cover flaps or the adjacent structures. The deployed passenger air bag was rectangular, measuring 76 centimeters [29.9 inches] horizontally and 55 centimeters [21.7 inches] vertically. The air bag had two vent ports, each with a diameter of 4 centimeters [1.6 inches] at the 9:30 and 2:30 o'clock positions. There were two horizontal tethers, each 40 centimeters [15.7 inches] wide. There was no evidence of damage or occupant contact on the passenger's air bag (**Figure 5**).

**Figure 5:** Front of passenger's air bag

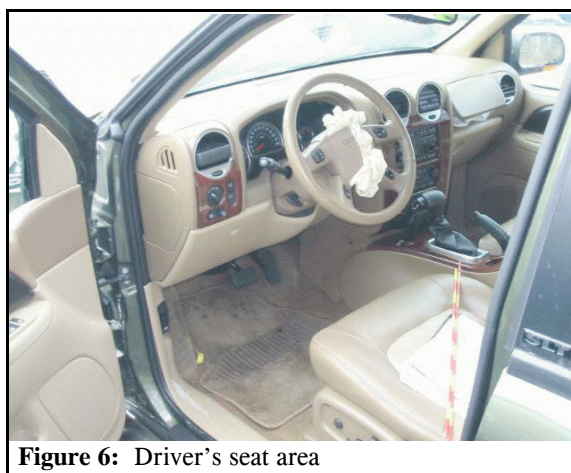
The case vehicle driver (39-year-old male; white, non-Hispanic; 173 centimeters and 73 kilograms [68 inches, 161 pounds]) was restrained by the available manual, three-point, lap-and-shoulder safety belt system. He was seated in a normal driving posture with the seat back slightly reclined and the seat track adjusted at the middle position (**Figure 6**).

**Figure 6:** Driver's seat area

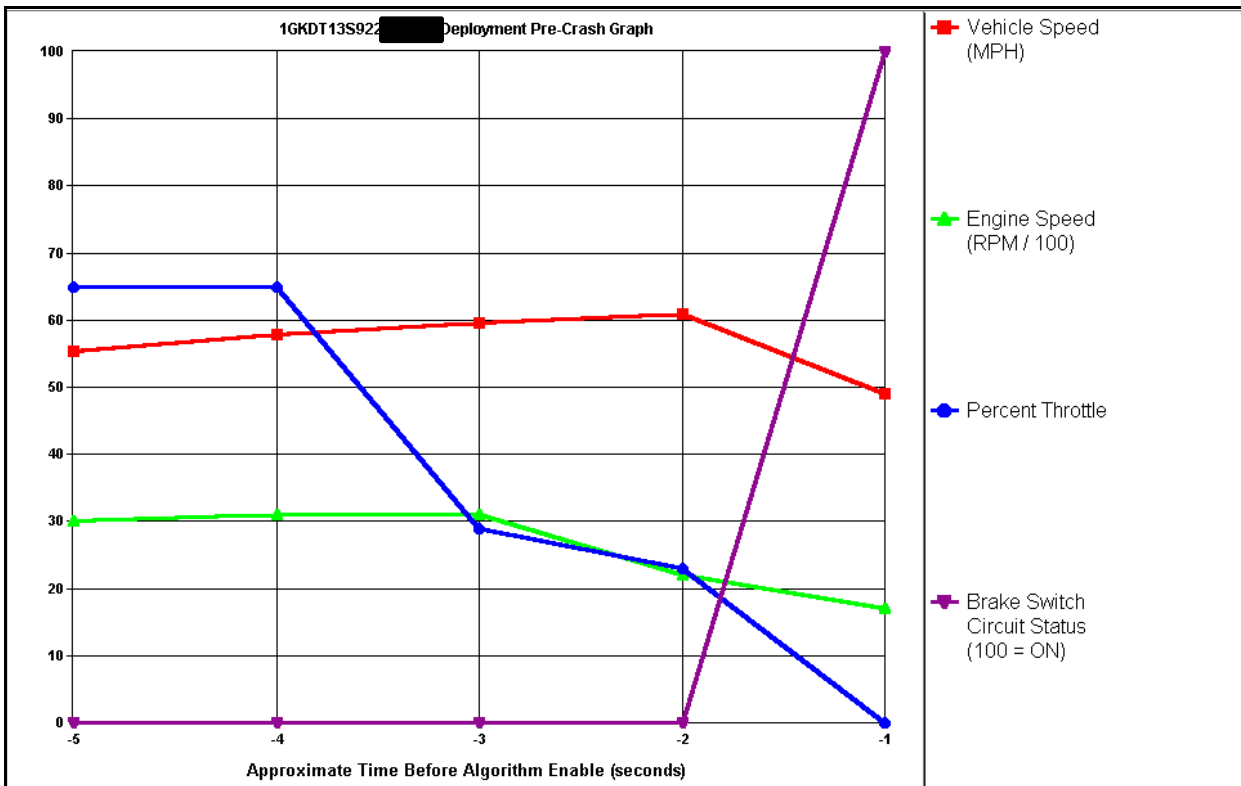
The Pre-Crash Data (**Figures 7 and 8**) indicate that the case vehicle was traveling 88.5 km.p.h. [55.0 m.p.h.] at five seconds prior to algorithm enable, and accelerated to 98.2 km.p.h. [61 m.p.h.] at two seconds prior. The driver braked during the last one second interval and the case vehicle's speed decreased to 78.8 km.p.h. [49 m.p.h.] at one second prior to algorithm enable.

Figure 8: Sensing and Diagnostic Module Pre-Crash Graph

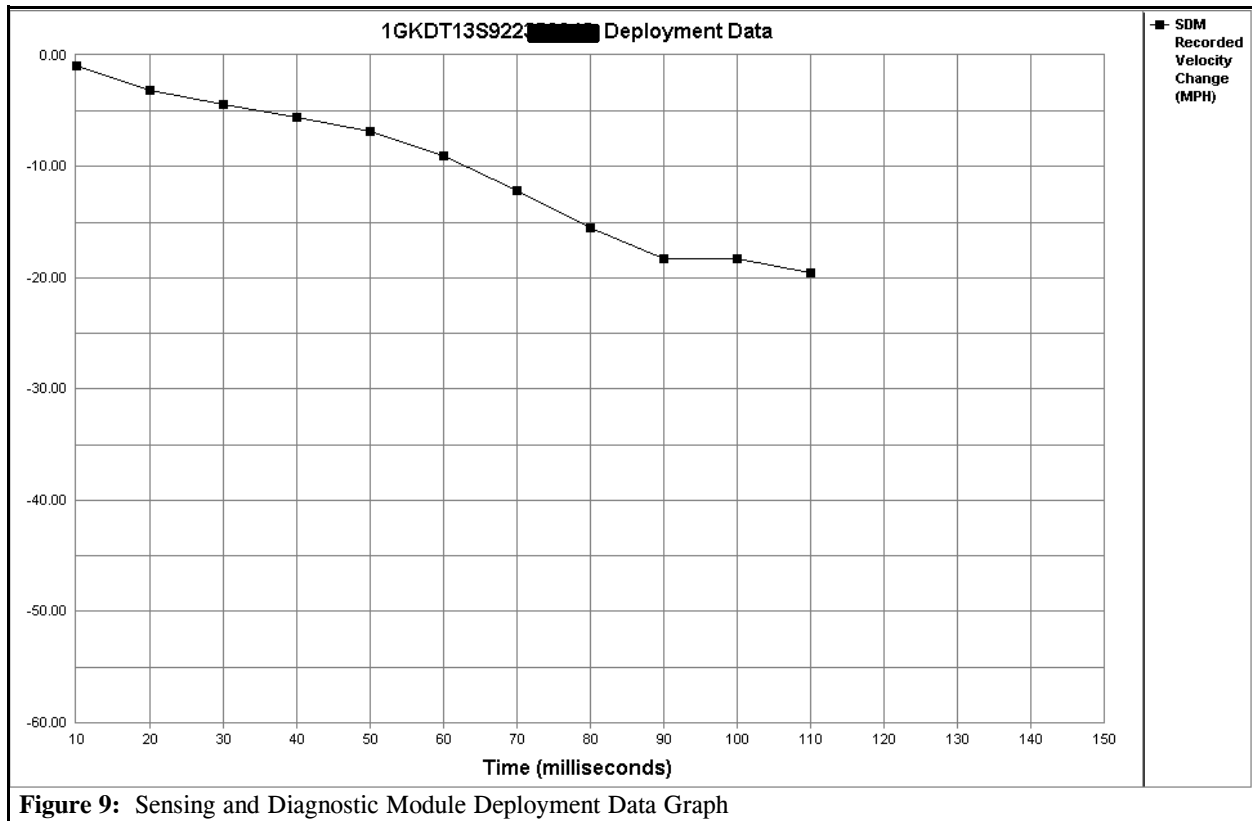
The command for first stage deployment was issued to the driver's and front right passenger's air bags at 15 milliseconds [0.015 seconds] after algorithm enable, and the command for second stage deployment was not issued. The EDR recorded a maximum longitudinal velocity change of -34.8 km.p.h. [-21.61 m.p.h.] at 170 milliseconds [0.17 seconds] after algorithm enable (**Figure 7**). The Deployment Data and Graph (**Figures 7 and 9**) show a gradual slope (i.e., not a steep spike) that reached -31.4 km.p.h. [-19.53 m.p.h.] at 110 milliseconds, and then recording stopped.

Figure 9: Sensing and Diagnostic Module Deployment Data Graph
