**CALSPAN ON-SITE CERTIFIED ADVANCED 208-COMPLIANT
VEHICLE CRASH INVESTIGATION**

NASS/SCI CASE NO: 2003-09-017J

VEHICLE: 2003 CHEVROLET TAHOE

CRASH DATE: JANUARY 2003

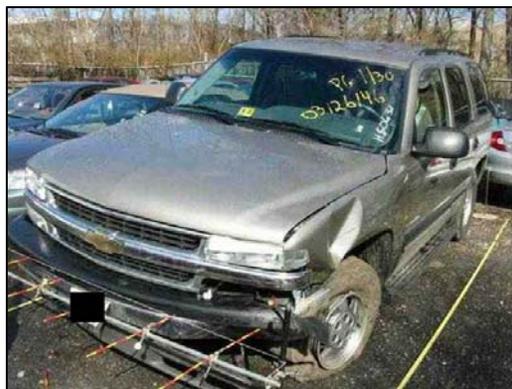
Figure 1 - Damaged 2003 Chevrolet Tahoe.

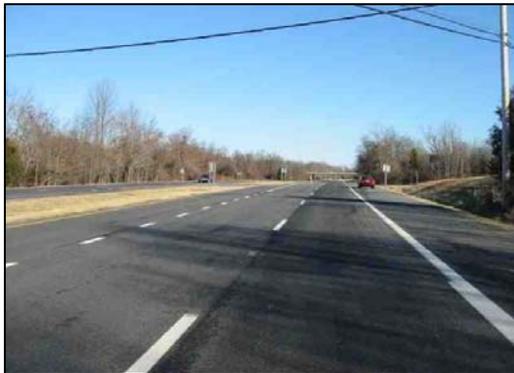
Figure 3 - Eastbound approach of Chevrolet Tahoe.

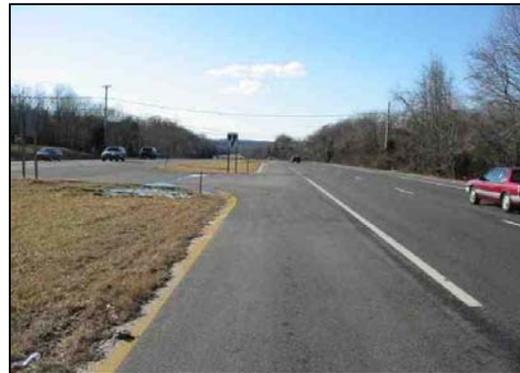
Figure 2 - Westbound approach of Mazda 626.

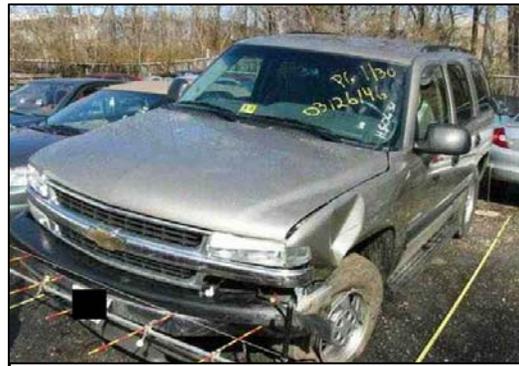
The 2003 Chevrolet Tahoe (**Figure 4**) sustained moderate damage as a result of the impact with the 2000 Mazda 626. The NASS vehicle inspection revealed that the direct contact damage began at the front left bumper corner and extended 34 cm (13.4") to the right. The combined direct and induced damage encompassed the entire front bumper and measured 166 cm (65.4") in length. The maximum crush was located at the front left bumper corner and measured 20 cm (8") in depth. The SCI revised Collision Deformation Classification (CDC) for this frontal impact was 12-FLEE-1. Six equidistant crush measurements were documented across the full width of the chrome bumper and were as follows: C1 = 20 cm (8"), C2 = 0 cm, C3 = 0 cm, C4 = 0 cm, C5 = 0 cm, C6 = 0 cm. The SCI made a revision of the C1 measurement, extending the crush from 9 cm (3.5") to 20 cm (8"). The original C1 measurement was underestimated during the NASS investigation as it was measured to the outer bumper covering strip rather than to the chrome bumper at its deepest level of crush.

Figure 4 - Damaged 2003 Chevrolet Tahoe.

The front end of the Mazda contacted and damaged the front left wheel of the Tahoe as the Mazda pivoted around its front left corner. As a result of this continuous contact, the chrome bumper was deflected rearward into the front left wheel and restricted the tire.

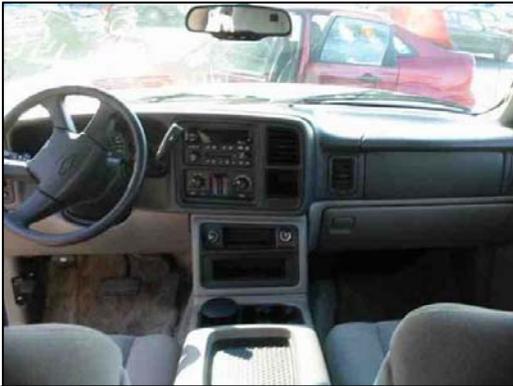
There was no damage to the interior of the 2003 Chevrolet Tahoe. The NASS investigation identified two possible contact points to the steering assembly attributable to the driver's chest and right hand. However, no correlative evidence was present for substantiation. **Figures 5 and 6** are views of the front aspect and the driver's area of the interior.

Figure 6 - Overall view of front aspect of interior.

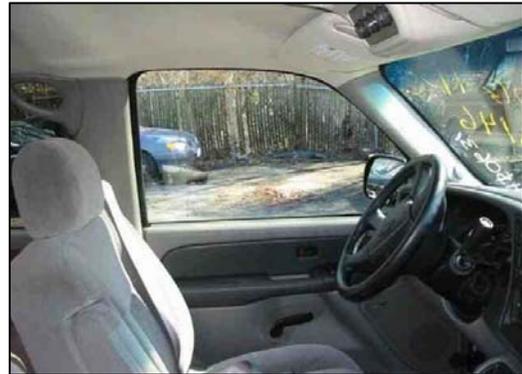
Figure 5 - Driver's area of Tahoe.

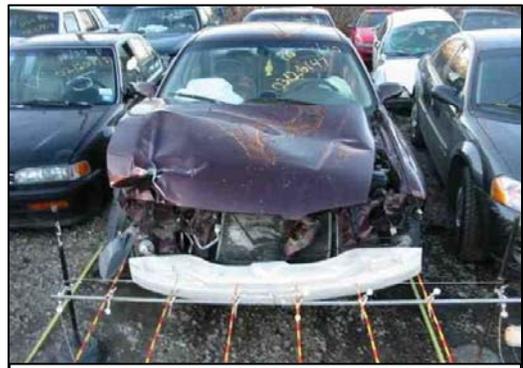
The 2000 Mazda 626 sustained moderate damage as a result of the frontal impact with the 2003 Chevrolet Tahoe. The NASS inspection revealed that the direct contact damage began at the front right bumper corner and extended the full length of the bumper measuring 137 cm (54"). The maximum crush was located 14 cm (5.5") right of the vehicle's centerline and measured 20 cm (8") in depth. Crush profiles were taken to both the bumper reinforcement beam to the radiator support by the NASS team. The crush profile taken to the bumper beam resulted in the following profile: C1 = 5 cm (2"), C2 = 3 cm (1.2"), C3 = 4 cm (1.6"), C4 = 5 cm (2"), C5 = 4 cm (1.6"), C6 = 9 cm (3.5"). The crush profile taken to the upper radiator support resulted in the following profile: C1 = 0 cm, C2 = 7 cm (2.8"), C3 = 13 cm (5.1"), C4 = 20 cm (8"), C5 = 10 cm (4"), C6 = 0cm. The two crush profiles were averaged the result of which was used to generate the delta-V. The averaged crush profile resulted in following: C1 = 5 cm (2"), C2 = 3 cm (1.2"), C3 = 4 cm (1.6"), C5 = 13 cm (5.1"), C5 = 4 cm (1.6"), C6 = 9 cm (3.5"). The CDC for this impact was 01-FDEW-1.

Figure 7 - Damaged 2000 Mazda 626.

The principal direction of force (PDOF) to the Mazda was determined to be 40 degrees. As a result of the impact, the front bumper cover was separated from the bumper and was not present at the vehicle inspection. The front right bumper mount was shifted to the right; however, the left bumper mount remained was not deformed. The front end was slightly swayed to the right, but short of an incremental level.
