**GENERAL DYNAMICS REMOTE CERTIFIED ADVANCED COMPLIANT
VEHICLE CRASH INVESTIGATION**

SCI TECHNICAL SUMMARY REPORT

NASS/SCI COMBO CASE NO. 03-09-224C

VEHICLE – 2003 GMC SIERRA

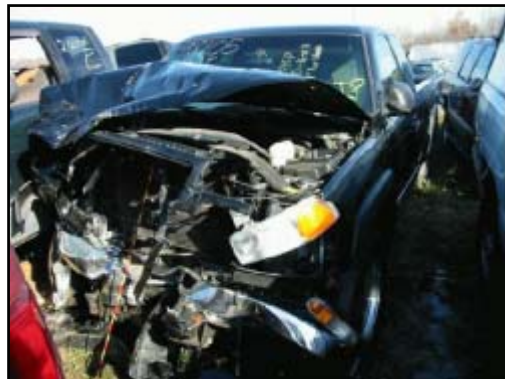
The 2003 GMC Sierra sustained moderate severity frontal damage as a result of the collision with the Ford (**Figure 5**). The maximum crush was located 19.0 cm (7.5") right of C3 and measured 39.0 cm (15.4"). The direct contact damage began on the front right bumper corner and extended left 117.0 cm (46.1"). The damage involved the bumper, hood, radiator support, and front right fender. Six crush measurements were

Figure 5. Damage to 2003 GMC Sierra.

documented along the front bumper using a combined direct and induced damage with of 156.0 cm (61.4”) and were as follows: C1 = 0.0 cm, C2 = 2.0 cm (0.8”), C3 = 9.0 cm (3.5”), C4 = 36.0 cm (14.2”), C5 = 27.0 cm (10.6”), C6 = 20.0 cm (7.9”). The Collision Deformation Classification (CDC) for this impact was 12-FDEW-2. The four doors remained closed and operational post-crash. The windshield was fractured at the base of the right A-pillar from contact with the rear right corner of the hood edge as it was deformed rearward. All side glazing and backlight remained intact.

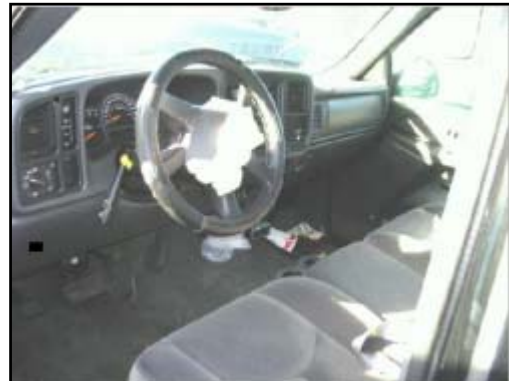
The 2003 GMC Sierra sustained minor interior damage (**Figure 6**) as a result of occupant contacts; no interior intrusions were noted. The occupant contacts consisted of the driver’s left hand contacting and fracturing the turn signal stalk and the driver’s left knee contacting and scuffing the knee bolster. Also noted, was body fluid on the front left air bag from contact with the driver’s face. The front right occupant contact involved his right hip contacting and scuffing the front right door panel. A small dirt scuff was noted to the glove box door that was not related to an occupant contact.

Figure 6. Interior view of front row. Note contact damage to turn signal lever.

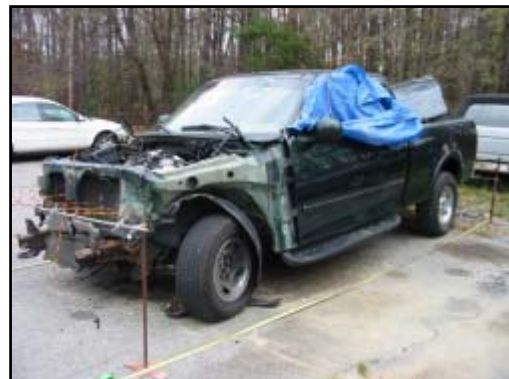
The 2001 Ford F-150 sustained moderate severity left side damage (**Figure 7**). The direct contact damage could not be identified due to the fenders, hood and frontal components being removed from the vehicle prior to the NASS inspection. The NASS researcher documented a crush profile at the upper left side frame and the maximum crush was approximately 20.0 cm (8.0”) at the forward aspect of the front left fender. The CDC for this impact was 71-LY99-9 with incremented shift of 60 and a direction of force of 11 o’clock.

Figure 7. Damage to 2001 Ford F-150

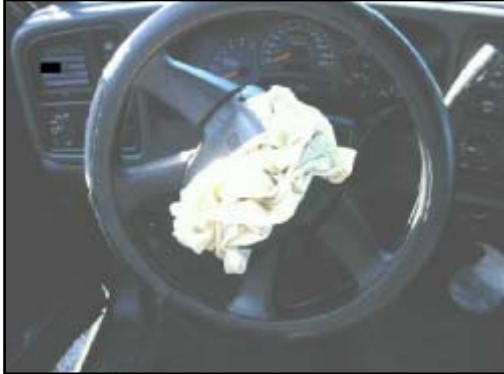
The 2003 GMC Sierra was equipped with a Certified Advanced Compliant safety system. The system included dual stage frontal air bags, seat track position sensors for the front left and front right seats and an occupant presence sensor for the front right seat. The system was monitored and controlled by a Sensing and Diagnostic control Module (SDM) that was mounted to the floor under the driver's seat. The SDM deploys the appropriate safety component(s) dependant on occupant presence, belt usage, seat track position and crash severity. In this crash, the SDM commanded a stage two deployment of the driver's frontal air bag (**Figure 8**). The front left air bag was located in the center of the steering wheel hub. The air bag was concealed by two I-symmetrical cover flaps that measured 12.0 cm (4.7") in height and 7.0 cm (2.8") in width. The air bag was 57.0 cm (22.4") in diameter and contained two tethers on the face of the air bag and two vent ports at the 11 and 1 o'clock positions on the rear aspect of the air bag. Body fluid was noted on the face of the air bag by the NASS researcher.

Figure 8. Deployed front left air bag.

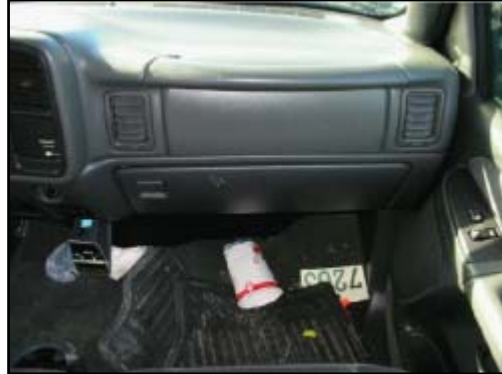
The SDM did not command a deployment of the front right air bag (**Figure 9**). Therefore, the front right occupant did not receive supplemental protection from the air bag. The front right air bag was equipped with a cut-off switch that was located on the bottom right aspect of the center instrument panel. The cut-off switch was keyed to "Auto-On" position at the time of the NASS inspection (**Figure 10**).

Figure 9. Non-deployed front right air bag.

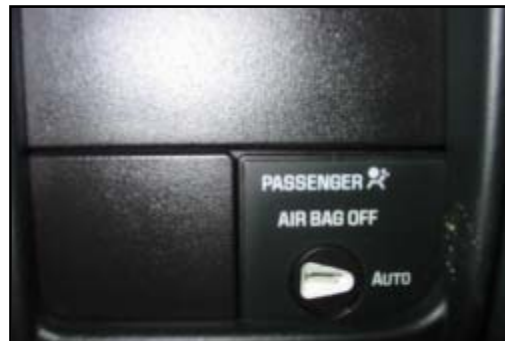
Figure 10. Front right air bag cut-off switch.
