**GENERAL DYNAMICS REMOTE CERTIFIED ADVANCED 208-COMPLIANT
VEHICLE CRASH INVESTIGATION**

SCI TECHNICAL SUMMARY REPORT

NASS/SCI COMBO CASE NO. 03-43-273E

VEHICLE – 2003 CHEVROLET SUBURBAN

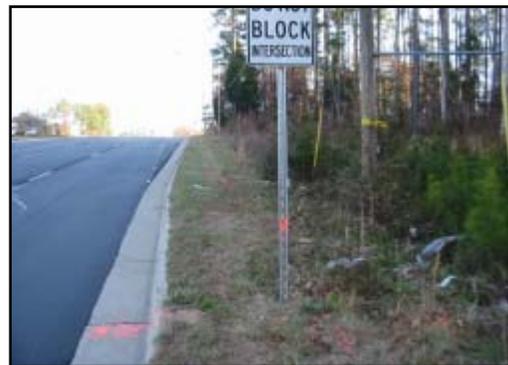
The Chevrolet traveled approximately 11.0 meters (36.0 feet) off-road and impacted a signpost with its front (**Figure 3**). The signpost subsequently sheared and impacted the right side of the roof. The Chevrolet continued an additional 60.0 meters (197.0 feet) and impacted a wooden utility pole with its front (**Figure 4**) which resulted in the Stage One deployment of the driver's frontal air bag at 10 milliseconds Algorithm Enable (AE). The EDR data indicated that the vehicle speed was 19.3 km/h (12.0 mph) five seconds prior to AE and the vehicle's speed increased to 64.3 km/h (40.0 mph) one second prior to AE. The EDR data also indicated that the brake switch status

Figure 3. Event 1, struck signpost.

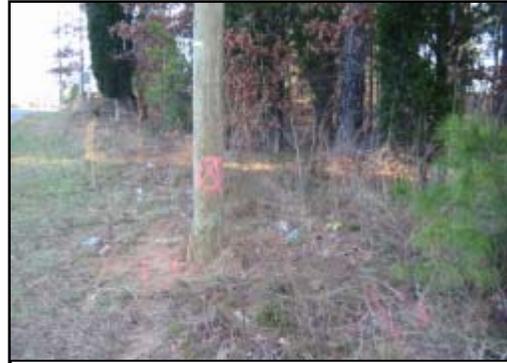
Figure 4. Event 3, with a utility pole, replaced.

The third event was the front of the Chevrolet impacting a utility pole. The exact area of contact could not be located on the vehicle. Based on the crash site images, it appears that the off-road rotating tire marks indicated that the replacement utility pole was positioned inboard of the left wheel. This was not consistent with the damage to the vehicle which did not support and impact to the front left aspect. The struck pole may not have been located in the position of the replacement.

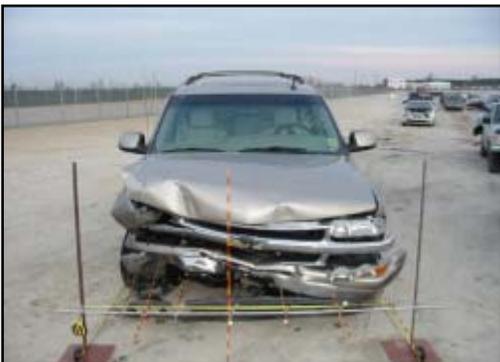
The 2003 Chevrolet Suburban sustained minor damage as a result of the initial impact to the signpost. Although it was not documented by the NASS researcher, the direct damage was located approximately 10.0 cm (4.0”) left of the centerline (**Figure 11**). The maximum crush was approximately 2.5 cm (1.0”) on the face of the hood. A crush profile was not documented for this impact due to the overlapping impacts to the frontal plane.

Figure 11. The damage from the signpost is located left of center.

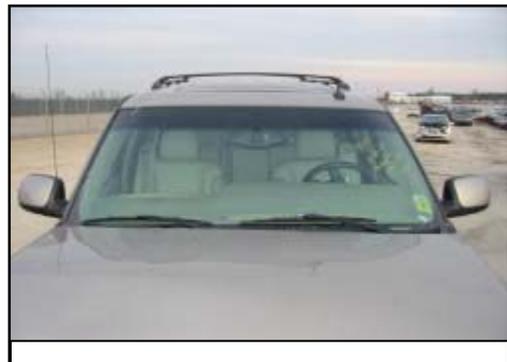
Figure 12. Roof damage from the signpost is located left of the right A-pillar.

The second event involved the initial signpost that was sheared and contacted the right side of the windshield header and upper windshield (**Figure 12**). The direct damage appeared to be approximately 5.0 cm (2.0”) in width and began left of the right A-pillar.

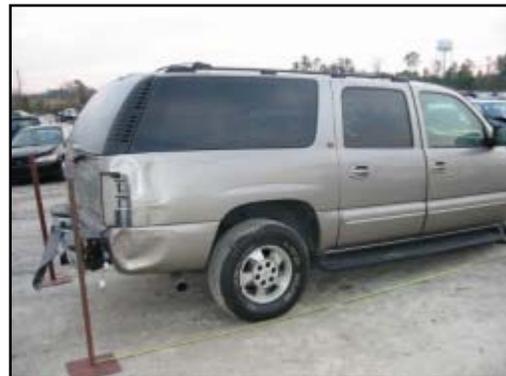
The eighth event consisted of the right rear side of the Chevrolet impacting a 13.0 cm (5.1”) diameter tree (**Figure 13**). The direct damage measured 62.0 cm (24.4”) and began on the right rear bumper corner and extended forward. The damage involved the right rear quarter panel, right rear taillight, and the rear bumper. Six crush measurements were documented along the mid-door level using a combined direct and induced damage width of 177.0 cm (69.7”) and were as follows: C1= 3.0 cm (1.2”), C2= 2.0 cm (0.8”), C3= 0, C4= 0, C5= 0, C6= 0.

Figure 13. Area of damage from tree and signpost.

The ninth event consisted of the right rear side of the Chevrolet impacting a signpost (**Figure 13**). The NASS researcher did not measure the residual damage for this event. Therefore, the direct damage was estimated for this report by the SCI investigator. The direct measured approximately 12.7 cm (5.0”) and was located approximately 52.0 cm (21.0”) forward of the right rear bumper corner. A crush profile was not obtained for this impact.

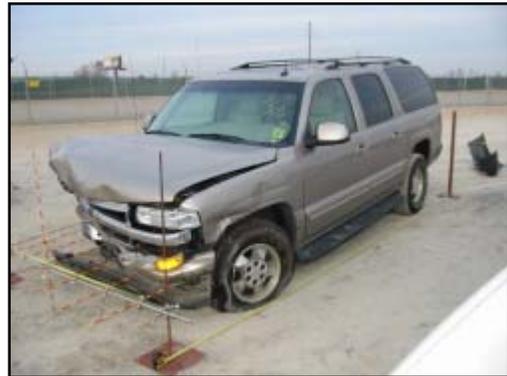
The tenth event was the left front aspect of the Chevrolet sideswiping the right side of the Geo (**Figure 14**). The direct damage width measured 101.0 cm (39.8") and began on the front left bumper corner and extended rearward. The direct damage consisted black longitudinal abrasions on the left side of the front bumper from contact with Geo's right rear tire and lateral deformation of the left front fender. Six crush measurements were documented along the mid-door level using a combined direct and induced damage width of 179.0 cm (70.5"), and were as follows: C1= 0, C2= 0, C3= 0, C4= 1.0 cm (0.4"), C5= 3.0 cm (1.2"), C6= 2.0 cm (0.8").

Figure 14. Area of damage from impact with the Geo.

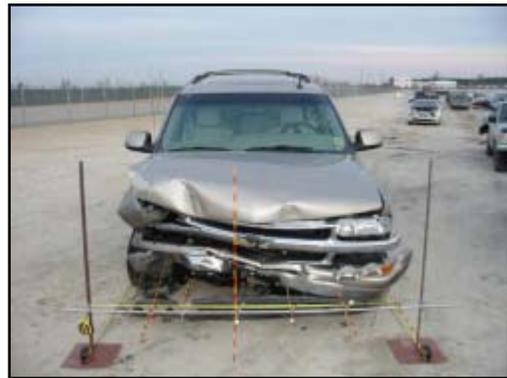
The eleventh event involved the frontal aspect of the Chevrolet (**Figure 15**) impacting the frontal aspect of the Toyota. The direct damage measured 111.0 cm (43.7") and began 50.0 cm (19.7") right of the front left bumper corner and extended right. The maximum crush was located 82.0 cm (32.3") right of the front left bumper corner and measured 63.0 cm (24.8"). The damage consisted of longitudinal deformation of the front bumper, hood, radiator, and the right frame rail. As a result of the impact the right side wheelbase was reduced 26.0 cm (10.2") and left side wheelbase was increased 5.0 cm (1.9"). Six crush measurements were documented along the front bumper using a combined direct and induced damage width of 161.0 cm (63.3") and were as follows: C1= 1.0 cm (0.4), C2= 11.0 cm (4.3"), C3= 25.0 cm (9.8"), C4= 41.0 cm (16.1"), C5= 41.0 cm (16.1"), C6= 54.0 cm (21.3").

Figure 15. Damage from impact with the Toyota.

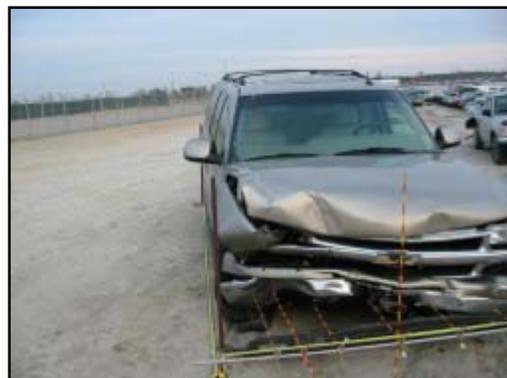
The thirteenth event involved the front impacting a guy wire (**Figure 16**). The direct damage was located approximately 25.0 cm (10.0") right of the centerline and consisted of vertical abrasions and longitudinal deformation of the hood edge.

Figure 16. Damage from guy wire impacts is right of the center.

The fourteenth event involved the front right hood edge impacting a guy wire (**Figure 16**). The direct damage consisted of longitudinal deformation and vertical abrasions to the front right hood edge.

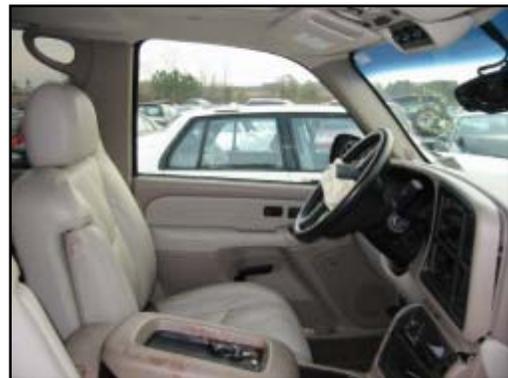
The 2003 Chevrolet Suburban sustained minor interior damage (**Figure 17**) as a result of occupant contacts. There were no intrusions into the passenger compartment. The NASS researcher documented a probable contact from the driver’s face to the frontal air bag. Body fluid was noted to multiple aspects of the air bag. A scuffmark from the driver’s left knee was noted to the knee bolster and a scuffmark to the inboard aspect of the center instrument panel/console from the driver’s right knee. The shoulder belt portion of the safety belt contained a red clothing transfer from the driver’s left shoulder loading the belt. Also noted was stretching to the lap belt portion of the safety belt from the driver’s abdomen loading the belt.

Figure 17. Overall view of driver's position.

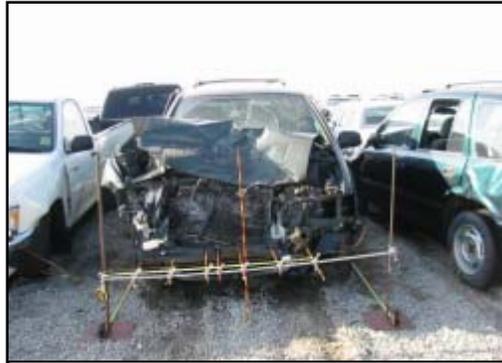
The 1999 Toyota Sienna sustained moderate frontal damage as a result of the frontal impact with the Chevrolet (**Figure 18**). The direct damage width was 109.0 cm (42.9”) and began on the front left bumper corner and extended the full width of the bumper. The damage involved the bumper support, upper and lower radiator supports, front right fender, and the hood. Two crush profiles were documented at the level of the bumper and upper radiator support using a combined direct and induced damage width of 118.0 cm (46.9”). The average both crush profiles and was as follows: C1= 6.0 cm (2.4”), C2= 37.0 cm (14.6”), C3= 39.0 cm (15.4”), C4= 39.0 cm (15.4”), C5= 40.0 cm (15.7”), C6= 32.0 cm (12.6”). The CDC for this impact was 12-FDEW-3.

Figure 18. Damage sustained from frontal impact with the Chevrolet.

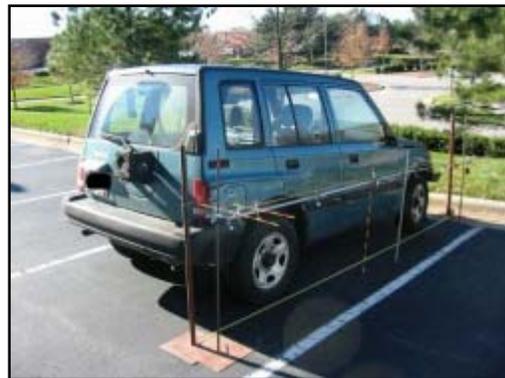
The 1996 Geo Tracker sustained minor right side damage (**Figure 19**) as a result of the sideswipe impact with the Chevrolet. The direct damage width was 378.0 cm (148.8”) and began 70.0 cm (27.5”) rear of the right rear axle and extended forward. The maximum crush measured 2.0 cm (0.8”) and was located at the end of the right rear quarter panel. The damage involved the entire right side of the vehicle and it consisted of lateral deformation and longitudinal abrasions. Six crush measurements were documented along the mid-door level using a combined direct and induced damage width of 378.0 cm (148.8”), and were as follows: C1= 2.0 cm (0.8”), C2= 1.0 cm (0.4”), C3= 0, C4= 0, C5= 0, C6= 0. The CDC for this impact was 06-RDES-1.

Figure 19. Sideswipe damage from impact with the Chevrolet.

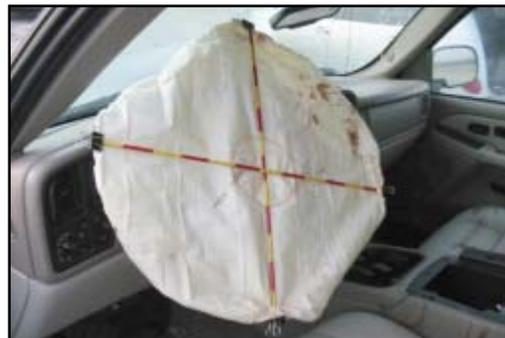
Figure 20. Deployed driver's frontal air bag. Note body fluid is a result of driver bleeding on the air bag and not from contact.

the front right seat. The system is monitored and controlled by a Sensing and Diagnostic Module (SDM). The SDM deploys the appropriate safety system dependant on crash severity, occupant presence, and seat track position. The third event of the crash involved the front of the Chevrolet impacting a utility pole. The system commanded a stage one deployment of the driver's frontal air bag at 42.5 milliseconds from AE. The air bag was located in the center of the steering wheel hub and was concealed by two symmetrical I-configuration cover flaps that measured 12.0 cm (4.7") in height and 7.0 cm (2.8") in width. The air bag membrane measured 68.0 cm (26.7") in diameter in its deflated state and contained two tethers. Two vent ports on the rear aspect of the air bag at the 11 and 1 o'clock positions vented the air bag. The NASS researcher documented the air bag as a probable contact point that was evidenced by body fluid on the air bag membrane.
