**GENERAL DYNAMICS REMOTE SIDE IMPACT INFLATABLE OCCUPANT
PROTECTION INVESTIGATION**

NASS/SCI COMBO CASE NO. 03-48-222C

VEHICLE – 2001 VOLKSWAGEN BEETLE

CRASH DATE – NOVEMBER 2003

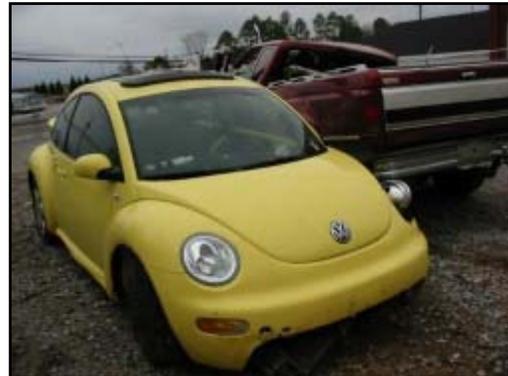
Figure 1. Subject 2001 Volkswagen Beetle.

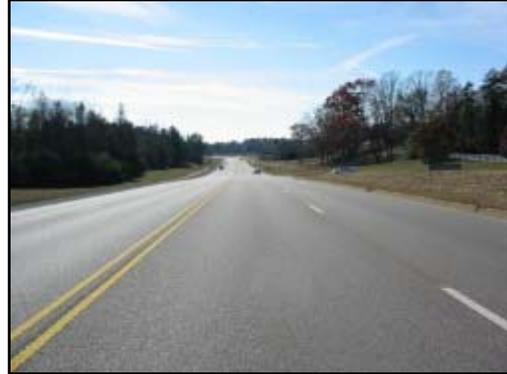
This multiple event crash occurred during the evening hours of November 2003 in the state of Alabama. At the time of the crash, there were no adverse weather conditions and the asphalt road surface was dry. The crash events occurred on a four-lane roadway and on the west roadside. The north/southbound roadway consisted of two travel lanes in each direction and was delineated by a double yellow centerline. The southbound travel lanes curved left and had a slight uphill grade. The west roadside consisted of a barrier curb, grass, trees, and driveway culverts. The posted speed limit for this roadway was 72 km/h (45 mph). **Figure 2** is a southbound view of the crash site.

Figure 2. Southbound view of the crash site.

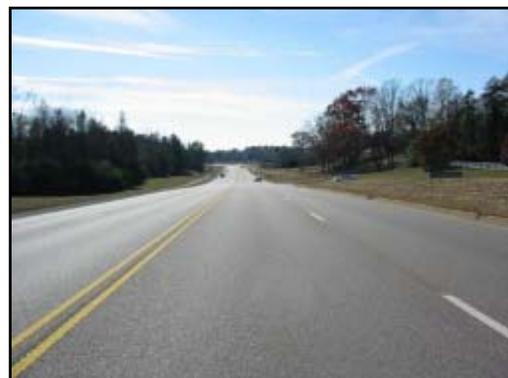
The front left aspect of the Volkswagen impacted the rear right aspect of the Mercury in the inboard lane (**Figure 3**). The resultant directions of force were within the 12 o'clock sector for the Volkswagen and 6 o'clock for the Mercury. The WINSMASH damage algorithm was used to calculate a delta for this impact. The total delta V for the Volkswagen was 15.0 km/h (9.3 mph). The longitudinal and lateral components were -15.0 km/h (-9.3 mph) and

Figure 3. Area of impact between the Volkswagen and the Mercury.

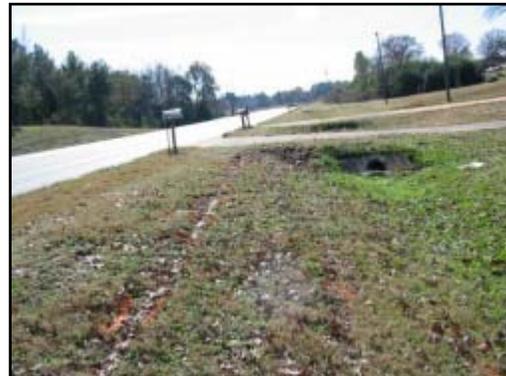
The Volkswagen subsequently departed the west roadside and began to travel in a southwest direction initiating a counterclockwise yaw. The Volkswagen traveled off-road approximately 47.0 meters (154.0 feet) and impacted a shallow driveway culvert with its right side (**Figure 4**). The resultant direction of force was within the 1 o'clock sector. The WINSMASH program was not used to calculate a delta V for this impact due to the lack of crush measurements. This impact resulted in the deployment of the right seatback mounted side impact air bag.

Figure 4. Area of impact between the Volkswagen and the first culvert.

The initial driveway culvert impact involved the right side and undercarriage and redirected the Volkswagen in clockwise rotation.

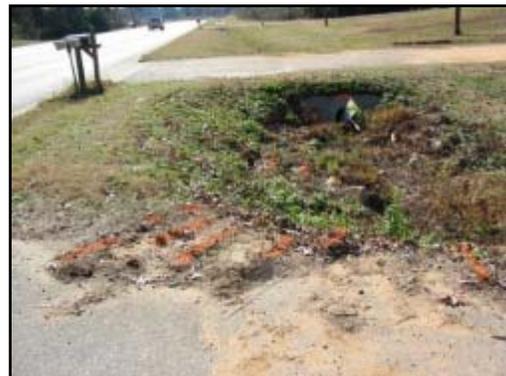
The Volkswagen traveled approximately 9.0 meters (30.0 feet) beyond the culvert and impacted a second driveway culvert with its lower frontal aspect (**Figure 5**). The resultant direction of force for this impact was within the 12 o'clock sector. This impact resulted in minor damage to bumper fascia of the Volkswagen. Therefore, the WINSMASH program was not used to calculate a delta V for this impact. This impact arrested the Volkswagen's forward momentum and the vehicle came to rest against the culvert facing a southerly direction.

Figure 5. Second culvert impact and final rest for the Volkswagen.

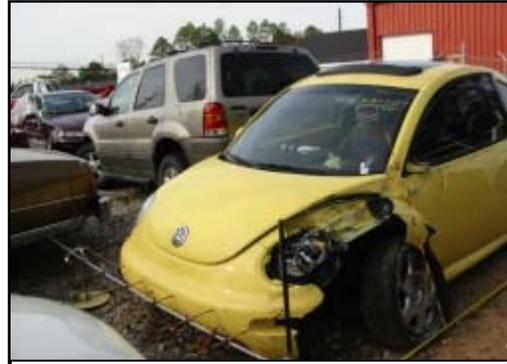
The 2001 Volkswagen Beetle sustained moderate severity damage as a result of the multiple event crash. The damage from the impact with the rear of the Mercury (**Figure 6**) consisted of longitudinal displacement of the front bumper; fractured composite left front fender, fractured left side mirror, and longitudinal displacement of the front left axle. The direct damage began at the front left corner and extended 21.0 cm (8.3”) laterally right onto the bumper fascia. The maximum crush measured 2.0 cm (0.8”) and was located at the front left bumper corner. Six equidistant crush measurements were documented along the bumper using a combined direct and induced damage width of 143.0 cm (56.3”) and were as follows: C1 = 2.0 cm (0.8”), C2 = 2.0 cm (0.8”), C3 = 1.0 cm (0.4”), C4 = 1.0 cm (0.4”), C5 = 1.0 cm (0.4”), C6 = 0.0 cm. The Collision Deformation Classification (CDC) for this impact was 12-FLAE-7.

Figure 6. Damage from the impact with the Mercury.

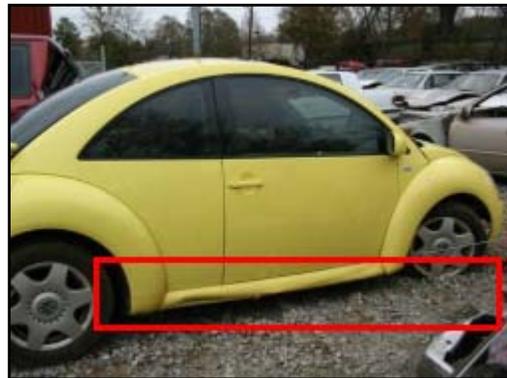
The damage from the first culvert impact consisted of a cut front right tire, lateral abrasions on the right sill, and lateral crush to the right sill (**Figure 7**). A crush profile was not documented for this impact; therefore the direct damage width and crush measurements were unknown. Based on the images of the damage, the crush appeared to be approximately 2.5 cm (1.0”) at the sill level. The NASS researcher documented a CDC for this impact of 00-U999-9. Based on the SCI damage evaluation the CDC was revised for this report as follows: 01-RYLS-1.

Figure 7. Residual damage from the first culvert impact.

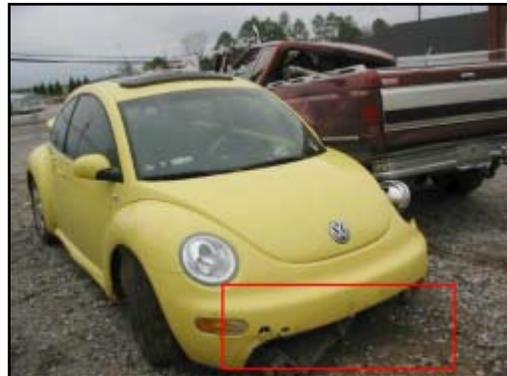
The Volkswagen sustained minor severity damage as a result of the second driveway culvert impact (**Figure 8**). The damage consisted of a fractured grille that was mounted to lower front bumper fascia. The NASS researcher measured the direct damage at 63.0 cm (24.8”) along the bumper. A crush profile was not obtained for this impact. The vehicle did not appear to have sustained crush as a result of this impact. The NASS researcher documented a CDC for this impact of 00-F9LW-9. Based on the SCI damage evaluation

Figure 8. Frontal damage from the second culvert impact.

the CDC was revised for this report as follows: 12-FDLW-1.

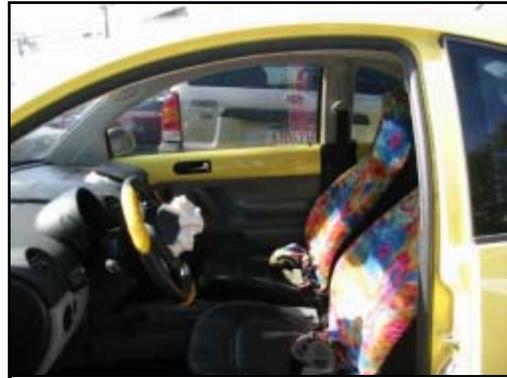
The Volkswagen Beetle sustained no interior damage (**Figure 9**) as a result of passenger compartment intrusion. The NASS researcher documented an occupant contact to the front right safety belt that consisted of stretching to the upper portion from occupant loading. Also noted was the torn seam on the right side of the aftermarket seat cover.

Figure 9. Overall view of the interior front row.

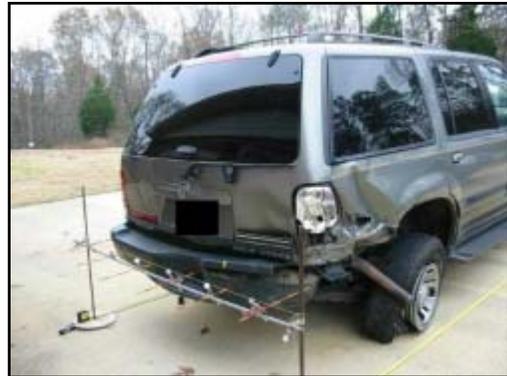
The 1999 Mercury Mountaineer sustained moderate severity damage to the rear aspect as a result of the impact with the Volkswagen (**Figure 10**). The direct damage measured 33.0 cm (13.0”) and began at the rear right bumper corner and extended left. The maximum crush was 24.0 cm (9.4”) and was located at the rear right bumper corner. The damage involved longitudinal displacement of the rear bumper, tailgate, right rear fender, and the right rear axle. Six crush measurements were documented at the rear bumper using a combined direct and induced damage width of 150.0 cm (59.1”), and were as follows: C1 = 4.0 cm (1.6”), C2 = 3.0 cm (1.2”), C3 = 5.0 cm (2.0”), C4 = 4.0 cm (1.6”), C5= 6.0 cm (2.4”), C6= 24.0 cm (9.4”). The CDC for this impact was 06-BREE-4.

Figure 10. Resultant damage from the impact with the Volkswagen.

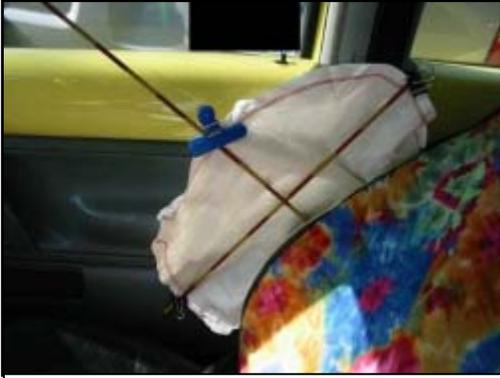
The 2001 Volkswagen Beetle was equipped seatback mounted side impact air bags for the front seating positions. The sensors for the side impact air bags were located under the front seats. In the subject crash, the right side impact air bag deployed (**Figure 11**). Aftermarket seat covers were installed on the front bucket seats of the Volkswagen. The seatback was completely covered on all four sides of the seat back. The aftermarket seat cover appears to be one-piece and was stretched over the OEM seatback completely covering the side impact air bag module. However, the aftermarket seat cover did not appear to impede the deployment of the air bag (**Figure 12**). The aftermarket seat cover seam and the seam of the front right seatback appeared to overlap which may have contributed to the unimpeded deployment. The seam of the aftermarket seat cover and seatback were torn open by the deploying air bag. The air bag measured 27.0 cm (10.6”) in height and 55.0 cm (21.7”) in width. The air bag contained no tethers or vent ports. No occupant contacts or failures were noted to the air bag.

Figure 11. Deployed front right side impact air bag.

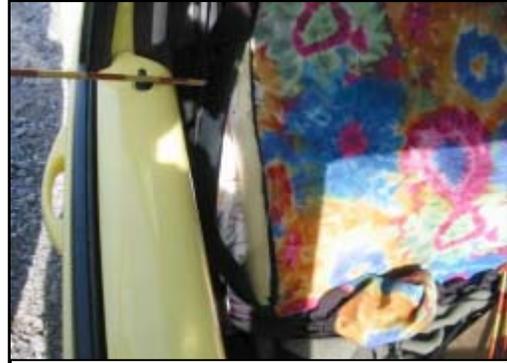
Figure 12. Side impact air bag cover flap. Note the aftermarket seat cover seam and the seam of the seat appear to overlap.

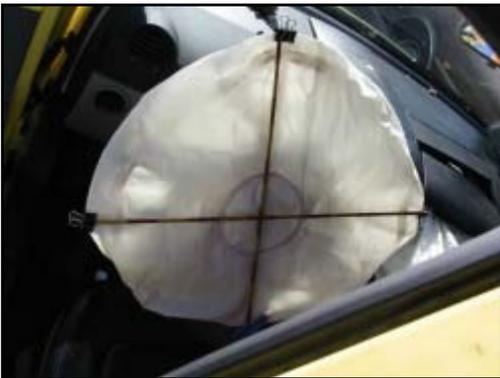
The 2001 Volkswagen Beetle was equipped with redesigned frontal air bags that deployed in the subject crash. The driver's air bag was housed in the center of the steering wheel hub (**Figure 13**). The air bag module consisted of H-configuration cover flaps. The air bag measured 58.0 cm (22.8") in diameter in its deflated state and contained three tethers. A single vent port that was located at the 12 o'clock position on the rear aspect vented the air bag. The NASS researcher noted black smudges on the face of the air bag. No damage or failures were noted to this air bag.

Figure 13. Deployed driver's frontal air bag. Note the steering wheel is rotated 180 degrees therefore the top of the air bag is at the bottom of the picture.

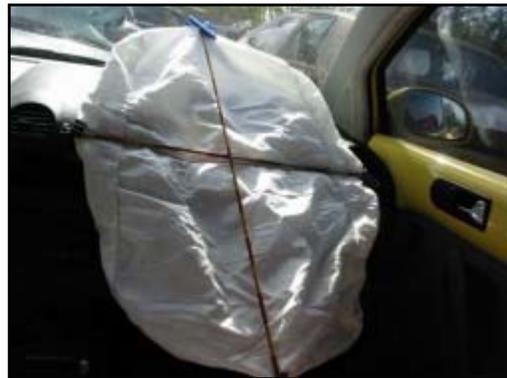
The front right air bag was a top mount design on the front right instrument panel. The air bag module contained a single cover flap. The air bag measured 60.0 cm (23.6") in height and 84.0 cm (33.0") in width and contained one tether (**Figure 14**). Two vent ports that were located at the 1 and 5 o'clock positions on the right aspect vented the air bag. The NASS researcher noted black smudges on the face of the air bag. No damage or failures were noted to this air bag.

Figure 11. Deployed front right frontal air bag.

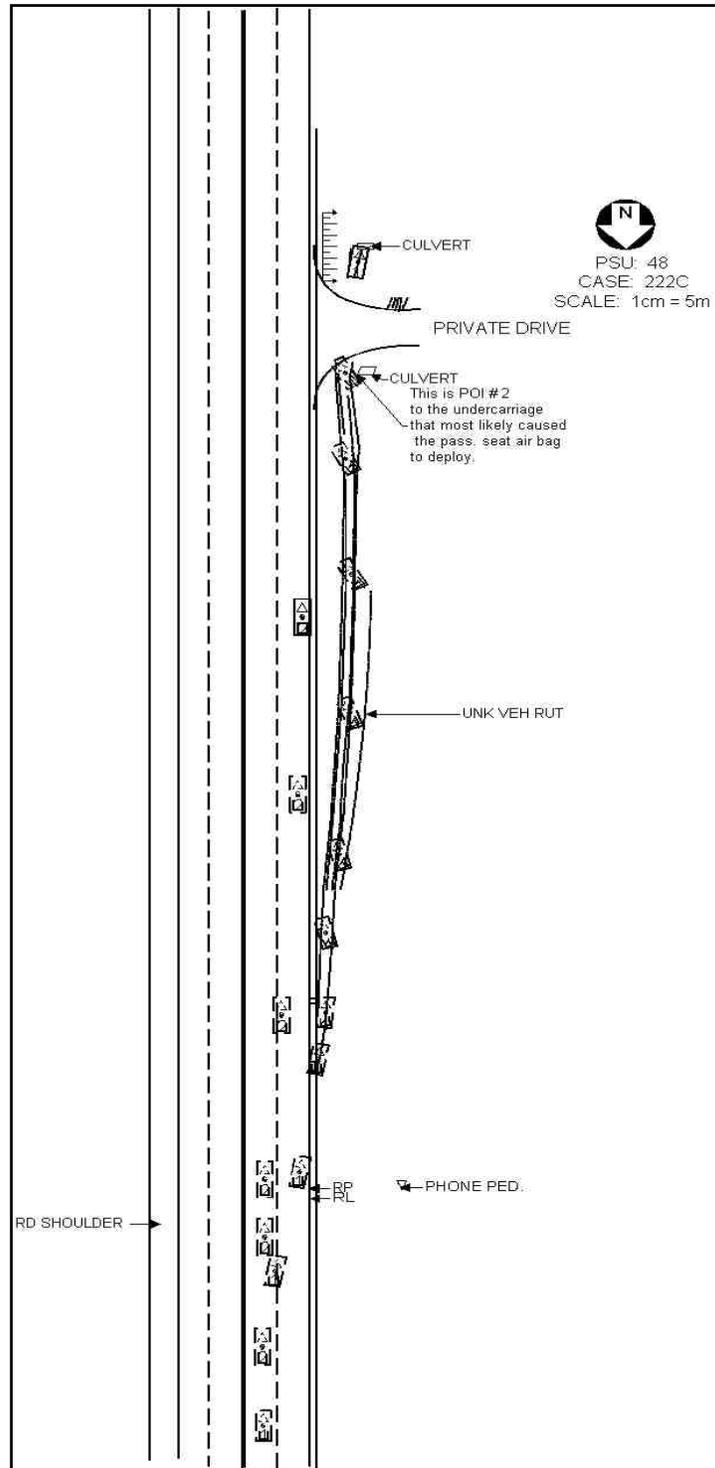
Figure 15. NASS Scene Schematic

The NASS scene schematic is included as **Figure 15** of this report. Although it's not represented in the NASS scene schematic the southbound roadway has a slight left curve and a "T" intersection prior to the location of the initial impact.
