Advanced 208 Compliant Investigation / Vehicle to Vehicle  
Dynamic Science, Inc. / Case Number: 2003-79-039J  
2003 GMC Yukon  
California  
February, 2003

1. Report No. 2003-79-039J	2. Government Accession No.		3. Recipient Catalog No.	
4. Title and Subtitle  Advanced 208 Compliant Investigation, SCI/NASS Combination Case			5. Report Date

14. Sponsoring Agency Code	
15. Supplemental Notes				
16. Abstract  This was a single vehicle rollover collision. The collision occurred in February, 2003 at 0905 hours in the state of California. The crash occurred on a six-lane divided interstate highway. The speed limit is 105 km/h (65 mph). The case vehicle is a 2003 GMC Yukon Denali SLT 4x2 sport utility vehicle driven by an unrestrained 23-year-old female. The rear left seat was occupied by a 2-year-old female who was seated in a Graco forward facing convertible child safety seat. The rear middle seat was occupied by a 5-month-old male who was seated in a rear facing infant seat. The case vehicle was traveling southbound at a police estimated speed of 97-105 km/h (60-65 mph) in the first lane from the right. In the adjacent lane was a second sport utility vehicle. Witnesses indicate tha

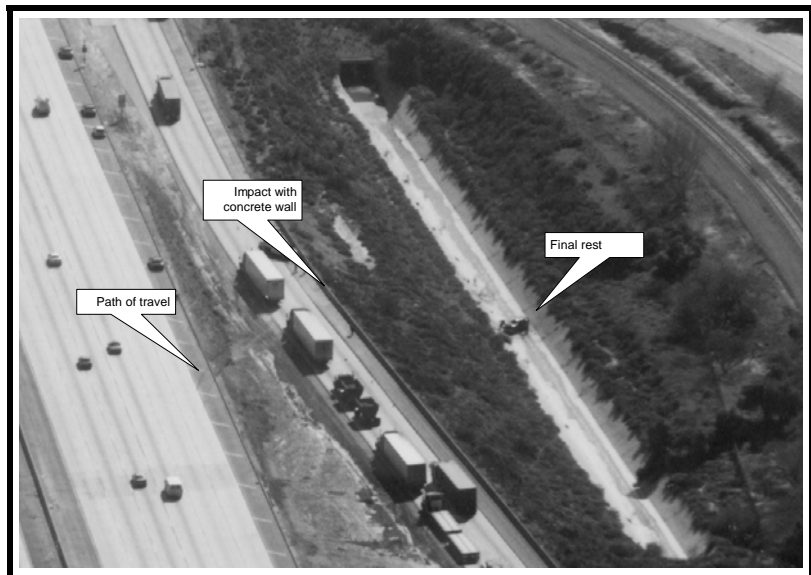
The crash occurred on a six-lane divided interstate highway. To the west of this roadway is a 12 m (40 ft) dirt embankment with a negative grade. Immediately to the west of the embankment is a two-lane, one way truck by-pass roadway that is bordered to the west by a 0.9 m (3 ft) high concrete wall. To the west of the wall is a 27 m (90 ft) wide descending dirt and foliage embankment. To the west of this embankment is a 12 m (40 ft) wide water drainage culvert. The speed limit is 105 km/h (65 mph).

**Figure 1.** Overview of crash scene

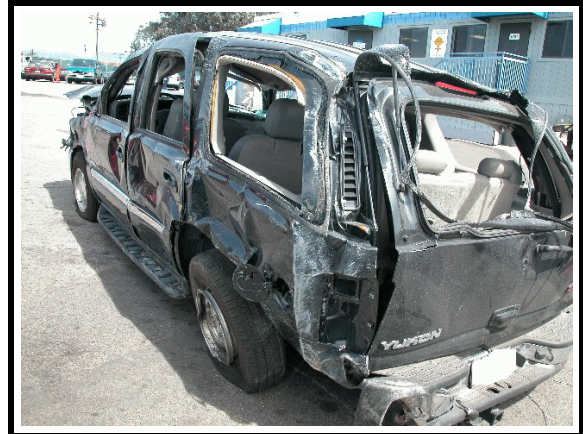
Figure 2. Left rear, case vehicle

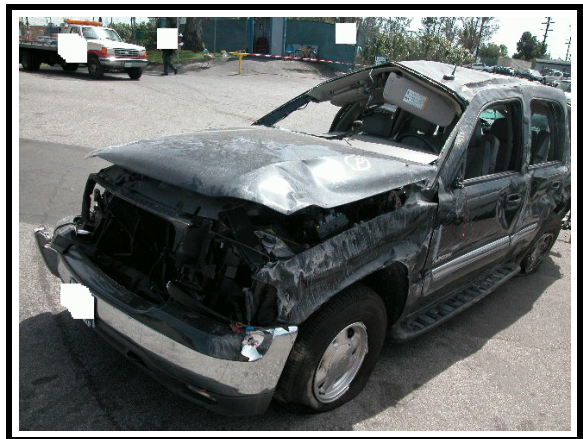
Figure 3. Front left, case vehicle

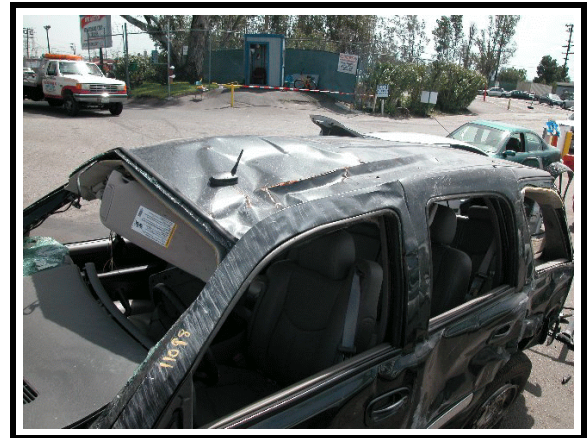
Figure 4. Top, left side

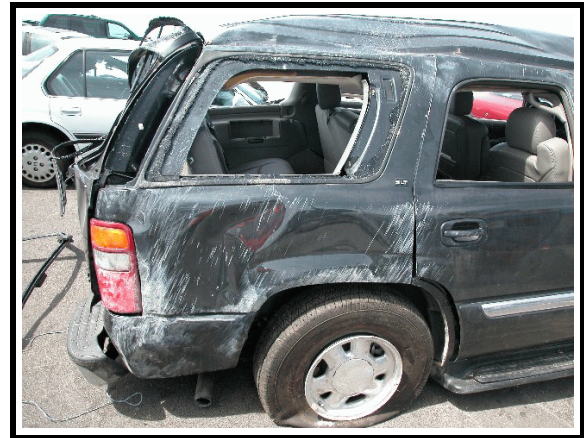
Figure 5. Right rear

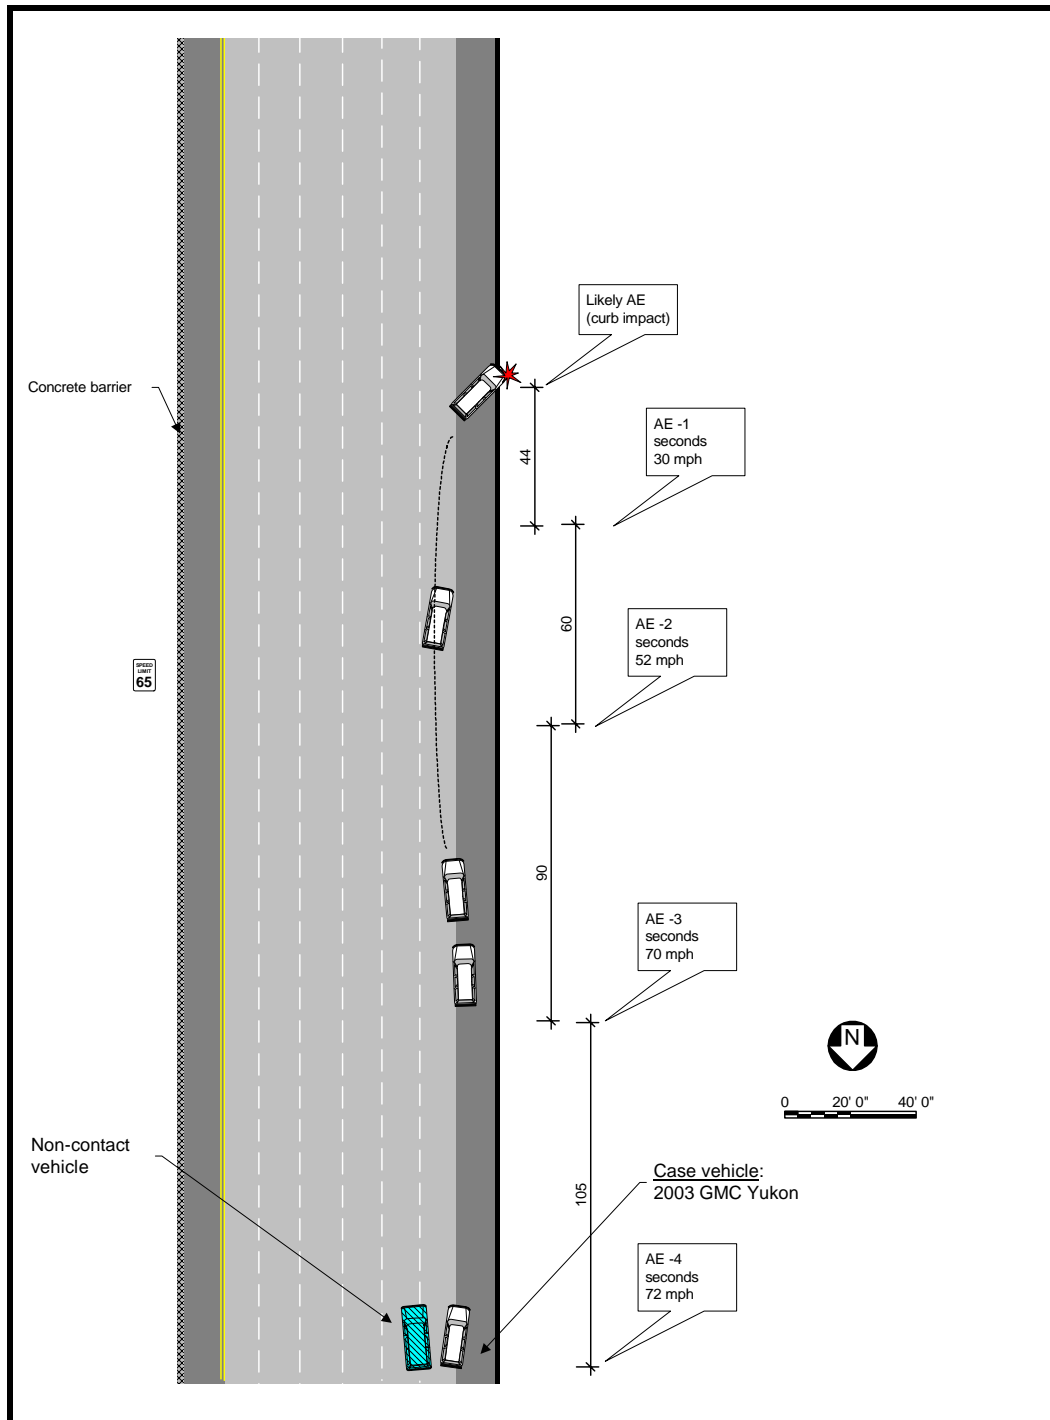
The case vehicle struck a curb (event 1)—causing an air bag non-deployment event. The vehicle departed the roadway on the right side and traveled down an embankment onto a two lane truck bypass where it overturned (event 2). It crossed the roadway and then contacted its roof against a concrete wall (event 3). The vehicle went down another embankment and continued overturning until coming to rest on its left side in a concrete culvert.

Figure 6. Initial evasive maneuver and contact with curb

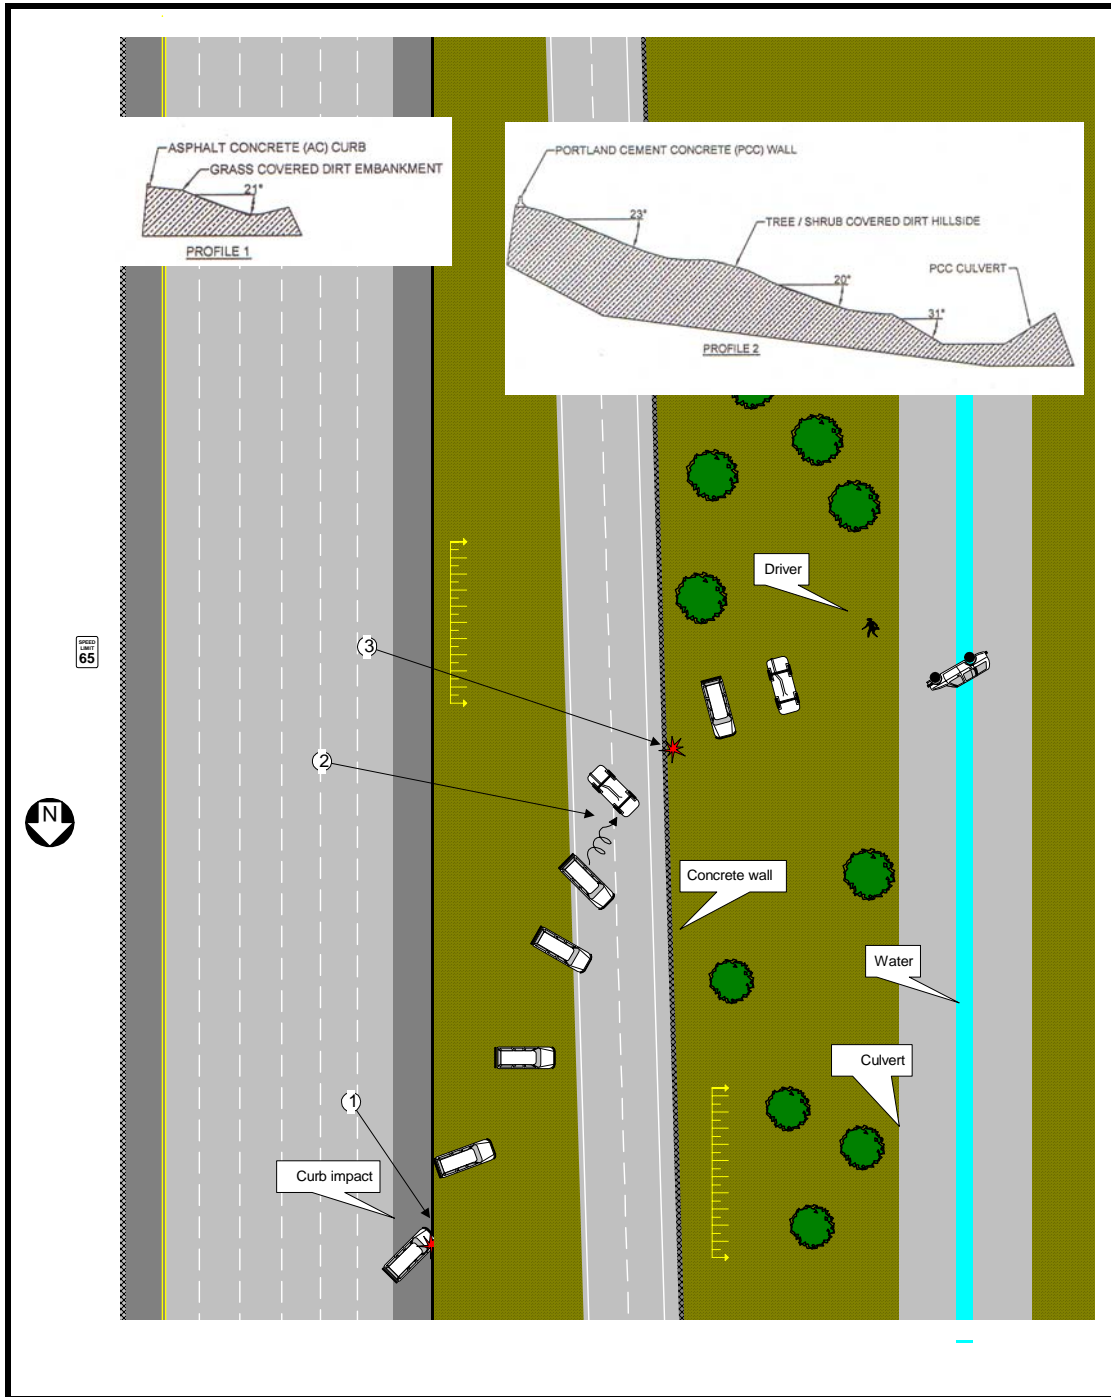
Figure 7.. Travel path after initial contact with curb

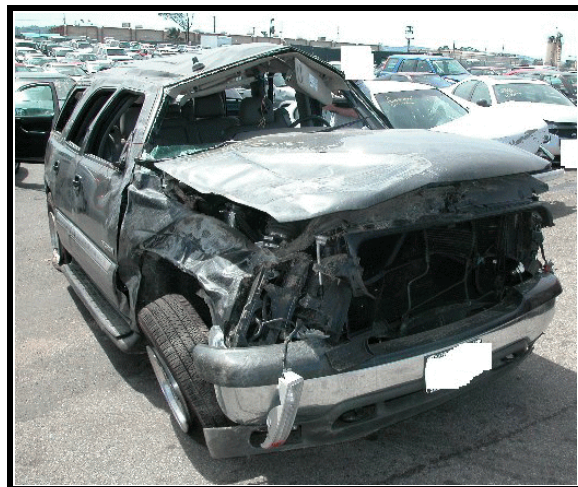
**Damage Description:** The left front door, left rear door, and the tailgate were all jammed shut. There was integrity loss for the windshield, both the left and right side windows, and the backlight. There was lateral and vertical intrusions, primarily to the right side. There was damage to all four rims. With the exception of the left rear, the damage appears to be rollover related. The rear left might also be from the rollover, but there is a longitudinal component that could be related to the initial curb impact.

**CDC:**  
 Impact 1 (curb): 09LFWN1  
 Impact 2 (rollover): 00TDD03  
 Impact 3 (wall impact): 00TFZW2

**Figure 8.** Front right, case vehicle

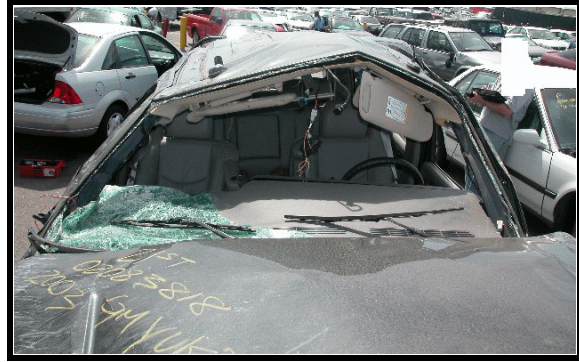
The GMC Yukon sustained interior damage from intrusion and occupant contacts. There was vertical intrusion along the entire right side roof rail, the right side A/B/C pillars, and through the right side door rail. The most significant intrusion occurred at the front left seat area roof side rail and measured 14.0 cm (5.5 in) along the vertical axis. There were skin scuffs and transfers found on the front header and left side roof rail from the driver as she was ejected from the vehicle. The roof mounted climate control/lighting pod was dislodged from the vehicle and came to rest within the vehicle. The turn signal was broken off at the base. The windshield was holed from impact forces. The left, right, and rear glazing was disintegrated from impact forces. The left front door, left rear door, and rear hatch were all jammed shut. The right side doors remained closed and operational.

**Figure 9.** Front view of case vehicle showing windshield and roof rail intrusions

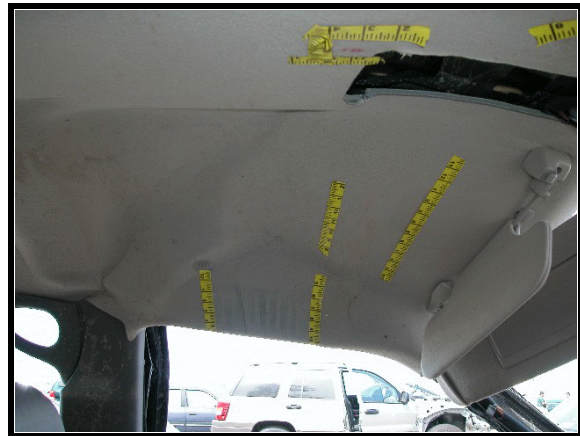
**Figure 10.** Driver contacts to roof, roof rail, and header

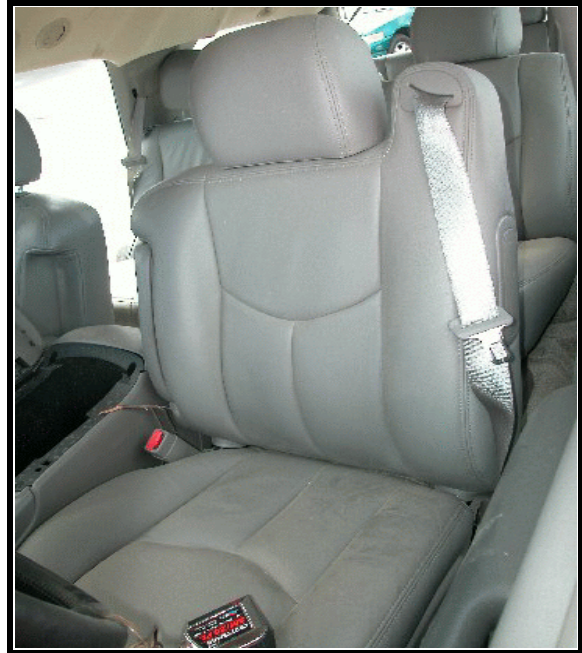
**Figure 11.** Driver's seated position

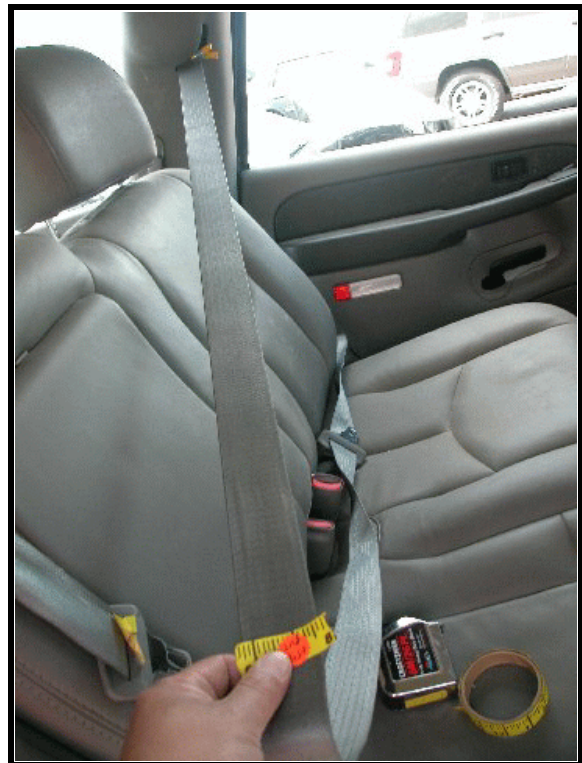
**Figure 12.** Second row left seat belt

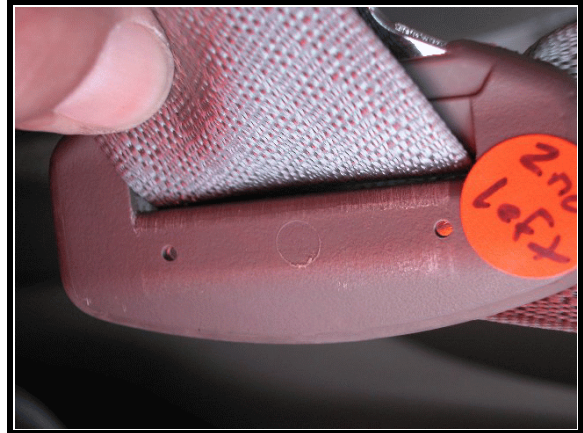
The second row left seat was occupied by a 2-1/2 year old seated in a Graco Eddie Bauer forward facing convertible child seat with a tray shield. The model, model number, and date of manufacture are not known. This seat position was equipped with a LATCH connection but the LATCH was not used. According to the driver interview and seat belt evidence (see Figure 13), the child seat was tightly anchored to the vehicle using the 3-point lap and shoulder belt. The vehicle seat belt was routed through the back of the child seat. The harness straps were routed through the top slot of the seat back at the child's shoulder level. A harness clip was present and had been placed at armpit level on the child. The space between the harness and the child's chest was estimated to be the distance of one finger.

**Figure 13.** Load marks to left rear seat belt latch

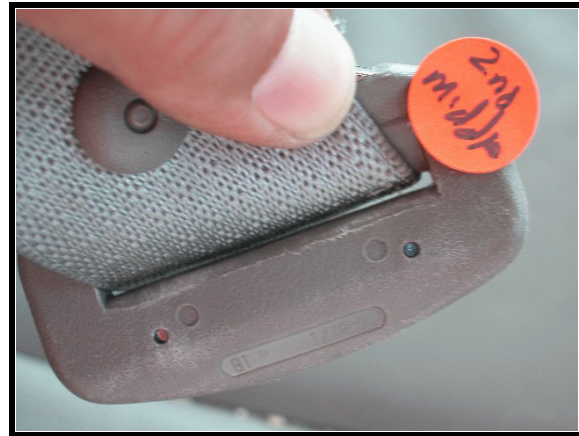
The second row middle seat was occupied by a 5-month-old seated in a Graco rear facing infant seat. The model, model number, and date of manufacture are not known. The driver indicated that the seat was to be used for children weighing less than or equal to 11 kg (25 lbs). According to the driver interview and seat belt evidence (see Figure 14), the child seat was tightly anchored to the vehicle using the 3-point lap and shoulder belt. The vehicle seat belt was routed across the front of the child seat. The seat was equipped with a 3-point harness. The harness straps were routed through the top slot of the seat back at the child's shoulder level. A harness clip was present and had been placed at armpit level on the child. The space between the harness and the child's chest was estimated to be the distance of one finger. This seat position was equipped with a LATCH connection but the LATCH was not used.

**Figure 14.** Load marks to middle rear seat belt latch

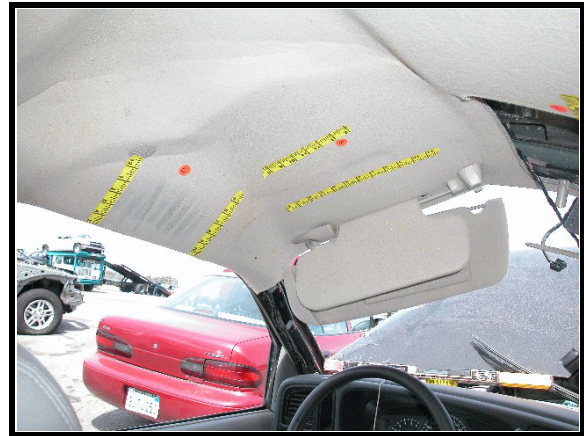
Figure 15. Driver ejection path

embankment while continuing the clockwise rotation until it was in excess of 100 degrees. As the vehicle reached the adjacent roadway it tripped and began overturning. The driver likely came out of her seat at this point, striking the bottom of the steering wheel with her thighs, and came into contact with the interior roof both on the left, middle, and right side. The vehicle continued overturning as it engaged a concrete wall that was parallel to the roadway. This was a minimal contact that did not alter the trajectory of the vehicle. The vehicle continued overturning. The driver was ejected from the vehicle through the driver's window and came to rest on the ground near a concrete culvert. Her injuries were attributed to contacts with the ground, but a number of the injuries could easily have come as a result of contacts within the vehicle during the rollover and her subsequent ejection.

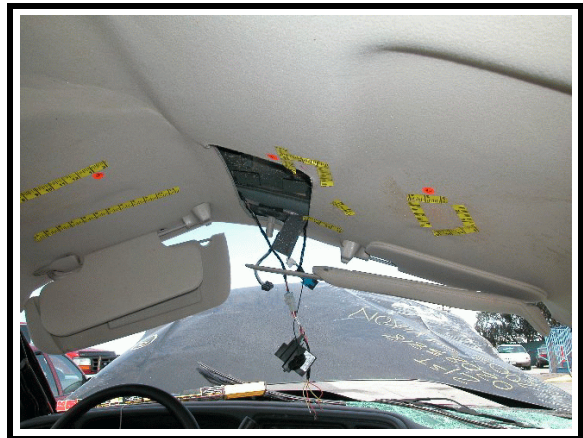
Figure 16. Contacts to the roof and header area

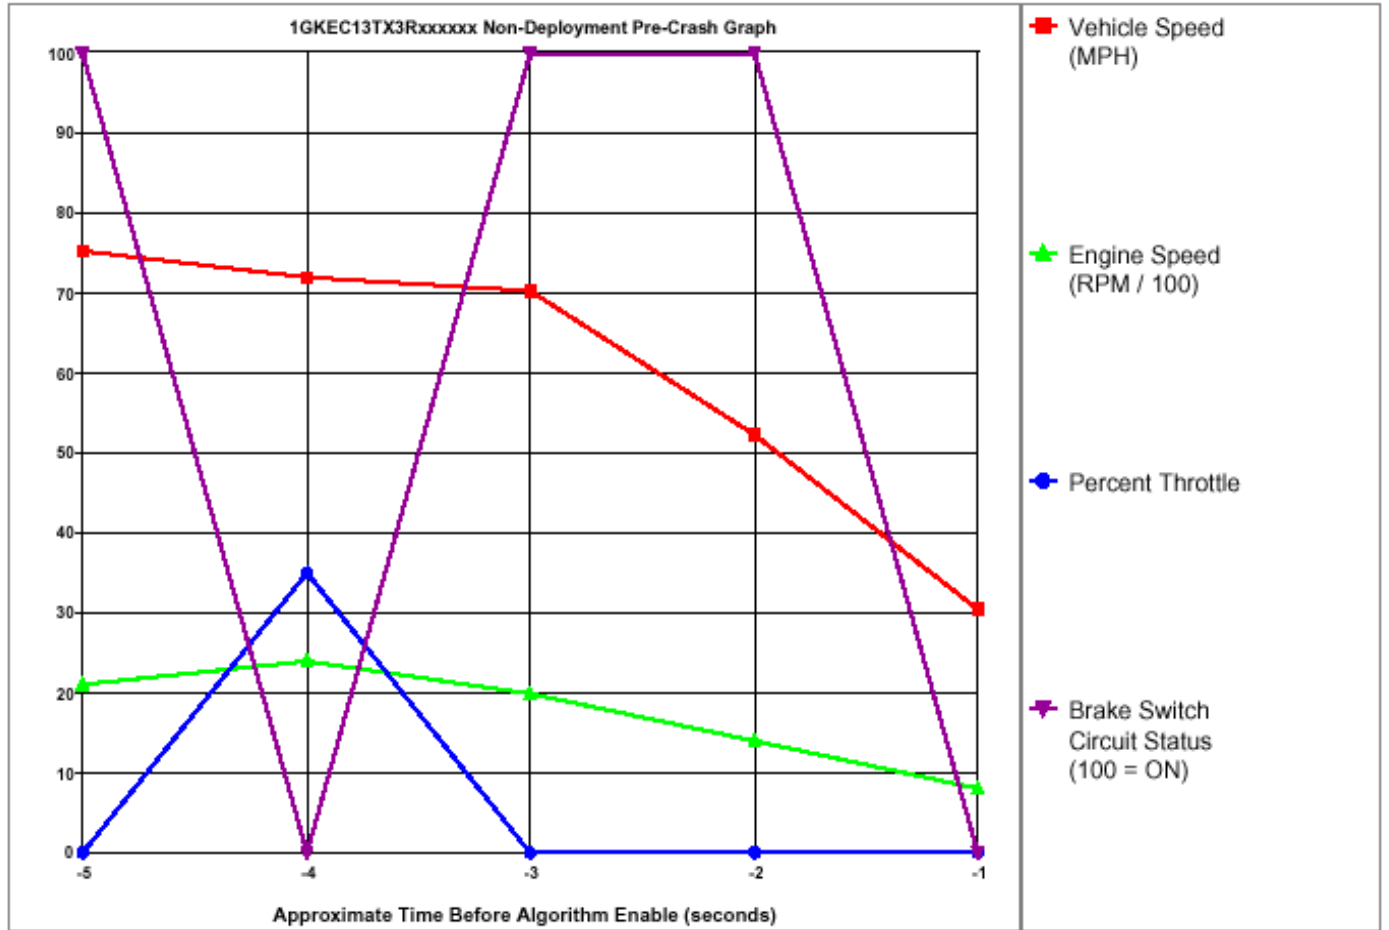
1. The driver's belt switch status was unbuckled.
2. The time from algorithm enable (AE) to maximum recorded velocity change was 170 milliseconds
3. There were no air bag deployments.
4. The brake switch status was ON 5 seconds before algorithm enable (AE), was OFF for the next second, back ON for the next 2 seconds, and finally OFF in the last second.
5. There were 4 ignition cycles between the non-deployment event and the time of investigation.
5. The vehicle speed was 121 km/h (75 mph) five seconds before AE, decelerating to 48 km/h (30 mph) before AE.

Seconds Before AE	Vehicle Speed (MPH)	Engine Speed (RPM)	Percent Throttle	Brake Switch Circuit Status
-5	75	2112	0	ON
-4	72	2432	35	OFF
-3	70	2048	0	ON
-2	52	1408	0	ON
-1	30	768	0	OFF

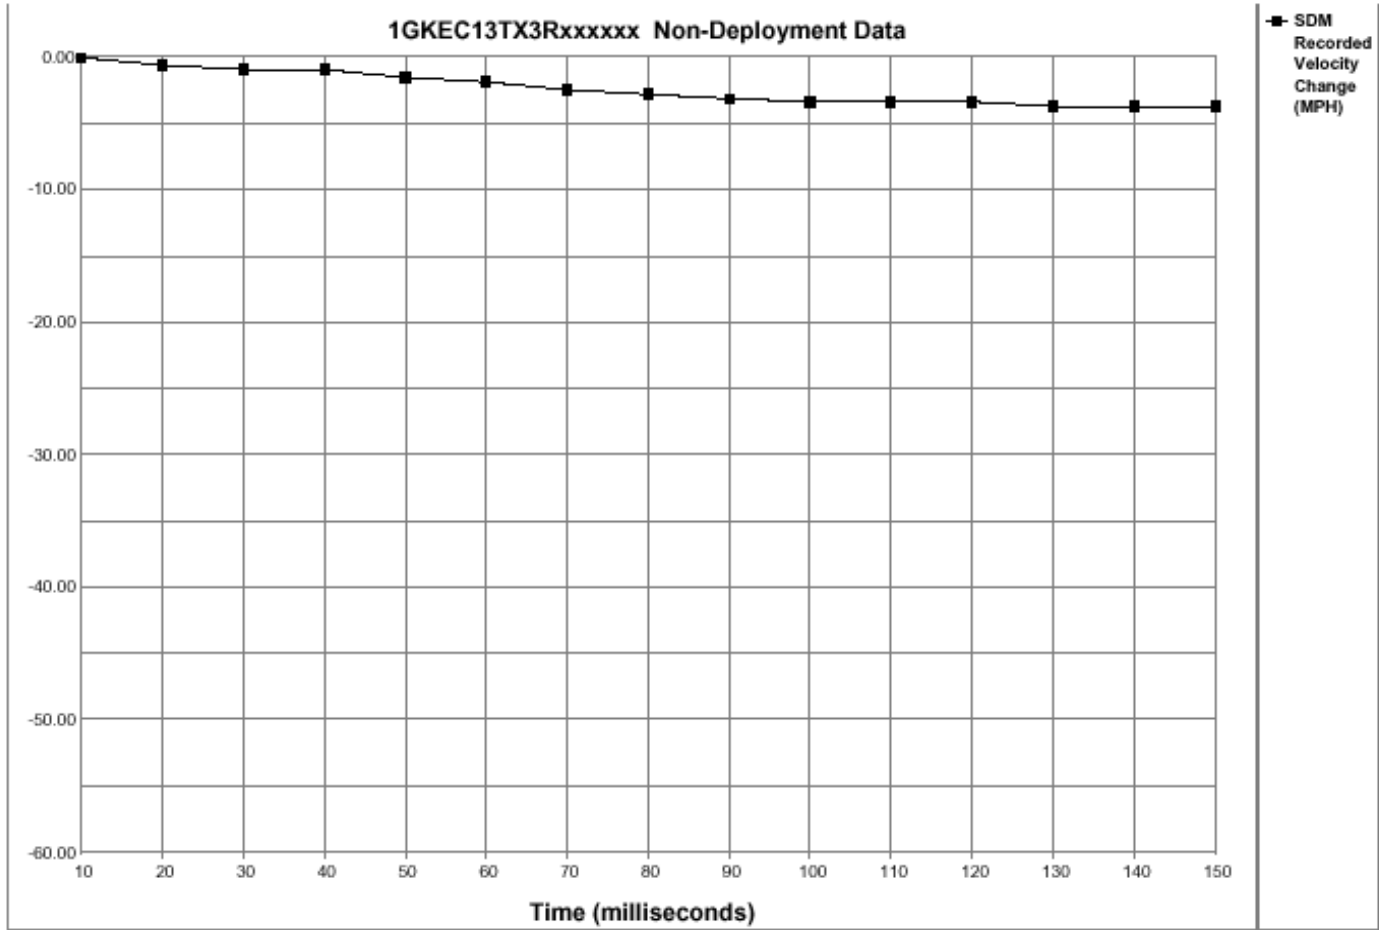
The downloaded data indicated that the case vehicle had a maximum recorded velocity change of 6.94 km/h (-4.31 mph) at the 150 ms mark.

Time (milliseconds)	10	20	30	40	50	60	70	80	90	100	110	120	130	140	150
Recorded Velocity Change (MPH)	0.00	-0.62	-0.93	-0.93	-1.55	-1.86	-2.48	-2.79	-3.10	-3.41	-3.41	-3.41	-3.72	-3.72	-3.72
