**TRANSPORTATION SCIENCES  
CRASH DATA RESEARCH CENTER**

**OFFICE OF DEFECTS INVESTIGATION**

**2000 FORD CROWN VICTORIA POLICE INTERCEPTOR REAR IMPACT CRASH**

**VERIDIAN CASE NO: CA03-002**

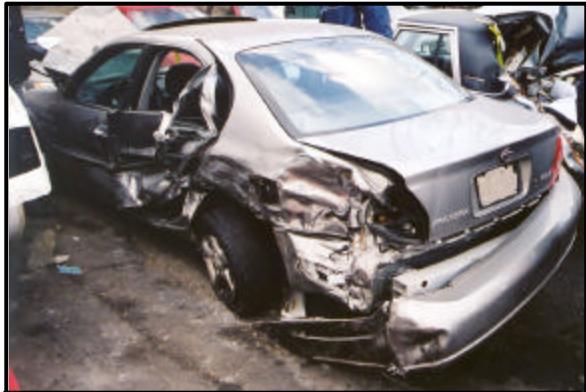
Approximately 122 m (400 ft) south of the stopped Police Interceptor, the Jeep began to overtake the Nissan. For unknown reasons, the right frontal area of the Jeep sideswiped the left rear quarterpanel of a 2000 Nissan Maxima and drove up the left side of the vehicle, **Figure 2**. The force of the impact caused the Nissan to rotate counter-clockwise and its driver lost control. The Jeep then passed in front of the Nissan without redirection. However, the impact aired out the right front tire of the Jeep and the driver lost directional control. The drag of the deflated right front tire caused the Jeep to drift to the right during its northbound travel. The lack of directional control combined with the left road curvature displaced the Jeep laterally from the inboard lane to the outboard lane over its trajectory. The Jeep's pre-crash trajectory, **Figure 3**, was evidenced by a continuous scratch mark attributed to the right front wheel rim. The length of the scratch mark measured 58 m (190 ft) and led to the point of impact with the Police Interceptor.

**Figure 2:** Nissan left rear view.

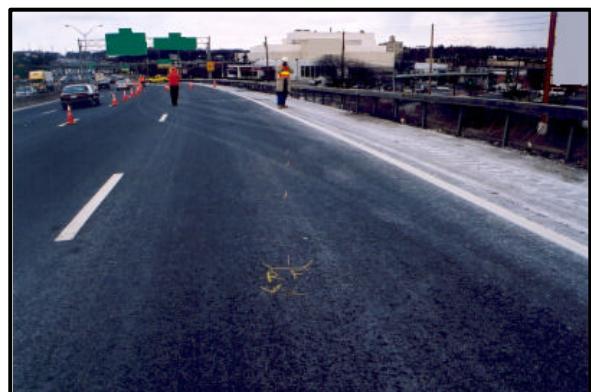
**Figure 3:** Trajectory of the Jeep evidenced by the RF scratch mark

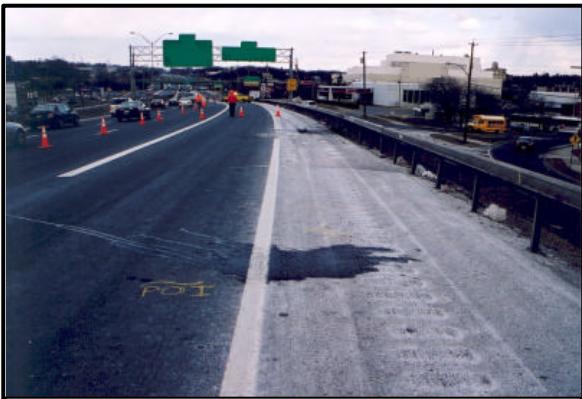
The front plane of the Jeep impacted the back plane of the 2000 Ford Police Interceptor in a 12/6 o'clock impact configuration. The Principle Direction of Force was an estimated 190 to 195 degrees with respect to the Ford. The momentum of the Jeep caused it to then override the rear aspect of the Ford as it was accelerated forward. The force of the impact severely crushed the Ford's left rear quarterpanel and trunk, and buckled the rear frame members. The override forced the rear aspect of the Ford down to the pavement. A tire scuff identified during the police investigation was attributed the left rear tire of the Ford and identified the point of impact. A pattern of pavement gouges was also identified leading away from the point of impact. **Figure 4** is a view of the point of impact.

**Figure 4:** Point of impact.

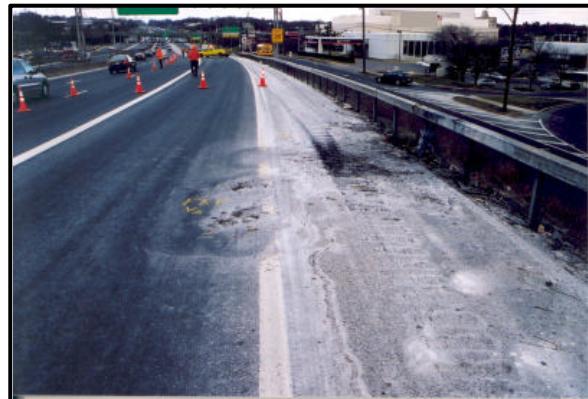
**Figure 5:** Final rest position of the Jeep and Ford CVPI.

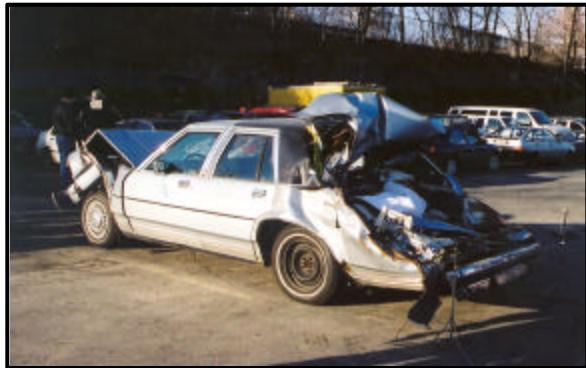
The impact momentum of the Jeep displaced the 2000 Ford Police Interceptor forward into a secondary collision with the 1990 Ford Crown Victoria. The front plane of the 2000 Police Interceptor impacted and overrode the back plane of the 1990 Ford causing the crush and displacement of its trunk lid to the backlight, **Figure 6**. The 1990 Ford in-turn was displaced forward and impacted the back plane of the Toyota Camry, **Figure 7**. These vehicles remained in sustained contact and the front aspect of the Toyota then impacted work boom of the tow truck. The driver of the Toyota was standing in front of the 1990 Ford during this secondary collision sequence and was struck by the front of the vehicle, wrapping onto the hood, and then displaced into the Ford's windshield. This driver was fatally injured as a result of this impact. The operator of the tow truck was in the process of hooking up to the Toyota and was also injured in this secondary collision sequence. A schematic of the crash developed by the NYSP is attached as **Figure 22** at the end of this report.

**Figure 6:** Left rear view of the 1990 Ford.

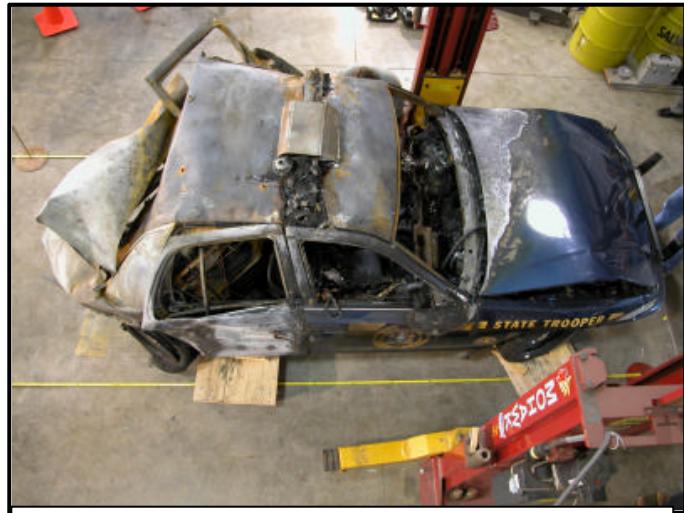
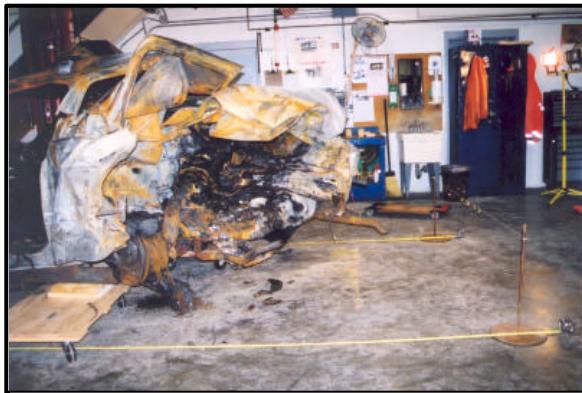
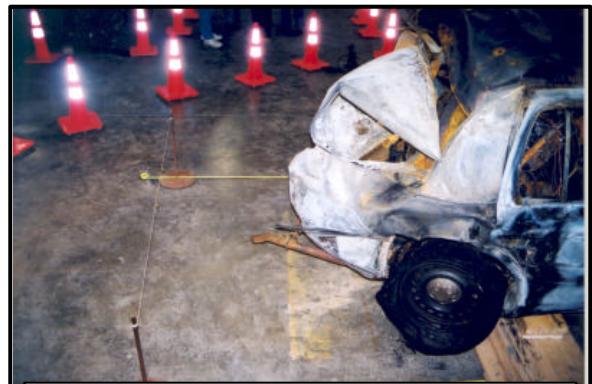
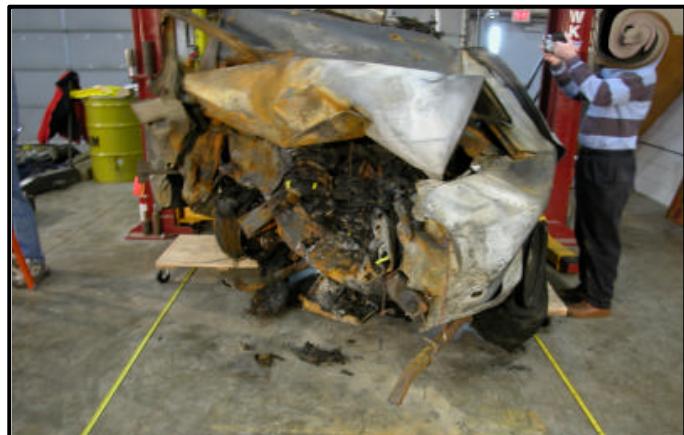
**Figures 9 through 12** are an overhead, left lateral, right lateral and rear view of the damaged Ford, respectively. The back plane of the vehicle sustained severe impact damage that extended across its entire 142.2 cm (56.0 in) end-width. The damage was biased to the left side and extended longitudinally forward to the left B-pillar. The left rear door was crushed and buckled outward. The left C-pillar was crushed forward within 25 cm (10 in) of the left B-pillar. The left front door was jammed shut and removed by extrication. The left A-pillar and B-pillar were cut during its removal. The right doors were fully intact and were jammed shut due to the deformation of the vehicle's frame. The trunk space collapsed and its contents completely crushed. The deformation extended forward through the rear occupant space to approximately the front seat backs. The intrusion of the mid-aspect of the left rear seat frame measured 73.2 cm (28.8 in). The fire consumed everything rearward of the instrument panel.

The force of the impact deformed and buckled the rear frame members. The deformation of the trailing end of the left and right frame measured 177.8 cm (70.0 in) and 80.0 cm (31.5 in), respectively. The left wheelbase was foreshortened 95.0 cm (37.4 in). The right wheelbase was foreshortened 9.7 cm (3.8 in). The longitudinal deformation at the upper aspect of the C-pillars was 30.7 cm (12.1 in) and 6.7 cm (2.6 in), measured at the left and right aft corners of the roof respectively.

The crush profile of the Ford was measured along the rear bumper reinforcement beam. The residual crush profile was as follows: C1 = 184.7 cm (72.7 in), C2 = 182.3 cm (71.8 in), C3 = 178.6 cm (70.3 in), C4 = 88.1 cm (34.7 in). The Collision Deformation Classification (CDC) was 06-BDEW-6. The total Delta V of the Ford calculated by the Damage Algorithm of the WINSMASH model was 73.0 km/h (45.4 mph). The longitudinal and lateral components were +71.9 km/h (+44.7 mph) and +12.7 km/h (+7.9 mph), respectively. A conservative estimate of the Jeep's impact speed was approximately 113 – 121 km/h (70 – 75 mph) based on the Conservation of Momentum.

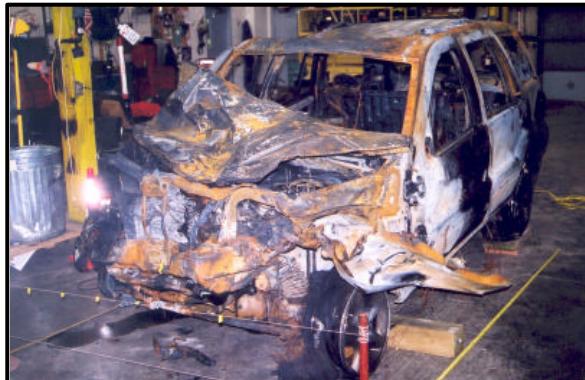
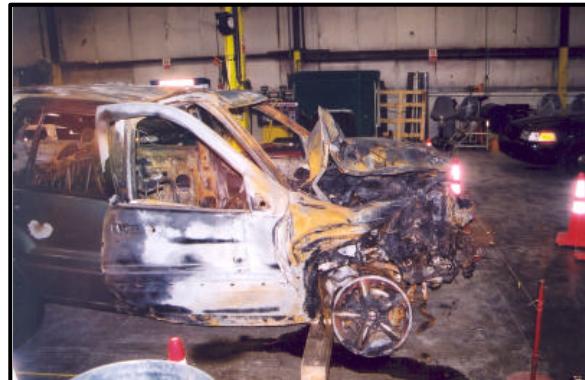
The 2002 Jeep Grand Cherokee was a four door, 4wheel drive sport utility vehicle with a 269 cm (105.9 in) wheelbase. The vehicle sustained severe impact damage that extended across its entire 158 cm (62 in) front-end width as a result of the impacts with the Nissan and the Ford. The forward aspect of the right frame was buckled and the right wheelbase was reduced 21.3 cm (8.4 in). The left wheelbase lengthened 4.6 cm (1.8 in) due to a rotation of the front axle. The left front door and both right side doors were jammed shut by the impact force. The left rear door was opened by extrication. The right A-pillar was displaced rearward and caused the roof to buckle. The residual crush profile measured along the bumper reinforcement bar was as follows: C1 = 58.2 cm (22.9 in), C2 = 38.9 cm (15.3 in), C3 = 39.1 cm (15.4 in), C4 = 30.5 cm (12.0 in), C5 = 17.3 cm (6.8 in), C6 = 26.9 cm (10.6 in). The Collision Deformation Classification of the overlapping damage patterns was 12-FDEW-3. The total delta V calculated by the Damage Algorithm of the WINSMASH was 69.0 km/h (42.9 mph). **Figures 13 and 14** are the front left and right lateral views of the Jeep.

**Figure 13:** Left front view of the Jeep.

**Figure 14:** Right lateral view.

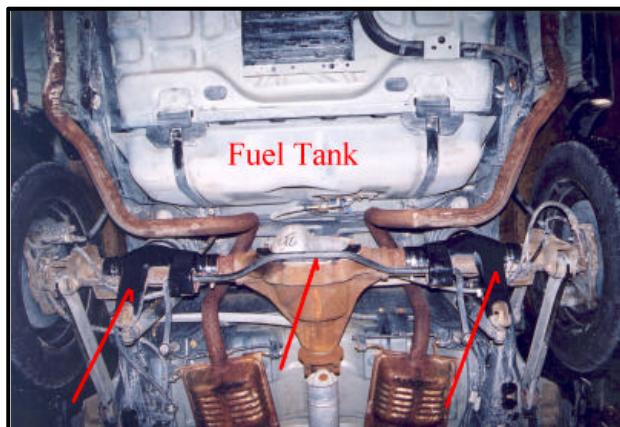
It should be noted that a retrofit kit provided by Ford Motor Company had been installed on the exemplar vehicle. The kit was comprised of two molded plastic shields that cover the shock mount and sway bar brackets on the respective sides of the vehicle, and a rubber guard that covered the lower rear aspect of the differential cover. The purpose of the kit was to provide a layer of protection between the fuel tank and the offending rear axle/suspension components during a rear impact. The arrows in the figure denote the components of the retrofit kit. This retrofit kit was not installed on the subject Ford Crown Victoria.

**Figure 15:** Undercarriage view of an exemplar 2000 Ford Crown Victoria.

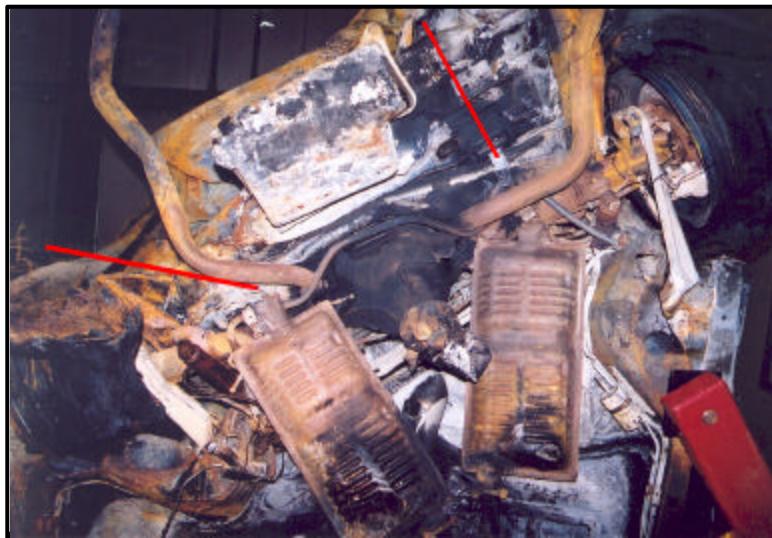
**Figure 16** is an overall undercarriage view of the subject Ford. The front of the vehicle is located at bottom of the photograph and can be compared to the exemplar vehicle in Figure 15. The arrows in the figure denote the locations of the tank straps. **Figure 17** is a close up view of the residual location of the deformed tank. The extensive crush reduced the trunk's volume to near zero and displaced the tank forward. The force of the collision buckled the drive shaft and it separated from the differential. The rear axle rotated down and the differential cover contacted and punctured the center aspect of the deforming fuel tank. The left sway bar bracket and left shock absorber mount contacted and punctured the left side of the tank. The procedure to grind the tabs on the sway bar bracket referenced in the Technical Safety Bulletin (TSB) issued by Ford on October 21, 2001 had been completed on the subject vehicle.

**Figure 16:** Undercarriage view of the deformation.

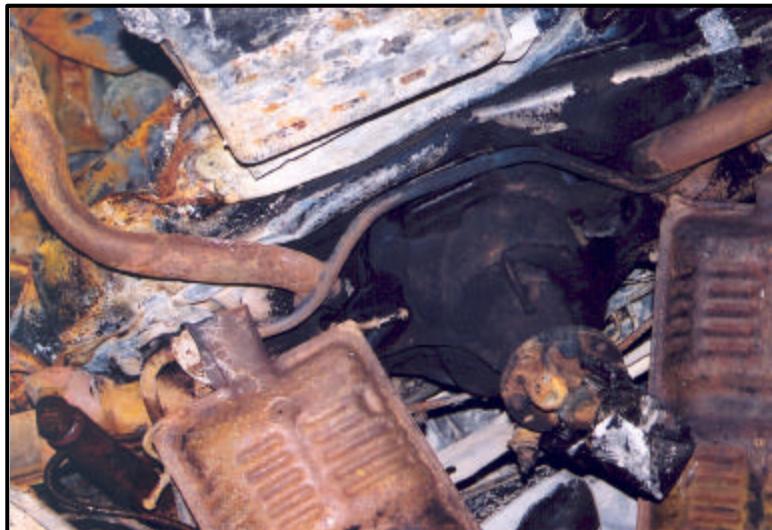
**Figure 17:** Close-up of the deformed tank.

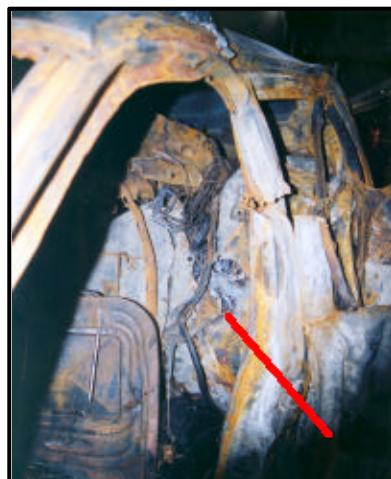
was displaced forward 139.4 cm (54.9 in) by the crash forces. Post-crash, it was located approximately 15 cm (6 in) behind the driver's seat and 15 cm (6 in) inboard of the left B-pillar, **Figure 18**.

**Figure 18:** Residual location of the filler neck.

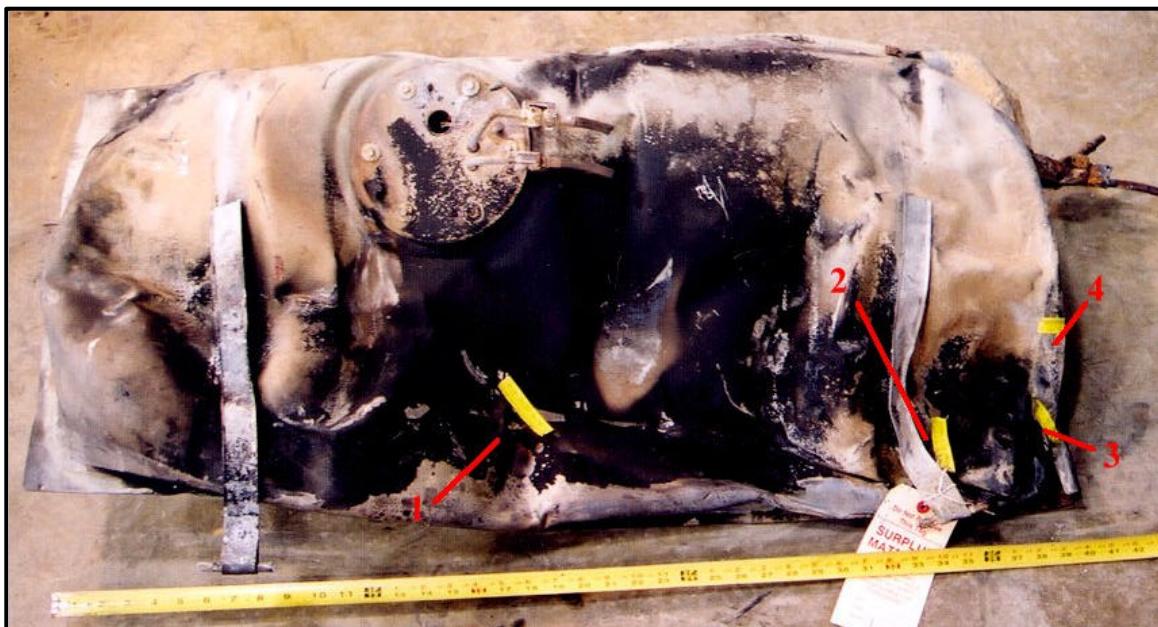
**Figure 19** is a view of the front side of the fuel tank. The left side of the tank is on the right. A distinct burn pattern was noted. The tank was punctured in four locations denoted by the arrows. The table below summarizes the size of the puncture and the component that punctured the tank.

**Figure 19:** View of the front side of the fuel tank.

Puncture	Size	Contacting component
1	22.2 x 19.1 mm (7/8 x 3/4 in)	Rear differential
2	41.3 x 6.4 mm (1-5/8 x 1/4 in)	Left tank strap and sway bar bracket
3	19.1 x 19.1 mm (3/4 x 3/4 in)	Left rear shock mount
4	3.2 x 3.2 mm (1/8 x 1/8 in)	Left rear shock mount

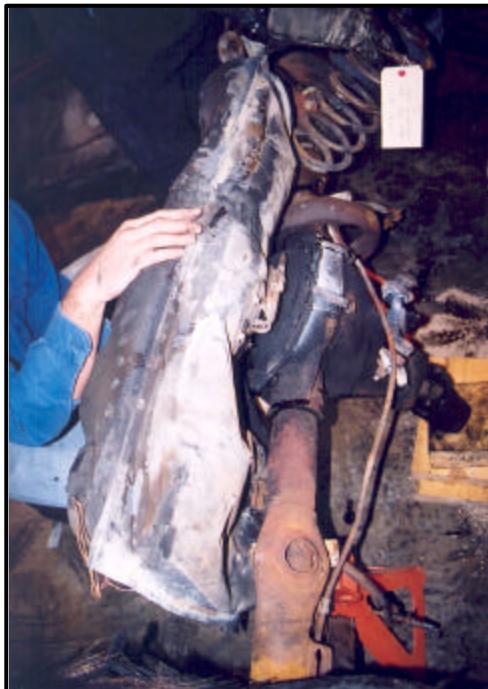
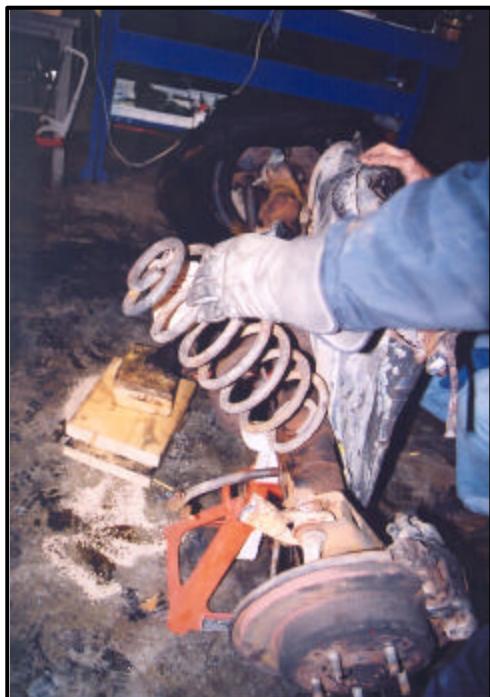
The Ford's drive shaft buckled and separated from the differential, forward of the companion flange. During the vehicle's deformation, the rear axle of the Ford rotated counterclockwise (with respect to the left side of the vehicle). This rotation allowed the differential's input shaft to contact the pavement and presented the rear cover of the differential to the front wall of the fuel

tank. Contact between the front wall of the tank and the differential cover punctured the center aspect of the tank. The deformed left rear sway bar bracket and left rear shock absorber mount punctured the left side of the tank as it was crushed forward. A crash induced fire ignited and was fed by the punctured fuel tank. The Jeep and Ford Police Interceptor remained in sustained contact and became engaged. Reportedly, the vehicles had to be separated by tow trucks. **Figure 5** is a view of the final rest location of the Jeep and Police Interceptor.

**Figures 20 and 21** are views of the rear axle and fuel tank after removal and depict their probable interaction. Ford's retrofit kit places shields over all the components that damaged the tank in this crash, however the kit was not installed on the subject vehicle.

Figure 20: Right view along the rear axle.

Figure 21: Left view along the rear axle.
