TRANSPORTATION RESEARCH CENTER

ON-SITE ADVANCED OCCUPANT PROTECTION SYSTEM INVESTIGATION

CASE NUMBER - IN-03-002
LOCATION - Texas
VEHICLE - 2001 HONDA ACCORD
CRASH DATE - December 2002

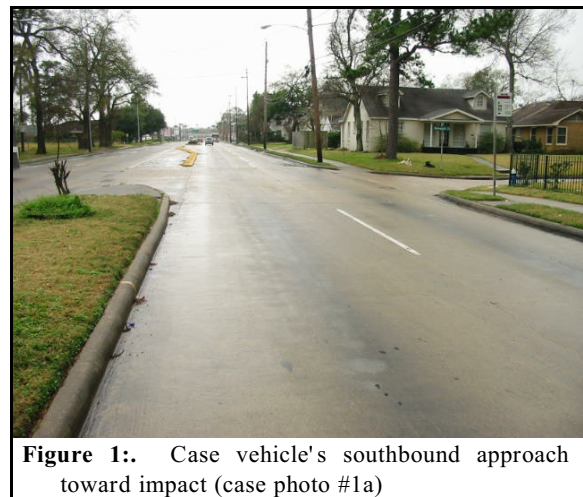
The case vehicle was traveling south in the inside southbound lane of a two-lane roadway that was part of a divided trafficway, approaching a three-leg intersection with no controls for north-south traffic, and intended to continue straight ahead. The divided trafficway had a curbed, grass median north of the intersection, a cut through the median within the intersection, and a raised concrete divider south of the intersection (**Figure 1**). It was daylight, the weather was clear, the roadway was straight and level, and the concrete surface was dry and free of defects. The speed limit for the north-south roadway was 56 km.p.h. [35 m.p.h.]. The other vehicle had been stopped at a stop sign, heading east in the eastbound lane of the intersecting two-lane undivided roadway, intending to cross the southbound lanes, pass through the median cut and turn left to travel north. The other vehicle started from a stop and entered the intersection, across the case vehicle's path. The case vehicle's driver did not attempt any avoidance maneuvers. The crash occurred within the intersection.

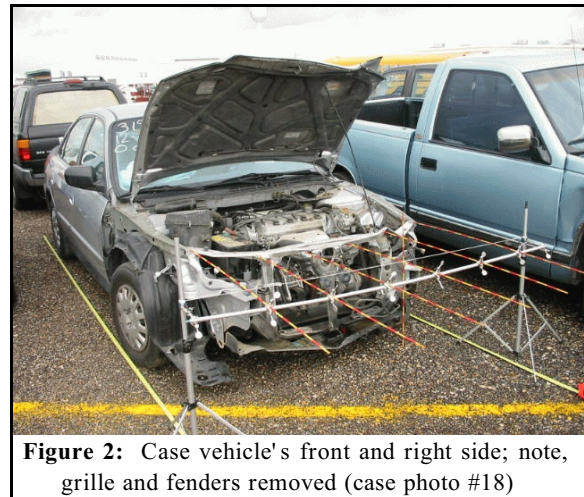
Figure 2: Case vehicle's front and right side; note, grille and fenders removed (case photo #18)

The case vehicle's front bumper, grille and headlamp assemblies, and both front fenders had been removed at the time of the inspection (**Figure 2**). With these frontal components absent it is not possible to determine the exact extent of direct damage. Based on an assessment of the radiator support bracket, the leading edge of the hood, and the damage on the other vehicle, direct contact likely began at the front left corner of the vehicle and extended approximately 55 centimeters [21.7 inches] inward from the left corner, with induced damage encompassing the entire front (**Figure 3**). It is unclear whether the fenders were directly contacted. Maximum crush was measured as 8 centimeters [3.1 inches] at C3. The wheelbase on both sides was shortened by 2 centimeters [0.8 inches]. None of the tires were deflated or restricted and there was no glazing damage.

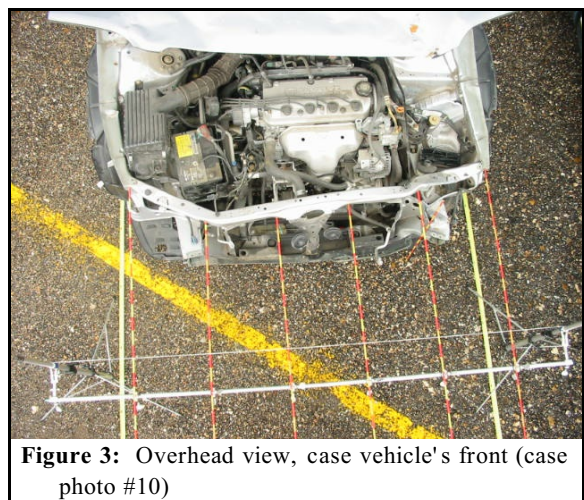
Figure 3: Overhead view, case vehicle's front (case photo #10)

Based on the vehicle inspection, the CDC for the case vehicle was determined to be: **01-FYEW-1 (20 degrees)**. The WinSMASH reconstruction program, damage only algorithm based on the measured crush profile of the other vehicle and adjusted measurements taken along the case vehicle's radiator support bracket, was used on the case vehicle's highest severity impact. The Total, Longitudinal, and Lateral Delta Vs are, respectively: 16.0 km.p.h. [9.9 m.p.h.], -15.0 km.p.h. [-9.3 m.p.h.], and -5.5 km.p.h. [-3.4 m.p.h.]. These results seem reasonable. The crash severity for the case vehicle was low (14-23 km.p.h. [9-14 m.p.h.]).

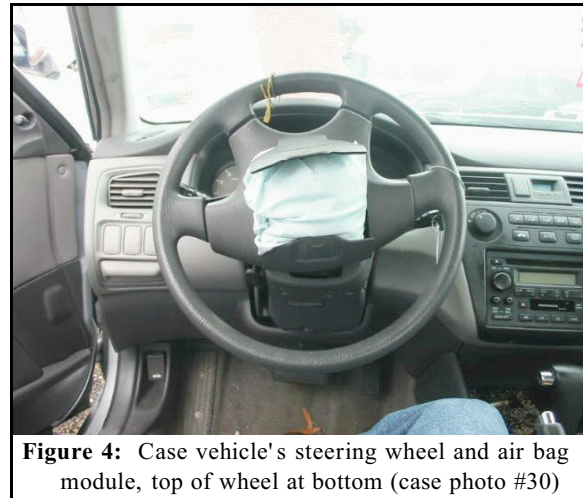
The case vehicle was equipped with dual-stage frontal air bags that deployed. The driver air bag was located in the steering wheel hub (**Figure 4**). Inspection of the driver air bag module's cover flaps and air bag revealed that the cover flaps opened at the designated tear points, and there was no evidence of damage during the deployment to the air bag or the cover flaps. The driver's air bag was designed with two tethers, each 7.5 centimeters [3 inches] wide. The driver's air bag had two vent ports, approximately 5 centimeters [2 inches] in diameter, located in the center of the back of the air bag at the 9:30 and 2:30 o' clock positions. The deployed driver's air bag was round with a diameter of 62 centimeters [24 inches]. There were areas of body oil and possible cosmetics transfers on the front of the driver's air bag (**Figure 5**).

Figure 4: Case vehicle's steering wheel and air bag module, top of wheel at bottom (case photo #30)

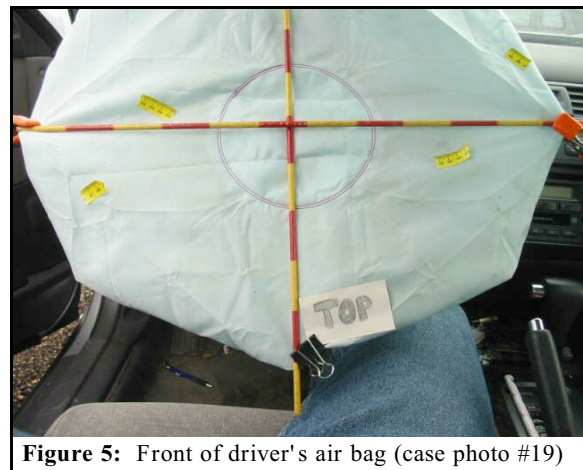
Figure 5: Front of driver's air bag (case photo #19)

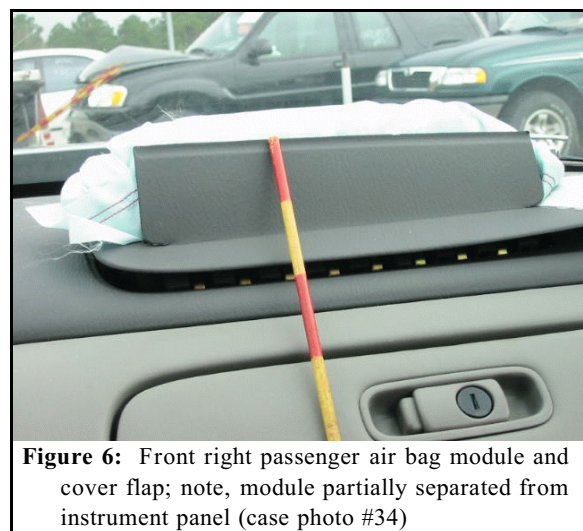
The front right passenger's air bag was located in the top of the instrument panel. Inspection of the front right air bag module's cover flaps and air bag revealed that the cover flaps opened at the designated tear points, and there was no evidence of damage during the deployment to the air bag or the cover flaps. Note, however, that the module was lifted and partially separated from its mounting in the instrument panel (**Figure 6**). The front right passenger's air bag was designed without any tethers and had two

Figure 6: Front right passenger air bag module and cover flap; note, module partially separated from instrument panel (case photo #34)

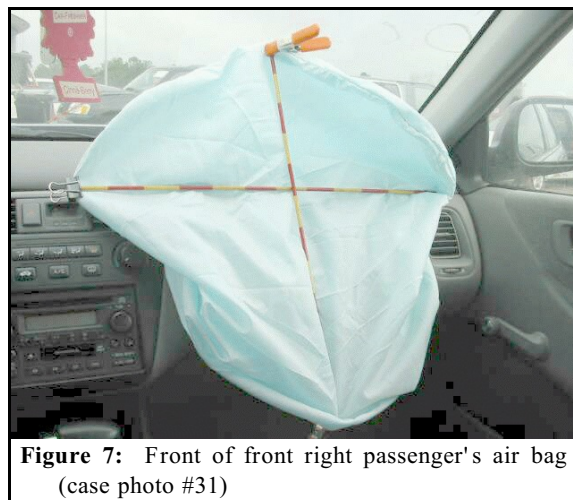
vent ports, approximately 7 centimeters [2.8 inches] in diameter, located at the 3:00 and 9:00 o'clock positions. The deployed front right air bag was rectangular with a height of approximately 60 centimeters [23.6 inches] and a width of approximately 64 centimeters [25.1 inches]. There was no contact evidence apparent on the front right passenger's air bag (**Figure 7**).

Figure 7: Front of front right passenger's air bag (case photo #31)

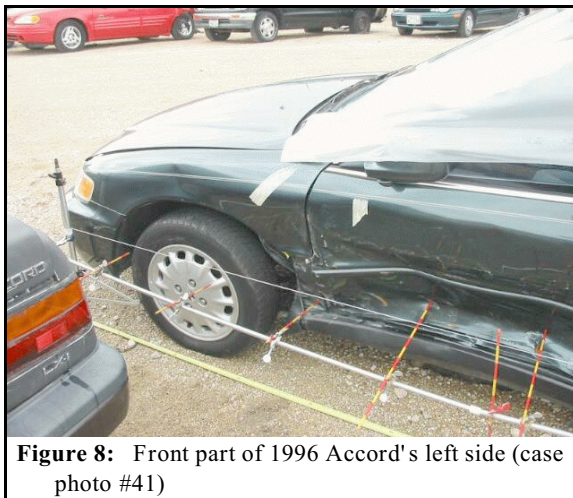
The other vehicle was a 1996 Honda Accord EX front wheel drive, four-door, five-passenger sedan (VIN: 1HGCD5658TA-----). Based on the vehicle inspection, the CDC for the 1996 Accord was determined to be: **10-LYEW-2 (290 degrees)** (maximum crush was 20 centimeters [7.9 inches]). The WinSMASH reconstruction program, damage only algorithm based on the measured crush profile of both vehicles, was used on the 1996 Honda's single impact. The Total, Longitudinal, and Lateral Delta Vs are, respectively: 15.0 km.p.h. [9.3 m.p.h.], -5.1 km.p.h. [-3.2 m.p.h.], and + 14.1 km.p.h. [+ 8.8 m.p.h.]. The crash severity for the 1996 Accord was low (14-23 km.p.h. [9-14 m.p.h.]). This vehicle was equipped with frontal air bags that did not deploy. The 1996 Accord was towed due to damage (**Figures 8 and 9**).

Figure 8: Front part of 1996 Accord's left side (case photo #41)

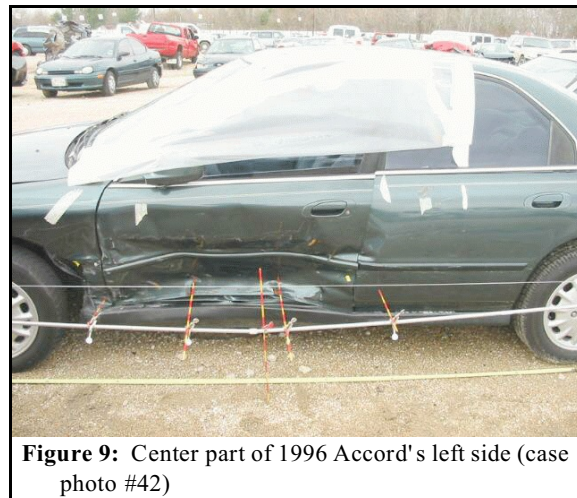
Figure 9: Center part of 1996 Accord's left side (case photo #42)
