Bus Crash Investigation / Vehicle to Vehicle
Dynamic Science, Inc. / Case Number: DS03009
1998 Dina Autobus Viaggio 1000 tour bus
California
March, 2003

1. Report No. DS03009		2. Government Accession No.		3. Recipient Catalog No.	
4. Title and Subtitle Bus crash investigation				5. Report Date August 1, 2006

14. Sponsoring Agency Code	
15. Supplemental Notes					
16. Abstract <p>This on site investigation focused on the performance of a 1998 Dina Autobus Viaggio 1000 tour bus that was involved in a six vehicle crash. This chain reaction crash occurred in March 2003 at 1520 hours in southern California. The crash occurred on an interstate highway. The case vehicle was a 1998 Dina Autobus Viaggio 1000 motor coach (Bus1) being driven by a lap and shoulder belt restrained male. The first other vehicle in the case was an MCI J4500 motor coach (Bus 2). There were a total of 104 people on board the two buses. The second other vehicle is a 2003 Ford Expedition. The third other vehicle was a 2001 Chevrolet Blazer driven by a 46-year-old male. The fourth other vehicle was an unknown make/model automobile. The fifth other vehicle was a 1999 Chrysler Sebring. All six vehicles were traveling

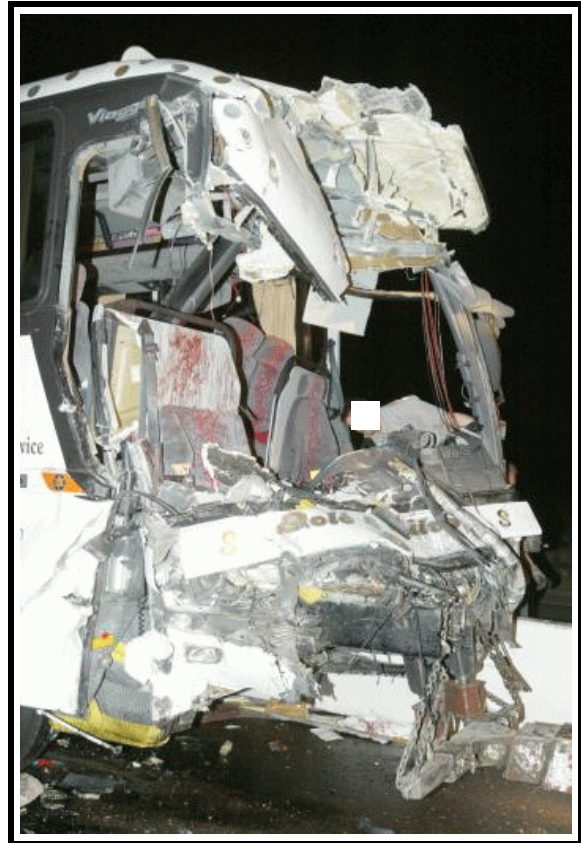
Figure 1. Case vehicle (Bus 1)

The vehicle sustained substantial front end damage. The right bumper/frame rail failed and the right sliding door and stairwell were compressed to the B pillar area. The front bus body panels were crushed and pushed upward and rearward. The hydraulic lines, brake lines and electrical wiring were exposed and crushed rearward. The forward portion of the roof was cracked and torn away.

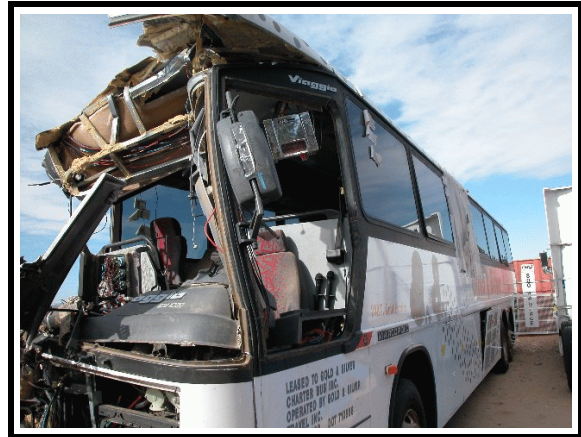
Figure 3. Front left, case vehicle

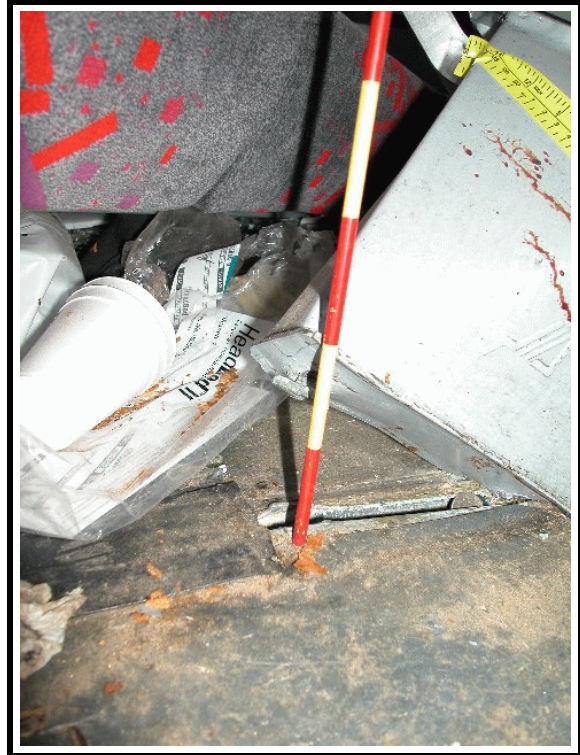
All the passenger seat units (with the exception of the left side row 14 seat unit and the right side row 12 unit) failed to one extent or another (see Table 2). There were three types of failures: complete separation on the outboard side, partial separation on the inboard side, and complete separation on the inboard side. All the failed seats separated on the outboard side. This caused the seat to begin to pivot forward (clockwise on the left, counterclockwise on the right) about the floor mounted stanchion. In most cases the seat rotated at least 45 degrees. Many of the seats showed evidence of occupant loading from the rear. As the movement continued, the stanchions began to separate from the floor. It appears that nine of the seat units completely separated from the vehicle.

Figure 5. Inboard seat unit pedestal, partial separation

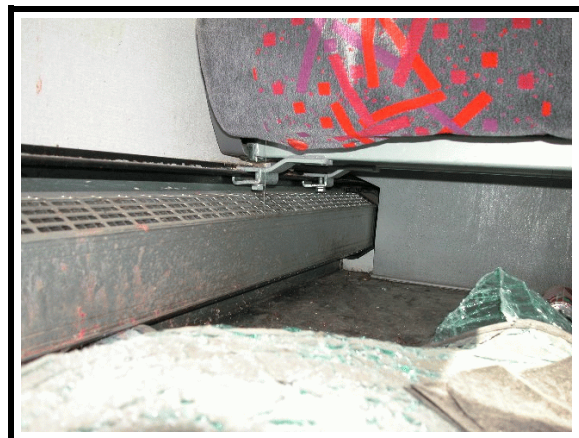
The passenger seats were composed of a seat frame containing two individual seat positions; each position had a seat bottom cushion, an integral headrest, and an armrest. The seat frame was attached to an aluminum track on the interior sidewall by two C-clamps. A single pedestal offset from the frame center was attached to the floor track by two T-bolt fasteners. The seating was designed so that the seating arrangement can be changed (number of seats and distance between rows). The seats can essentially be moved forward and backward after the bolts are loosened.

Figure 6. Outboard seat unit attachment

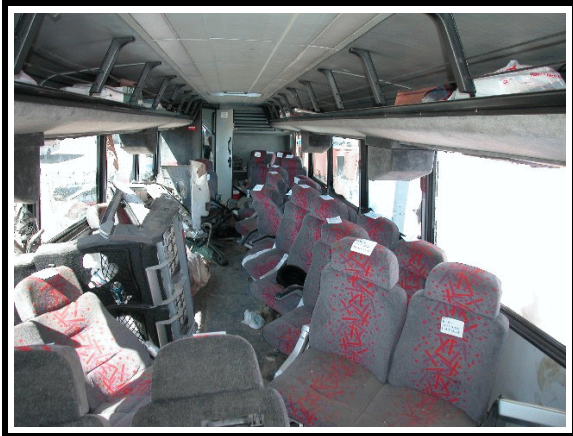
Figure 7. Looking towards rear of bus (shows seat rotation)

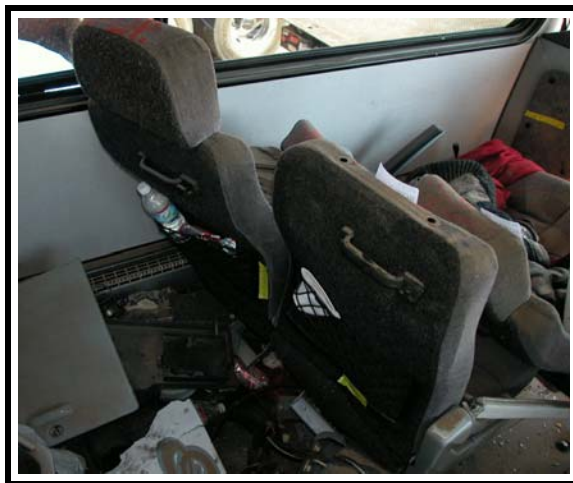
Figure 9. Example of occupant loading from the rear

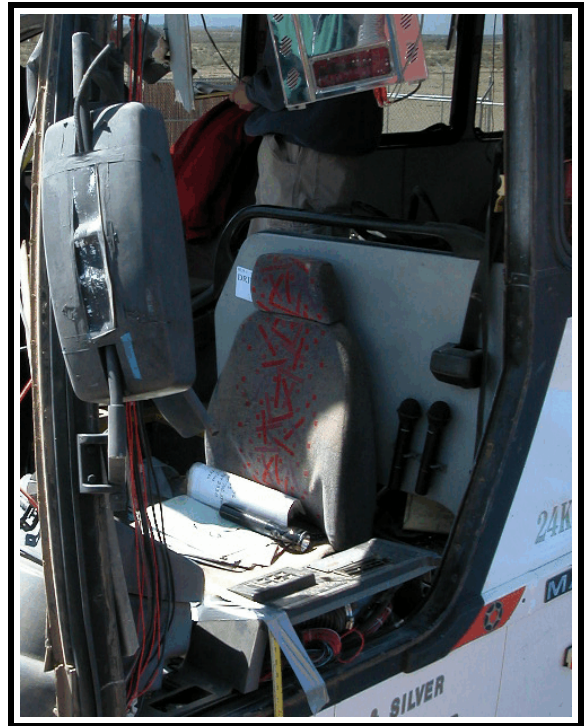
The 49-year-old male driver was seated in an upright posture and was restrained by the 3-point manual lap and shoulder belt. He was using the cell phone at the time of the crash. At impact, he initiated a forward trajectory. He loaded the lap and shoulder belt. The driver's knees and lower legs engaged the intruding lower instrument panel causing multiple knee joint injuries. He was entrapped in the vehicle and required extrication. He was transported from the scene to a local trauma center. He arrived with a GCS score of 14. He was hospitalized for two days.

Figure 11. Driver seated position

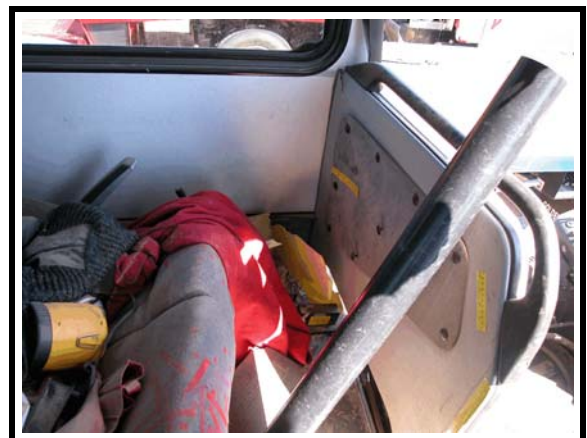
The 41-year-old female seated in bus row 1 in the left window seat was not restrained. At impact, she initiated a forward trajectory and engaged the wall that separates the driver from the passengers with her arms and knees. She sustained an indirect femur fracture and an indirect ulna fracture, in addition to minor contusions and lacerations to her lower and upper extremities. She was removed from the vehicle by rescue personnel due to her injuries. She was transported to a local trauma center by air. She arrived with a GCS score of 15. She was hospitalized for 11 days.

Figure 12. Contacts to separating wall–row 1, left seat–Occupant 2

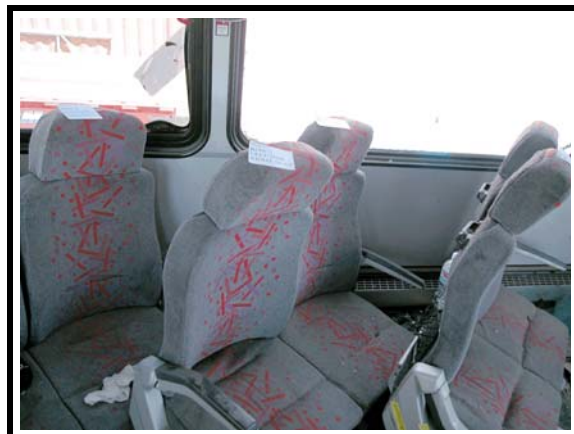
Figure 13. Typical seat movement

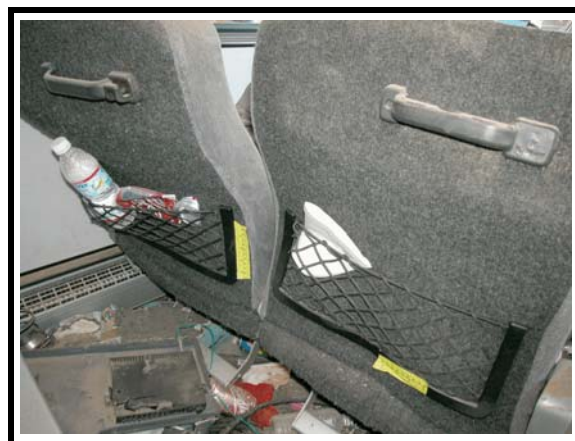
Figure 14. Common injury contact pattern (seat back and seat base)

By design, none of these bus passengers were restrained. Their exact seat positions are not known. The motion of the passengers at impact was essentially straight forward. These injured passengers either engaged the seat back of the seat in front of them or the rigid seat bottom. Most of the injuries were either to the lower limbs or to the face.
