**GENERAL DYNAMICS REMOTE ADULT AIR BAG RELATED SERIOUS INJURY
INVESTIGATION**

CASE NO: CA03-010

VEHICLE: 1997 FORD F-150 PICKUP TRUCK

CRASH DATE: SEPTEMBER 1998

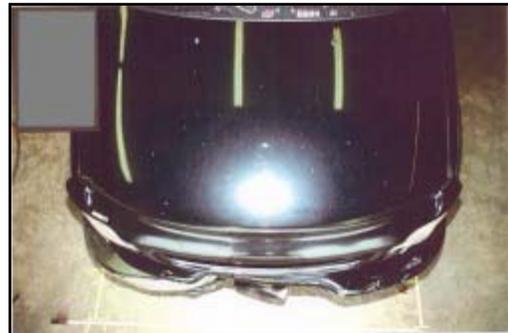
Figure 1. Overhead view of the damaged Ford F-150 pickup truck

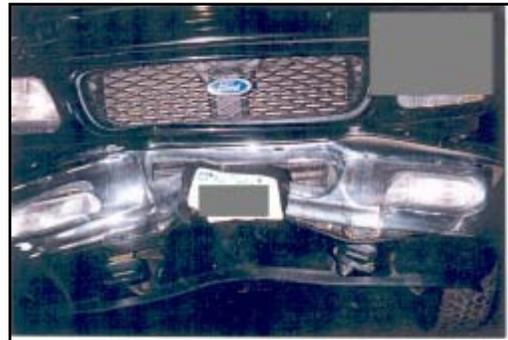
The exterior damage to the 1997 Ford F-150 was based on photographs obtained from the plaintiff's attorneys. The pickup truck sustained moderate frontal damage (**Figures 2 and 3**) as a result of the impact with the Lincoln Town Car. The direct contact damage began at the front right bumper corner and extended 162 cm (64") laterally across the bumper to the front left corner. Paint transfers were present across the entire width of the bumper from contact with the Town Car. The maximum crush at the front bumper was reported as 22.6 cm (8.9") and was located approximately 8 cm (3") to the right of the vehicle's centerline. The damage to the center aspect of the F-150's bumper appeared to be a result of direct engagement with the left front corner of the Town Car's bumper. Scuff marks and paint transfers were present on the upper aspect of the bumper and the lower aspect of the grille and headlamps. The vertical height of the damage did not extend above the lower aspect of the grille. The combined direct and induced damage involved the entire frontal width of the vehicle. The left front fender was buckled slightly rearward and the front aspect of the left frame rail was deflected slightly to the right. The plastic license plate frame was partially separated.

The Collision Deformation Classification (CDC) for the frontal impact with the Lincoln Town Car was 12-FDEW-1. Six crush measurements were estimated along the front bumper of the Ford F-150 and were as follows: C1 = 0.0 cm, C2 = 3.8 cm (1.5"), C3 = 15.2 cm (6.0"), C4 = 20.3 cm (8.0"), C5 = 3.8 cm (1.5"), C6 = 0.0 cm.

Figure 2. Frontal view of damaged F-150 pickup truck

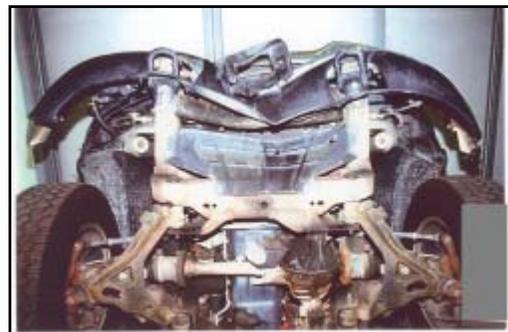
Figure 3. Undercarriage view of damaged Ford F-150

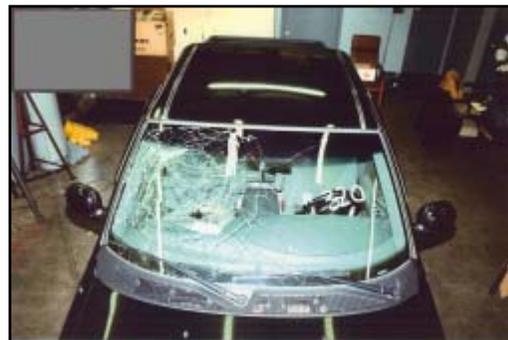
Interior damage to the F-150 was minor and attributed to occupant contact. The windshield sustained a focused fracture on the top right aspect (**Figure 4**) from probable contact with the front right passenger's hand. The entire right side of the windshield sustained a broad fracture from the compression of the front right passenger's air bag against the windshield.

Figure 4. View of fractured windshield

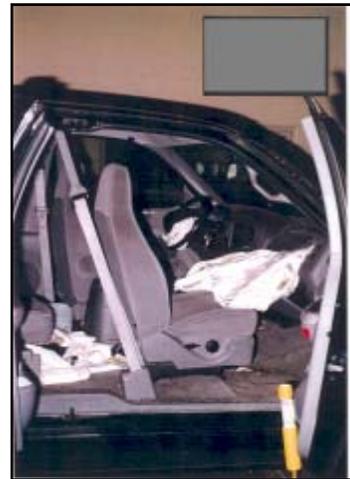
The top half of the steering wheel rim was deformed forward. There was no visible damage to the plastic knee bolster or left instrument panel. The glove box door was open post-crash (**Figure 5**) and it was stated that the latch was damaged as a result of occupant loading. There was no visible damage or deformation to the face of the glove box door in the photographs. There were no intrusions into the passenger compartment.

Figure 5. Interior view from right side

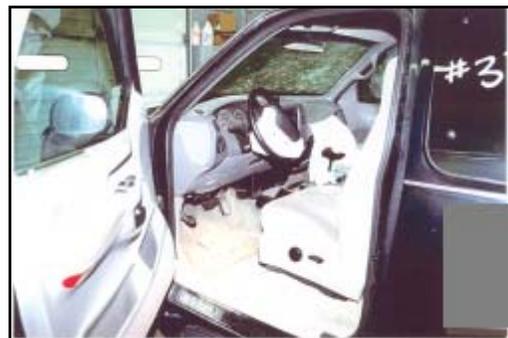
The Ford F-150 was equipped with frontal air bags (**Figure 6**) for the driver and front right passenger positions that deployed as a result of the frontal impact. The driver's air bag deployed from the center of the steering wheel hub through a single cover flap hinged at the top aspect. The driver's air bag was folded and partially exposed from the module in the photographs. There were no available photographs that displayed the entire face of the deployed driver's air bag.

Figure 6. View of frontal air bag system through driver's door

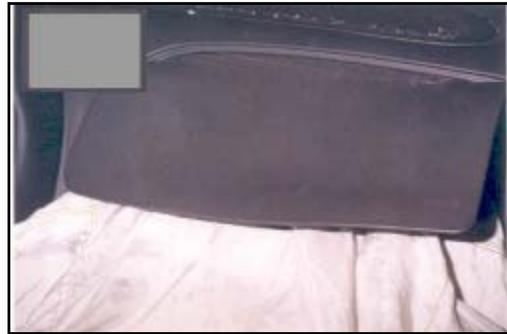
The front right passenger's air bag deployed from a mid-mount module with a single cover flap design. The cover flap was rectangular in shape and was hinged at the top/forward aspect (relative to the vehicle). The cover flap was distorted/twisted (**Figure 7**) from probable occupant contact with the front right passenger's right arm. The air bag was designed with an additional chamber on the left aspect which allowed the bag to extend laterally across both the right and center seating positions. The wide air bag (**Figure 8**) was designed with the intent to provide protection to a potential occupant seated in the center position, if the vehicle had been equipped with a bench seat. A vertical seam was present on the air bag fabric which separated the main chamber from the additional chamber. There were no vent ports visible in the photographs and it was stated in court documents that the air bag fabric was porous to allow a certain amount of venting, in addition to venting back through the air bag module.

Figure 7. View of front right passenger's air bag cover flap

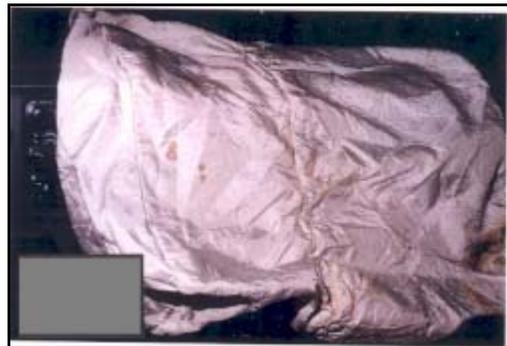
Figure 8. Partial view of the face of the front right passenger's air bag

A possible makeup transfer from the front right passenger was present near the center of the air bag face. Post-crash transfers of body fluid (blood) were also present on the air bag fabric.

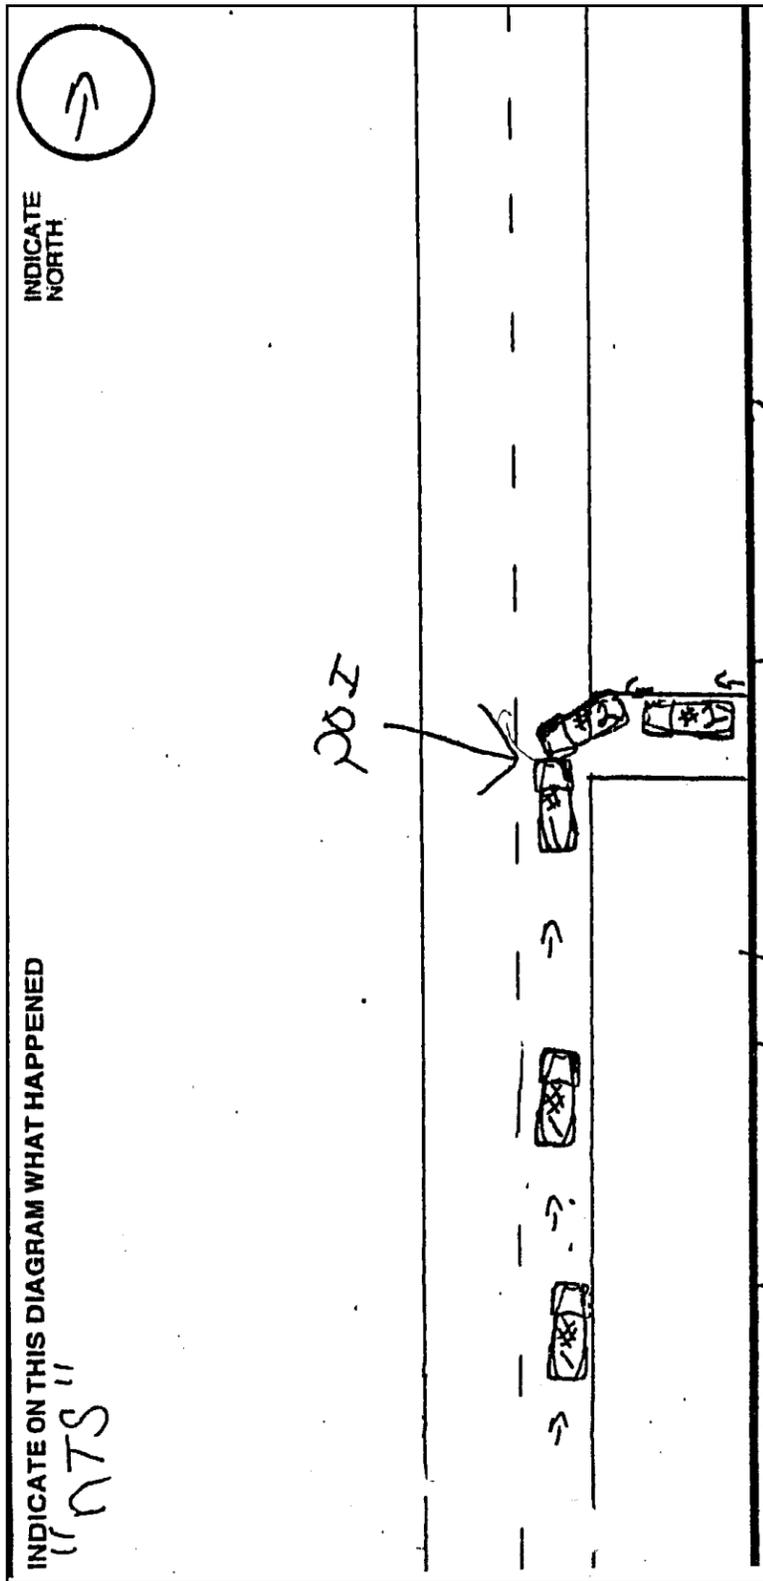
Figure 9. Police scene schematic

Police reported the width of the roadway to be 7.3 m (24.0'). The roadway was bordered by white fog lines and roadside ditches. The width and depth of the ditches was not specified, however, the centerline of the west ditch was located 4.3 m (14.0') outboard of the west fog line. The roadside environment included private driveways and residential areas. The posted speed limit was 89 km/h (55 mph). The police scene schematic is included as **Figure 9** at the end of this report.
