TRANSPORTATION RESEARCH CENTER

ON-SITE AIR BAG INVESTIGATION

CASE NUMBER - IN-03-014
LOCATION - Texas
VEHICLE - 2001 BUICK LESABRE
CRASH DATE - March 2003

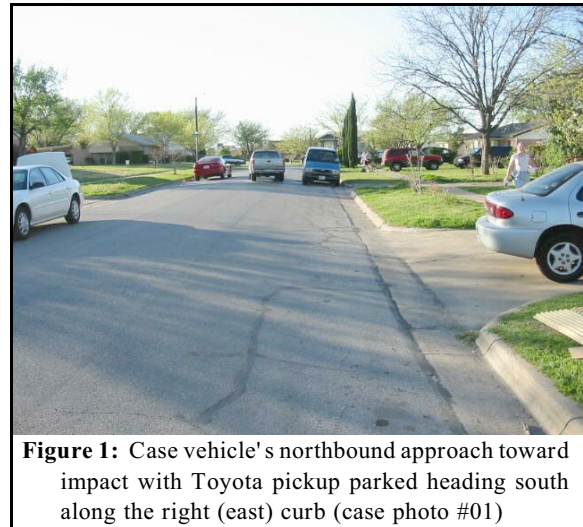
The case vehicle was traveling north in the northbound lane of a two-lane, undivided, residential street and apparently intended to proceed straight ahead. The 1986 Toyota pickup was parked and unoccupied, heading south along the east curb of the same roadway. The speed limit was 48 km.p.h. [30 m.p.h.], it was dark but lighted, raining and the asphalt road surface was wet. The paved road surface was 9.1 meters [29.8 feet] wide, with concrete curbs on both sides. The police crash report made no mention of any attempted avoidance maneuvers taken by the case vehicle's driver. The EDR indicated that the driver braked a few seconds prior to the impact. The crash occurred in the northbound lane of the roadway (**Figure 1**).

Figure 1: Case vehicle's northbound approach toward impact with Toyota pickup parked heading south along the right (east) curb (case photo #01)

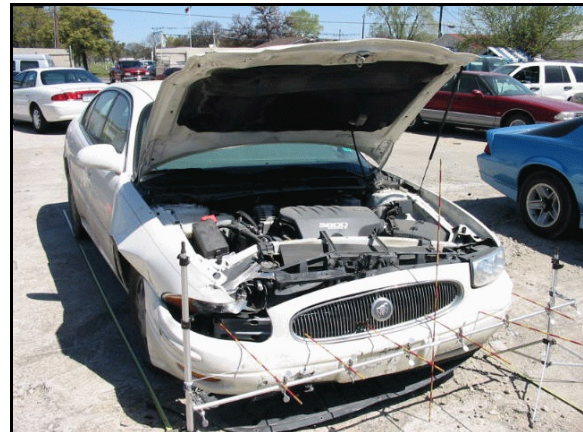
The case vehicle's initial contact with Toyota involved the front right bumper, grille and hood (**Figure 2**). Direct damage began at the right front bumper corner and extended a measured distance of 124 centimeters [48.9 inches] along the front bumper. All crush measurements were taken on the steel bumper as there was a significant gap between the bumper and bumper fascia, except C1 was taken on bumper fascia. Maximum crush was measured as 35 centimeters [13.8 inches] at C6. The case vehicle's front right bumper, bumper fascia, right headlamp/turn signal assembly, grille, hood, and radiator were directly damaged and crushed rearward (**Figure 3**). None of the tires/wheels were damaged or restricted and there was no glazing damage. The left headlight/turn signal assembly was slightly displaced and the left fender was undamaged.

Based on the vehicle inspection, the CDC for the case vehicle was determined to be: **12-FDEW-2 (0)**. The WinSMASH reconstruction program, missing vehicle algorithm based on the case vehicle's crush profile, was used on the case vehicle's single impact. The total, longitudinal, and lateral delta Vs for the case vehicle are, respectively: 17.0 km.p.h. [10.6 m.p.h.], -17.0 km.p.h. [-10.6 m.p.h.], and 0 km.p.h. [0 m.p.h.]. These results should be viewed as borderline but reasonable. The crash severity for the case vehicle was low (14 - 23 km.p.h. [9 - 14 m.p.h.]).

Figure 2: Case vehicle's front right damage area (case photo #25)

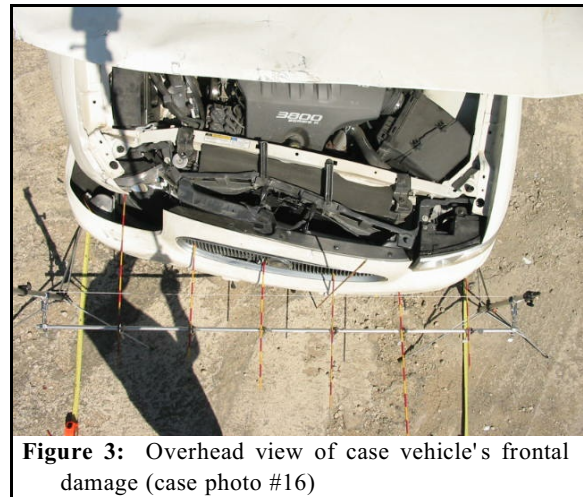
Figure 3: Overhead view of case vehicle's frontal damage (case photo #16)

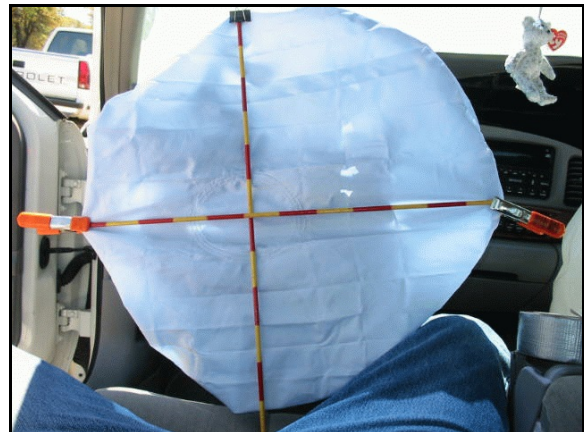
The case vehicle's driver air bag was located in the steering wheel hub (**Figure 4**). Inspection of the air bag module's cover flaps and air bag revealed that the cover flaps opened at the designated tear points and there was no evidence of damage to the air bag or the cover flaps. The driver's air bag had four tether straps, each 7.5 centimeters [3 inches] wide, and two vent ports, 3.5 centimeters [1.4 inches] in diameter, located at the 11 and 1 o'clock positions. The deployed driver's air bag was round with a diameter of 64 centimeters [25.2 inches]. There was no contact evidence apparent on the driver's air bag.

Figure 4: Front of driver's air bag (case photo #40)

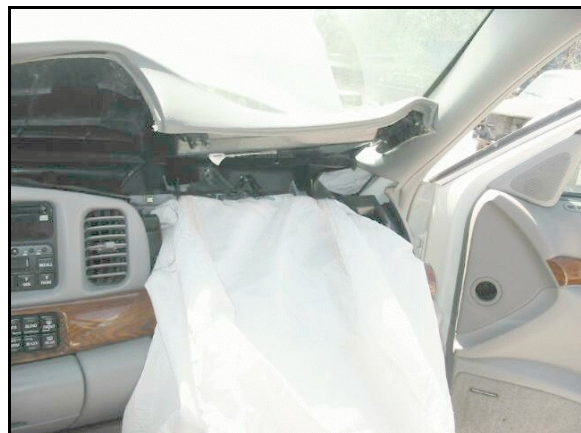
The front right passenger's air bag was located in the mid-mount position, on the front of the instrument panel, in a configuration that the manufacturer refers to as an "active instrument panel". There was no module cover flap as such. Rather, as the deploying air bag expands, it forces the top of the instrument panel upward, causing the points of attachment to break away and creating an opening between the horizontal top and the vertical front of the instrument panel. The air bag deploys through this opening (**Figure 5**). The deployed front right air bag was rectangular, measuring 55 centimeters [21.7 inches] vertically and 35 centimeters [13.8 inches] horizontally. The front right passenger's air bag had one tether, measuring 34 centimeters [13.4 inches], and two vent ports, each 4.5 centimeters [1.8 inches] in diameter, located at the 9:30 and 2:30 o'clock positions. There was no contact evidence apparent on the front right passenger's air bag (**Figure 6**).

Figure 5: Deployed front right passenger air bag, showing displaced top of "active instrument panel" (case photo #49)

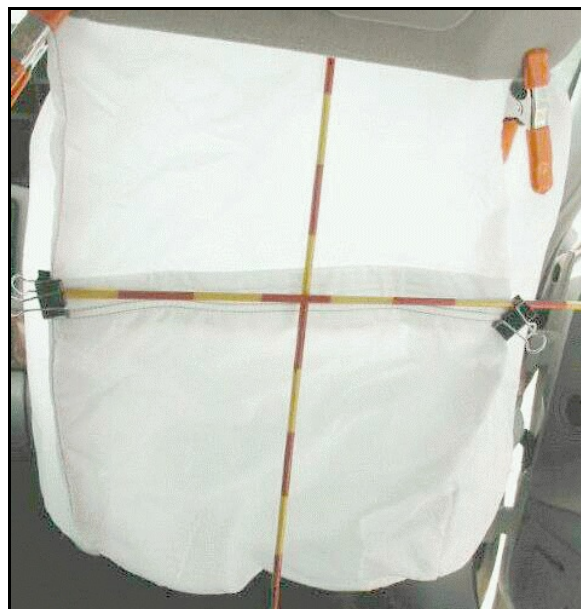
Figure 6: Front of passenger's air bag (case photo #44)

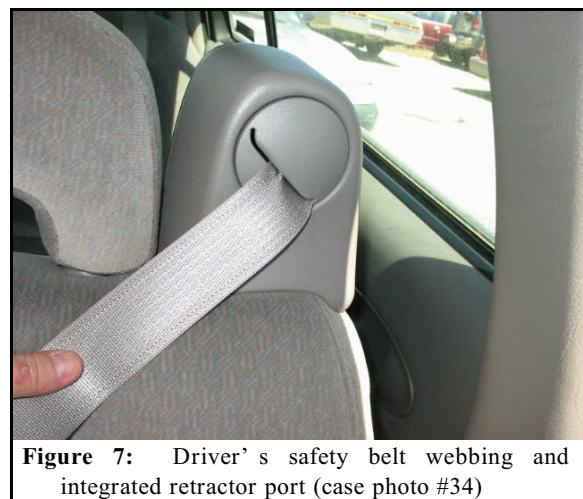
The case vehicle's driver (37-year-old male, white, unknown if Hispanic, height and weight unknown) refused to take a blood alcohol breath test and was cited by the police for driving while intoxicated. He also refused to be interviewed for this research investigation. He was seated in an unknown posture, probably with his left foot on the floor, his right foot on the foot controls and at least one hand on the steering wheel. At the inspection, his seat track was located between the middle and rearmost positions, the seat back was slightly reclined, and the tilt steering wheel was adjusted between its middle and down-most positions. The driver was restrained by his available, active, integrated, three-point, lap-and-shoulder safety belt system. The inspection of the driver's seat belt webbing showed evidence of loading (**Figure 7**).

Figure 7: Driver's safety belt webbing and integrated retractor port (case photo #34)

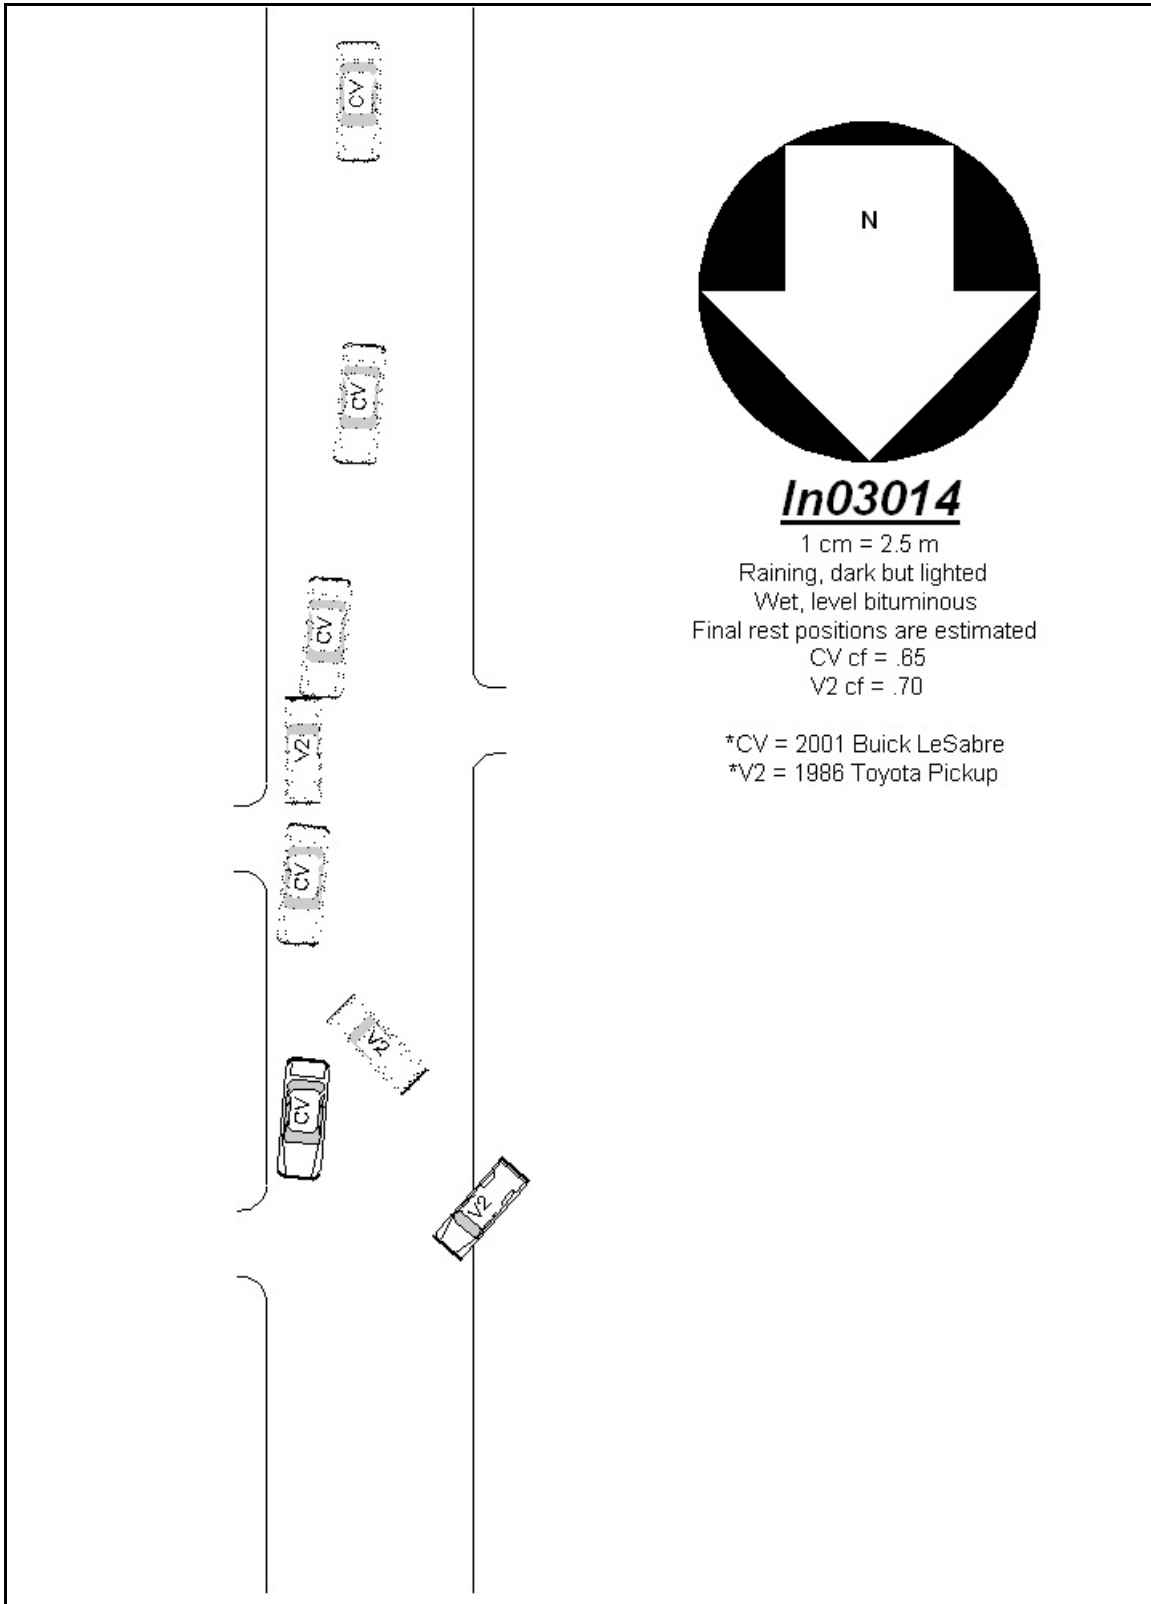
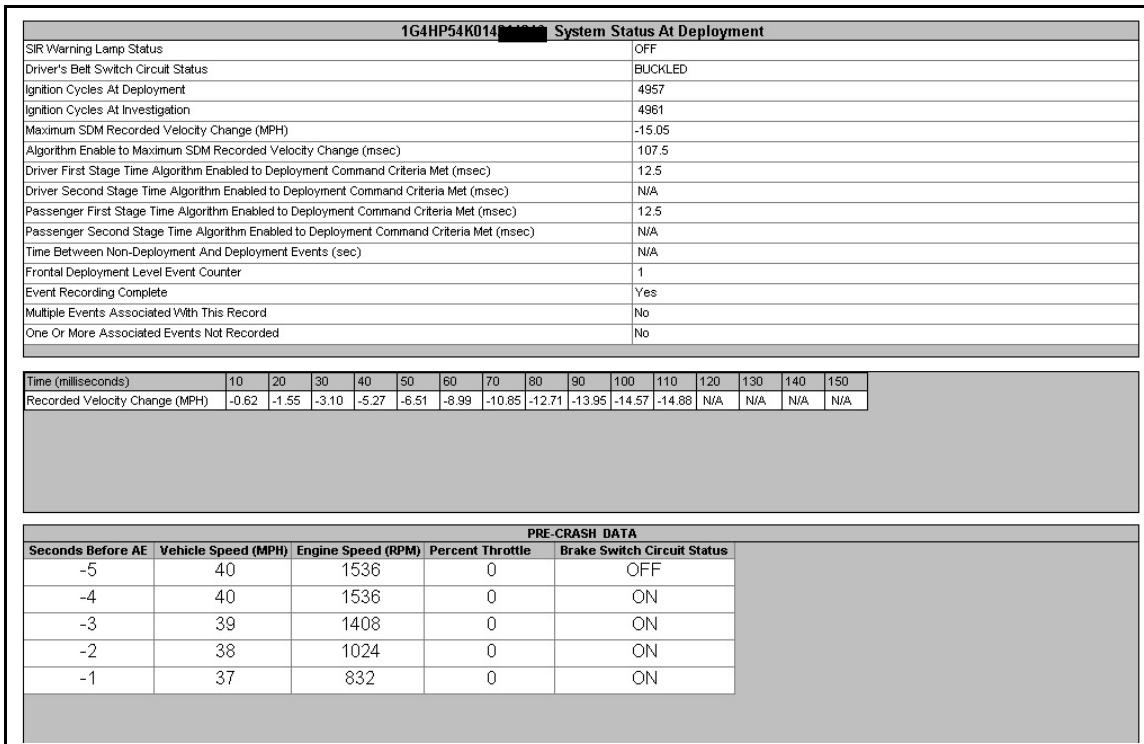
Figure 8: Sensing and Diagnostic Module (SDM) System Status at Deployment Report

The case vehicle's Event Data Recorder (EDR) was successfully downloaded in the field via the diagnostic port. The Sensing and Diagnostic Module (SDM) report is included as **Figures 8, 9 and 10**. The SDM report indicates that the SIR Warning Lamp Status was OFF, the driver's belt was buckled and the deployment event took place during ignition cycle 4,957 (**Figure 8**). The case vehicle was traveling at 64 km.p.h. [40 m.p.h.] with zero throttle five seconds prior to the impact. At approximately four seconds prior, the driver applied the brakes and the vehicle slowed to 60 km.p.h. [37 m.p.h.] at one second prior to the impact (**Figures 8 and 9**). The case vehicle driver and front right passenger air bags were equipped with multi-stage inflators. The SDM report indicates that the command for first stage deployment for both air bags was issued at 12.5 milliseconds [0.0125 seconds] after algorithm enable, and the criteria for second stage deployment was not met (**Figure 8**). The SDM report indicates that the maximum recorded velocity change was -24.2 km.p.h. [-15.05 m.p.h.], at 107.5 milliseconds [0.1075 seconds] after algorithm enable (**Figure 8**). The velocity change data show deltaV accumulating gradually to the maximum at approximately 110 milliseconds following algorithm enable, after which recording ceased (**Figures 8 and 10**). The SDM recorded velocity change is 7.2 km.p.h. [4.5 m.p.h.] greater than the WinSMASH missing vehicle calculated deltaV for the case vehicle.
