ON-SITE ADVANCED OCCUPANT PROTECTION SYSTEM INVESTIGATION

CASE NUMBER - IN-03-017
LOCATION - ALABAMA
VEHICLE - 2003 HONDA ACCORD EX
CRASH DATE - March 2003

January 30, 2007

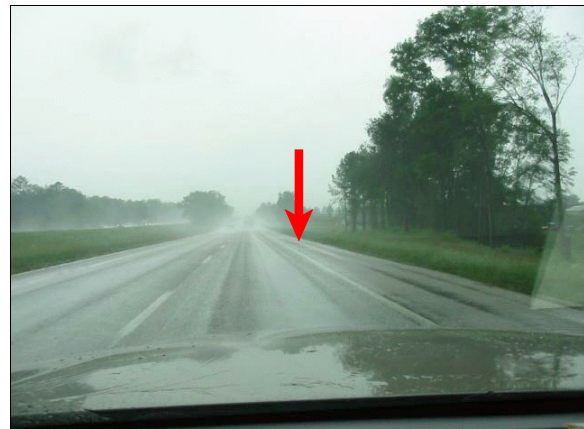
Figure 1: Arrow indicates estimated area of impact between case vehicle and Plymouth on eastern shoulder of northern roadway (case photo #03)

Pre-Crash: The case vehicle was traveling north-northwestward in the outside through lane of the northern roadway and intended to proceed straight ahead (**Figure 1** above). The Plymouth was stopped and abandoned, heading in a northerly direction, on the right (eastern) shoulder of the northern roadway (**Figure 1** above). According to the case vehicle's driver, he was distracted by the front right passenger and drifted off the roadway onto the right shoulder. The case vehicle's driver made no avoidance maneuvers prior to the crash. The crash occurred on the eastern shoulder of the northern roadway.

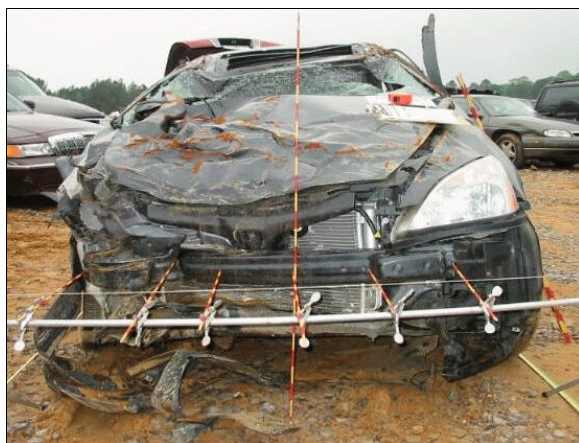
Figure 2: Case vehicle's frontal damage viewed at bumper level with contour gauge present; Note: damage primarily to right half (case photo #06)

Crash: The front right half (**Figure 2**) of the case vehicle impacted the back (i.e., most likely left half) of the Plymouth, causing the case vehicle's driver and front right passenger supplemental restraints (air bags) to deploy. It is unknown whether more than one stage of the multi-stage air bags was activated. The case vehicle's seat back-mounted side air bags and side inflatable curtains did not deploy as a result of the case vehicle's frontal impact with the Plymouth.

Exterior Damage: The case vehicle’s contact with the Plymouth involved the front with the damage distributed on approximately the right half (Figure 2 above). Direct damage began at the front right bumper corner and extended inward along the bumper (Figure 8). It was not possible to determine the direct damage length because the front bumper fascia was separated from the vehicle and not available during our inspection. Crush was measured on the actual bumper (Figure 2 above), and the residual maximum crush was measured as 44 centimeters (17.3 inches) at C₅. The table below shows the case vehicle’s crush profile.

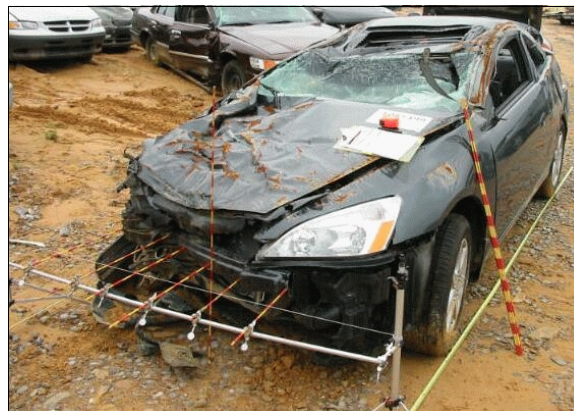
Figure 3: Elevated view from left of front showing case vehicle's frontal damage from impact with Plymouth and subsequent rollover damage; Note: greater vertical crush to right "A"-pillar and damage to left fender, "A"-pillar, and roof side rail (case photo #08)

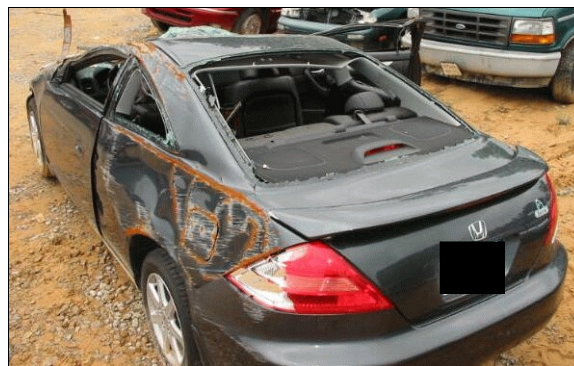
Figure 4: Elevated view from left of back showing rollover damage to case vehicle's left quarter panel and roof side rail (case photo #20)

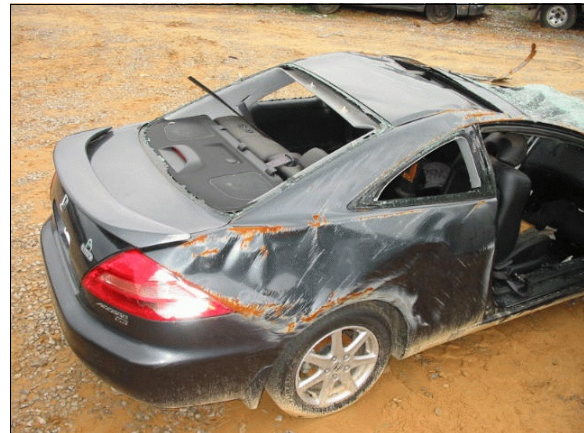
Figure 5: Rollover damage to case vehicle's right quarter panel, front door, roof side rail, and "A"-pillar; Note: backlite and right side glazing disintegrated (case photo #21)

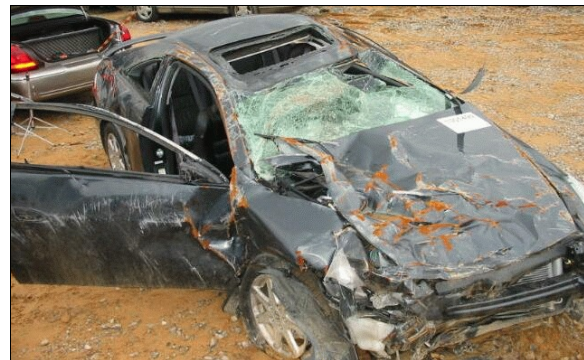
Figure 6: Elevated view from right of front of showing extensive rollover damage to case vehicle's top and right side (case photo #22)

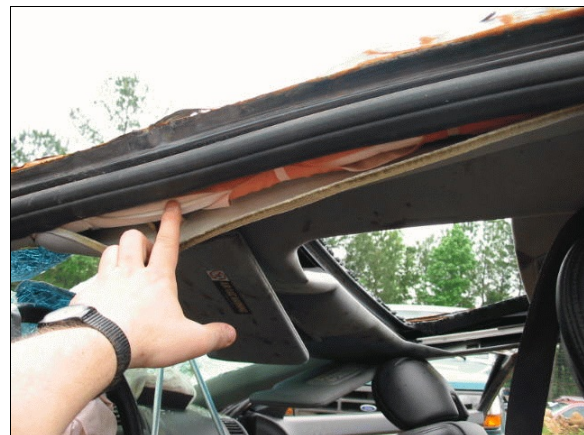
Figure 7: Case vehicle's exposed, non-deployed, left side-inflatable curtain air bag; Note: air bag exposed during rollover event as a result of damage to left "A"-pillar and roof side rail (case photo #37)

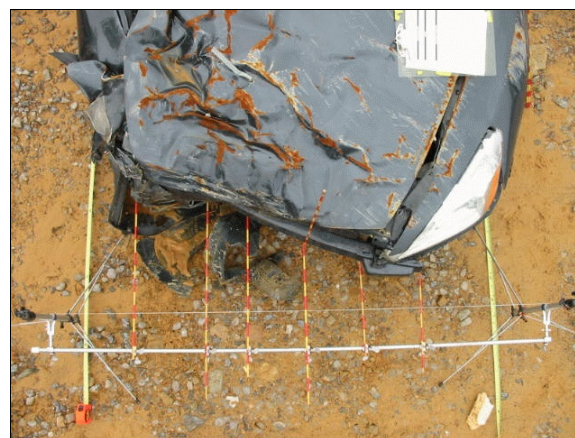
Figure 8: Overhead view of case vehicle’s frontal crush from impact with back of Plymouth; Note: contour gauge at bumper level and hood damage from subsequent rollover impact (case photo #18)

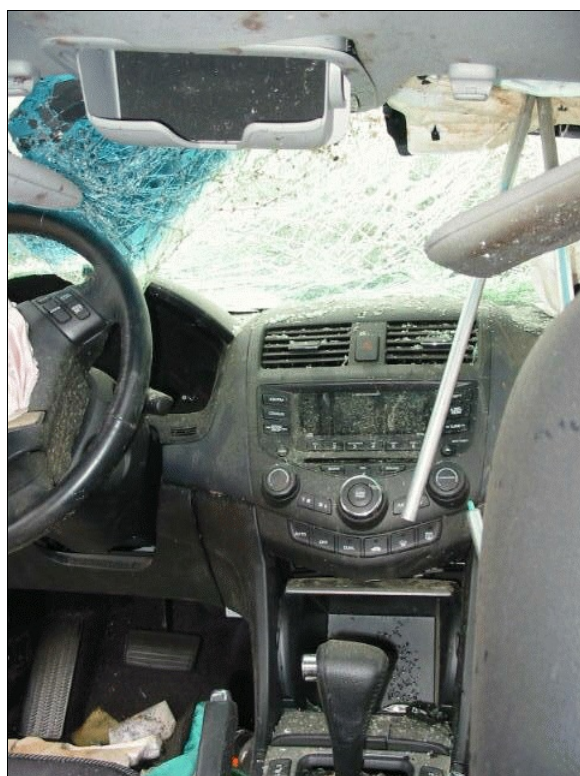
Figure 9: Vertical view of case vehicle’s center instrument panel area showing no obvious contact evidence to right side driver’s knee bolster or center instrument panel (case photo #42)

Interior Damage: Inspection of the case vehicle’s interior revealed no obvious occupant contact evidence (**Figure 9**) except for copious amounts of blood splattered throughout the roof and sun visors (**Figure 10** and **Figures 11** and **12** below). There were numerous vertical intrusions to the case vehicle’s front seating area including: the left and right “A”-pillars and roof side rails (**Figure 7** above, **Figure 10**, and **Figure 12** below), the windshield, the windshield’s header (and sun visors–**Figure 10**), and roof (**Figure 12** below). There was also vertical intrusion from the roof into the back left and right seating positions. The greatest intrusion involved the windshield and the roof into the driver [17 centimeters (6.7 inches)] and front right passenger [23 centimeters

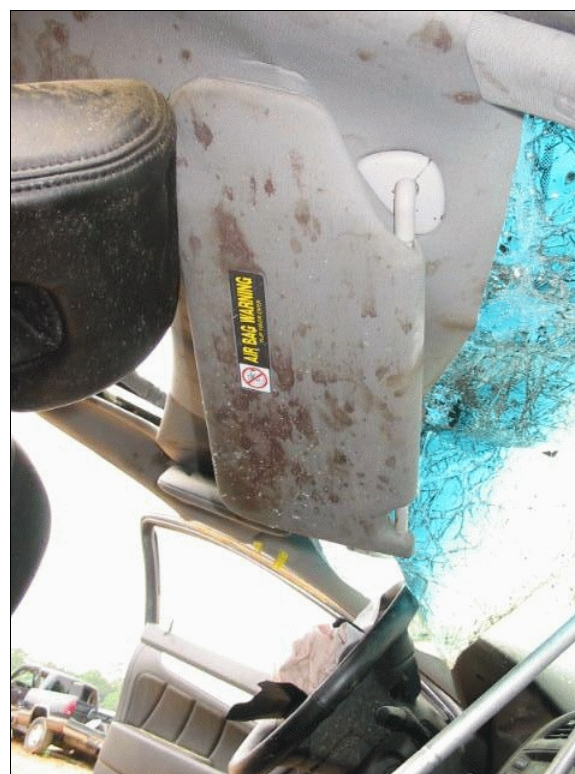
Figure 10: Case vehicle’s blood splattered front right sun visor viewed from right; Note: sun visor and roof/windshield header have been collapsed downward against front right headrest (case photo #46)

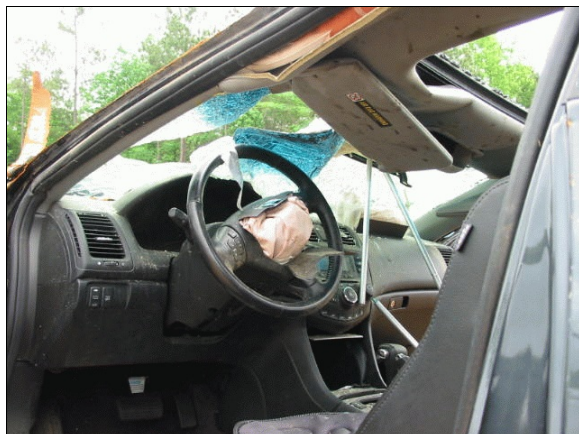
Figure 11: Case vehicle's driver seating area viewed from left at seat level; Note: blood splatter to driver's sun visor and roof and exposed, non-deployed, left side-inflatable curtain air bag (case photo #27)

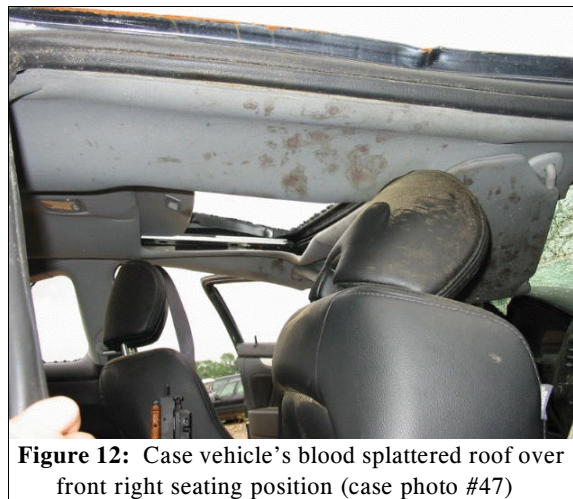
Figure 12: Case vehicle's blood splattered roof over front right seating position (case photo #47)

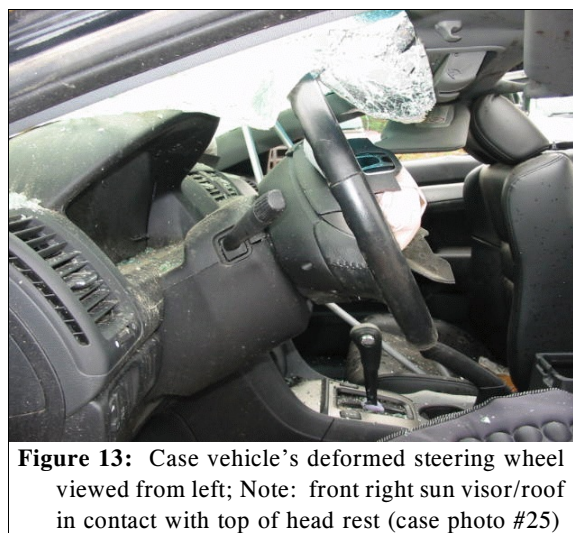
Figure 13: Case vehicle's deformed steering wheel viewed from left; Note: front right sun visor/roof in contact with top of head rest (case photo #25)

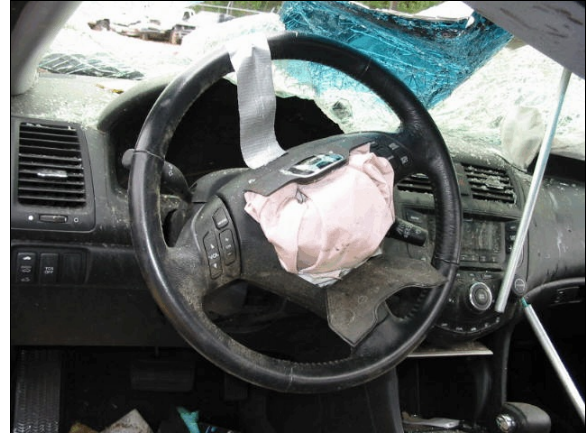
Figure 14: Configuration of cover flaps on case vehicle's driver air bag module and no obvious contact evidence to driver's knee bolster (case photo #26)

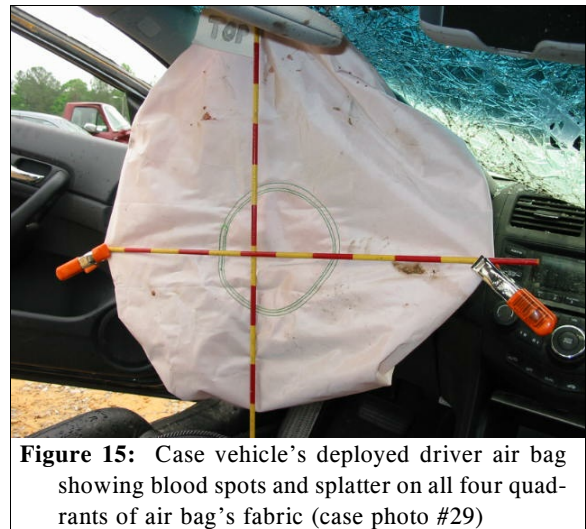
Figure 15: Case vehicle's deployed driver air bag showing blood spots and splatter on all four quadrants of air bag's fabric (case photo #29)

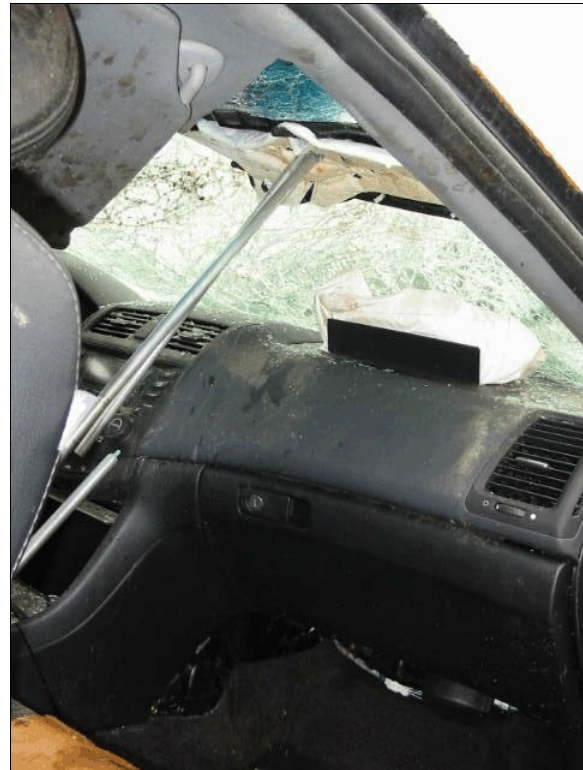
The front right passenger's air bag was located in the top of the instrument panel (**Figure 16** below). There were two symmetrical, "H"-configuration, modular cover flaps made of a medium, pliable vinyl with overall dimensions of 24 centimeters (9.4 inches) at both the top and bottom horizontal seams and 5 centimeters (2.0 inches) along both vertical seams. The profile of the case vehicle's instrument panel resulted in a 13 centimeter (5.1 inch) setback of the leading edge of the cover flap relative to the protruding right instrument panel. An inspection of the front right air bag module's cover flaps and the air bag's fabric revealed that the cover flaps opened at

Figure 16: Case vehicle's top-mounted front right passenger air bag showing lower cover flap and no obvious contact evidence to front right knee bolster or glove box (case photo #45)

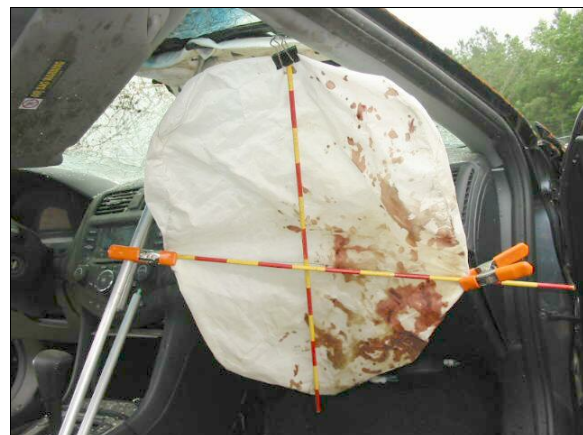
the designated tear points, and there was no evidence of damage during the deployment to the air bag or the cover flaps. The front right passenger's air bag was designed without any tethers. The front right air bag had two vent ports, approximately 5 centimeters (2.0 inches) in diameter, located at the 9 and 3 o'clock positions. The deployed front right air bag was rectangular with a height of approximately 68 centimeters (26.8 inches) and a width of approximately 46 centimeters (18.1 inches). The distance between the mid-center of the front right seat back, as positioned at the time of the vehicle inspection, and the front surface of the air bag's fabric at full excursion was 17 centimeters (6.7 inches). An inspection of the front right passenger's air bag fabric revealed large blood stains on the front right half of the air bag's front surface (**Figure 17**). Based on the driver's interview and the injuries he reported for his daughter (i.e., front right passenger), it is unlikely that the front right passenger's initial contact with the air bag caused this heavy bleeding. Instead, the copious blood evidence found on the air bag's front surface most likely resulted from the driver's lesions while he was in the process of extricating his daughter from the vehicle.

Figure 17: Case vehicle's deployed front right passenger air bag showing copious amounts of blood evidence, primarily on right half (case photo #48)

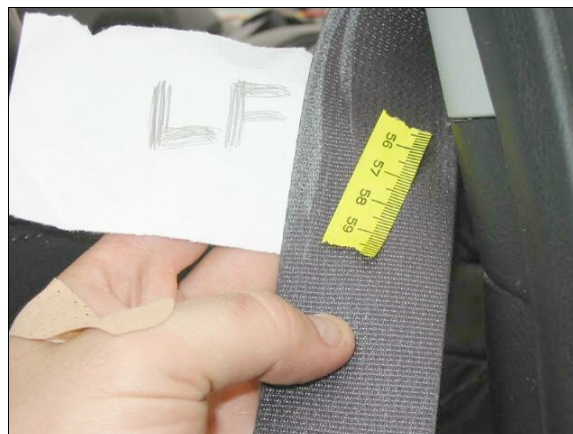
The case vehicle's driver was restrained by his available, active, three-point, lap-and-shoulder, safety belt system; the belt system was equipped with a retractor-mounted pretensioner, housed within the “B”-pillar. There was no mention by the driver of belt pattern bruising and/or abrasions to the driver's torso, but the inspection of the driver's seat belt webbing, “D”-ring, and latch plate revealed that the pretensioner had actuated and the belt webbing was bunched up and showed friction burns on the webbing at the “D”-ring (**Figure 18**).

Figure 18: Loading evidence (i.e., wear marks) on webbing of case vehicle's driver safety belt near “D”-ring (case photo #33)
