AIR BAG RELATED CHILD PASSENGER FATALITY INVESTIGATION

VERIDIAN CASE NO: CA03-018

VEHICLE: 1997 CHEVROLET VENTURE

CRASH DATE: FEBRUARY 2003

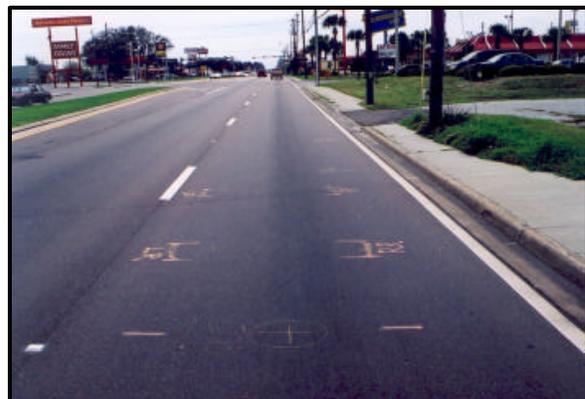
Figure 1: Trajectory view at the POI.

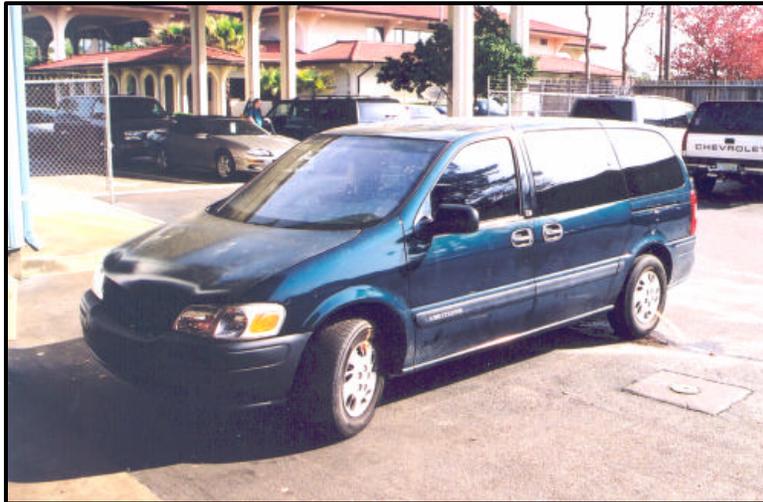
Figure 2: Left front view of the Chevrolet.

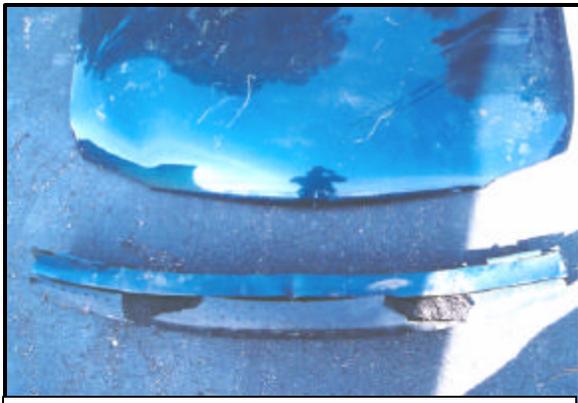
damaged bumper reinforcement bar. The center aspect of the bumper reinforcement bar was deformed across a width of 46 cm (18 in). The maximum deformation measured 2.5 cm (1.0 in) on the centerline of the vehicle.

Figure 3: View of the reinforcement bar and hood removed from the vehicle.

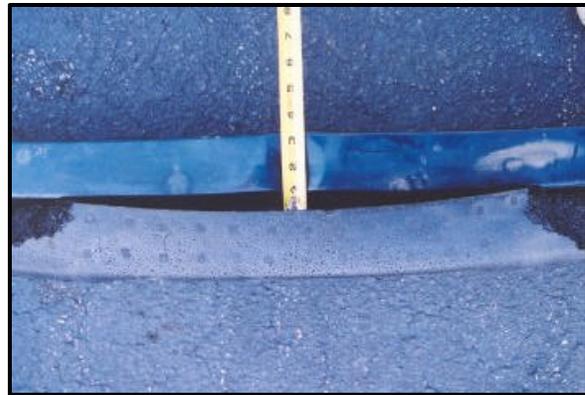
Figure 4: Close-up view of the deformed reinforcement bar.

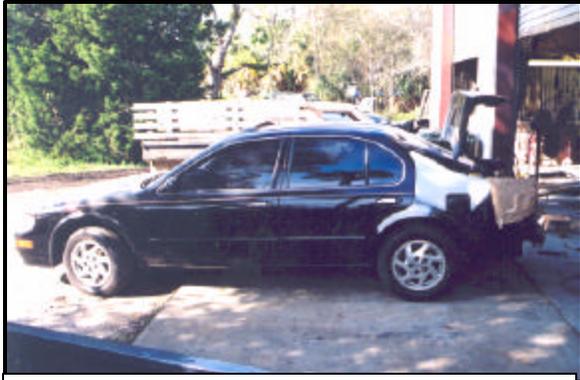
Figures 5 and 6 are left side and rear views of the Maxima. The Nissan was in partial disassembly and the rear bumper reinforcement had been replaced. Examination of the fascia revealed the rear bumper system sustained 150 cm (59 in) of direct contact as a result of the impact. Reportedly, the center section of the bumper reinforcement deformed approximately 10 cm (4 in) and was in contact with the aft wall of the trunk well. Examination of the vehicle identified minor repairs to the trunk well and to both rear quarterpanels. The damage to the trunk

Figure 5: Left side view of the Nissan.

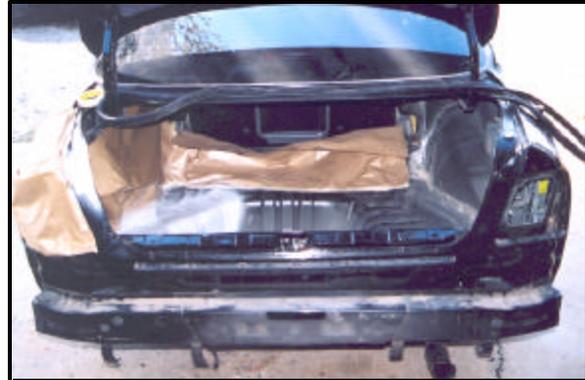
consisted of minor buckling to the floor and was considered crash related. It was not known if the quarterpanel damage was pre-existing or related to this crash event. The vehicle's repair estimate totaled approximately \$3,110 (parts and labor).

Figure 6: View of the repaired trunk well.

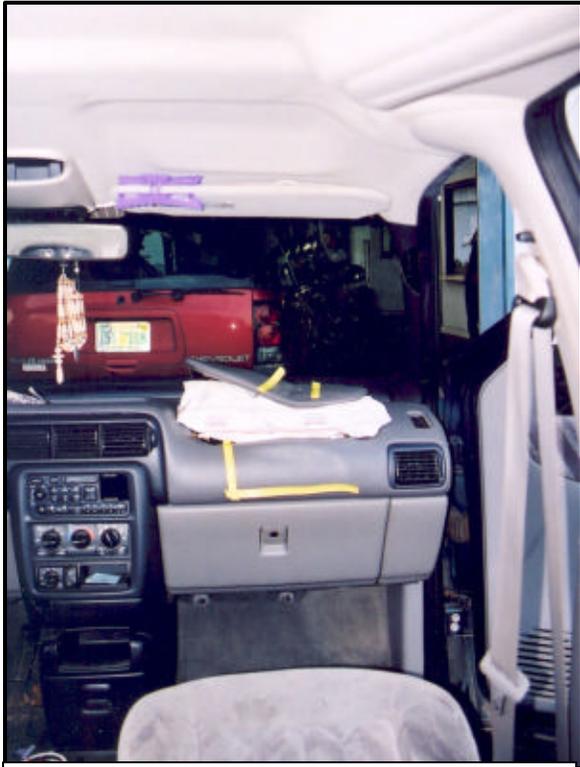
Figure 7: Overall view of the front right interior.

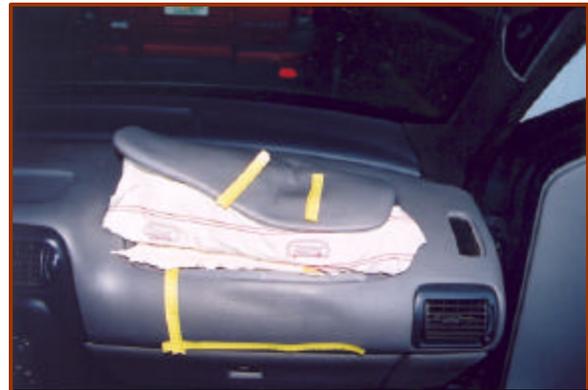
The cover flap was rectangular in shape and measured 39.4 cm x 25.9 cm (15.5 in x 10.2 in), width by depth. The flap was constructed of padded vinyl with a sheet metal backer. The sheet metal was designed to deform during the deployment and form the cover flap hinge. In this

crash, the forward position of the child's head impeded the rotation of the cover flap and resulted in the flap deformation. The elevation of the inboard and outboard corners of the flap measured 16.5 cm (6.5 in) and 8.4 cm (3.3 in), respectively. The deformed flap was creased along a 19.1 cm (7.5 in) depth. This crease was located 24.1 cm (9.5 in) right of the inboard edge of the flap.

Figure 8: View of the deformed cover flap.

The impeded deployment caused an over-pressurization within the module resulting in a fracture of the forward right mounting bracket internal to the instrument panel (IP). The fracture of this mount allowed the air bag module to rotate counterclockwise within the IP. This rotation was evidenced by a 20 cm x 8 cm (8 in x 3 in) area of deformation to the face of the instrument panel directly below the module. Refer to **Figure 8** above.

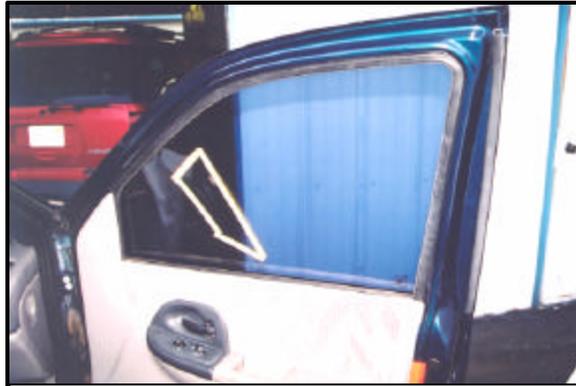
application of an aftermarket dark-colored film. Inspection of the right window glazing identified an area of abrasion corresponding to the air bag transfer, **Figure 9**. A fracture of the trim covering the right A-pillar was also noted. The fracture measured 16.5 cm x 3.8 cm (6.5 in x 1.5 in) and was located 38 cm (15 in) above the IP, **Figure 10**. The trim fracture resulted from an impact from the child's head during air bag expansion.

Figure 9: Area abrasion to the front right glazing.

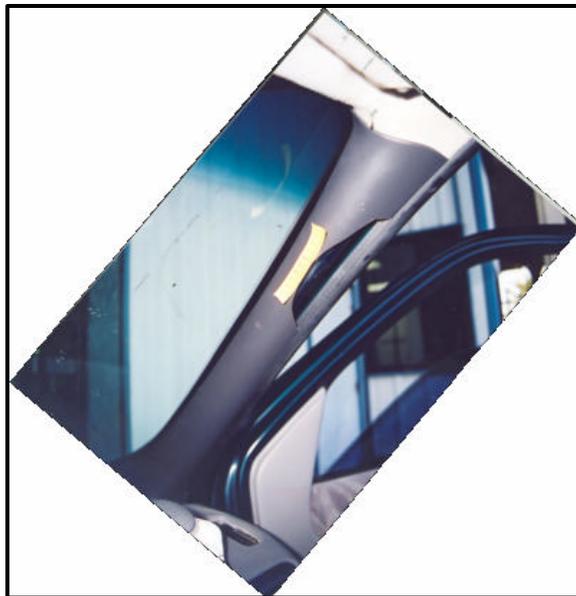
Figure 10: Fractured A-pillar trim.

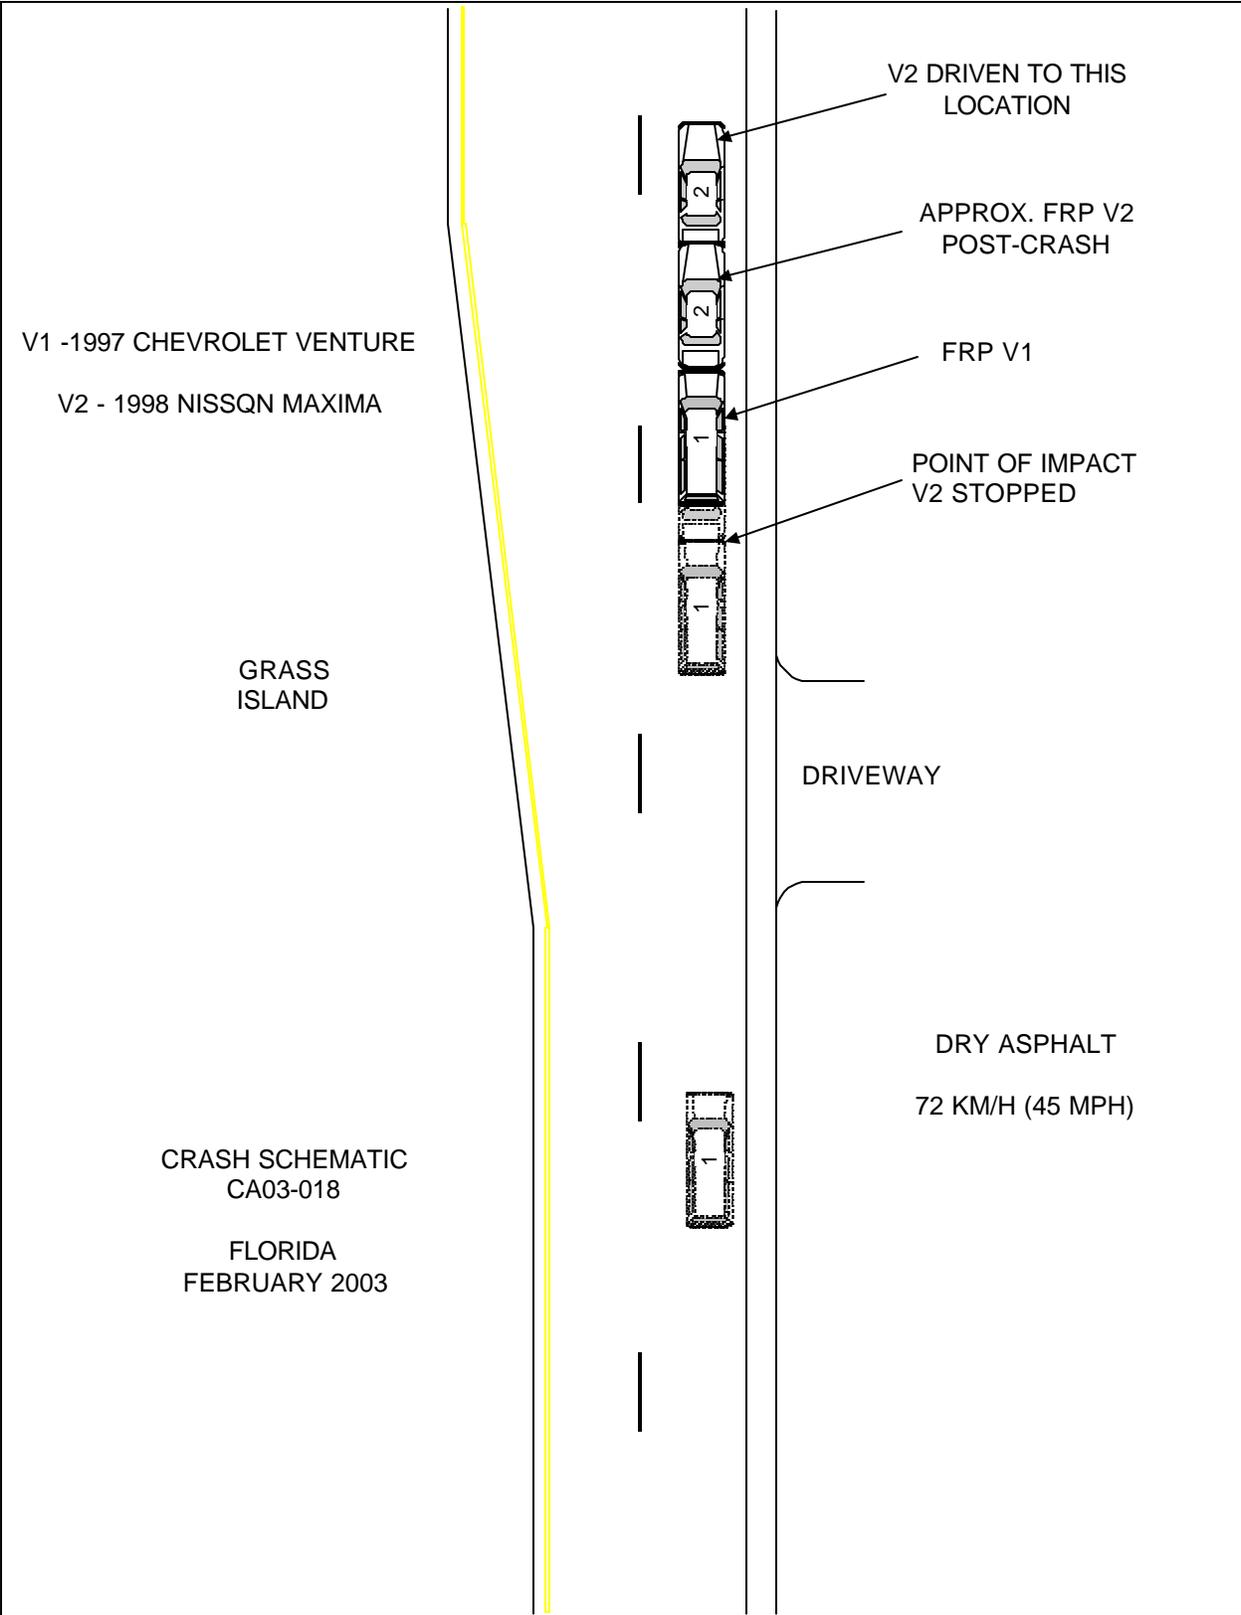
Figure 11: Crash Schematic.
