ON-SITE CHILD SAFETY SEAT INVESTIGATION

CASE NUMBER - IN-03-018
LOCATION - ALABAMA
VEHICLE - 2001 HONDA CIVIC EX
CRASH DATE - March 2003

May 24, 2007

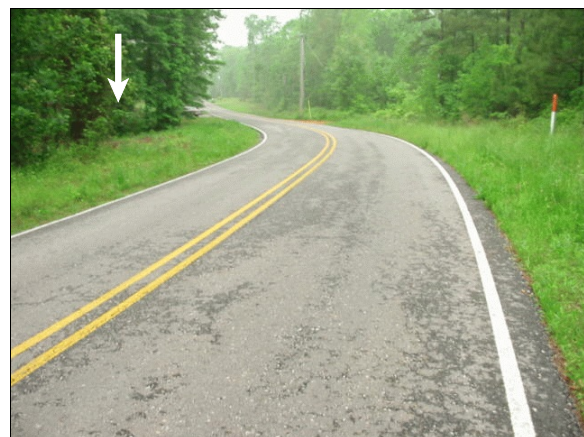
Figure 2: Case vehicle's south-southwesterly travel path after cresting top of hill in left-hand curve; Note: arrow indicates point of impact with tree (case photo #02)

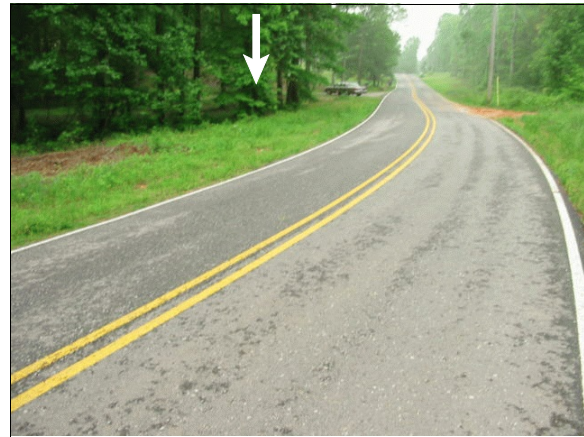
Figure 3: Case vehicle’s southerly travel path, obliquely across leftward curving road toward eastern (left) roadside and impact (arrow) with tree (case photo #03)

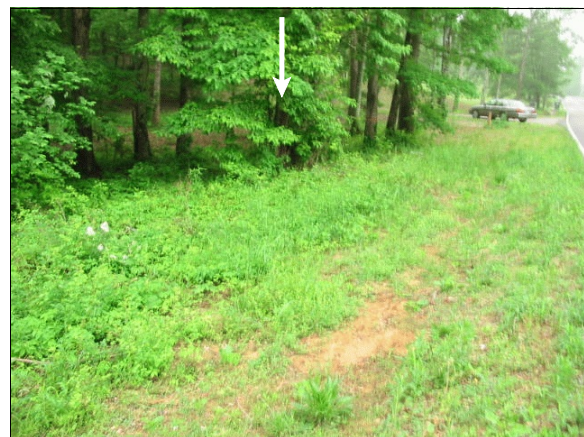
Figure 4: Case vehicle’s off-road, southerly travel path along eastern roadside toward impact (arrow) with tree (case photo #04)

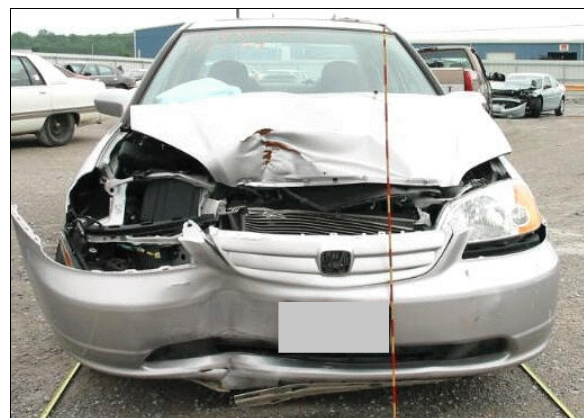
Crash: The front (**Figure 5** and **Figure 6** below) of the case vehicle impacted a medium sized tree (**Figure 7** below), causing the case vehicle’s driver and front right passenger supplemental restraints (air bags) to deploy. It is unknown whether more than one stage of the multi-stage air bags was activated.

Figure 5: Case vehicle’s frontal damage with bumper fascia placed in approximate post-crash position (case photo #09)

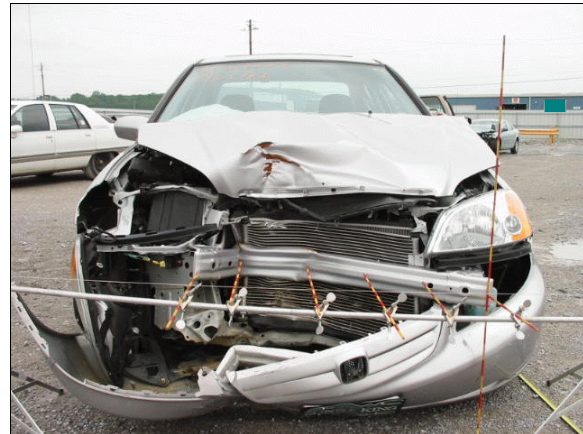
Figure 6: Case vehicle's frontal damage with contour gauge set at bumper level (case photo #10)

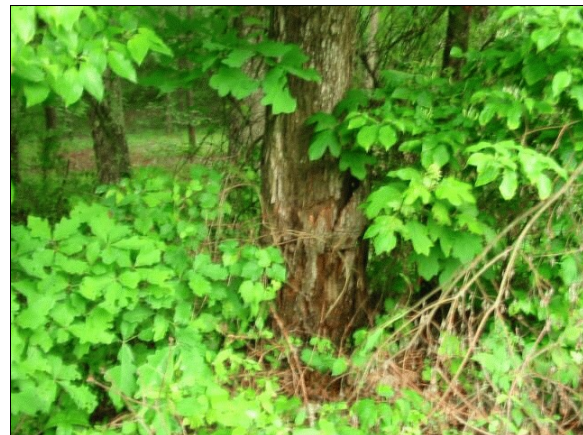
Figure 7: Tree on eastern side of road impacted by case vehicle's front (case photo #05)

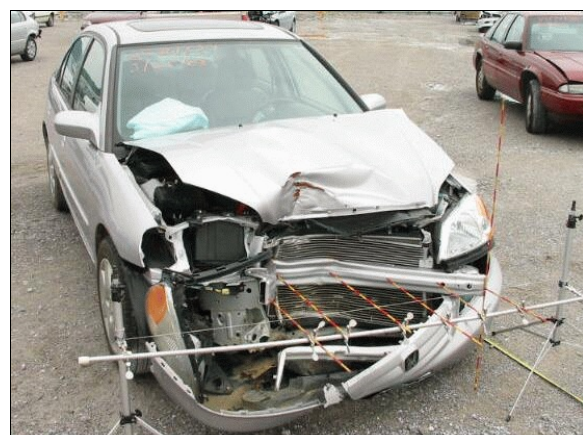
Figure 8: Elevated view of case vehicle's frontal damage with contour gauge set at bumper level, viewed from right of front (case photo #21a)

Exterior Damage: The case vehicle’s contact with the tree involved its front, just to the right of center (**Figure 8** above). Direct damage began 24 centimeters (9.4 inches) inward from the front right bumper corner and extended 66 centimeters (26.0 inches) along the front bumper, toward the left. Residual maximum crush was measured as 45 centimeters (17.7 inches) at C₅ (**Figure 9**). The table below shows the case vehicle’s crush profile.

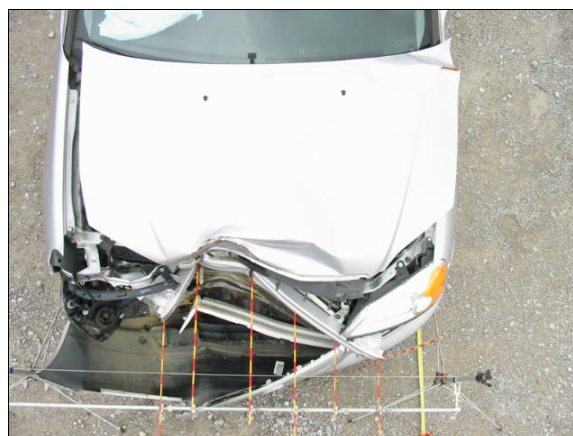
Figure 9: Overhead view of case vehicle’s frontal damage pocket from tree impact and crush profile measured at bumper level (case photo #10a)

Units	Event	Direct Damage		Field L	C ₁	C ₂	C ₃	C ₄	C ₅	C ₆	Direct	Field L
		Width CDC	Max Crush								±D	±D
cm	1	66	45	154	0	12	25	42	45	11	27	0
in		26.0	17.7	60.6	0.0	4.7	9.8	16.5	17.7	4.3	10.6	0.0

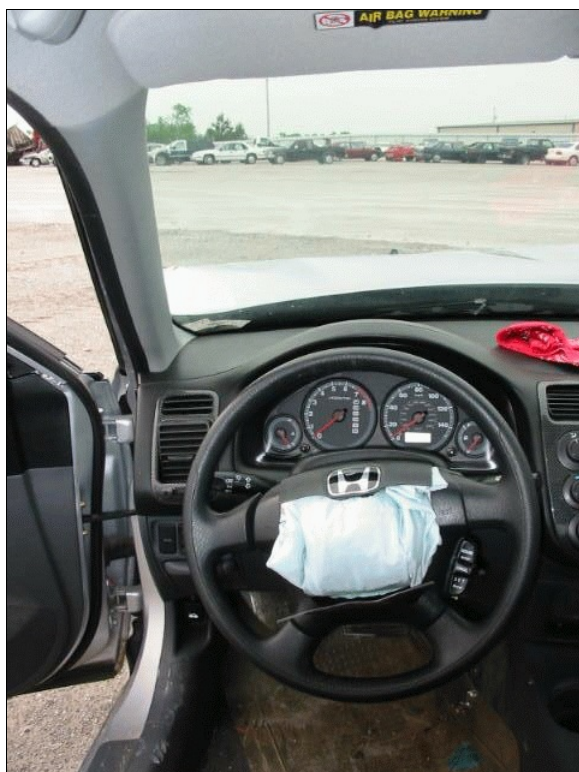
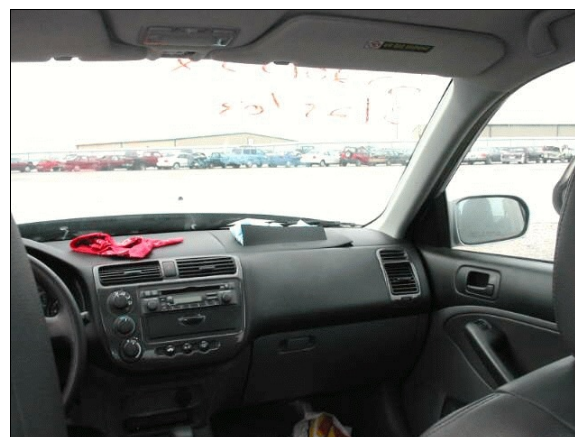
Figure 10: Vertical view of case vehicle's driver seating area showing deployed driver air bag and no obvious contact evidence to greenhouse area (case photo #27)

Figure 11: Case vehicle's front right seating area showing no occupant contact evidence to center or right instrument panels or greenhouse areas (case photo #40)

Vehicle Interior: Inspection of the case vehicle's interior (**Figures 10** and **11**) revealed a fairly significant contact to the knee bolster and/or instrument panel just to the right side of the steering column (**Figure 12**). Furthermore, the left side of the steering wheel rim was bent toward the left instrument panel, approximately 3 centimeters (1.2 inches—**Figure 13** below), as a result of the driver loading the air bag, momentarily blocking the air bag's forward expansion, and causing the air bag to expand against and bend the steering wheel rim. Finally, there was no evidence of intrusion to the case vehicle's interior but it could not be determined whether there was compression to the energy absorbing shear capsules in the steering column.

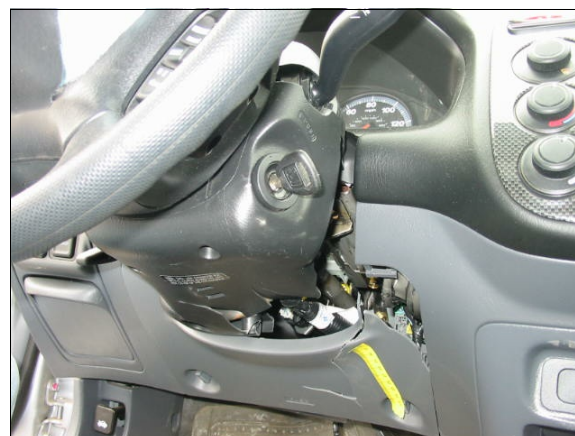
Figure 12: Close-up of contact damage to underneath surface of case vehicle's steering column and right side of driver's knee bolster (case photo #35)

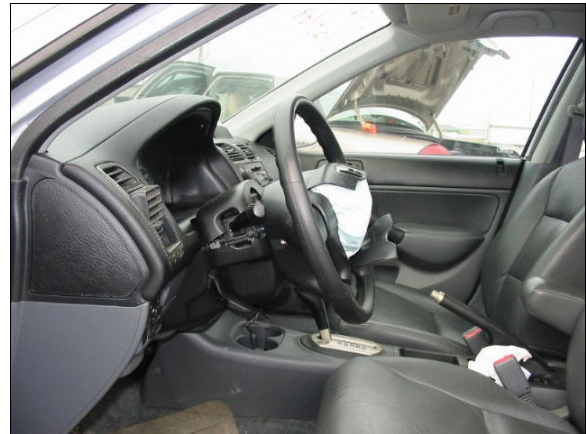
Figure 13: Case vehicle's driver seating area, viewed from driver's door, showing loading to steering column (case photo #25)

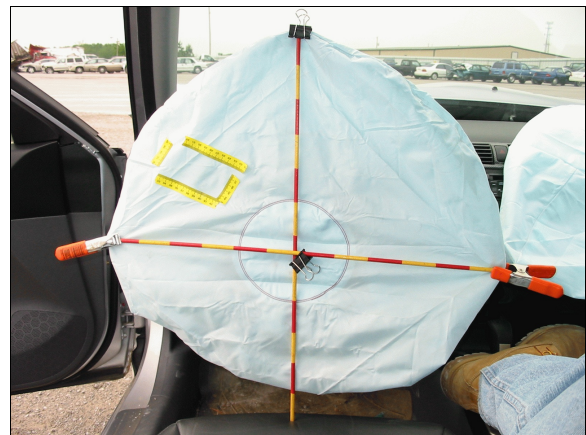
Figure 14: Case vehicle's deployed driver air; Note: yellow tape highlights area of occupant contact (case photo #28a)

slight contact on the upper left quadrant of the air bag's fabric (**Figure 14** above). This consisted of an obliquely oriented skin scuff (**Figure 15** above), most likely from either the top of her left hand or from her left ear area.

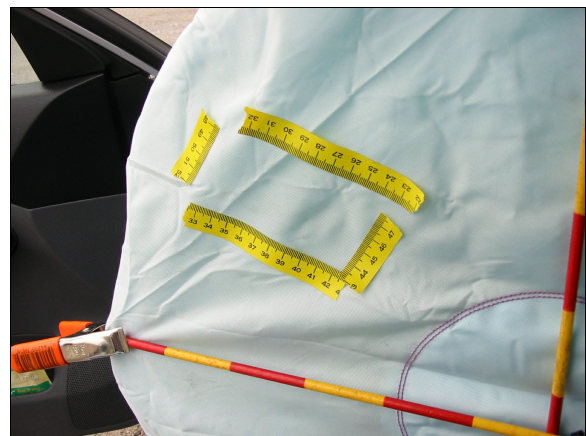
Figure 15: Close-up of occupant contact evidence on case vehicle's driver air bag (case photo #29)

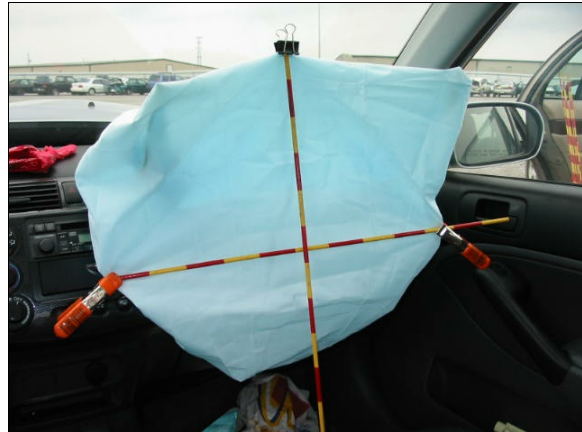
Figure 16: Case vehicle's deployed front right passenger air bag showing no occupant contact evidence (case photo #41)

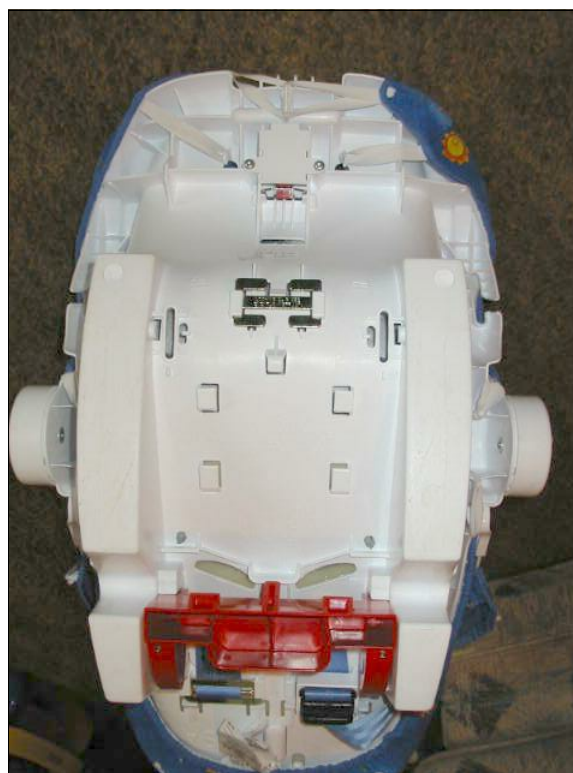
A close inspection of the child safety seat revealed no apparent damage, stress evidence, or fractures to the shell (**Figure 18**). In addition, no damage or fractures were noted along either side of the seat’s path for the vehicle’s safety belt (**Figure 19**). At the time of the crash the exact position of the child seat’s carrying handle is unknown.

Figure 18: Back surface of Evenflo Discovery infant child seat used by case vehicle’s back right passenger; Note: no visible evidence of damage (case photo #52)

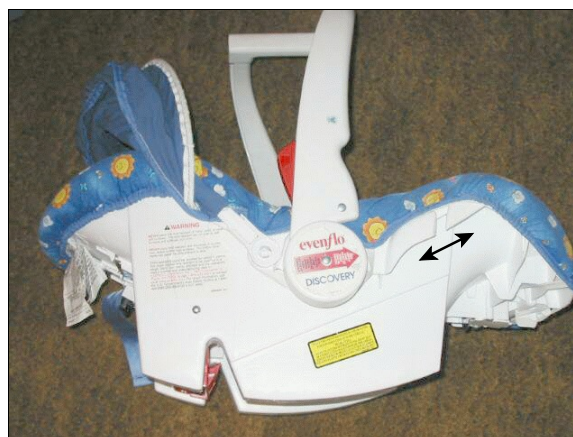
Figure 19: Left (inboard) side of Evenflo Discovery infant safety seat used in rear-facing position by case vehicle’s back right passenger; Note: arrow marks safety belt path (case photo #51)

There were two yellow warning labels—one on each side of the shell (Figure 19 above), warning the user/parent to not place this child seat in a vehicle's front right seat when the vehicle is equipped with a front right passenger air bag. The warning labels were bright yellow with black writing, advising that serious injury or death could occur if an air bag inflated against this child restraint. This yellow warning label was dated 5/95. The manufacturer's instructions for this child safety seat were not available on the back of the seat at the time of this contractor's inspection.

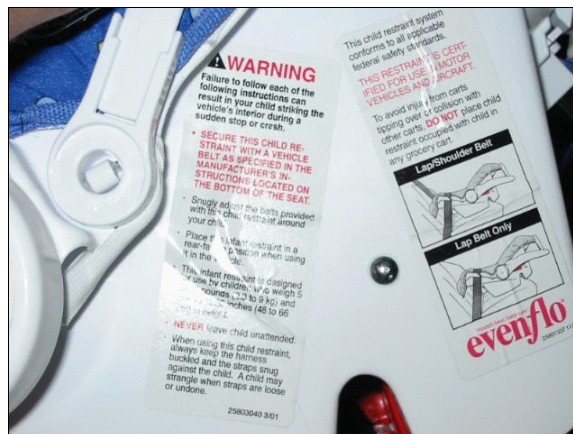
There was a manufacturer’s label affixed to the right side (i.e., outboard side for rear-facing) stressing the importance of securing the child restraint with a vehicle’s safety belt as specified in the vehicle manufacturer’s instructions (**Figure 20** below) and giving the child seat’s limitations

Figure 20: Close-up of manufacturer's labels on right side of Evenflo Discovery infant safety seat used by case vehicle's back right passenger (case photo #56)

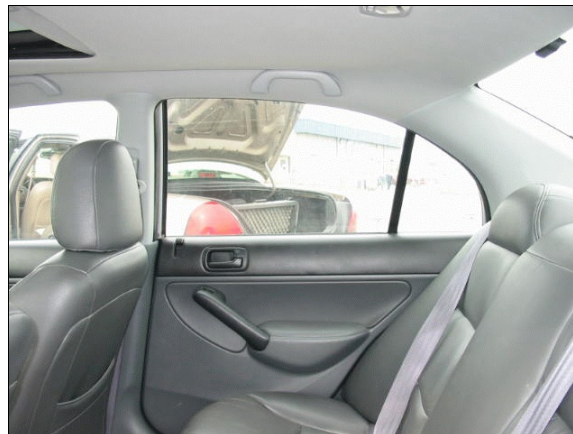
Figure 21: Case vehicle's back right seating area, view from left rear door, showing no obvious contact evidence from infant child seat (case photo #45)

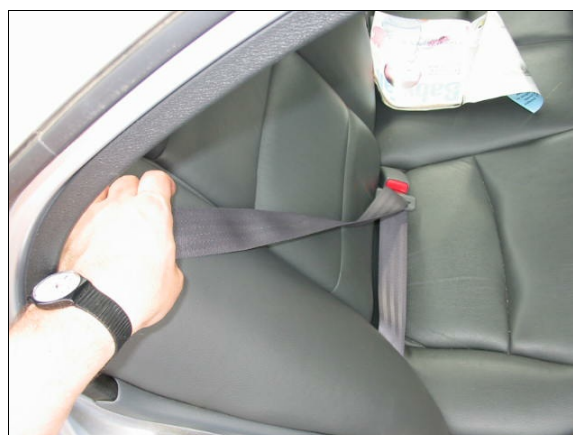
The case vehicle's back right passenger (i.e., son of driver) was restrained in the rear-facing child safety seat which was secured by the available, active, three-point, lap-and-shoulder, safety belt system for this position. There was no mention by the driver or any other evidence indicating the presence of harness belt pattern bruising and/or abrasions to the passenger's body, and the inspection of the passenger's seat belt webbing and latch plate showed only trace evidence of loading on the webbing (Figure 22).

Figure 22: Case vehicle's back right safety belt showing loading evidence on webbing of torso portion (case photo #46)

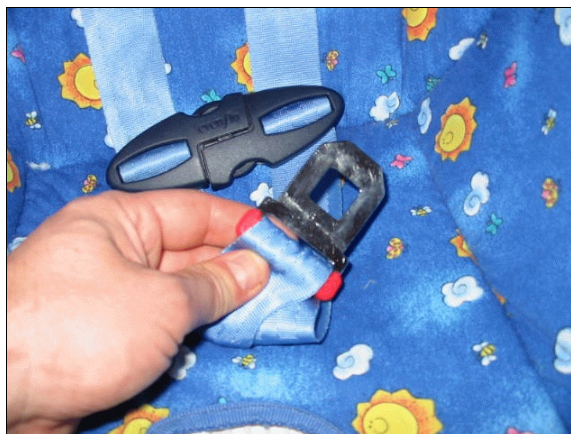
Figure 23: Loading evidence on latch plate of Evenflo Discovery infant child safety seat used by case vehicle's back right passenger (case photo #55)
