## REMOTE CHILD AIR BAG-RELATED FATALITY INVESTIGATION

CASE NUMBER - IN-03-021  
LOCATION - Georgia  
VEHICLE - 1999 DODGE NEON  
CRASH DATE - June 2001

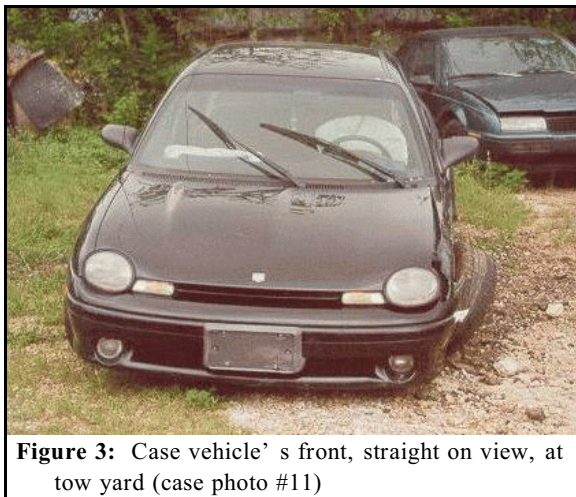
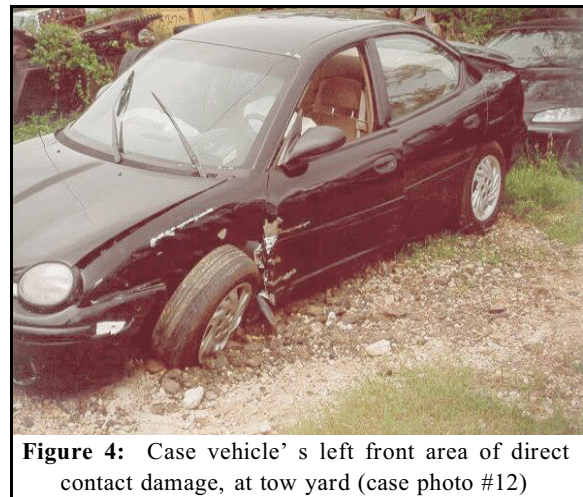
The case vehicle sustained direct contact on its left side, beginning just aft of the left front corner and extending along the wheel well to the left A-pillar and the leading edge of the driver's door (**Figures 3 and 4**). The case vehicle's left front wheel/tire assembly snagged against the other vehicle's left front wheel/tire assembly, causing the case vehicle's wheel to partially break from its suspension, but not break away completely (**Figures 4 and 5**). There was scraping and slight crush along the top of the wheel well and fender, continuing onto the left lower A-pillar and the forward portion of the left front door.

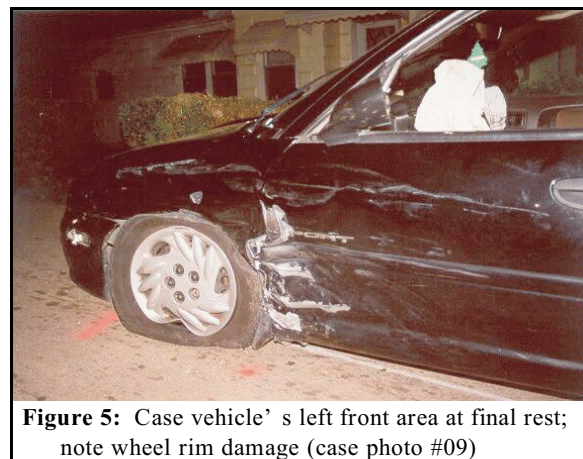
There is no other exterior damage visible in the available photographs. The left front tire was deflated, the wheel assembly was displaced rearward against the edge of the wheel well, and the rim was visibly dented. It appears that the left front suspension components were damaged, with the body sagging and compressing the tire (**Figure 5**). There was no other wheel/tire damage. The windshield had a small star-shaped crack on the right side directly above the front right passenger air bag module that probably resulted from the module cover flap striking the windshield. The driver's door window glazing was shattered from the impact with the other vehicle, and there was no other glazing damage.

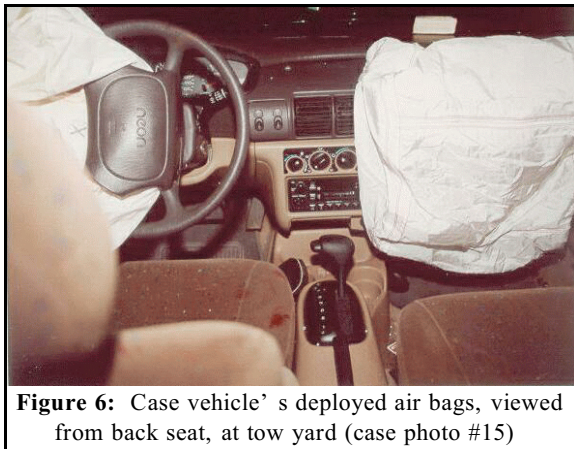
**Figure 6:** Case vehicle's deployed air bags, viewed from back seat, at tow yard (case photo #15)

The driver's air bag was located in the steering wheel hub, with a single module cover flap (**Figures 6 and 7**). The available photos show no obvious damage to the cover flap or the air bag. The details about the size, shape and features of the air bag and its module cover flap are otherwise not known. There was blood smeared on the back of the driver's air bag (**Figure 8**). These blood marks appear to be the result of handling/removing the child victim after the crash.

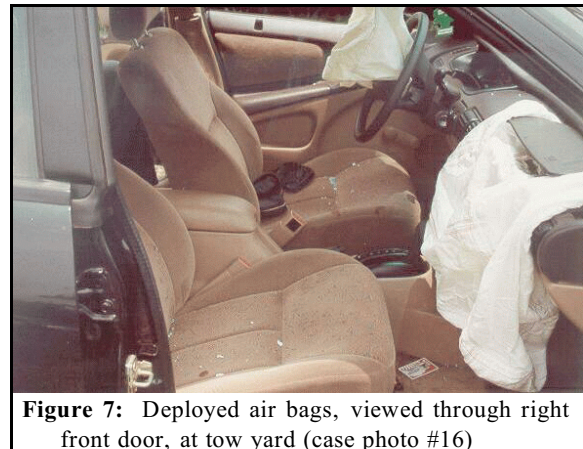
**Figure 7:** Deployed air bags, viewed through right front door, at tow yard (case photo #16)

The front right passenger's air bag was located in the top of the right instrument panel, with a single cover flap (**Figures 6 and 7**). The details about the size, shape and features of the air bag and its module cover flap are otherwise not known. There were teeth marks in the top surface of the air bag cover flap (**Figure 9**), and no other evidence of damage to the cover flap or air bag. There were a few droplets of blood on the front left area of the air bag's fabric (**Figure 10**).

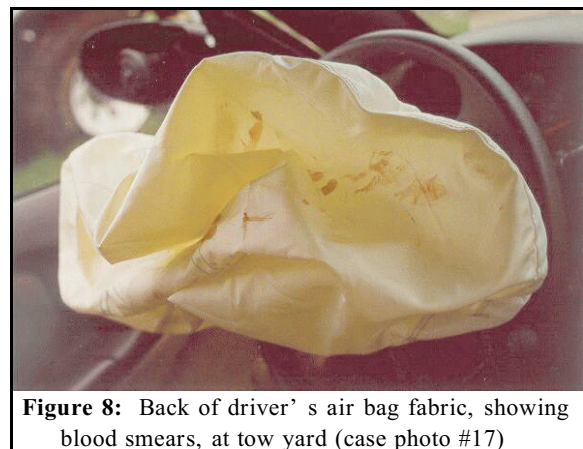
**Figure 8:** Back of driver's air bag fabric, showing blood smears, at tow yard (case photo #17)

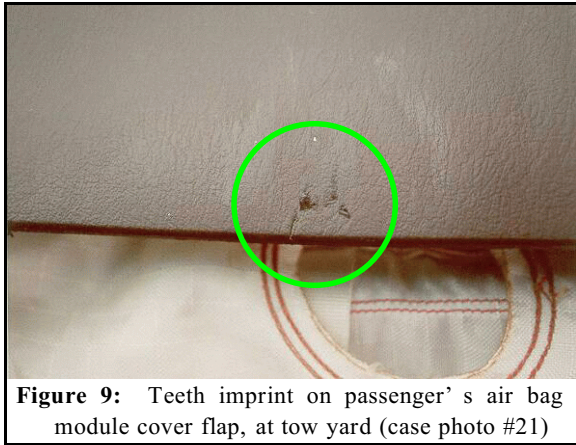
**Figure 9:** Teeth imprint on passenger's air bag module cover flap, at tow yard (case photo #21)

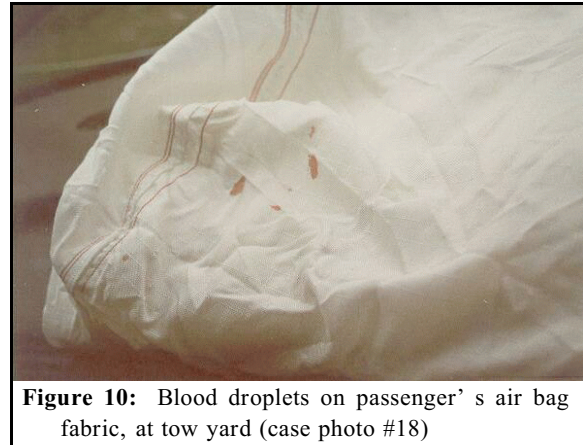
**Figure 10:** Blood droplets on passenger's air bag fabric, at tow yard (case photo #18)

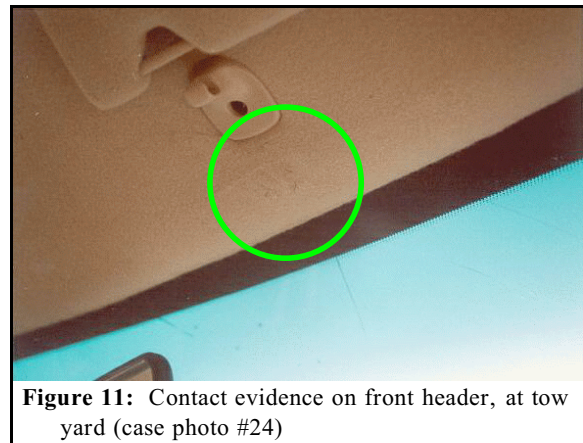
The case vehicle driver made no known avoidance maneuvers and the child's posture probably did not change immediately prior to the crash. The case vehicle's impact with the other vehicle caused the child to move forward and slightly leftward, toward the 12:00 o'clock direction of force, and caused the front right air bag to deploy. The front edge of the air bag module cover flap struck the child in the mouth, as evidenced by the imprint of his upper teeth in the top surface of the module's cover flap (**Figure 9**), causing at least four teeth be knocked loose or broken (three whole loose teeth and a fourth fractured tooth were found during the police inspection of the case vehicle). The expanding air bag lifted the child and his head struck the front header as evidenced by an area of indentation with hair in the headliner (**Figure 11**). The child fell back and probably struck the adult front right passenger in the face. The child's position at final rest is not known.

**Figure 11:** Contact evidence on front header, at tow yard (case photo #24)

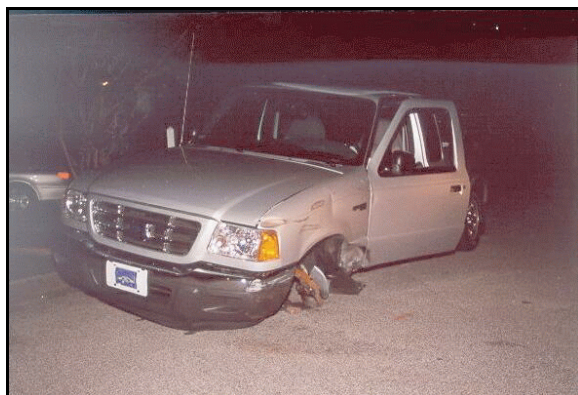
**Figure 12:** Ford' s front and left side after police apprehension two miles away from the scene of the crash (case photo #35)

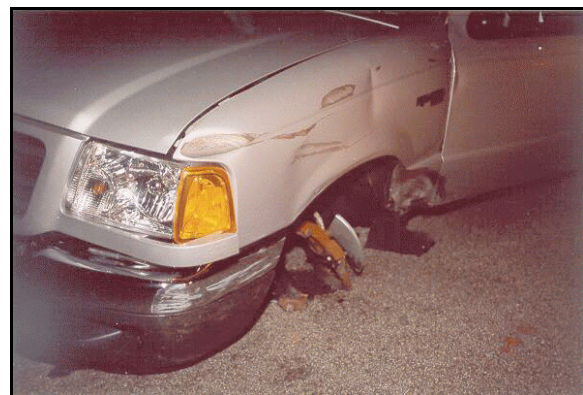
**Figure 13:** Ford' s front and left damage area after police apprehension two miles away from the scene of the crash (case photo #36)

The Ford' s front left corner contacted the left side of the case vehicle in a swiping-type engagement, and the two vehicles' left front wheels snagged causing wheel and suspension damage (**Figures 13 and 14**). The Ford' s driver drove the pickup away from the scene without stopping and the left front wheel was torn off a short distance (approximately 30 meters [100 feet] from the point of impact), such that the exact nature of the impact damage to the wheel/tire assembly is not known. There was light denting and scraping on the front end of the fender and the bumper, and scraping along the top of the fender and around the wheel well, extending rearward to the left lower A-pillar. The Ford' s left front suspension was damaged, allowing the vehicle' s front end to fall such that the oil pan was damaged, causing the crankcase oil to leak, leaving a trail in the roadway as the driver fled (**Figures 1 and 2**). The front left tire had a large gash in the inside sidewall, but it is not known if this was from the impact or from driving on the damaged wheel/tire (**Figure 15**). There was no other damage visible in the available photos.

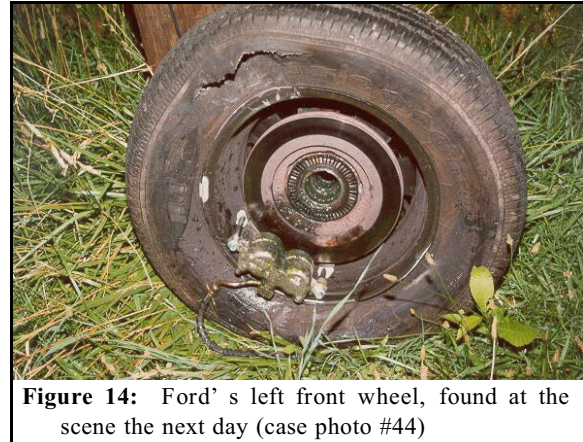
**Figure 14:** Ford' s left front wheel, found at the scene the next day (case photo #44)
