**TRANSPORTATION SCIENCES
CRASH DATA RESEARCH CENTER**

ON-SITE SIDE IMPACT AIR BAG OCCUPANT PROTECTION INVESTIGATION

GENERAL DYNAMICS CASE NUMBER: CA03-021

VEHICLE: 2002 CHEVROLET VENTURE

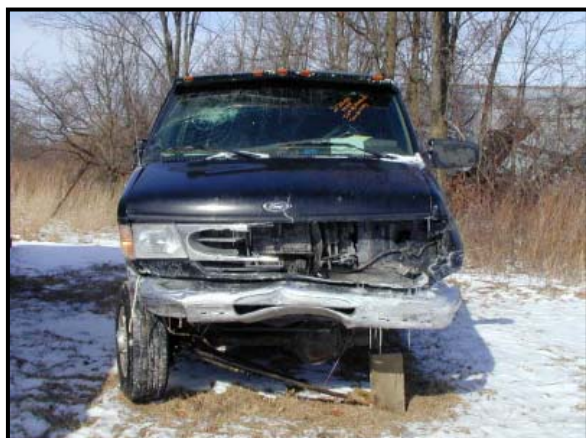
Figure 5: Front view of the Ford.

Analysis of the photographs indicated the front plane of the Ford sustained approximately 114 cm (45 in) of direct contact damage as a result of its impact to the Chevrolet and subsequent contact to the guardrail. The direct damage began approximately 30 cm (12 in) right of center and extended to the left corner. The estimated maximum crush was 15 cm (6 in) at the front left corner. There was a minor right-to-left end-shift caused by the lateral momentum of the

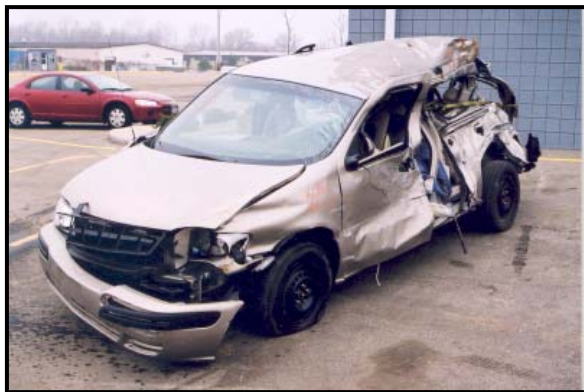
The Chevrolet Venture sustained severe left side damage as a result of the impact with the Ford van. **Figures 7 – 9** are the left front, left rear and rear longitudinal views of the Venture. The combined width of the direct and induced damage measured 340 cm (134 in). The induced damage began on the forward aspect of the left front door, 46 cm (18 in) rearward of the left front axle. The left side direct damage began 152 cm (60 in) aft of the left front axle at the location of the left B-pillar and extended through the D-pillar to the left rear corner. The width of the direct contact damage measured 234 cm (92 in). The principle direction of force was in the 10 o'clock sector. The direct contact deformed the left B-, C-, and D-pillars laterally and deformed the roof downward. The left sliding door separated from the vehicle at its hinges. The principle exterior damage was above the level of the sill and did not result in a measurable change in the left wheelbase dimension. The residual crush profile measured at the mid door height was as follows: C1 = 78.2 cm (30.8 in), C2 = 55.4 cm (21.8 in), C3 = 53.8 cm (21.2 in), C4 = 21.1 cm (20.1 in), C5 = 8.1 cm (3.2 in), C6 = 0. The delta V calculated by the Missing Vehicle Algorithm of the WINSMASH model was 52.0 km/h (32.3 mph). The longitudinal and lateral components of the delta V were -33.4 (-20.8 mph) and 39.8 km/h (24.7 mph), respectively. The Collision Deformation Classification (CDC) of the damage was 10-LZAW-5.

Figure 7: Left front view of the Chevrolet Venture.

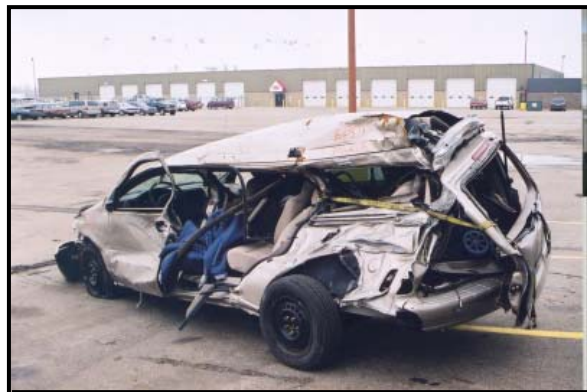
Figure 8: Left rear view of the Venture.

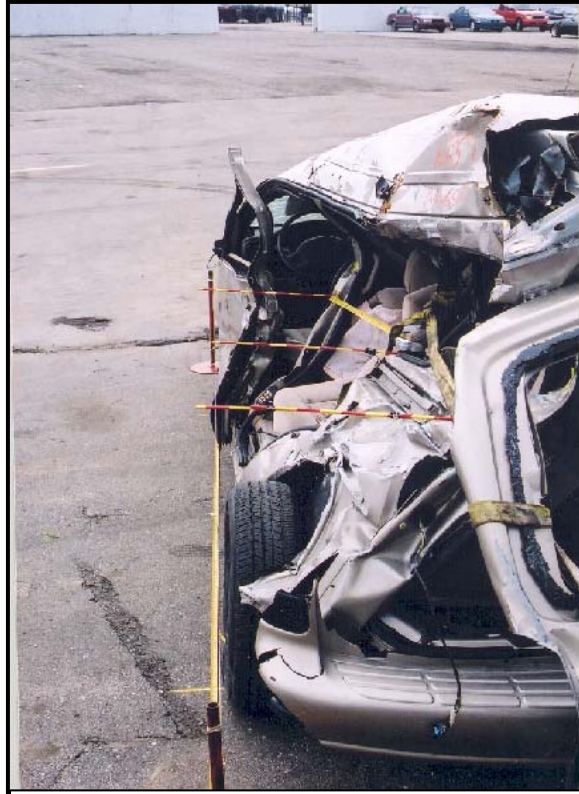
Figure 9: Rear left longitudinal view of the Venture.

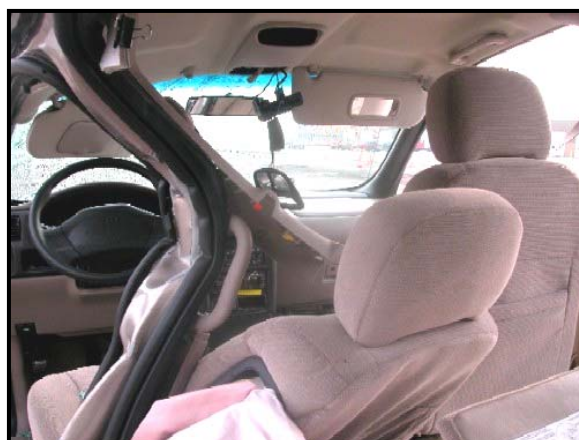
The front seating row consisted of manual bucket seats with adjustable head restraints. The driver seat, **Figure 10**, was adjusted to a full rear track position and was jammed in place by deformation. The head restraint was in its lowest position. The trim panel covering the left B-pillar was displaced from the deformed pillar at the belt line and was in contact with the driver seat back. The seat back was deformed to the right in partial contact with the right seat and had rotated counterclockwise. The seat back was laterally compressed approximately 8 cm (3 in). The interior panel of the left door immediately below the arm rest exhibited a 13 cm x 8 cm (5 in x 3 in) contact by the left flank of the driver. The front right seat was adjusted to a rear track position and measured 2.5 cm (1.0 in) forward of the full rear track position. The seat back was nearly upright and measured 5 degrees aft of vertical. The head restraint was in the lowest position.

Figure 10: Driver seat deformation and left B-pillar intrusion.

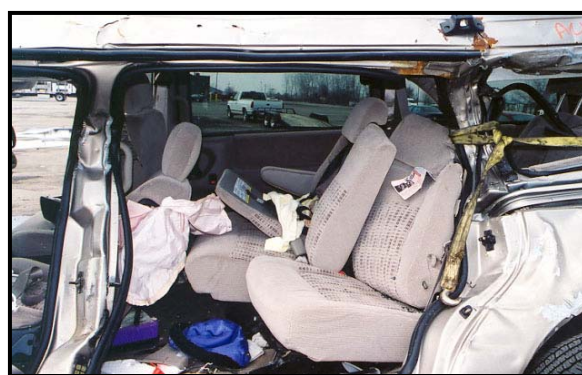
Figure 11 View of the second row seat deformation and intrusion.

floor deformed and released by overload. The floor pan and mount exhibited corresponding damage. The seat deformed rearward and laterally to the right. The rearward displacement of the seat cushion and the lateral displacement of the seat back measured 23 cm (9 in) and 28 cm (11 in), respectively.

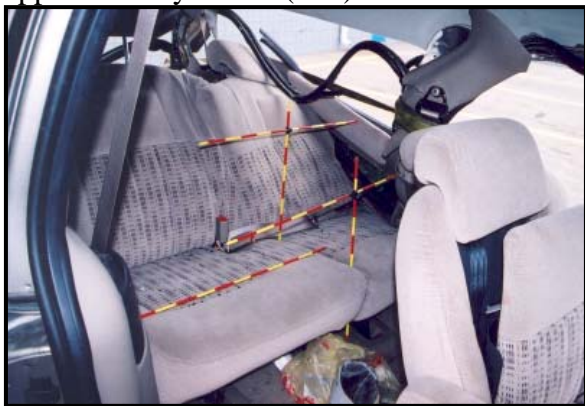
The left side wall and C-pillar were severely intruded into this region, **Figures 13 and 14**. The width of the right seat cushion measured 61 cm (24 in). This measurement was taken from the centerline of the seat to the right side wall. At the forward edge of the left seat cushion, the distance from the centerline to the residual location of the intruded C-pillar measured 20 cm (8

in). At the seat bight, the left lateral distance from the center to the residual position of the left side wall at the seat bight measured 30 cm (12 in). The left wall was in contact with the left seat back. This contact had displaced it to the right and had compressed the right seat back laterally approximately 10 cm (4 in).

Figure 13: Right view into the third row.

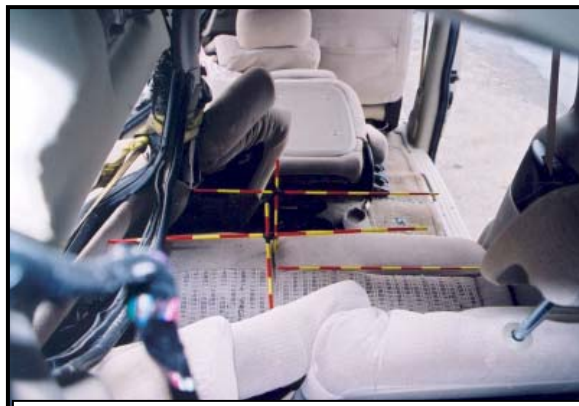
Figure 14: Forward view of the third row intrusion.

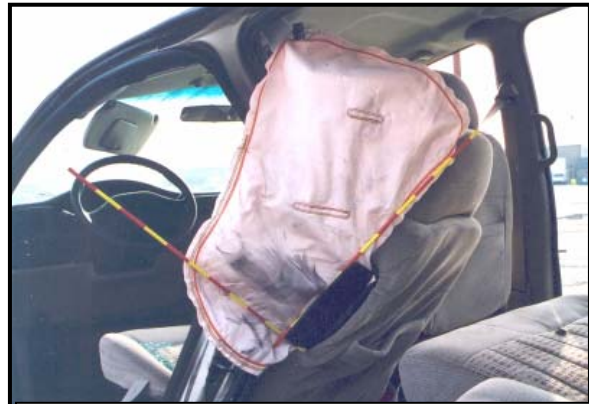
Figure 15 is a left view of the SAB. Note the position of the deployed air bag is aft and outside the left B-pillar. During the impact sequence, the B-pillar intrusion, and deformation/rotation of the driver's seat back caused the side impact air bag to deploy behind the pillar. The deployment of this SAB offered the driver no protection during this crash.

Figure 15: View of the deployed left SAB.

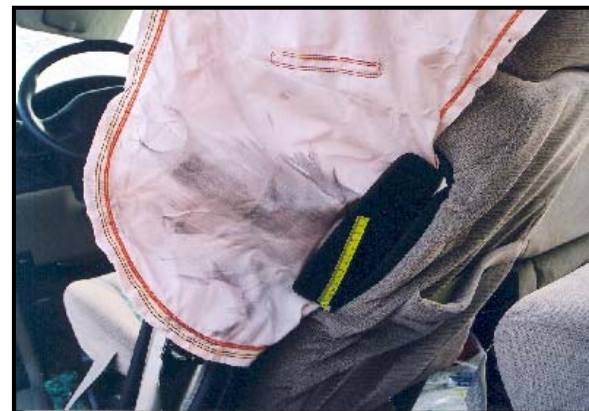
Close-inspection of the cover flap revealed a 13 cm (5 in) contact between the flap and the B-pillar trim panel, **Figure 16**. A corresponding vinyl transfer was identified on the trim panel (now in contact with the seat back). The outboard lower section of the side bag exhibited a heavy (8 in x 8 in) vinyl transfer caused by the impeded expansion of the bag. The inboard side of the bag exhibited a 23 cm x 10 cm (9 in x 4 in) transfer.

Figure 16: Close-up view of the impeded SAB.

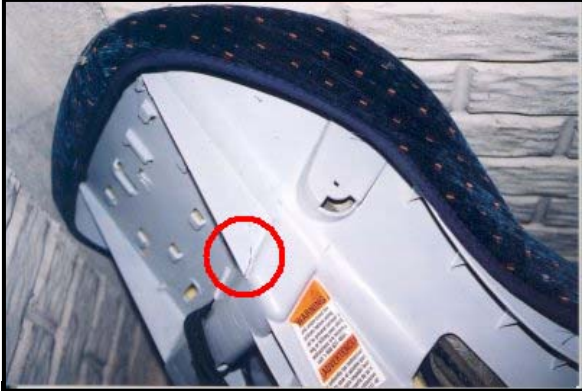
Examination of the shell identified two areas of crash related evidence. Contact to the upper right aspect of the shell from the intruding left side and C-pillar was identified, **Figure 18**. This contact resulted in a fracture to the plastic reinforcement on the back side of the shell. Corresponding stress marks were identified on the interior side of the seat back, **Figure 19**. The shell deformation was located in the region where the rear right aspect of the infant's head was probably located.

Figure 18: View of damage to the back of the CSS shell.

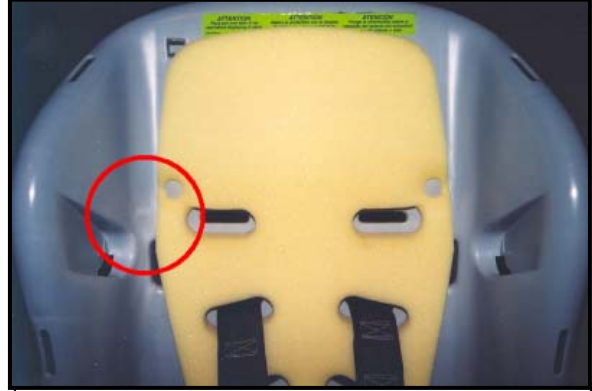
Figure 19: View of plastic stresses to the shell.

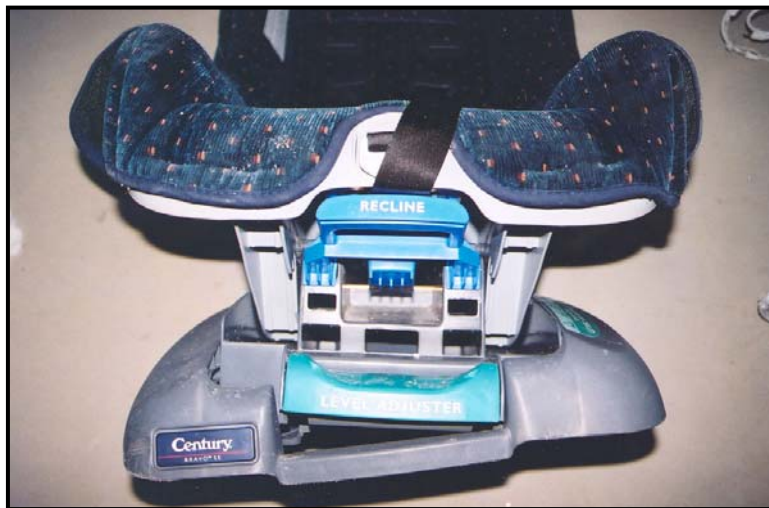
Inspection of the CSS also identified damage to the adjustable foot, **Figure 20**. The left side of the foot had collapsed due to overload. This occurred when the upper right rear aspect of the shell was impacted causing the CSS to rotate forward onto the foot.

Figure 20: View of the damage to the adjustable foot.
