On Site Certified Advanced 208-Compliant Investigation / Vehicle to Object  
Dynamic Science, Inc. / Case Number: DS03025  
2003 GMC 1500 Yukon  
Texas  
May, 2003

1. Report No. DS03025	2. Government Accession No.	3. Recipient Catalog No.	
4. Title and Subtitle Certified Advanced 208-Compliant Investigation		5. Report Date

**Dynamic Science, Inc.**  
**Crash Investigation**  
**Case Number: DS03025**

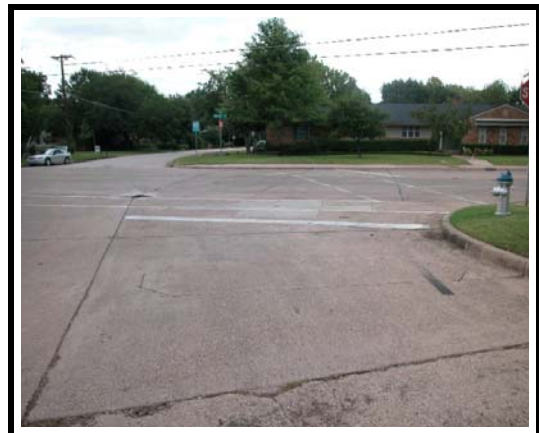
**Figure 1.** View showing case vehicle's northbound pre-impact trajectory

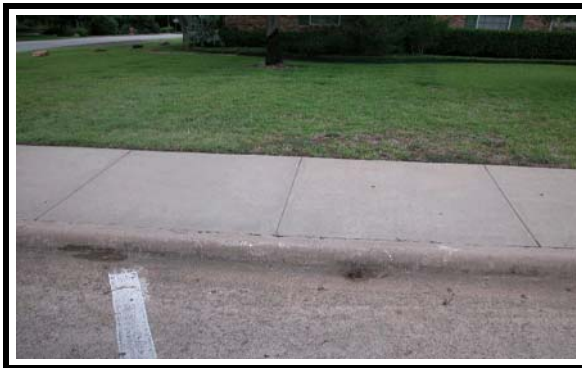
**Figure 3.** Close-up views showing curb impacts (Crash Events 1 and 2)

The case vehicle impacted and then overrode the 15.2 cm (6.0 in) high concrete curbing located at the northeast intersection quadrant (refer to Figure 3). These impacts (Crash Events 1 and 2) resulted in tire and rim deformation (12FRWN3 and 12FLWN3). The case vehicle continued in a northerly trajectory traveling approximately 9 m (30 ft) across the lawn of a private residence. The front, center of the case vehicle impacted (12FCEN2) a 33.0 cm (13.0 in) diameter oak tree. The case vehicle came to rest engaged with the impacted tree and facing north (Refer to Figure 4). The maximum crush depth was 48.2 cm (19.0 in) and was located at the vehicle centerline or 10.0 cm (3.9 in) left of C<sub>3</sub>.

Minor/ Secondary Front Wheel/Tire Impacts (Second Highest Delta V): Both the front right and front left tires were deflated due to the initial curb impact. Additionally, the rims on both front wheel assemblies sustained residual damage.

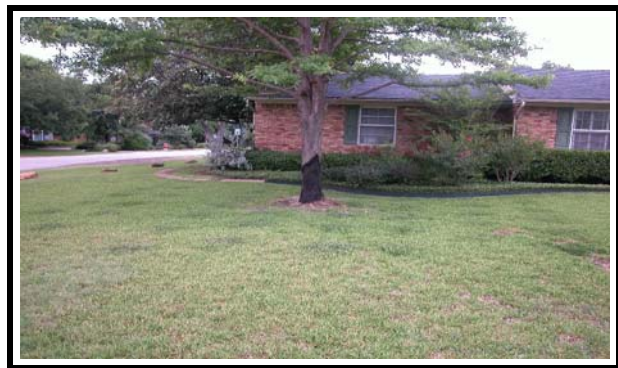
**Figure 4.** View showing impacted 33 cm (13 in) diameter oak tree and final rest position

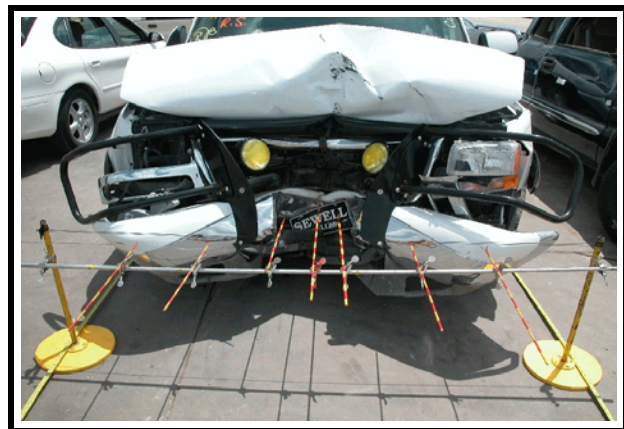
**Figure 5.** View of case vehicle showing frontal deformation (maximum crush depth 48.2 cm)

Damage Description: Moderate/ Primary Frontal Impact (Highest Delta V):  
Longitudinal displacement deformation to the front bumper, brush guard, grille and hood. In addition the front, right headlight was broken and deformation was noted to the left fender.

During impact 3 (highest delta v), the case vehicle sustained 128.0 cm (50.4 in) of direct and induced contact damage that extended across the entire frontal end width of the vehicle. The impact energy was managed by the forward structures of the vehicle. The damaged components included the front bumper fascia and reinforcement bar, brush guard, upper and lower radiator supports, grille area and the hood. In addition the front, right headlight was broken and deformation was noted to the left fender. Six crush measurements were documented at the bumper level: C1= 0.0 cm (0.0 in), C2= 1.0 cm (0.4 in), C3= 44.0 cm (17.3 in), C4= 41.2 cm (16.2 in), C5= 1.0 cm (0.4 in), C6= 0.0 cm (0.0 in). A Collision Deformation Classification (CDC) of 12FCEN2 was assigned to the damage. The principal direction of force was within the 12 o'clock sector and was an estimated 0 degrees. There was a reduction of approximately 4.0 cm (1.6 in) to both wheelbases. All doors remained closed and operational, and the windshield glazing was cracked from contact with the hood.

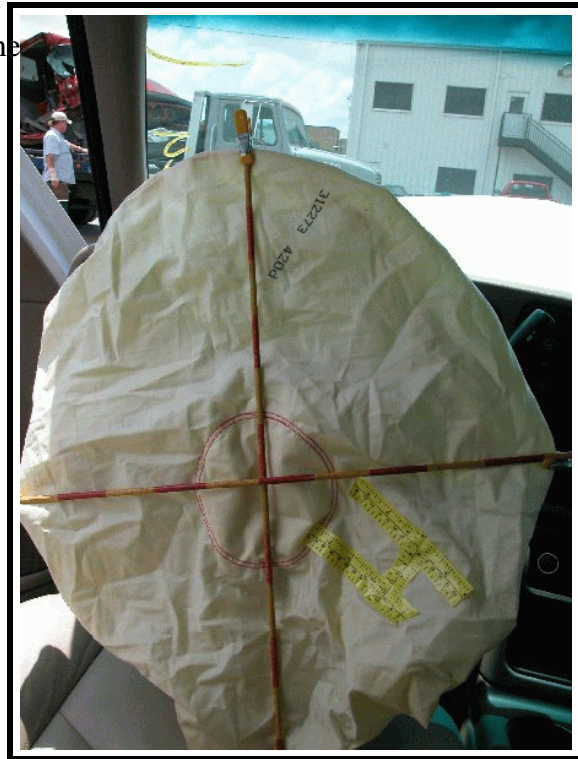
The driver's air bag deployed at impact with the tree. The driver's air bag module was located in the center hub of the steering wheel rim and had two module cover flaps. The flaps opened in a designed I-configuration. Both module cover flaps measured 8.0 cm (3.1 in) by 12.0 cm (4.7 in). There was no contact evidence on the cover

flaps. The diameter of the driver's air bag measured 61.0 cm (24.0 in) in its deflated state. The driver's air bag had a maximum excursion of 22.0 cm (8.7 in). It had vent ports at the 11 and 1 o'clock positions and two tethers. On the back and top of the air bag membrane was what appeared to be dried blood. On the face of the lower right quadrant of the air bag was what appeared to be smeared lipstick.

**Figure 7.** View showing deployed front, left (drivers) air bag

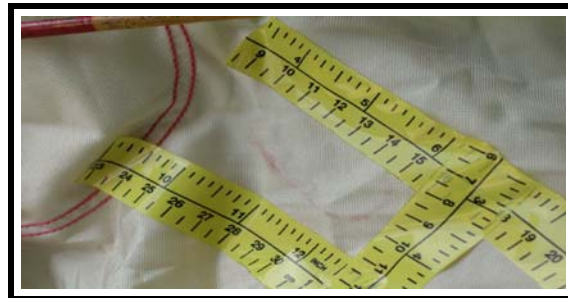
The interior greenhouse area of the case vehicle was void of any intruding components and the case vehicle's integrity was not compromised (no avenues for ejection through damaged glazing or opened doors). There was a permanent yellow scuff transfer noted to the knee bolster/lower instrument panel located at the front, left drivers position. This scuff mark was due to direct contact from the driver's left leg. The drivers face made contact with the deploying driver's air bag as evidenced by a probable lip stick /facial cosmetic transfer.

**Figure 8.** Close-up view of the driver's air bag showing lipstick/cosmetic transfer

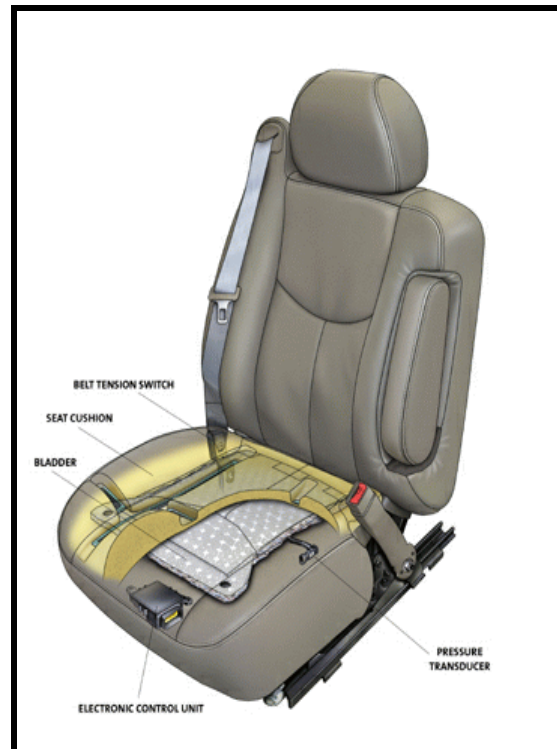
The front right passenger air bag was a mid-mount design located in the right aspect of the instrument panel. The front right passenger air bag did not deploy due to case vehicle being equipped with a Passenger Sensing System, and the absence of a front right occupant. The Passenger Sensing System is designed to automatically switch the air bag on or off based on a passenger's weight. The system also uses a sensor in the passenger-side seat belt to measure how much tension is exerted by the seat belt when it is being cinched down, another means of determining what may be on the seat. There is an indicator on the rear-view mirror that alerts vehicle occupants to the status of the system at all times. If the light reads "Passenger Air Bag ON," the air bag is programmed to deploy in a frontal crash of sufficient severity. If it reads "Passenger Air Bag OFF," the system has turned off the air bag because it determined either that there is no occupant on the front passenger seat, or that a rear-facing infant seat, a forward-facing child restraint, a booster seat or a smaller person, such as a child who has outgrown child restraints, is present.

**Figure 9.** Front right Passenger Sensing System
