**GENERAL DYNAMICS ON-SITE CHILD SAFETY SEAT CRASH INVESTIGATION
SCI TECHNICAL SUMMARY REPORT**

CASE NO: CA03-029

VEHICLE: 2001 CHRYSLER PT CRUISER

CRASH DATE: MAY 2003

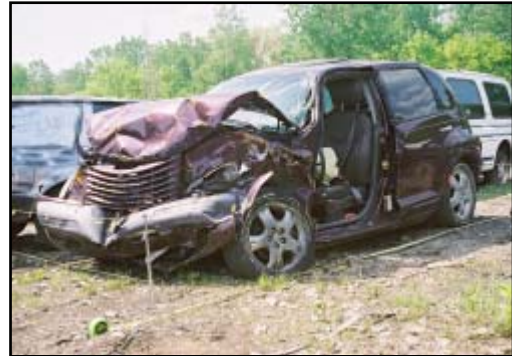
Figure 1. Damaged 2001 PT Cruiser

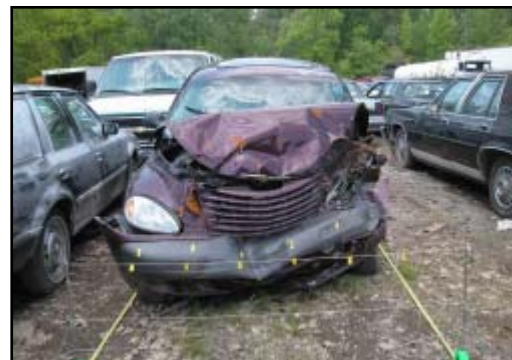
The 2001 Chrysler PT Cruiser sustained severe frontal damage (**Figures 5 and 6**) as a result of the frontal impact with the 1992 Ford Escort. The direct damage began at the front left corner and extended 148.6 cm (58.5”) across the bumper to 64.1 cm (25.3”) right of the centerline. White paint transfers from the Escort were present on the bumper, grille, and hood from direct contact. The left front fender was crushed rearward. The hood was buckled rearward and displaced slightly right. The bumper was crushed rearward, most severely on the left aspect. The left front wheel was displaced rearward and restricted

Figure 5. View of frontal damage to the PT Cruiser

against the base of the left A-pillar, which resulted in the reduction of the left wheelbase by 30.0 cm (11.8"). The left A-pillar was displaced 12.0 cm (4.6") rearward at the base. The left A-pillar was also deflected outward 6.4 cm (2.5"). The maximum lateral deflection was located 5.1 cm (2.0") above the beltline. The combined direct and induced damage involved the entire frontal width of the vehicle and measured 132.1 cm (52.0") parallel to the established reference line.

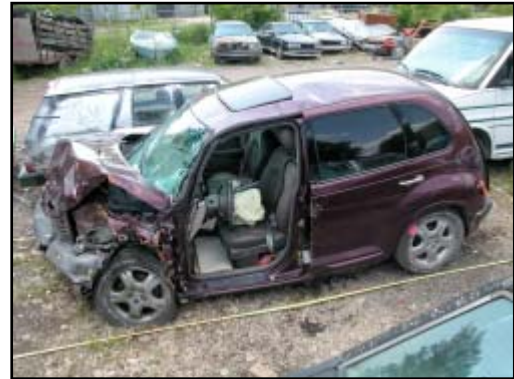
The left rear door was displaced rearward and buckled from induced damage. The left side rail was buckled 86.4 cm (34.0") rear of the windshield header and the right roof side rail was buckled slightly 61.0 cm (24.0") rear of the windshield header. The moonroof was displaced slightly, however, the glass was not shattered. The roof sustained buckling aft of the B-pillars. The Collision Deformation Classification (CDC) for the frontal impact with the Ford Escort was 12-FDEW-3. Six crush measurements were documented across the front bumper and were as follows: C1 = 54.9 cm (21.6"), C2 = 45.1 cm (17.8"), C3 = 39.4 cm (15.5"), C4 = 32.7 cm (12.9"), C5 = 11.8 cm (4.6"), C6 = 0.0 cm.

Figure 6. Left side view of the damaged PT Cruiser

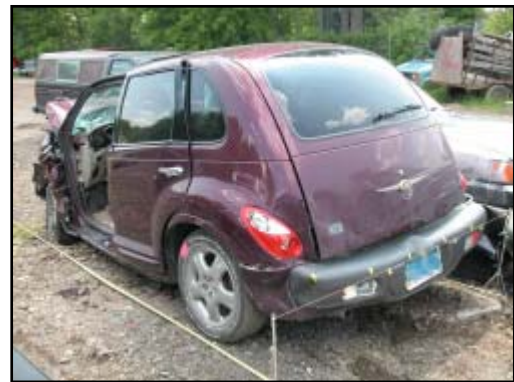
The 2001 PT Cruiser sustained minor rear damage (**Figure 7**) as a result of the secondary impact with the Pontiac Vibe. The direct contact damage on the rear bumper began 5.1 cm (2.0") left of the centerline and extended 73.7 cm (29.0") to the rear left corner of the bumper. The bumper exhibited abrasions and paint transfers from contact with the Pontiac Vibe. Direct contact and paint transfers on the rear hatch began 18.4 cm (7.3") left of center and extended laterally 43.8 cm (17.3) to the rear left aspect. The entire bumper was deflected slightly to the right. The left rear brake light lens was fractured. The combined direct and induced damage involved the entire rear width of the vehicle and measured 138.4 cm (54.5"). The CDC for the rear impact to the PT Cruiser was 06-BYEW-1. Six crush measurements were documented across the rear bumper and were as follows: C1 = 8.9 cm (3.5"), C2 = 7.3 cm (2.9"), C3 = 7.9 cm (3.1"), C4 = 4.8 cm (1.9"), C5 = 2.5 cm (1.0"), C6 = 0.6 cm (0.3").

Figure 7. View of rear damage from the Pontiac Vibe

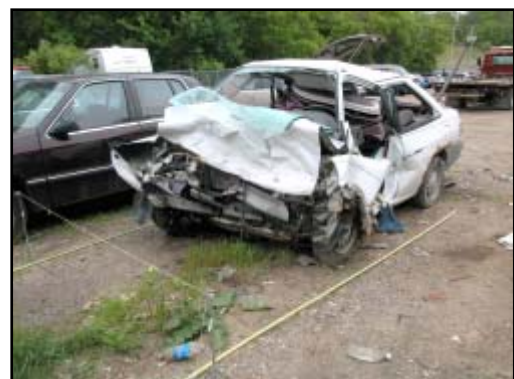
The 1992 Ford Escort (**Figure 8**) sustained severe frontal damage as a result of the impact with the PT Cruiser. The direct damage began at the right front

Figure 8. View of frontal damage to the Ford Escort

corner and extended 139.7 cm (55.0") across the entire frontal width, measured parallel to the damaged profile. The front bumper fascia and grille were fractured and completely separated from the vehicle as a result of the impact. The severe crush resulted in moderate deformation of the upper and lower radiator support. The radiator core sustained contact damage from displaced frontal components and was also crushed rearward. The hood was severely buckled rearward and direct contact abrasions and paint transfers were present on the hood. The combined direct and induced damage also involved the entire frontal width and measured 121.9 cm (48.0"), parallel to the established reference line.

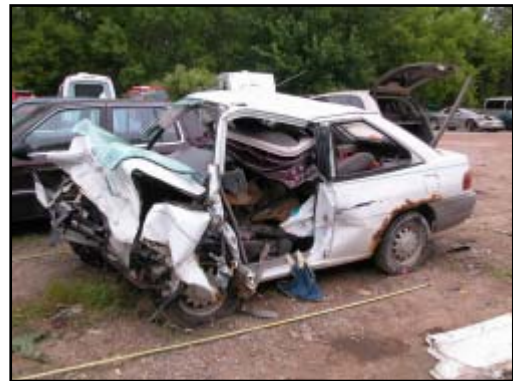
The frontal crush resulted in the severe outward buckling of both front fenders. The left front sill was buckled and deflected outward in a CCW direction aft of the left A-pillar. The lateral outward deflection measured 22.9 cm (9.0"). The left A-pillar was deflected rearward. The frontal crush also resulted in the reduction of the left wheelbase by 70.0 cm (27.6") and the reduction of the right wheelbase by 28.0 cm (11.0"). **Figure 9** illustrates the reduction of the left wheelbase and left A-pillar deflection. The maximum crush measured 103.0 cm (40.5") at the front left corner. Six crush measurements were documented across the upper radiator support and were as follows: C1 = 95.0 cm (37.4"), C2 = 93.2 cm (36.7"), C3 = 91.9 cm (36.2"), C4 = 84.9 cm (33.4"), C5 = 70.3 cm (27.7"), C6 = 50.0 cm (19.7"). The CDC for the frontal collision with the PT Cruiser was 12-FDEW-5.

Figure 9. Left side view showing wheelbase reduction

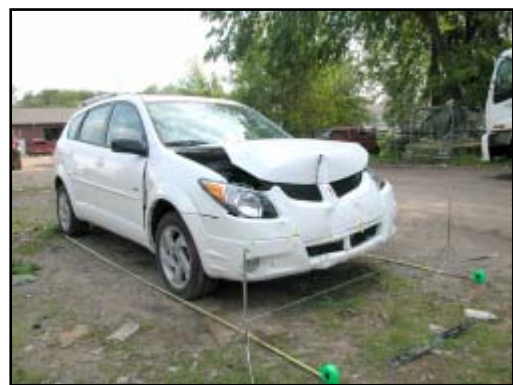
The 2003 Pontiac Vibe (**Figure 10**) sustained minor frontal damage as a result of the impact with the PT Cruiser. The direct damage began 31.8 cm (12.5") left of the centerline and extended 94.0 cm (37.0") laterally to the right across the front bumper. Paint transfers and abrasions were present on the front bumper fascia. A circular imprint of the PT Cruiser's exhaust pipe was present on the lower aspect of the bumper fascia and was located 23.5 cm (9.3") to the right of the centerline. The combined direct and induced damage involved the entire frontal width of the Pontiac Vibe and measured 141.0 cm (55.5"). The hood was buckled rearward and both head lamps were displaced. The left side aspect of the bumper fascia was displaced and the right front fender was deflected slightly rearward. The maximum crush on the front bumper measured 14.3 cm (5.6") and was located 8.3 cm (3.3") to the right of the centerline. Six crush measurements were documented along the front bumper and were as follows: C1 = 0.0 cm, C2 = 1.3 cm (0.5"), C3 = 4.8 cm (1.9"), C4 = 10.5 cm

Figure 10. Damaged 2003 Pontiac Vibe

(4.1”), C5 = 9.8 cm (3.9”), C6 = 9.7 cm (3.8”). The CDC for the impact with the PT Cruiser was 12-FZEW-1.

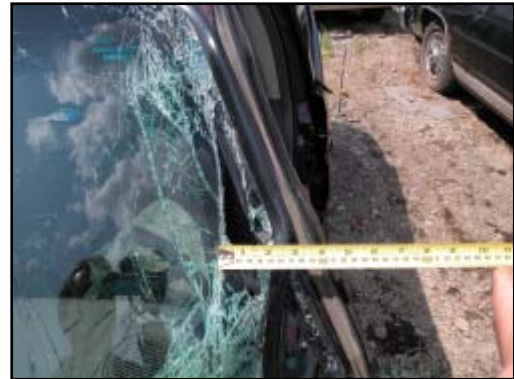
The 2001 Chrysler PT Cruiser sustained moderate interior damage as a result of passenger compartment intrusion and occupant contact. Rescue personnel removed the left front door and the left rear door was jammed shut. The remaining doors were operational. The windshield was fractured as a result of impact forces and displacement of the left A-pillar and separation of the windshield gasket was noted on the bottom left aspect. The windshield laminate was torn adjacent to the left A-pillar (**Figure 11**), possibly a result of the left A-pillar displacement or post-crash extrication efforts. The tear was vertical in nature, and was located 12.7 cm (5.0”) below the windshield header. The tear measured 21.6 cm (8.5”) in length and the maximum width measured 3.2 cm (1.3”). The remaining vehicle glazing was not damaged.

Figure 11. View of torn windshield laminate and left A-pillar displacement

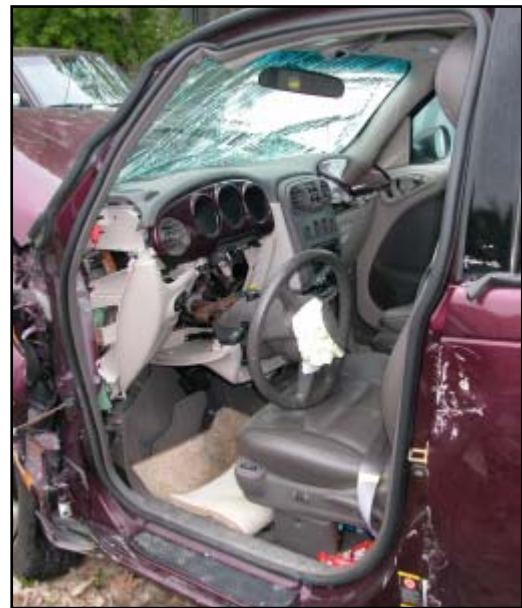
Figure 12 illustrates the interior damage to the front seating positions. The steering wheel rim was deflected forward 2.5 cm (1.0”) at the 8 o’clock aspect and was deflected forward 1.9 cm (0.8”) at the 2 o’clock aspect. The steering rim deflection resulted in a gap at the spoke located at the 3 o’clock position that measured 1.6 cm (0.6”) and a gap at the spoke located at the 7 o’clock position, which measured 0.3 cm (0.1”) from the steering wheel hub. During the frontal impact, the steering column shear capsules in the PT Cruiser sustained complete separation, probably a combination of the driver’s loading through the deployed air bag the rearward intrusion of the steering column. The steering wheel rim was found resting on the driver’s seat cushion at the time of the inspection. NHTSA New Car Assessment Program (NCAP) test results for the PT Cruiser were reviewed for a 56 km/h (35mph) frontal barrier test, and there was no reported shear capsule separation in the test. However, similar deformation was seen on the steering wheel rim as a result of the driver loading through the deployed air bag. The knee

Figure 12. View of collapsed steering column, rim deflection, and interior damage to the driver's seating position

bolster was deformed from occupant contact over an area that measured 10.2 cm (4.0”) in width and 15.2 cm (6.0”) in height. The deformation began 2.5 cm (1.0”) right of the centerline of the steering column and extended to the left. A blue scuff, possibly a fabric transfer was present on left instrument panel, below the outside mirror controls that measured 7.6 cm (3.0”) in height and

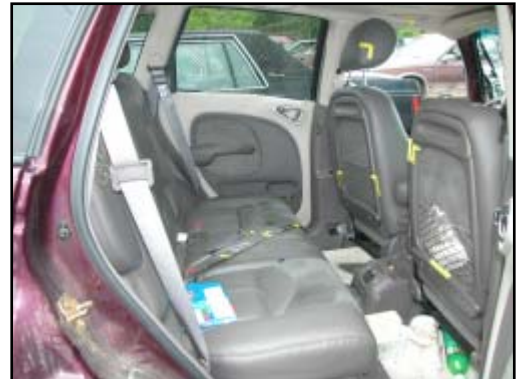
The rear aspects of the front seat backs exhibited minor damage (**Figure 13**). The driver’s seat back sustained a scuff on the rear inboard corner of the head restraint. Abrasions and a faint blue plastic transfer were located on the left aspect of the plastic seat back frame from contact with the CSS. Abrasions and scuffs were also present on the right aspect of the seat back from CSS contact.

Figure 13. View of damage to the front seat backs

Abrasions were also present on the left aspect of the right front seat back, and a linear blue plastic transfer was located on the left upper aspect of the seat back. Abrasions were present on the right aspect of the front right seat back but were not related to this crash.

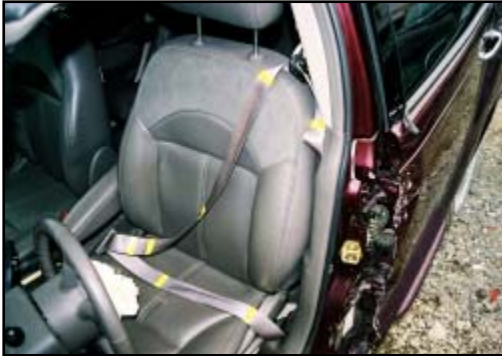
The driver's safety belt (**Figure 14**) was restricted in the used position at the time of the vehicle inspection as a result of pretensioner actuation. Stretch marks and cupping on the lap belt and shoulder belt webbing were present from occupant loading. An abrasion on the webbing from the latch plate was located 78.7 cm (31.0") from the lower anchor. A heavy plastic transfer from the D-ring was located 144.8 cm (57.0") above the lower anchor and measured 8.3 cm (3.3") in length. The cover for the cinch mechanism on the driver's latch plate came apart (**Figure 15**) as a result of occupant loading and abrasions were present on the latch plate from engagement against the safety belt webbing, but did not affect the performance of the safety belt.

Figure 14. View of driver's safety belt

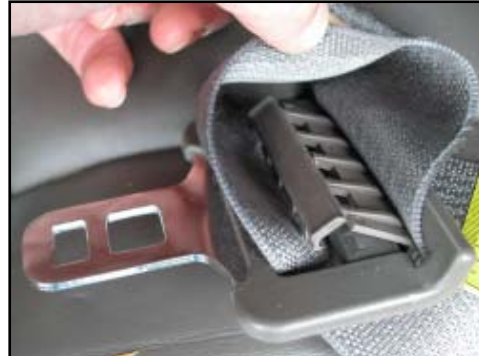
Figure 15. Close-up of cinch mechanism cover

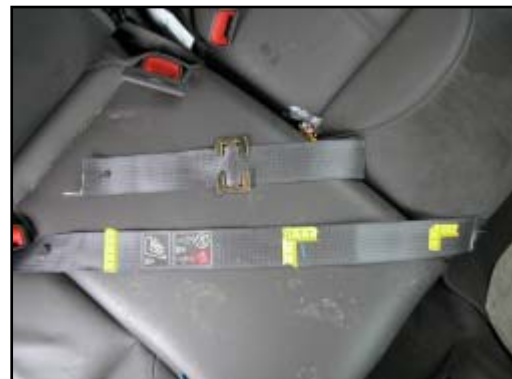
The rear center lap and shoulder belt (**Figure 16**) was cut by rescue personnel 64.8 cm (25.5") above the anchor and a second cut was made 98.4 cm (38.8") above the anchor. Three blue plastic transfers were present on the lap belt section from engagement against the CSS base. The first plastic transfer was located 22.9 cm (9.0") from the anchor and extended across the entire width of the webbing. The two remaining transfers were located 43.8 cm (17.3"), and 53.8 cm (24.0") from the lower anchor and measured 2.5 cm (1.0") and 1.9 cm (0.8"), respectively. The safety belt webbing exhibited stretch marks from the CSS loading and a crease from the latch plate was located 49.5 cm (19.5") from the anchor. The second section of webbing (cut) also exhibited stretch marks from loading and a slight crease from the CSS locking clip.

Figure 16. View of rear center lap and shoulder belt and the position of the locking clip

Two labels (visible in **Figure 16**) were located 25.4 cm (10.0”) and 29.2 cm (11.5”) above the safety belt anchor that identified the presence of the switchable ELR/Automatic Locking Retractor (ALR) for use with CSS’s.

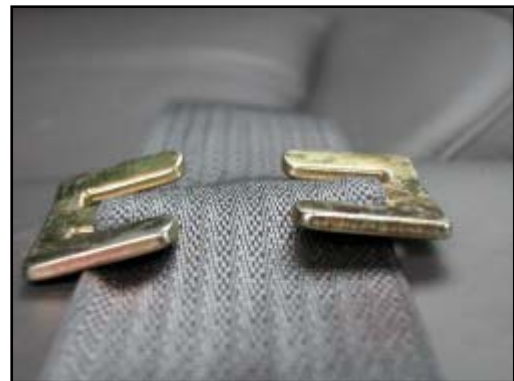
At the time of the vehicle and CSS inspection, the rear center lap and shoulder belt webbing was found to have been cut by rescue personnel in two places and the sliding latch plate was engaged in the buckle. A locking clip was present on the webbing and was located 81.9 cm (32.3") above the restraint anchor. The locking clip (**Figure 19**) was deflected forward on the center aspect 0.4 cm (0.2") from loading and the surrounding safety belt webbing was stretched. The position of the locking clip and deflection supported that the locking clip was positioned on the right side of the CSS (relative to the vehicle), opposite the side where the latch plate was located. The shoulder harnesses were routed through the top slots on the CSS and the harness retainer clip was found snapped together near the latch plate at the time of the inspection.

Figure 19. View of deflected locking clip

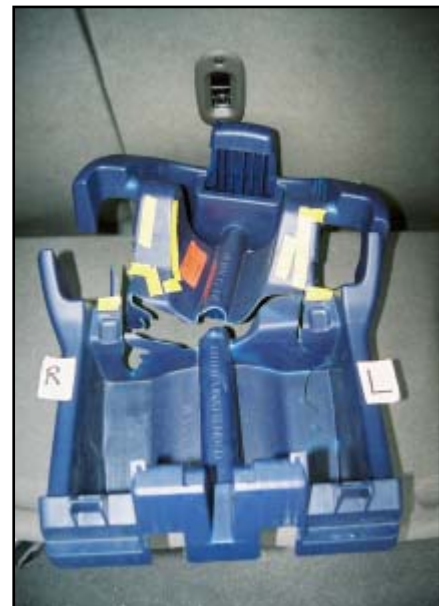
The Evenflo Discovery rear-facing CSS sustained severe damage to the detachable base and minor damage to the CSS. The detachable base sustained significant fractures at the forward aspect of the belt path (in a rear facing orientation) and at the forward panel of the base. **Figure 19** documents the fracture at the belt path, which began on the right side of the base (relative to the front of the vehicle) 3.8 cm (1.5") below the top aspect of the belt path opening on the inboard aspect and continued laterally and downward in a jagged fashion. The fracture extended to the left belt path opening and radiated longitudinally toward the front aspect of the base. The longitudinal fracture extended vertically to the floor of the base and extended forward 10.2 cm (4.0") in a jagged fashion. The termination point of the longitudinal fracture was the point that prevented the base from completely separating into two pieces and allowed the front aspect of the base to rotate CCW from the rear aspect. A second fracture was located on the forward panel of the CSS

Figure 20. View of fractured CSS base

base. The fracture began on the floor of the base, 2.5 cm (1.0”) aft of the front panel on the left side. It radiated laterally along the floor of the base and extended forward onto the front panel from the centerline and terminated on the front panel 3.8 cm (1.5”) inboard of the right side.

In addition to the fractures, multiple stress marks were present on the plastic CSS base. Both the left and right aspects of the belt path were abraded from engagement with the vehicle’s safety belt webbing. The left outboard aspect displayed an abrasion that measured 7.6 cm (3.0”) in height and 1.3 cm (0.5”) in width. A 5.1 cm (2.0”) linear abrasion was present on the left inboard aspect of the belt path. The outboard aspect of the right belt path exhibited an abrasion that measured 6.4 cm (2.5”) in height. The right inboard aspect sustained an abrasion that measured 10.2 cm (4.0”) in length. An area of abrasion was present on the face of the rear aspect of the CSS base (in the rear-facing orientation) that measured 9.5 cm (3.5”) and was located 10.2 cm (4.0”) left of the centerline.

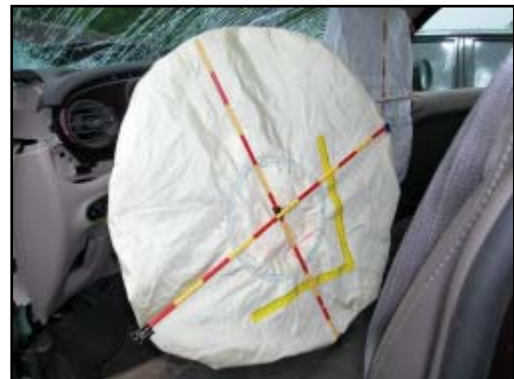
Figure 21. Deployed redesigned driver's air bag showing makeup transfer

The transfer measured 16.5 cm (6.5”) in height at 14.0 cm (5.5”) in width. It began 4.4 cm (1.8”) left of vertical centerline and 7.0 cm (2.8”) above the horizontal centerline, and extended downward and to the right. Two lipstick transfers were located within the makeup transfer and

measured 6.4 cm (2.5”) in width. The center of the lipstick transfers was located 8.3 cm (3.3”) right of the vertical centerline and 7.6 cm (3.0”) above the horizontal centerline.

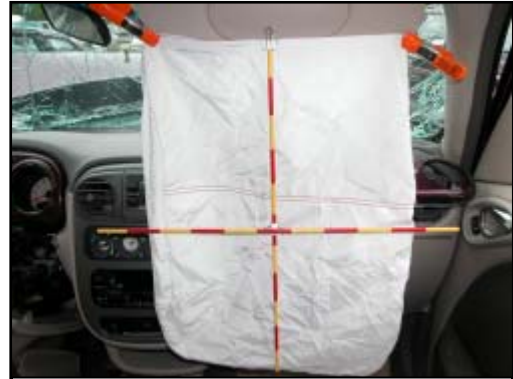
The front right redesigned air bag (**Figure 22**) deployed from a mid-mount module configured with a single plastic cover flap. The cover flap measured 17.8 cm (7.0”) in height and 47.0 cm (18.5”) in width. The air bag measured 40.6 cm (16.0”) in width and 61.0 cm (24.0”) in height. The air bag was tethered by two full-width internal straps and vented by two circular ports that were positioned on the top panel of the air bag and located 10.8 cm (4.8”) from the inflator. The ports measured 6.4 cm (2.5”) in diameter and were spaced 4.4 cm (1.8”) apart. There was not contact evidence to the front right passenger’s air bag.

Figure 22. Redesigned front right passenger's air bag
