TRANSPORTATION RESEARCH CENTER

REMOTE ADVANCED OCCUPANT PROTECTION SYSTEM INVESTIGATION

CASE NUMBER - IN-03-029
LOCATION - Texas
VEHICLE - 2001 FORD ESCAPE
CRASH DATE - June 2001

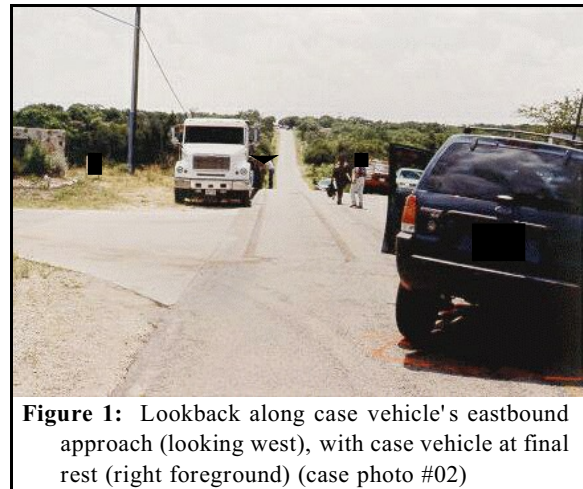
Figure 1: Lookback along case vehicle's eastbound approach (looking west), with case vehicle at final rest (right foreground) (case photo #02)

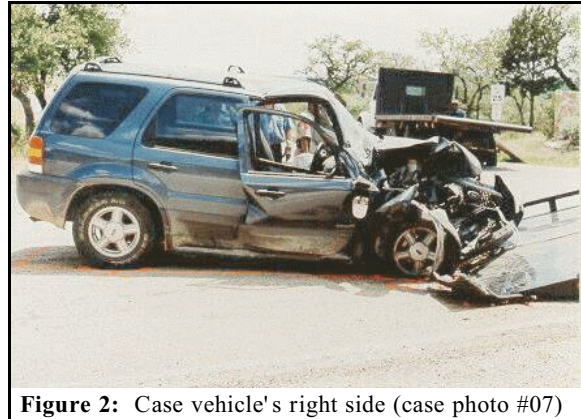
The right third of the case vehicle's front impacted the straight truck's right rear dual wheel assembly, causing heavy crush to the bumper, grille, right fender, hood and into the engine compartment (**Figures 2 and 3**). As the case vehicle rotated clockwise, it penetrated beneath the rear overhang of the straight truck's cargo deck, with the windshield and right A-pillar sustaining direct contact (**Figures 3 and 4**). The case vehicle's right front wheel assembly was displaced rearward, the right A-pillar was deformed and the roof was buckled in the area over the right front door. The windshield was shattered across its entire width, the right front door window glazing was disintegrated, and there was no other glazing damage. The right front tire was restricted and deflated, with no other damage to the wheels/tires.

The CDC was estimated from the available photographs as **12-FZAW-6 (0)**. This collision is out of scope for the WinSMASH reconstruction program (heavy truck impact), but the barrier equivalent speed (BES) was calculated. Based on the WinSMASH barrier algorithm with CDC-only, the BES was 49 km.p.h. [30.4 m.p.h.]. This result seems slightly high but reasonable. This was a crash of high severity (greater than 40 km.p.h. [25 m.p.h.]) for the case vehicle.

Figure 2: Case vehicle's right side (case photo #07)

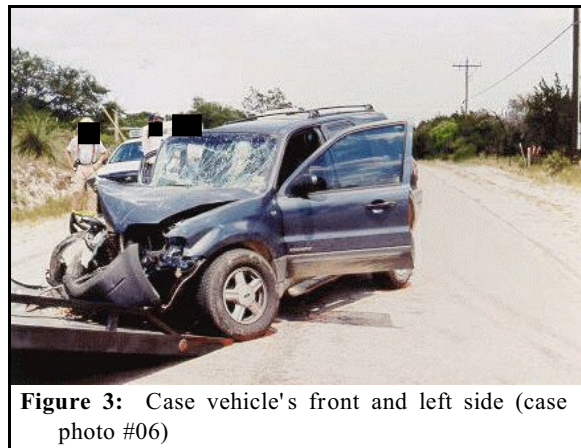
Figure 3: Case vehicle's front and left side (case photo #06)

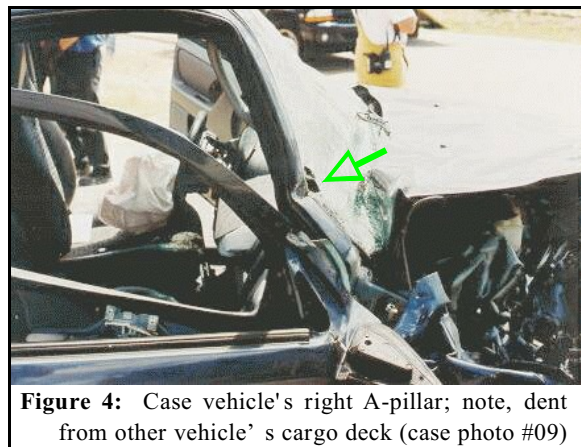
Figure 4: Case vehicle's right A-pillar; note, dent from other vehicle's cargo deck (case photo #09)

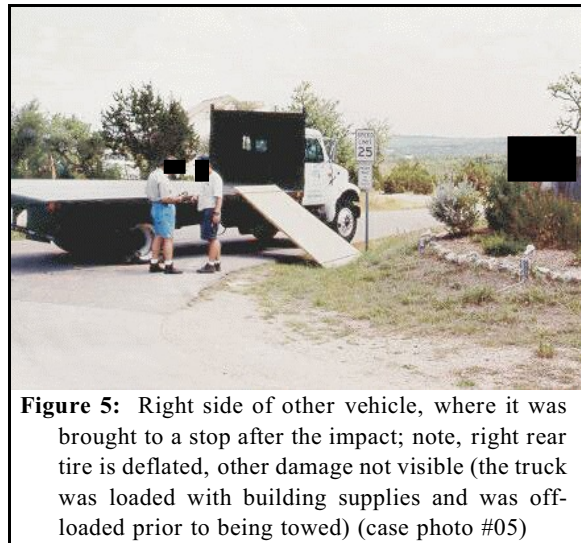
The other vehicle was a 1994 International 4700 flatbed straight truck (VIN: 1HTSCACN6RH-----), equipped with air brakes and with a GVWR rating of 11,794 - 14,969 kilograms [26,001 - 33,000 pounds]. Further details are not known. The truck was towed due to disabling damage to the right rear dual wheel assembly.

Figure 5: Right side of other vehicle, where it was brought to a stop after the impact; note, right rear tire is deflated, other damage not visible (the truck was loaded with building supplies and was off-loaded prior to being towed) (case photo #05)
