On Site Infant Safety Seat Investigation / Vehicle to Vehicle  
Dynamic Science, Inc. / Case Number: DS03032  
1994 Ford Explorer  
North Dakota  
August, 2003

1. Report No. DS03032	2. Government Accession No.		3. Recipient Catalog No.	
4. Title and Subtitle Infant Safety Seat Investigation			5. Report Date November 7, 2004

**Dynamic Science, Inc.**  
**Crash Investigation**  
**Case Number: DS03032**

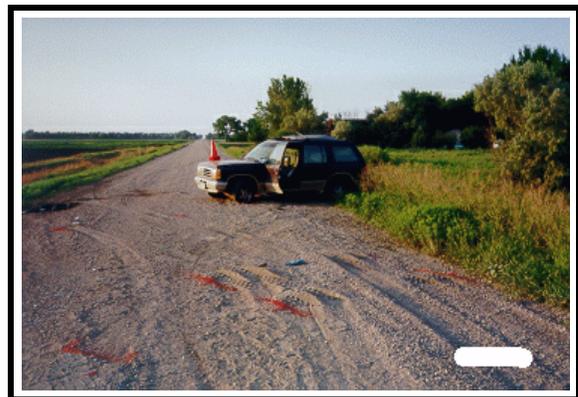
**Figure 1.** Final rest, case vehicle (looking north)

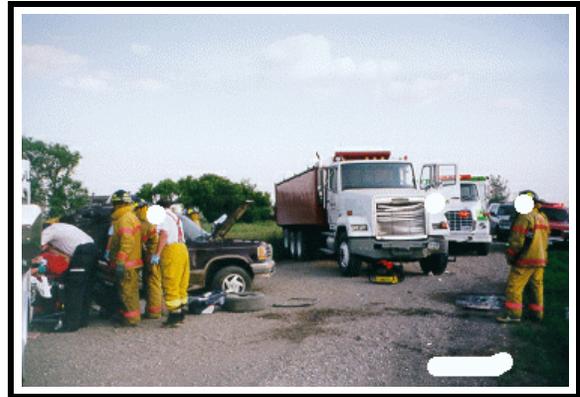
The case vehicle rotated in a clockwise direction and came to rest near the east ditch facing southwest. The other vehicle slid a short distance before coming to rest facing northwest.

**Figure 2.** Final rest for both vehicles (looking south)

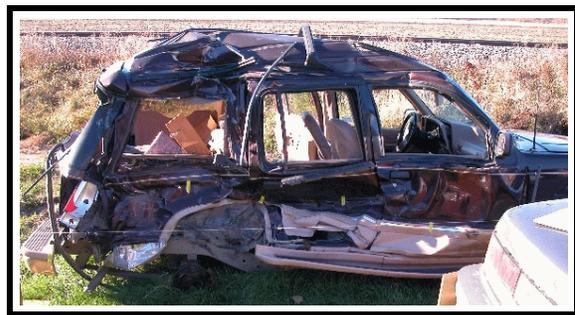
The case vehicle was struck in the right side (03RZAW03) by the front of the other vehicle (12FDEW01). The total velocity change calculated by the Barrier algorithm of the WINSMASH collision model was 35.0 km/h (21.7 mph). The longitudinal and lateral delta V components were  $-6.1$  km/h ( $-3.8$  mph) and  $-34.5$  km/h ( $-21.4$  mph), respectively.

**Figure 3.** Right side, case vehicle

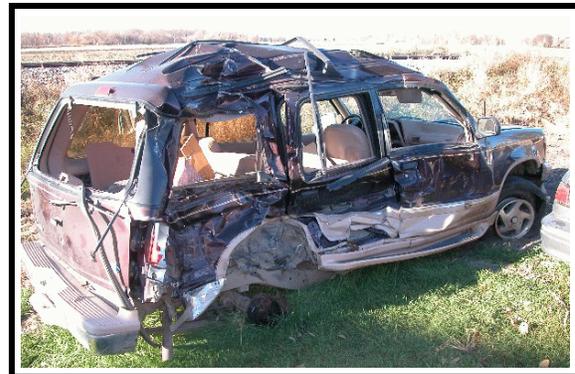
**Figure 4.** Right rear, case vehicle

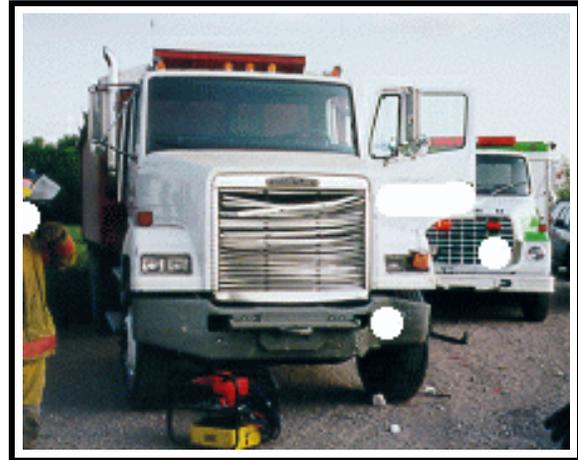
Figure 5. Front, other vehicle

The case vehicle sustained heavy damage to the right side and all four tires were flattened. The case vehicle was towed due to damage and placed on a police hold. The other vehicle sustained minor damage to the bumper, grille, and hood. It was driven from the scene.

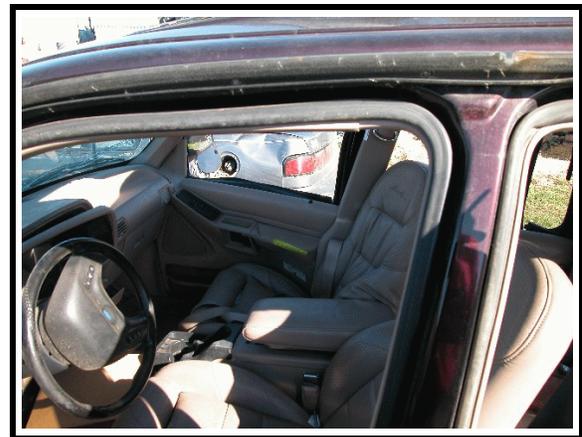
Figure 6. Front seating area

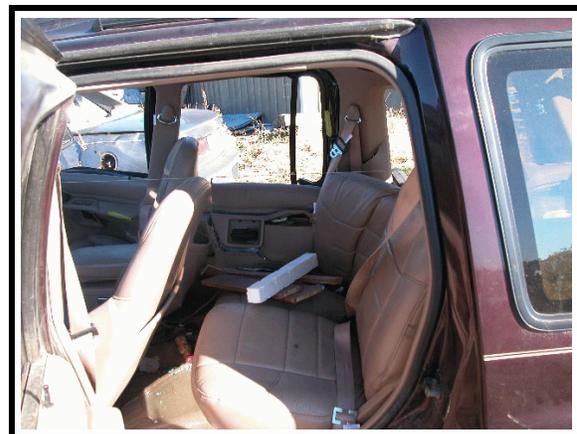
Figure 7. Rear seating area

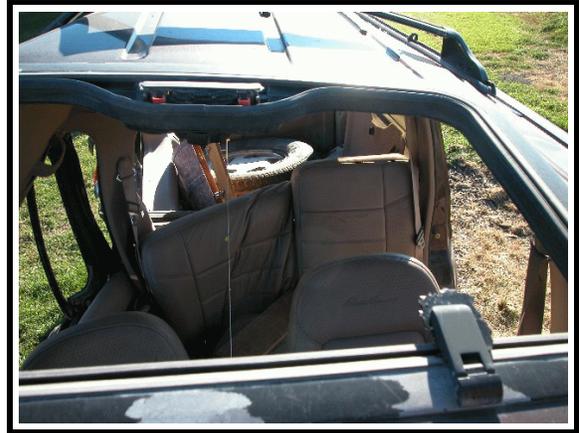
**Figure 8.** Overview of right side interior intrusion

Interior damage to the Explorer was major and attributed to occupant contacts and passenger compartment intrusion. The windshield was fractured from impact forces. All the right side windows were disintegrated from impact forces. The sun roof was disintegrated from impact forces. The right front door, right rear door, and rear hatchback were jammed shut. There was intrusion to the right front B pillar, right front door, right roof rail, right sill, and the right C pillar. The maximum intrusion was to the right rear door and measured 33.0 cm (12.9 in). There was loading to the right front door arm rest from the right front occupant. There were contacts (scuffing) to the right rear door and C pillar. There were a variety of longitudinal scuffs along both sides of the interior roof. The left side marks appear to be related to the ejection of the middle occupant while those on the right appear to be related to the ejection of the right rear occupant.

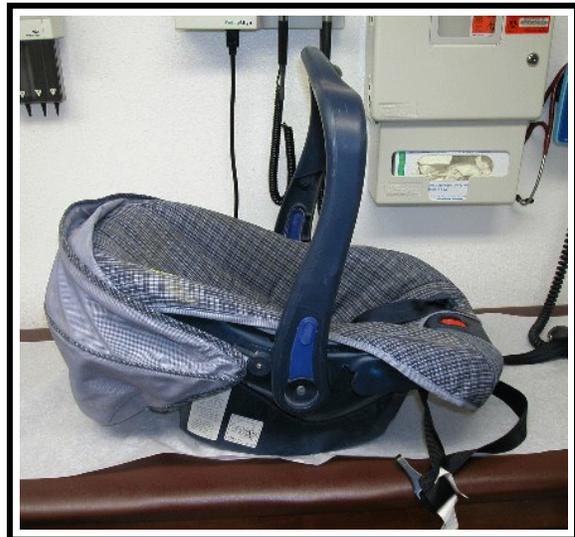
**Figure 9.** Cosco Arriva infant safety seat

The Cosco Arriva (model number 22-002-JAS) infant safety seat was manufactured on 11/06/02. The manufacturer recommends that it be used rear-facing only and would be appropriate only for those infants weighing less than 10 kg (22 lbs) and with a height less than 74 cm (29 in). It can be purchased with or without a base. In this case, a base was not being used. It was equipped with a 3-point harness. The harness had been routed through the lower set of slots and was in use at the time of the crash. The seat is designed to be secured to the vehicle by using either a lap belt or a lap and shoulder belt. In this case, the seat was not anchored to the case vehicle. The seat was also equipped with lower LATCH connectors which were not used during this crash.

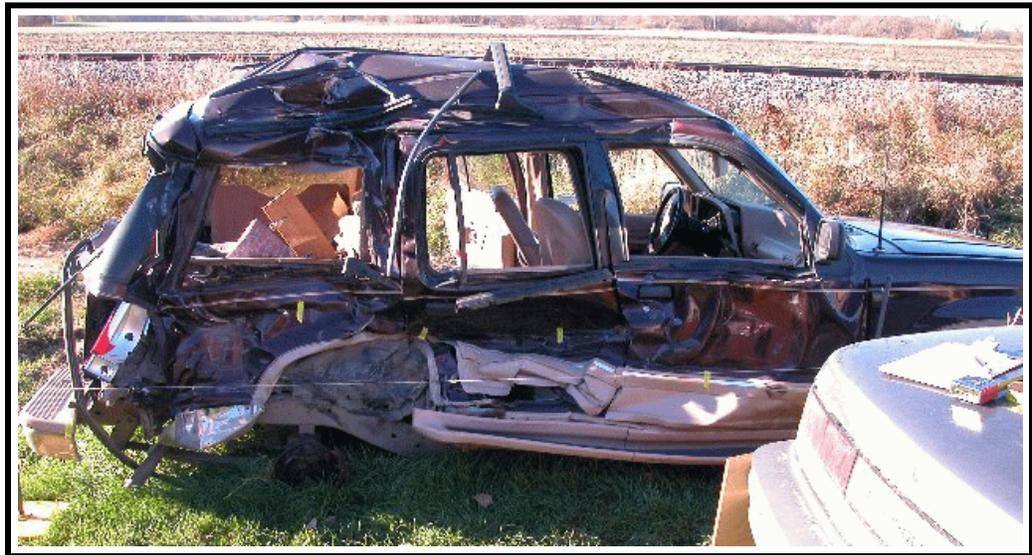
Damage Description:	Major right side damage. Right side doors jammed shut. Tailgate jammed shut. Right side and rear side glass disintegrated. The right rear tire was broken off.	
CDC:	03RZAW03	
Delta V <sup>1</sup> :	Total	35.0 km/h (21.7 mph)
	Longitudinal	-6.1 km/h (-3.8 mph)
	Latitudinal	-34.5 km/h (-21.4 mph)
	Energy	90,122 joules (66,471 ft lbs)

The case vehicle sustained 267.0 cm (105.1 in) of direct contact damage that began 81 cm (31.8 in) rear of the front axle. The residual crush measured above the sill was as follows: C1=0 cm (0 in), C2=48.0 cm (18.9 in), C3=46.0 cm (18.1 in), C4=45.0 cm (17.7 in), C5=13.0 cm (5.1 in), C6=0 cm (0 in). The maximum crush was 48.0 cm (18.9 in) and was located at C2. The principle direction of force was within the 9 o'clock sector and was an estimated 80 degrees. There was intrusion along the entire right side.

Figure 10. Right side, case vehicle

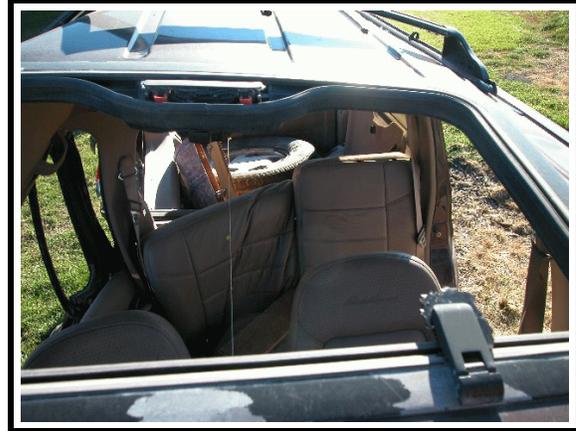
Figure 11. Interior view (from moon roof)

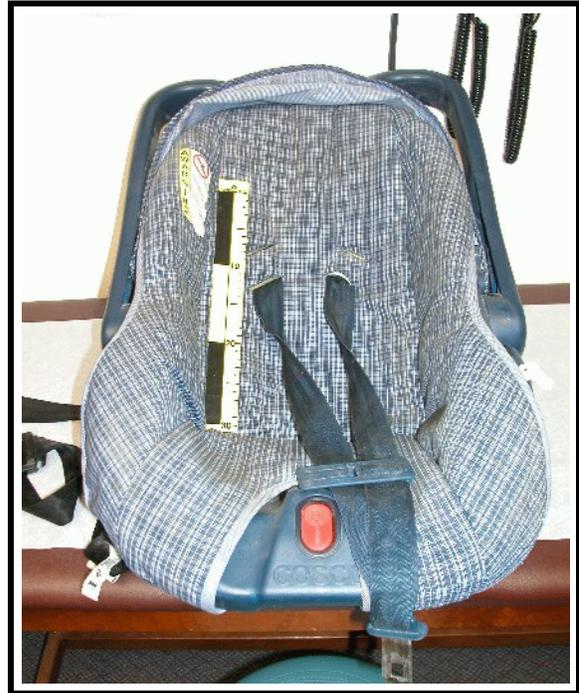
Figure 12. Cosco infant seat

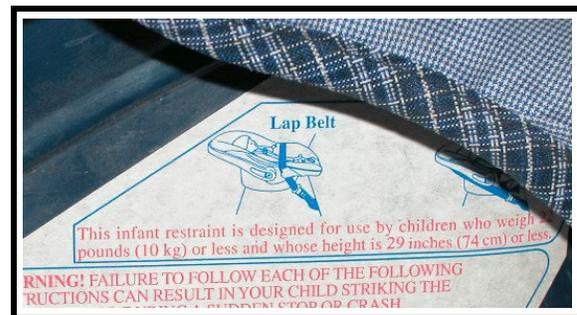
Both rear outboard seats were equipped with emergency locking retractors. A locking clip had been incorrectly installed for both seat locations. The clip was installed on the lap portion of the belt but was not secured to the shoulder portion. The clip would have had no effect as it was installed.

Figure 13. Vehicle seat belt routing (lap belt position)

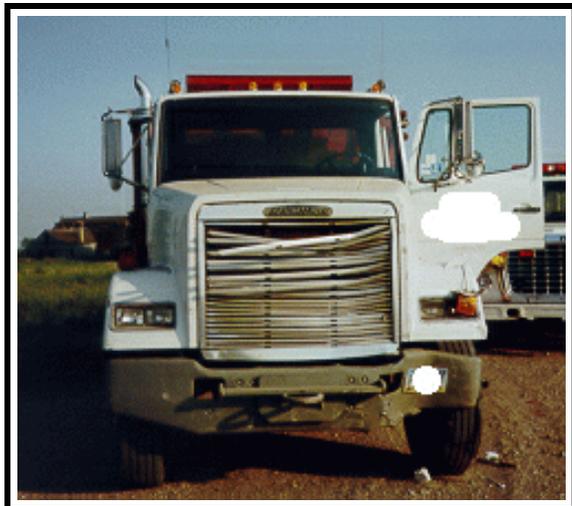
Description:	1990 Freightliner	
VIN:	Unknown	
Odometer:	Unknown	
Engine:	Unknown	
Reported Defects:	None	
Cargo:	Grain, unknown weight	
Damage Description:	Minor damage to bumper and grille. Vehicle driven from scene.	
Truck Deformation Classification:	12FDEW1	
Delta V:	Total	Unknown
	Longitudinal	Unknown
	Latitudinal	Unknown
	Energy	Unknown

Figure 14. Front, other vehicle

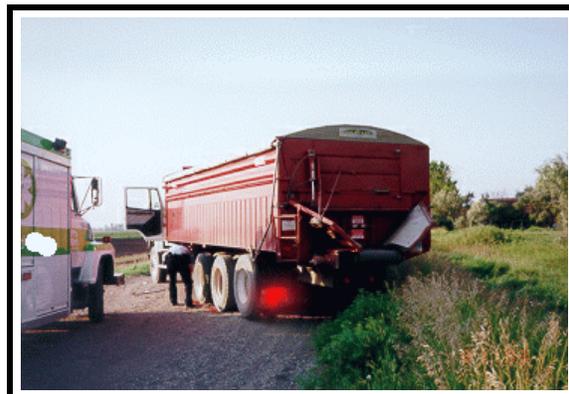
Figure 15. Left rear, other vehicle

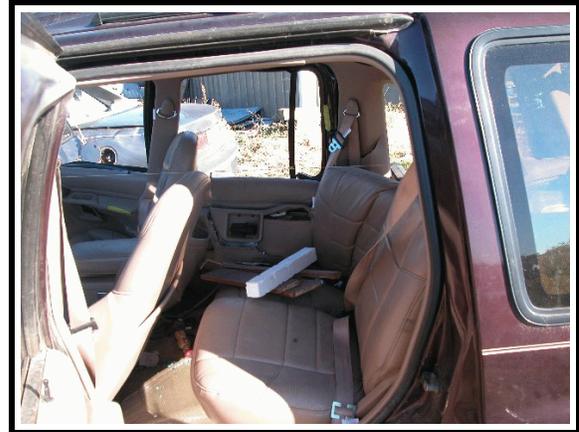
Figure 16. Overview of right rear seat area

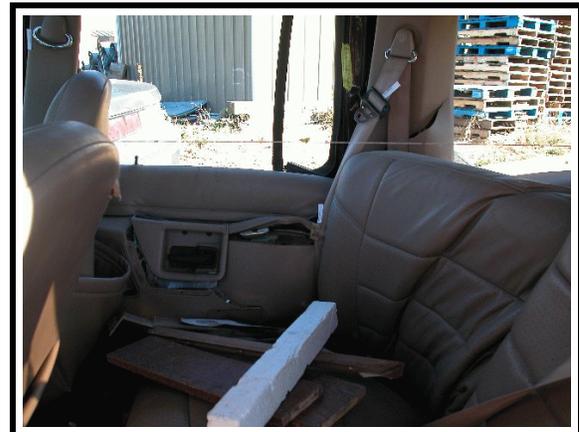
Figure 17. Right rear seat area/door contact

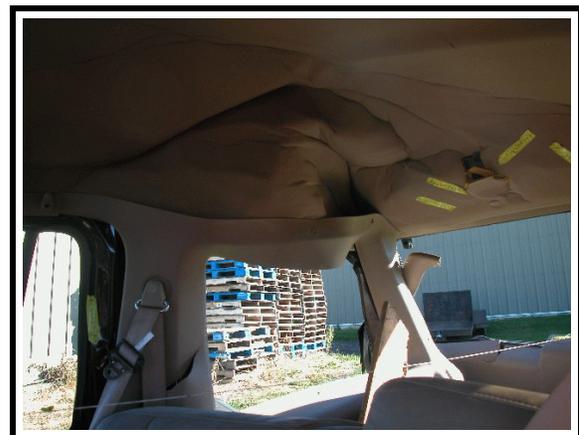
Figure 18. Ejection path towards backlight

The 6-month-old male rear seat middle occupant was seated in a Cosco Arriva (model number 22-002-JAS) infant safety seat. The seat was being used in a rear facing fashion and was not anchored to the vehicle. The child appears to have been properly harnessed to the safety seat. The seat had been placed on the leather covered bench seat with folding back. The seat back was slightly reclined by design. Prior to impact, the driver had steered the case vehicle sharply to the left and the vehicle was in a counterclockwise rotation with the right side leading. At impact, the infant seat responded to the 80 degree direction of force by moving to the right and likely engaged the right rear occupant to some extent. The case vehicle was pushed into a sharp clockwise rotation by the striking vehicle. The infant seat slid up the right side of the vehicle and responded to the centrifugal forces by sliding along the roof towards the backlight. The backlight glass had likely already disintegrated by the time the infant seat reached it. The infant seat was ejected through the backlight during the spinning rotation and came to rest along the east roadway edge. The child sustained a minor facial contusion on the left side of the upper lip, edema on the left lower side of the lower jaw, a clavicle contusion, forehead abrasions, and multiple minor puncture wounds. The puncture wounds would appear to be related to flying glass fragments. The clavicle contusions was likely related to interaction with the child seat harness. The sources of the remaining injuries are essentially unknown, given the impact and the post-impact ejection. The child was transported by ground ambulance to a local hospital and arrived at 1830 hours. He was hospitalized overnight as a precaution.

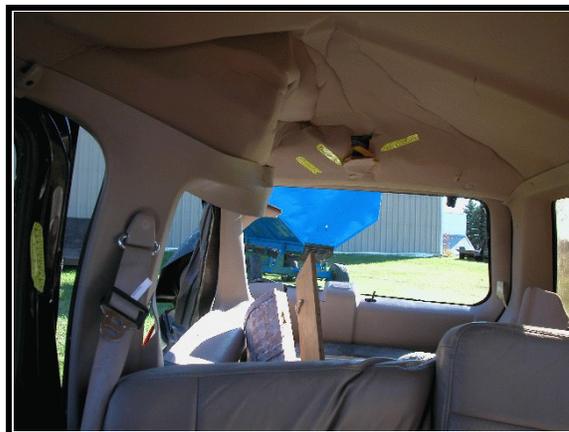
**Figure 19.** Overview of hatch area/likely ejection area

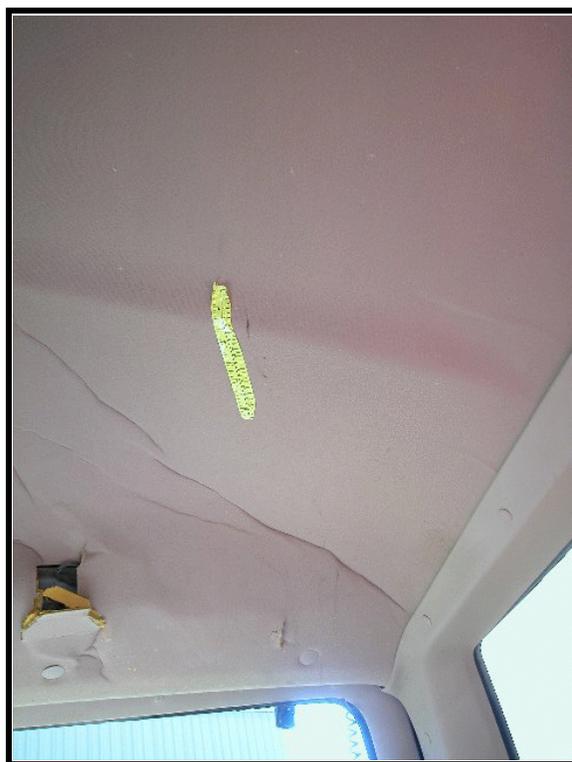
**Figure 20.** Marks along roof from ejected occupants

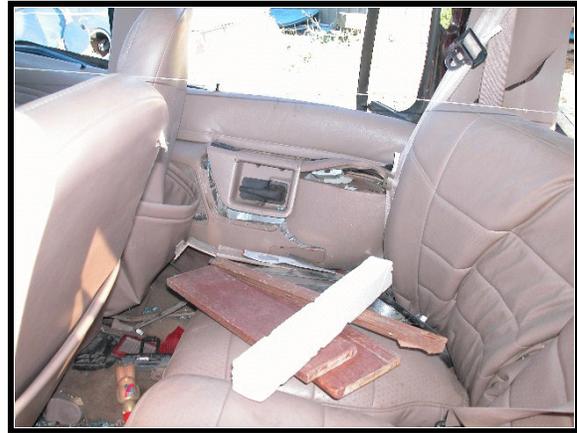
**Figure 21.** Right rear door

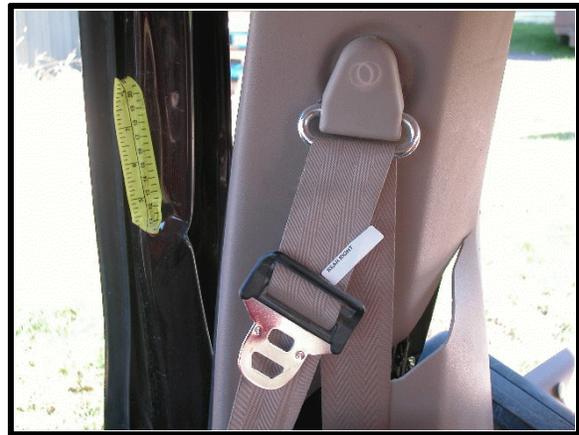
The 19-year-old female rear seat right occupant was seated on the leather covered bench seat with folding back. The seat back was slightly reclined by design. Prior to impact, the driver had steered the case vehicle sharply to left and the vehicle was in a counterclockwise rotation with the right side leading. At impact, the rear right occupant responded to the 80 degree direction of force by moving to the right and engaged the right rear door with her torso—causing the thoracic injuries. This occupant also sustained a spinal cord transection. She also likely contacted the C pillar/side glass frame area—possibly causing the facial contusion. According to the non-invasive death certificate, this occupant sustained a spinal cord transection. The location of the transection is not known. The injury mechanism for this injury is not known. The case vehicle was pushed into a sharp clockwise rotation by the striking vehicle. This occupant slid up the right side of the vehicle and responded to the centrifugal forces by sliding along the roof towards the backlight. The backlight glass had likely already disintegrated by the time she reached it. This occupant was ejected through the backlight during the spinning rotation and came to rest along the east roadway edge. She was fatally injured.

**Figure 22.** Possible contact to C pillar/side glass frame
