Advanced Occupant Protection System Investigation/ Vehicle to Vehicle
Dynamic Science, Inc. / Case Number: DS03033
2004 Toyota Corolla S Four-Door Sedan
California
September, 2003

Dynamic Science, Inc.
Crash Investigation
Case Number: DS03033

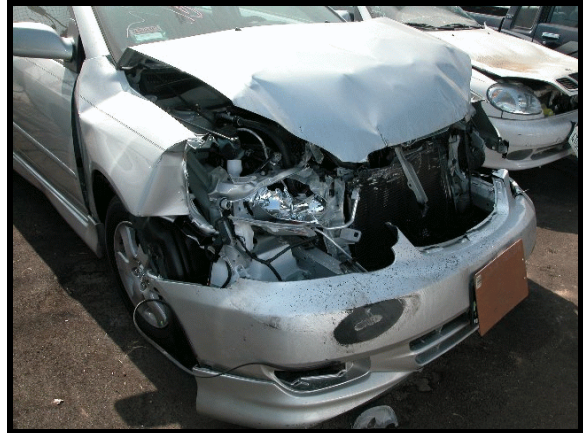
Figure 1. Front, right view of case vehicle showing significant underide deformation

Damage Description: Moderate/Primary Frontal Impact: The frontal plane of the case vehicle underrode the other vehicle which resulted in a “step” in the deformation pattern. The front bumper revealed no crush while the grille and upper radiator support was displaced significantly rearward. Crush averaging was utilized and the maximum crush was calculated to be 19.0 cm (7.5 in.) located at C4. Damaged components included the front fascia cover, hood, grille, upper/lower radiator supports, both fenders and the laminated windshield glazing was cracked.

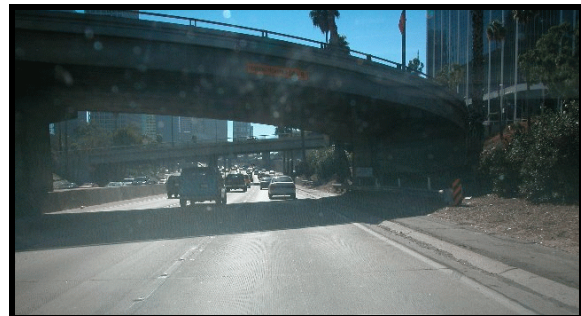
Figure 2. View showing the approximate impact area

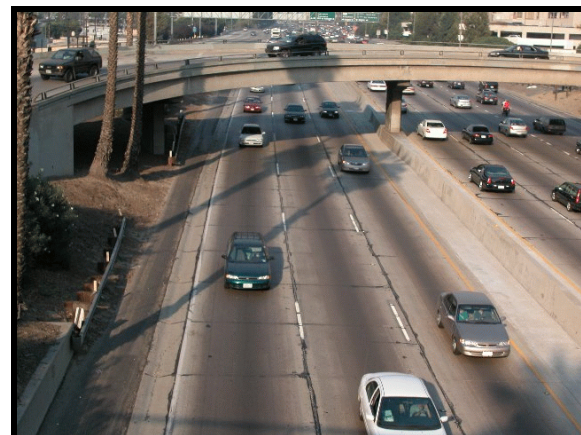
Figure 3. Overhead look-back view (north) showing area of the collision

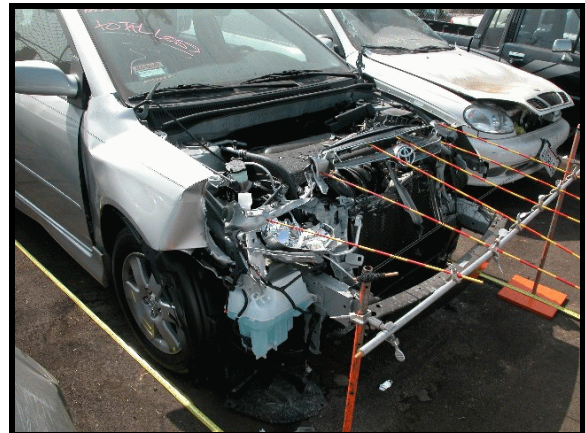
Figure 4. View of case vehicle with hood and fascia removed exposing the extent of upper bumper deformation

C-measurements (crush profile): Crush averaging was utilized due to the underride “step” in deformation. Six equidistant crush measurements were documented at the bumper bar level and the crush profile is as follows: C₁ = 0 cm, C₂ = 0 cm, C₃ = 0 cm, C₄ = 0 cm, C₅ = 0 cm, C₆ = 0 cm. The front bumper bar revealed no residual crush. A second set of crush values was documented at the upper radiator support level and the crush pattern was 22.0 cm (8.7 in) at C₁, 27.0 cm (10.6 in) at C₂, 36.0 cm (14.2 in) at C₃, 38.0 cm (15.0 in) at C₄, 30.5 cm (12.0 in) at C₅ and 24.5 cm (9.6 in) at C₆. Crush averaging yielded the following crush profile: C₁=11.0 cm (4.3 in), C₂ = 13.5 cm (5.3 in), C₃ = 18.0 cm (7.0 in), C₄ = 19.0 cm (7.5 in), C₅ = 15.3 cm (6.0 in), C₆ = 12.3 cm (4.8 in).

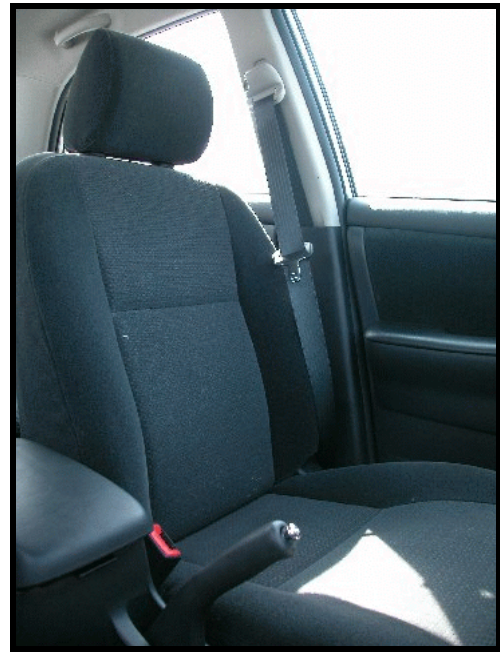
The driver's manual restraint system consisted of a continuous loop three-point lap and shoulder belt with a free sliding latch plate and an Emergency Locking Retractor (ELR). The shoulder belt adjuster was in the full up position. The driver's lap and shoulder belt exhibited evidence of historical usage. The shoulder belt webbing did not exhibit evidence of stretching due to occupant loading.

Figure 5. View showing manual restraint system at the front right driver's position

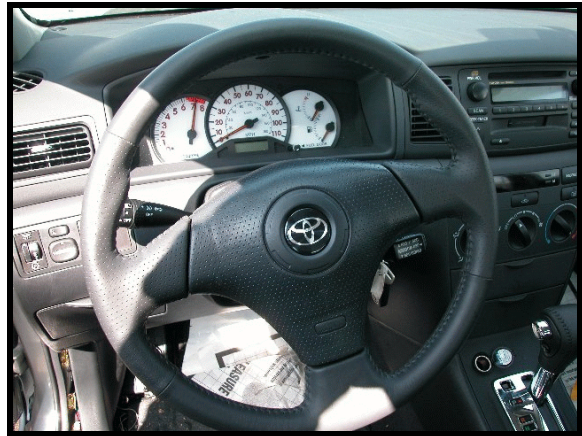
This vehicle was equipped with an advanced occupant protection system that consists of dual-stage/dual-threshold driver and front right passenger air bags. The air bag sensor assembly consists of a safing sensor and an air bag sensor. There were no air bag deployments in this override type crash. According to the Corolla Owner's Manual: *"The front air bags will deploy if the severity of the impact is above the designed threshold level, comparable to an approximate 25 km/h (15 mph) collision when impacting straight into a fixed barrier that does not move or deform. This threshold velocity will be considerably higher if the vehicle strikes an object, such as a parked vehicle or sign post, which can move or deform on impact, or it is involved in an underride collision (e.g. a collision in which the nose of the vehicle "underrides", or goes under, the bed of a truck, etc.)."*

Figure 6. View showing non-deployed steering wheel hub mounted air bag

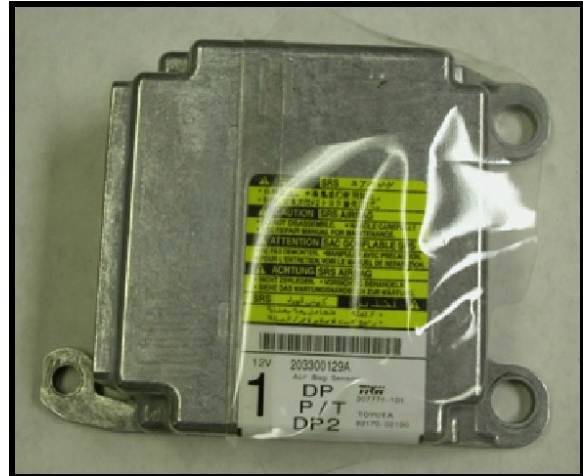
The air bag sensor assembly (Toyota part number 89170-02190) was removed from the case vehicle and sent to NHTSA on October 30, 2003 for reading of the recorded crash data by Toyota Motor Company. The sensor assembly was apparently lost at some point and no sensor data is available for this report.

Figure 7. Air bag sensor module (EDR)
