TRANSPORTATION RESEARCH CENTER

ON-SITE CERTIFIED ADVANCED 208- COMPLIANT VEHICLE INVESTIGATION

CASE NUMBER - IN-03-041
LOCATION - OKLAHOMA
VEHICLE - 2003 CHEVROLET K1500 TAHOE
CRASH DATE - August 2003

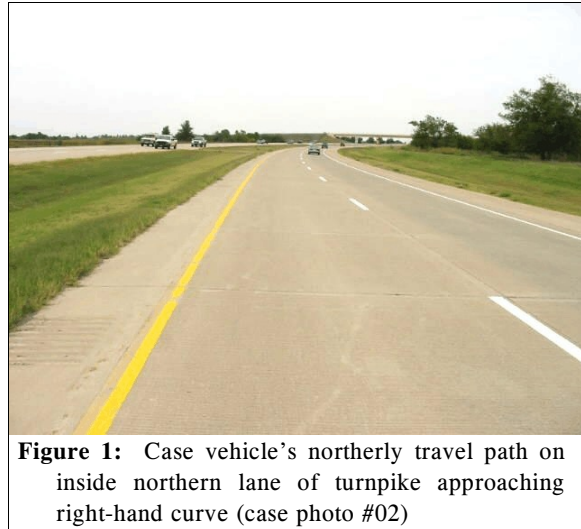
Figure 1: Case vehicle's northerly travel path on inside northern lane of turnpike approaching right-hand curve (case photo #02)

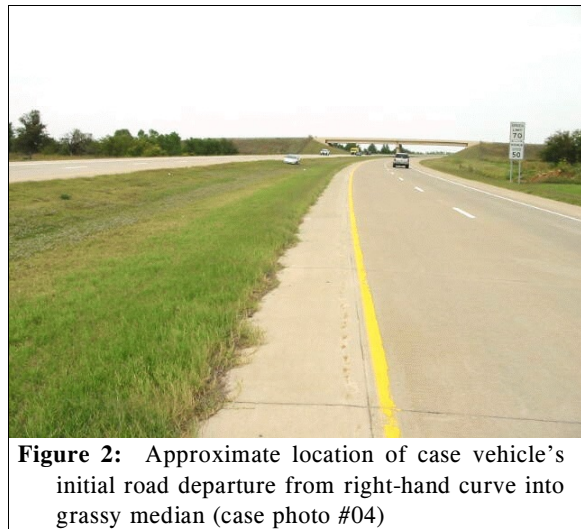
Figure 2: Approximate location of case vehicle's initial road departure from right-hand curve into grassy median (case photo #04)

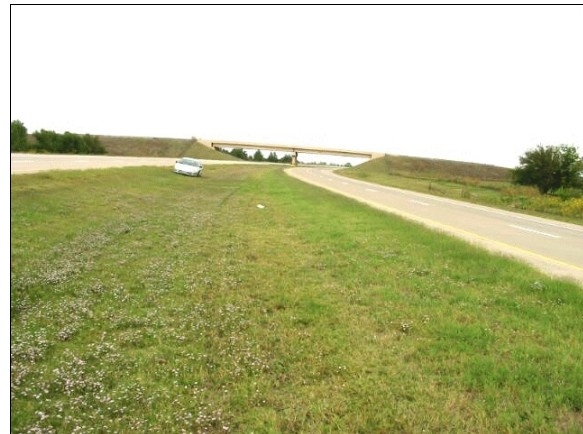
Figure 3: Yaw marks deposited by case vehicle during its initial road departure into grassy median (case photo #06)

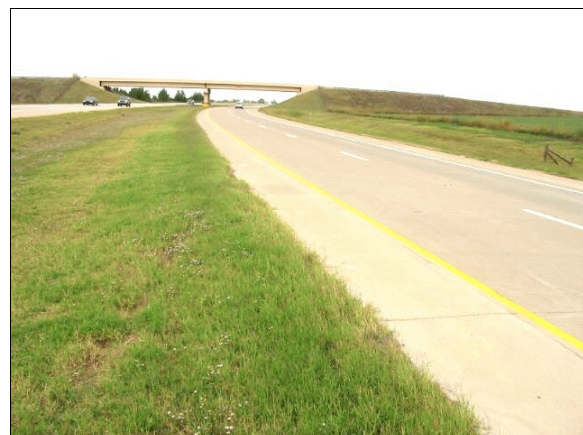
Figure 4: Case vehicle’s re-entrance onto road from grassy median (case photo #09)

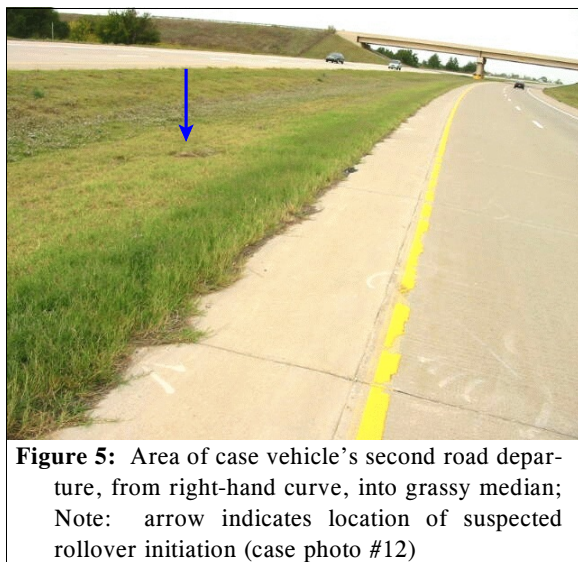
Figure 5: Area of case vehicle’s second road departure, from right-hand curve, into grassy median; Note: arrow indicates location of suspected rollover initiation (case photo #12)

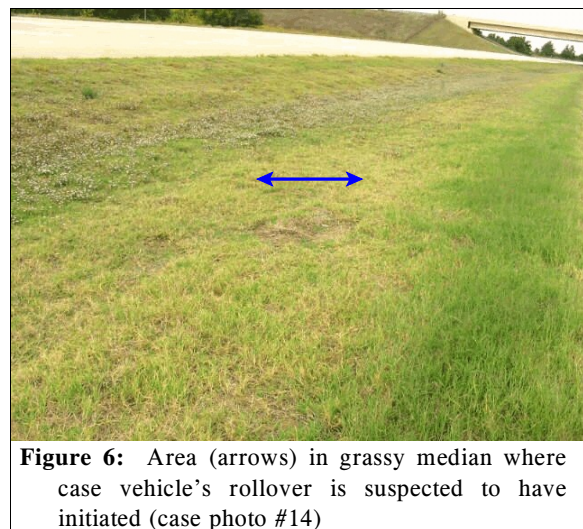
Pre-Crash: The case vehicle had been traveling north in the outside northbound lane and intended to negotiate the curve and continue in his northern travel path. The case vehicle departed the left side of the northern roadway into the grassy median at the location where the roadway begins to curve (**Figure 2** above). Based on the scene evidence, the driver most likely steered to the right in an effort to return the vehicle to the roadway. The case vehicle began to rotate clockwise while traveling approximately 100 meters on the grass median (**Figure 3**) before veering back to the right and re-entering the roadway (**Figure 4**). At this point, according to the Police Crash Report, the case vehicle began to rotate counterclockwise, traversing a distance of approximately 30 meters, before it departed the left side of the northern roadway again, into the grassy median (**Figure 5**). Based on this contractor’s experience, this vehicle behavior most likely occurred because the driver was steering back to the left in an effort to straighten the vehicle out. The crash sequence came to an end in the grassy median when the case vehicle rolled over (**Figure 6**) onto its top before coming to a rest.

Figure 6: Area (arrows) in grassy median where case vehicle’s rollover is suspected to have initiated (case photo #14)

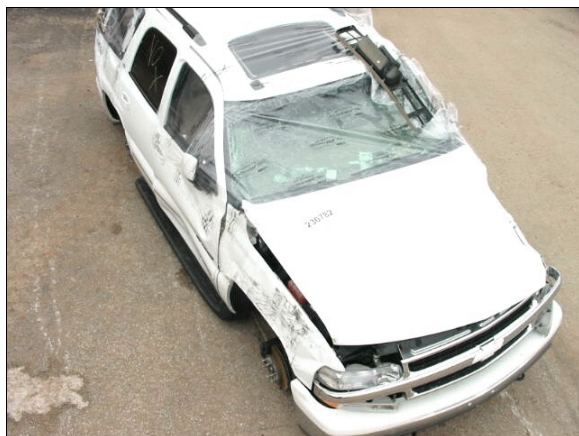
Crash: Based on the scene inspection, the case vehicle’s right front tire most likely dug into the grassy median enabling the vehicle to “trip over” contacting the ground with its right side (**Figure 7** below).

Figure 7: Elevated view of rollover damage to case vehicle's right side (case photo #37)

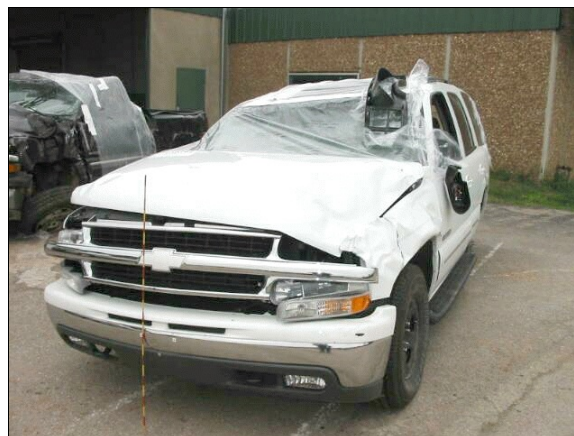
Figure 8: Rollover crush to case vehicle's left fender and front left hood viewed from left of front; Note: greater crush to right roof and right "A"-pillar and damaged left outside rearview mirror (case photo #23)

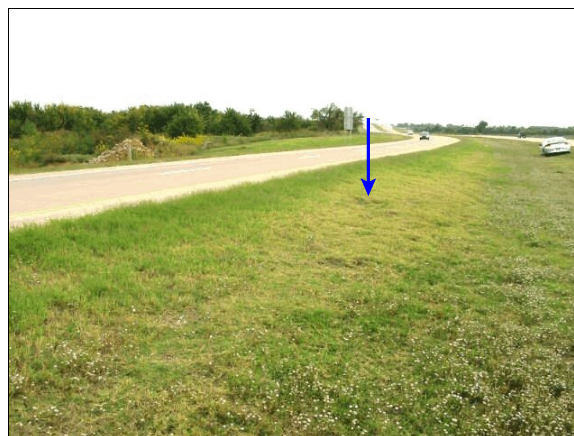
Figure 9: Southerly view from beyond case vehicle's approximate final rest position showing northerly travel path after failing to negotiate right-hand curve and suspected area (arrow) of rollover initiation (case photo #16)

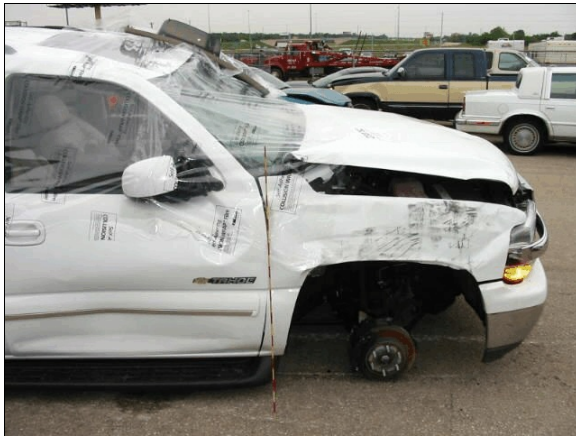
Figure 10: Rollover damage to case vehicle's right fender, lower right front door, right outside rearview mirror, right "A"-pillar, and right hood; Note: right front wheel missing (case photo #36)

Exterior Damage: The case vehicle's initial contact with the ground involved its entire right side (**Figure 7** above and **Figures 10** and **11**). As the case vehicle continued to roll over, it contacted the ground with its hood, windshield, windshield header, both "A"-pillars, and the front portion of its roof (**Figure 12**). Direct damage also occurred to its left fender and the left outside rearview mirror indicating that the case vehicle began, at least, to roll onto its left side (**Figure 8** above and **Figure 13** below). The case vehicle's wheelbase was unaltered from the crash. The case vehicle's entire right side was directly damaged and crushed inward, though at some points crush damage was almost nonexistent. There was also direct

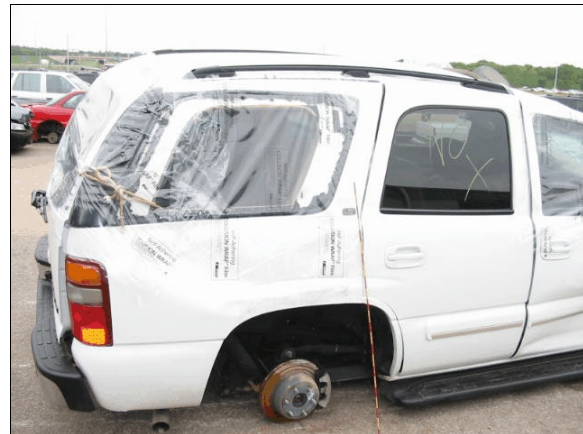
Figure 11: Rollover damage to case vehicle's right quarter panel and doors, including disintegrated right front door and 2nd right rear window glazings and remote buckling to doors and quarter panel (case photo #31)

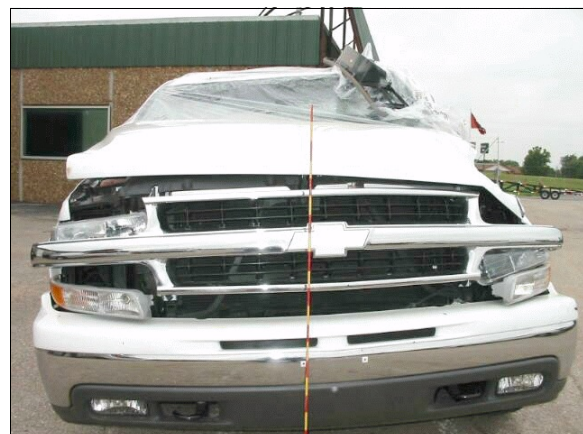
Figure 12: Case vehicle viewed from front bumper level showing greatest roof crush occurred along right roof and right "A"-pillar and induced damage to front and hood (case photo #22)

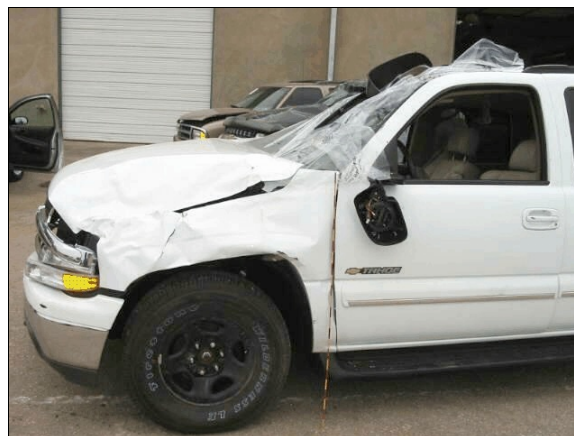
Figure 13: Rollover crush to case vehicle’s left fender and front left hood viewed from left front; Note: damage to left outside rearview mirror and removed piece of center instrument panel molding across windshield and roof (case photo #25)

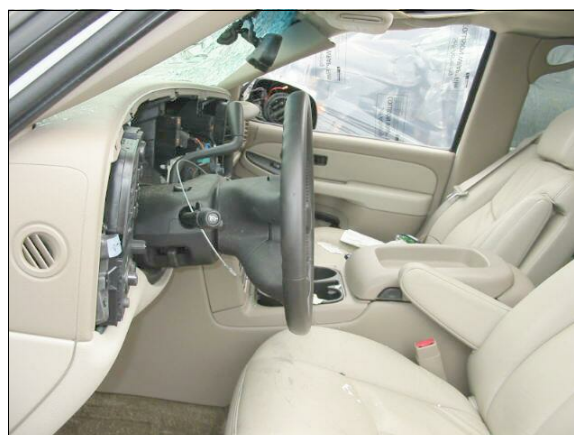
Interior Damage: Inspection of the case vehicle’s interior revealed contact to the driver’s right arm rest (i.e., bent toward the center of the vehicle—**Figure 14**). Furthermore, there was no obvious evidence of contact to the front of the

Figure 14: Case vehicle’s front seating area showing no deformation to steering wheel rim, driver’s armrest bent toward center console, and angulation of front seat backs (case photo #42)

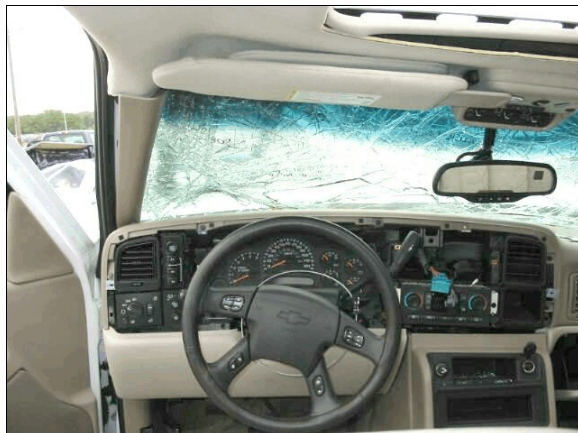
Figure 15: Case vehicle’s driver seating area showing non-deployed driver air bag, cracked windshield’s glazing, and removed center instrument panel molding; Note: no obvious evidence of occupant contact (case photo #43)

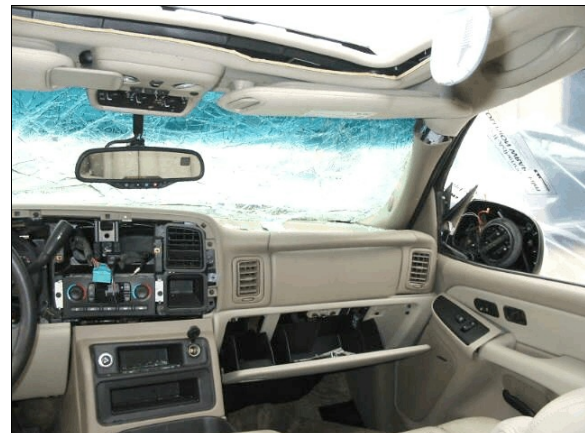
Figure 16: Case vehicle’s front right seating area showing non-deployed front right passenger air bag, cracked windshield, altered center instrument panel, and no obvious occupant contact evidence (case photo #45)

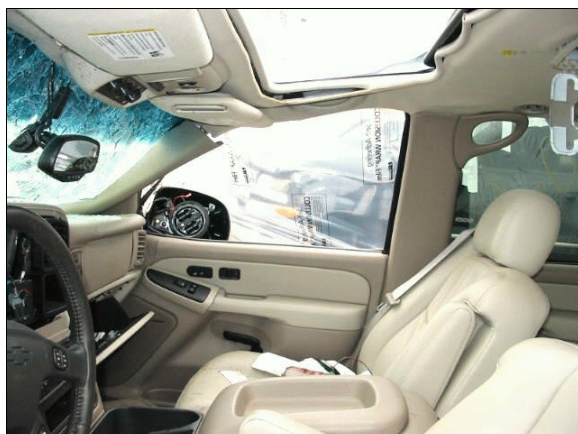
Figure 17: Case vehicle’s front seating area showing no evidence of occupant contact to sun visors; Note: reclined nature of front seat backs (case photo #39)

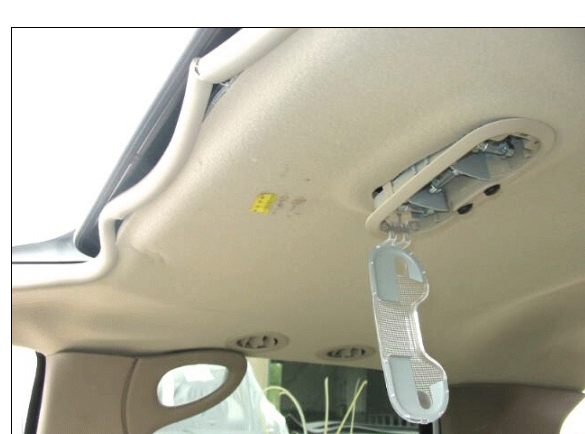
Figure 18: Contact evidence on case vehicle’s roof situated between moon roof and damaged dome light (case photo #52)

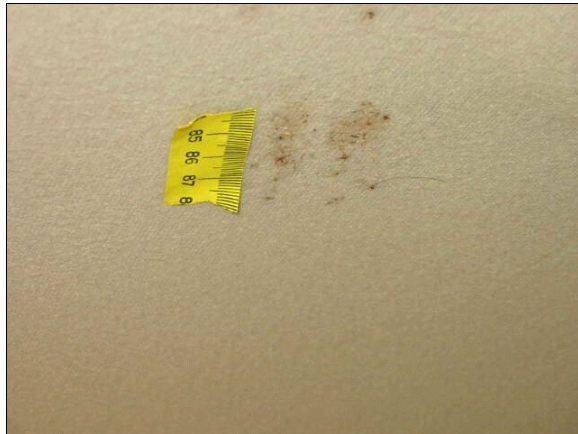
Figure 19: Close-up of contact evidence (e.g., hair, blood) on case vehicle's roof, situated between moon roof and dome light (case photo #53)

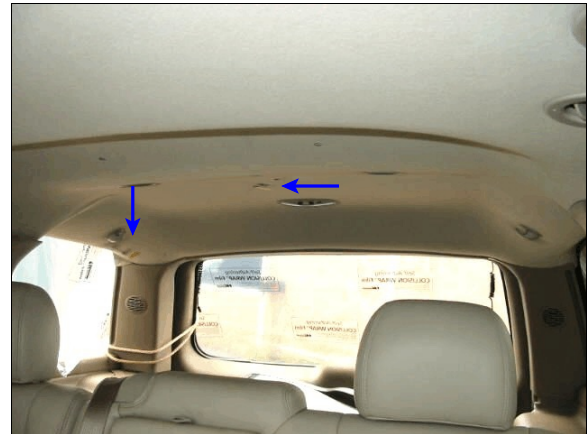
Figure 20: Oblique view of case vehicle's interior indicating driver's suspected front left to back right path of movement during rollover; Note: arrows show possible occupant contact locations (case photo #54)

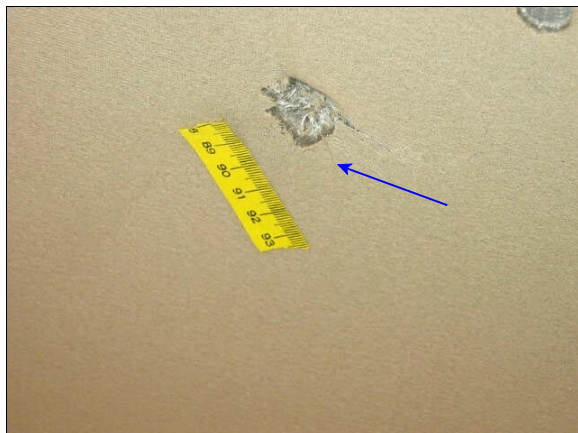
Figure 21: Close-up of contact (i.e., fabric gouge with hair) on roof surface over case vehicle's back seating area (case photo #54b)

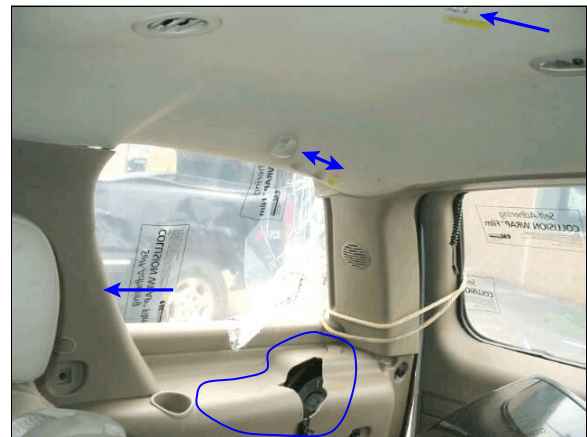
Figure 22: Case vehicle's back right seating area showing (i.e., arrows) areas of contact, some occupant-related, some probably related to an interior loose object (case photo #55)

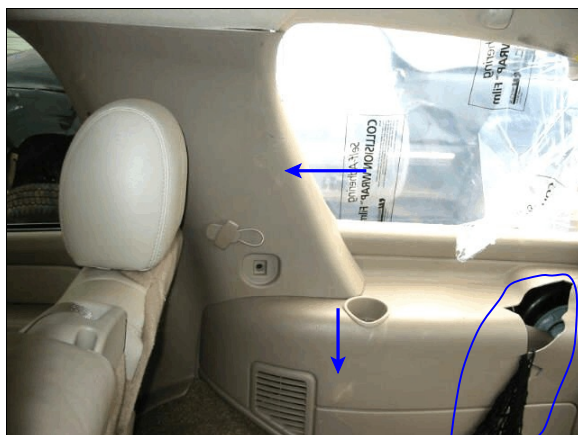
Figure 23: Right interior surface of case vehicle's back right seating area showing disintegrated 2nd right window glazing and contact evidence on interior surface, probably related to an interior loose object (case photo #57)

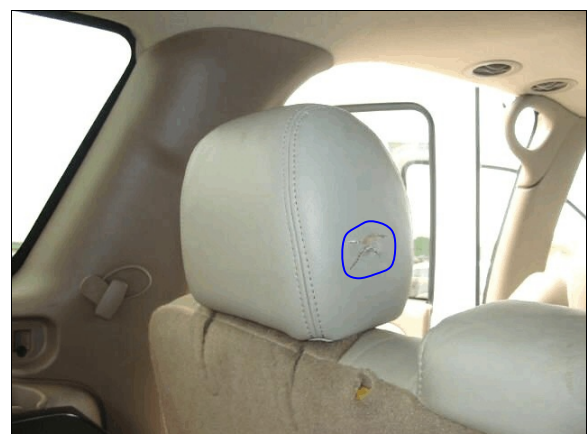
Figure 24: Close-up of contact-related tear on right side of case vehicle's second seat left headrest, probably caused by contact with an interior loose object (case photo #61)

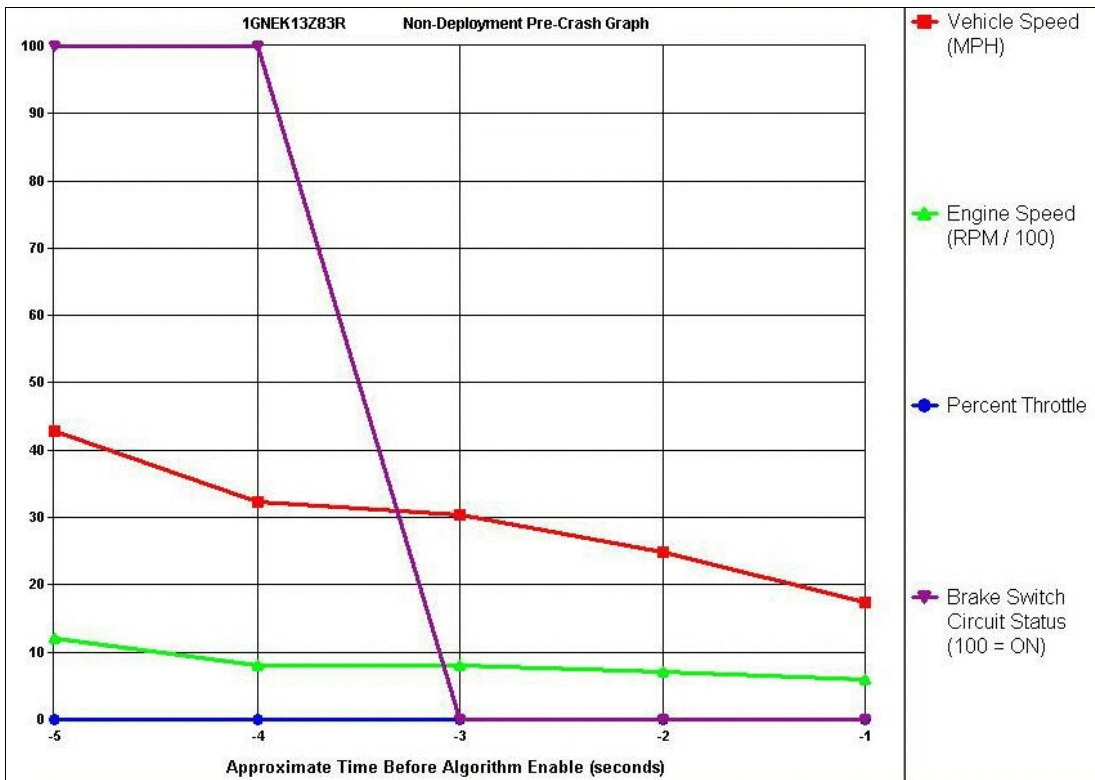
Figure 26: Case vehicle’s pre-crash speed and brake switch circuit status showing that the vehicle had decelerated to approximately 51 km.p.h. (32 m.p.h.) when the brake was activated approximately 4 seconds prior to algorithm enable.

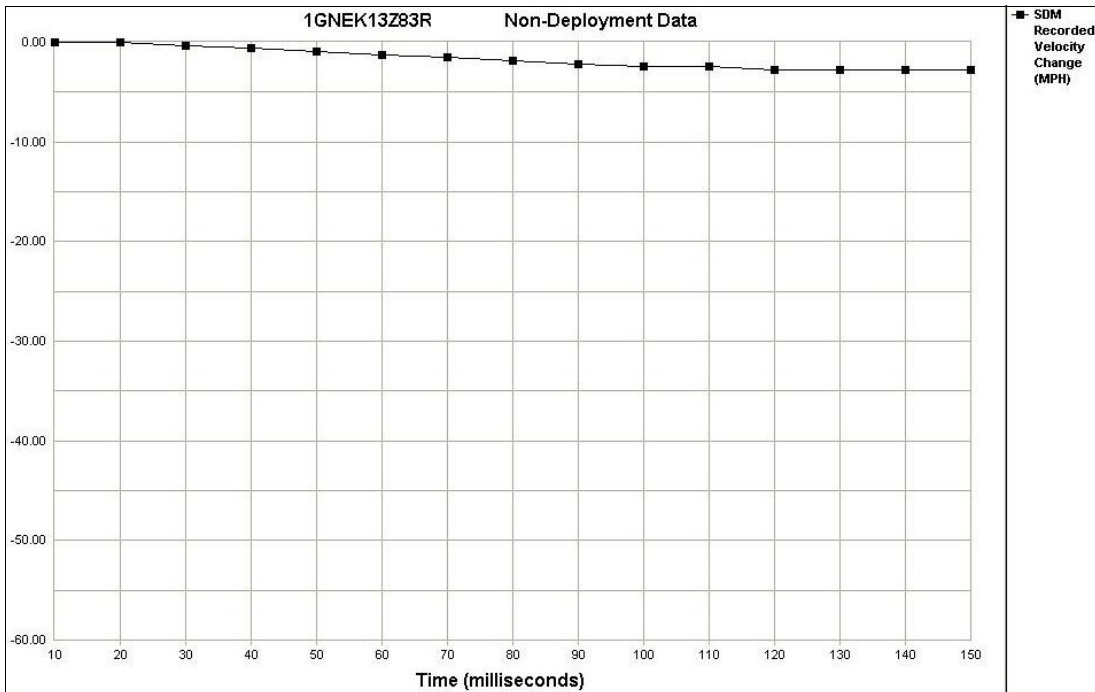
Figure 27: The case vehicle sustained a velocity change of approximately 4.5 km.p.h. (2.8 m.p.h.) during the first 150 milliseconds after the algorithm was enabled
