**ON-SITE CERTIFIED ADVANCED 208 COMPLIANT VEHICLE
CRASH INVESTIGATION**

GENERAL DYNAMICS CASE NO: CA03-045

VEHICLE: 2003 CHEVROLET TAHOE

CRASH DATE: JUNE, 2003

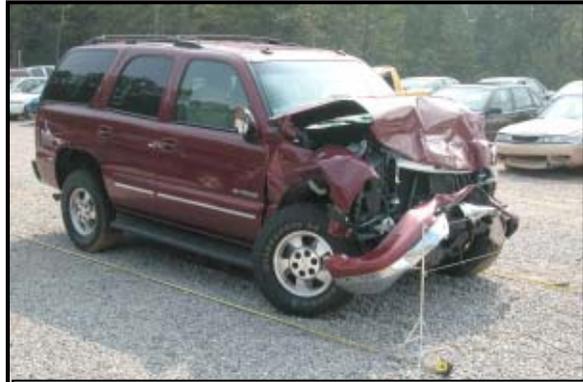
Figure 1: Right front view of the Chevrolet Tahoe.

the deployment of the frontal air bags based the crash severity and inputs from these sensors. The Chevrolet Tahoe, **Figure 1**, was involved in a front-to-side intersection crash sequence with a 2002 Chevrolet Silverado 1500 Series pick-up truck. The crash resulted in moderate frontal damage to the Tahoe and warranted the deployment of the vehicle's advanced frontal air bags. The Tahoe was equipped with an Event Data Recorder (EDR) that captured pre-crash and crash data related to the event. The EDR data was downloaded during the inspection and was used as a supplement to the on-site investigation. The Chevrolet Tahoe was occupied by a 32 year old restrained female driver, a 33 year old restrained male front right passenger, a 2 month old female passenger positioned in the second row left, a 2 year old male passenger seated in the second row right, and a 15 year old restrained female in the third row right position. The child passengers seated in the Tahoe's second row were restrained in child safety seats. The driver of the Tahoe sustained a right tibia/fibula fracture (at the ankle) and required hospitalization. The four other occupants in the Tahoe sustained minor severity injuries; however, they did not require medical attention. The 19 year old male driver of the Chevrolet Silverado suffered a police reported visible injury and was transported to a hospital.

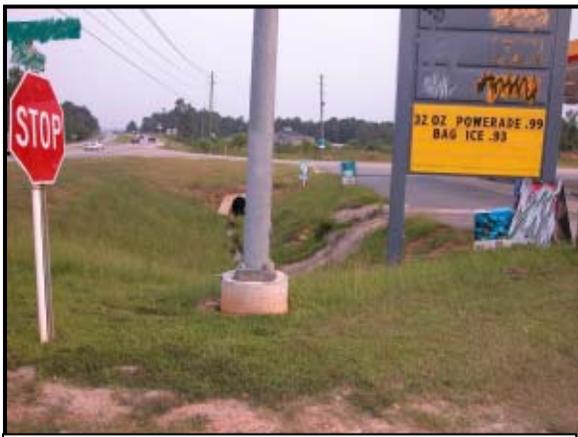
The eastbound momentum of the Tahoe and its impact forward of the Silverado's center of gravity caused the Silverado to rotate counterclockwise and the vehicles contacted again in a minor sideslap configuration. The vehicles separated from the secondary impact with a southeast trajectory. The Tahoe entered the southeast quadrant of the intersection and came to rest against the concrete base support for an overhead light, 23 m (75 ft) from the initial impact. The undamaged concrete base support measured 71 cm (28 in) in diameter and measured 43 cm (17 in) in height. The undamaged light pole measured 30 cm (12 in) in diameter and was 9 m (30 ft) tall. The Silverado departed the south road edge and drove down into the drainage area south of the road. The Silverado came to rest against the ditch embankment approximately 35 m (115 ft) from the initial point of impact. The area of the final rest locations of the vehicles is depicted in **Figure 4**. **Figure 5** is a close-up view of the concrete base support. A schematic of the crash sequence is included as **Figure 16** at the end of this narrative report.

Figure 4: View of the SE intersection quadrant and the area of final rest.

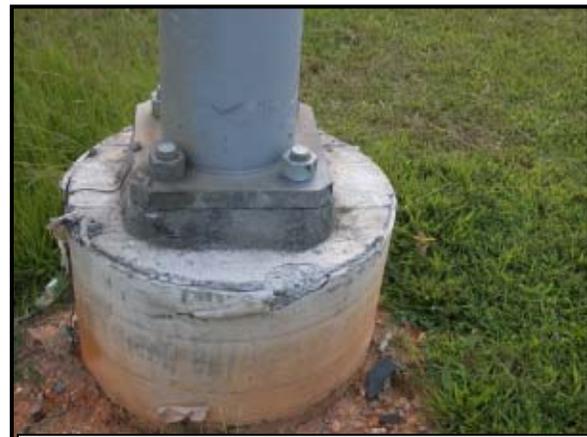
Figure 5: View of the concrete base support.

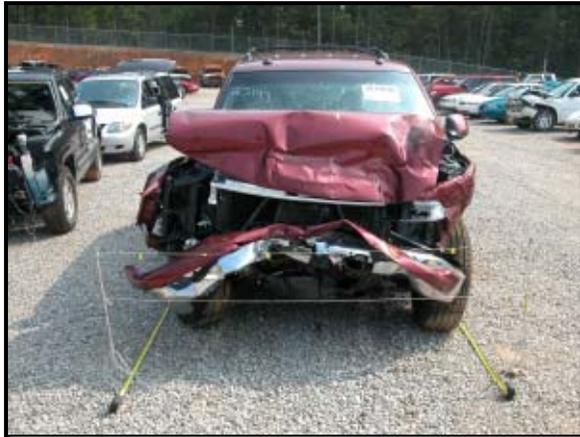
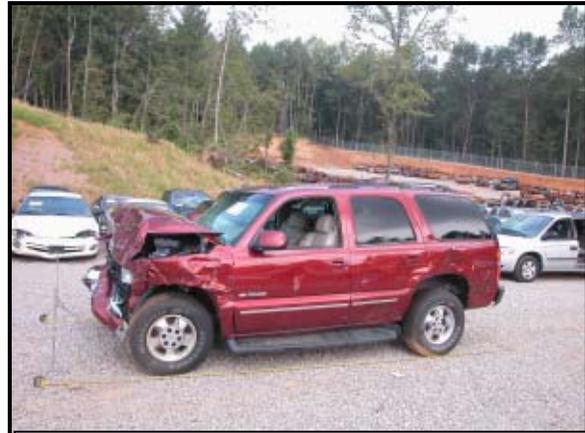
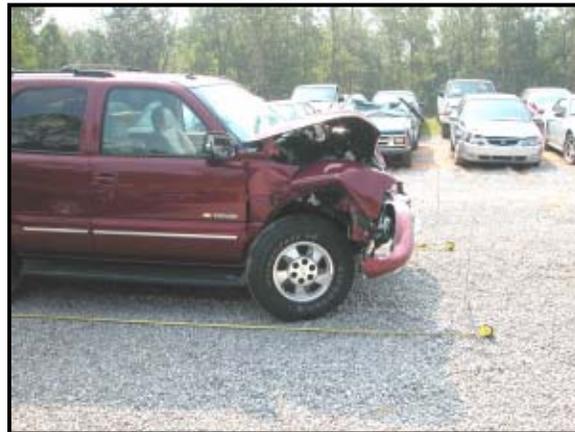
Figures 6 through 8 are the front, left side, and right lateral views of the Chevrolet Tahoe. The Tahoe's front plane sustained 167.6 cm (66.0 in) of direct contact damage that extended across its entire front end width. The damaged components included: the front bumper system, radiator, air conditioning condenser, headlamp assemblies, hood, and the left and right fenders. The residual crush profile measured along the front bumper was as follows: C1 = 26.0 cm (10.2 in), C2 = 31.0 cm (12.2 in), C3 = 42.0 cm (16.5 in), C4 = 43.0 cm (16.9 in), C5 = 23.0 cm (9.1 in), C6 = 23.0 cm (9.1 in). The maximum crush measured 49.0 cm (19.3 in) and was located 9.1 cm (3.6 in) right of vehicle centerline. The lateral momentum of the Silverado at engagement caused 30 cm (12 in) right end shift to the Tahoe. A 36 cm (14 in) black scuff mark was identified on the right aspect of the bumper cover. The scuff was attributed to contact with the right front tire of the Silverado at impact. The left and right wheelbase measurements were reduced 2.5 cm (1.0 in) and 18.0 cm (7.1 in), respectively. The lower aspect of the windshield fractured from the exterior crash force. The left front window glazing disintegrated. All the doors remained closed during the impact and were operational at inspection. The principle direction of the impact force was in the 11 o'clock sector. The Collision Deformation Classification was 71-FDEW-2. (The CDC was incremented by 60 to reflect the right end shift of the damage.) The total delta-V of the Tahoe calculated by the Missing Vehicle Algorithm of the WINSMASH model was 40 km/h (24.8 mph). The longitudinal and lateral components of the delta-V were -34.7 km/h (-21.6 mph) and 20.0 km/h (12.4 mph), respectively. The calculated

longitudinal delta-V component was in agreement with the -33.3 km/h (-20.7 mph) delta-V recorded by the Tahoe's EDR.

The left side of the Tahoe sustained localized abrasions and paint transfers to the body panels that extended from the left front fender to the left rear quarterpanel as a result of the secondary sideslap engagement with the Silverado. Additionally, the left rear quarterpanel was deformed immediately above of the left rear tire over a 65.5 cm (25.8 in) length from direct contact with the right rear corner of the Silverado. The maximum crush within the deformed area measured 5.6 cm (2.2 in) and was located 14.5 cm (5.7 in) aft of the left rear axle. The CDC of the side slap engagement was 09-LDMW-1.

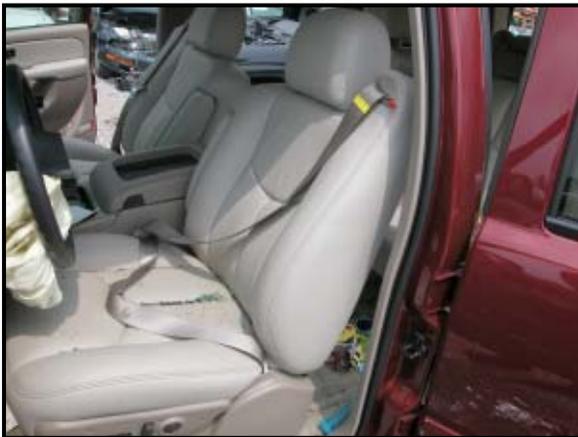
The manual restraint system in the front row of the Tahoe consisted of integrated 3-point lap and shoulder belts with continuous loop webbing and sliding latch plates. The driver's restraint was stowed within the ELR retractor upon inspection. Examination of the latch plate revealed minor indications of historical use consistent with the age of the vehicle. Inspection of the webbing revealed crash related evidence at the latch plate and belt guide of the integrated restraint consistent with the restraint being worn at the time of the crash, **Figure 9**. A crease in the webbing from loading at the latch plate was located 75.0 cm (29.5 in) above the outboard anchor. A webbing crease was identified at the belt guide with the webbing extended and buckled. The location of the crease measured 127.5 cm (50.2 in) from the outboard anchor. The SCI inspection determined the driver was restrained at the time of the crash. This determination was consistent with the downloaded EDR data; the EDR data indicated the driver restraint was buckled at the time of the crash.

Figure 9: Driver's restraint.

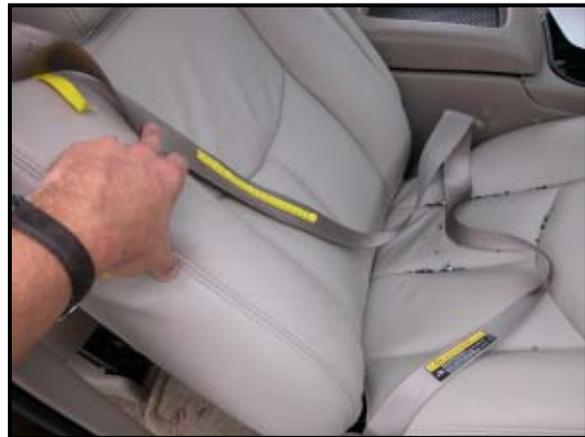
The front right passenger's integrated restraint was stowed at the time of the inspection. Examination of the latch plate revealed historical usage marks consistent with the vehicle's age. Crash related evidence was identified on the extended webbing consistent with the restraint being used at the impact, **Figure 10**. A crease in the webbing from the latch plate loading was located 75.7 cm (29.8 in) above the outboard anchor and a crease in the webbing was located 163 cm (64 in) above the anchor at the belt guide. A 16.5 cm (6.5 in) abrasion was noted on the body side of the restraint webbing. The abrasion began 122 cm (48 in) above the anchor. All evidence gathered at the SCI inspection indicated the front right passenger was restrained at the time of the crash.

Figure 10 Front right passenger's restraint.

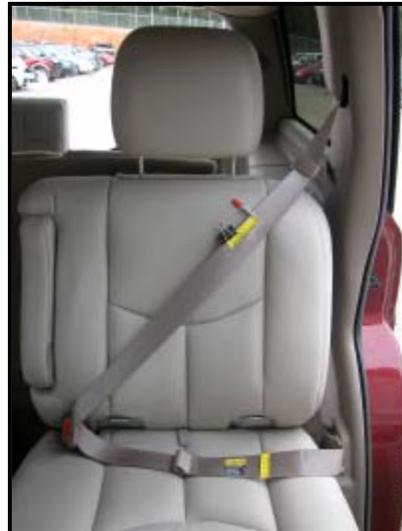
reported that she had installed the infant seat in a rear-facing direction using both the latch belt and the vehicle's manual restraint. She further stated that she installed the seat utilizing the switchable retractor. She was familiar with child seat installation with through experience (this was her second child). She reported that she had read the vehicle's owner's manual regarding the operation of the switchable retractors and routed the belt using the labeling on the restraint. Upon inspection, the manual restraint, **Figure 11**, was stowed within the retractor and the retractor was operational. Examination of the latch plate revealed historical use consistent with the vehicle's age. A 1.2 cm (0.5 in) crease of the webbing located 26.7 cm (10.5 in) above the outboard anchor was identified. This crease was attributed to probable contact with the base of the infant restraint at the time of the crash. A 5 cm (2 in) longitudinal crease of unknown origin was located 112 – 117 cm (44 - 46 in) above the anchor.

Figure 11: Second row left seat.

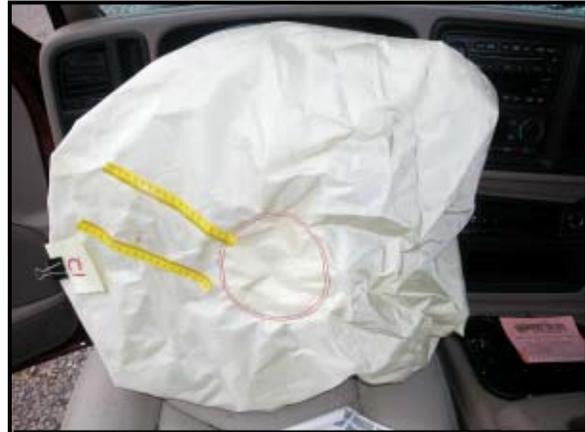
The driver air bag module was located in the center hub of the steering wheel. The symmetrical I-configuration module cover flaps measured 6.4 cm x 11.7 cm (2.5 in x 4.6 in), width by height. The flaps opened along the designated tear seams and were not damaged. There was no evidence of occupant contact to the flaps. The diameter of the deployed driver air bag, **Figure 12**, measured 64 cm (25 in) in its deflated state. It was tethered by two 8 cm (3 in) wide straps and vented by two ports located in the 11/1 o'clock sectors on the back side of the bag. A 5 cm x 13 cm (2 in x 5 in) scuff was identified in the 1 o'clock sector on the face of the bag. The center of the scuff was located 15 cm (6 in) from the center of the bag. A (post-crash) blood transfer was noted within the scuffed area. The scuffed area was attributed to contact with the driver's chest and face during the ride-down of the crash. The contact to the driver air bag resulted in a minor forehead abrasion.

Figure 12: Driver air bag. Note the 90 degree CCW rotation of the steering wheel.

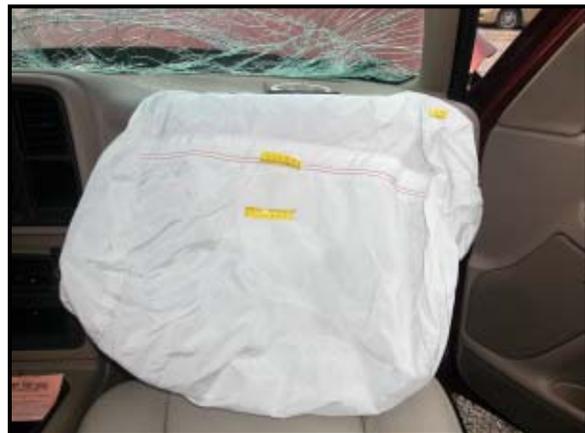
The front right passenger air bag was a mid-mount design located in the right aspect of the instrument panel. The module cover flap was rectangular and measured 38 cm x 11.4 cm (15 in x 4.5 in), width by height. The vinyl cover flap was hinged along its top edge and opened along the designated tear seams. There was no occupant contact to the cover flap. The face of the deployed front right passenger air bag, **Figure 13**, measured 64 cm x 71 cm (25 in x 28 in). The rearward excursion of the bag measured 56 cm (22 in). The bag was tethered by a 30 cm (12 in) wide strap and vented by two 2.5 cm (1.0 in) ports located on the side panels. A 3.8 cm x 5.1 cm (1.5 in x 2.0 in) area of blood and body fluid (nasal expulsion) was located on the centerline of the air bag 5.1 cm (2.0 in) below the tethered stitching. This evidence was attributed to direct contact with the face of the front right occupant during the ride-down of the crash. A post-crash blood transfer was located on the right aspect of the bag's top surface, 5 cm (2 in) forward of the face of the bag. The front right passenger reportedly wore prescription glasses and sustained a bloody nose as a result of the contact to the air bag.

Figure 13: View of the PAB.

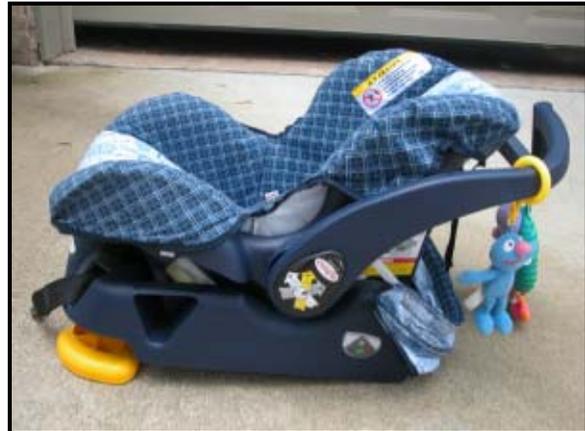
At the time of the crash, the 2 month old infant was transported in an Evenflo Port-About rear-facing infant carrier with a detachable base, **Figure 14**. The infant seat's date of manufacture was 17-Feb-2003 and the Model Number was 3741351 P1. This seat had been purchased new, approximately one week before the birth of this child. The carrier was designed for infants with a weight and height of 2.3 - 10 kg (5 - 22 lb) and 48 - 66 cm (19 - 26 in). It was equipped with a 3-point harness and two piece chest clip. The harness was routed through the middle slots in the carrier. Comfort sleeves were added to the harness for extra padding at the infant's shoulders. The driver estimated the harness was at the level of the infant's shoulders.

Figure 14: View of the infant carrier.

The detachable base had an adjustable foot to control the installed angle of the seat and it was equipped with a latch belt. The driver (mother) installed the seat and was familiar with the installation by experience and by referring to the labeling. The infant seat was installed in the left position of the second row. A folded towel was placed under the foot and the foot was adjusted to its mid position. The base was installed using both the latch belt and with the vehicle's 3-point safety belt utilizing the switchable retractor. The driver indicated she compressed the seat while tightening the belts. She noted the angle indicator for the carrier was in the "green". Inspection of the seat was unremarkable. The cloth cover was fully removed and inspected for damage. There was no evidence of damage to the shell or to the harness.

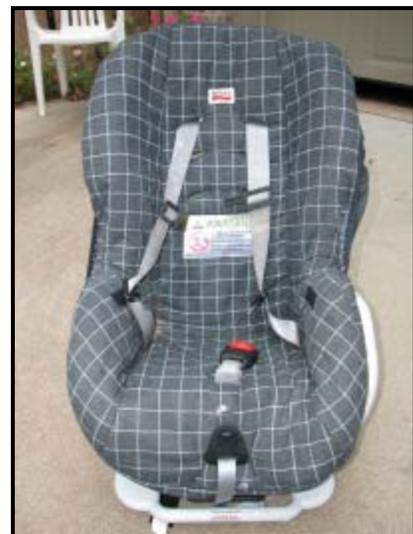
The 2 year old male was transported in a Britax Roundabout convertible seat, **Figure 15**. This seat had a manufacture date of May 14, 2001. The Model, Serial, and Batch numbers for the seat were as follows: E900230, E9002304088, 501063. The seat was designed for rear-facing use by infants 2.3 - 14 kg (5 - 30 lb) and for forward facing use by toddlers 9 - 18 kg (20 - 40 lb). The seat was equipped with a 5-point harness, two-piece chest clip, and a tether strap. The harness straps were routed through the top slots of the seat. The driver indicated that the seat was purchased new for the birth of this male child and had been used routinely since his birth.

Figure 15: View of the convertible seat.

was routed under the head restraint and attached to the tether anchor on the seat frame. Inspection of the seat was unremarkable. There was no damage identified on the shell of the seat or the harness straps.
