**CALSPAN ON-SITE CERTIFIED ADVANCED 208-COMPLIANT
VEHICLE CRASH INVESTIGATION**

SCI CASE NO: CA03-061

**VEHICLE: 2003 GMC SIERRA PICK-UP TRUCK
LOCATION: MICHIGAN
CRASH DATE: OCTOBER 2003**

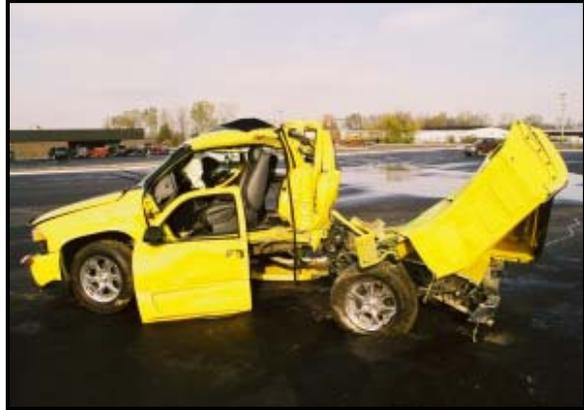
Figure 1: Left side view of the GMC Sierra.

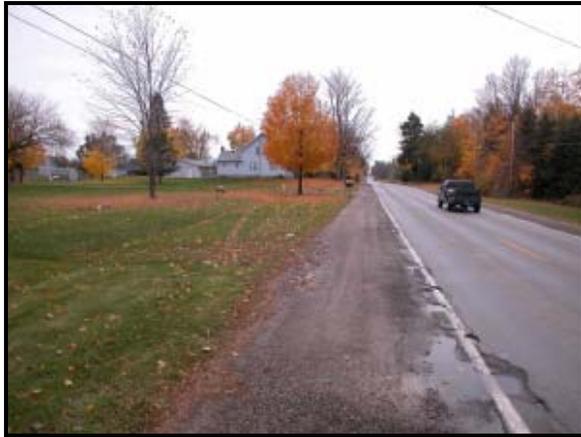
Figure 2 South view of the crash site.

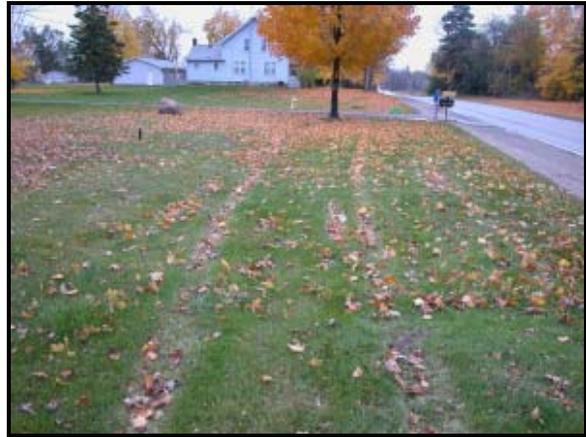
This run-off road/fixed object crash occurred during the daytime hours of October 2003. At the time of the crash, the weather was clear with no adverse conditions; however, the asphalt roadway surface was wet from prior rain. The crash occurred off the east side of a two-lane north/south roadway in the yard of a private residence. The road was straight and level in the area of the crash and the traffic lanes measured 3.1 m (10.2 ft) in width. The lanes were separated by a broken yellow centerline and bordered by white fog lines. There was a 2.2 m (7.2 ft) wide gravel shoulder east of the road edge that separated the grass lawns from the road. **Figure 2** is a southbound trajectory view of the crash site. The point of impact was a 29 cm (11.4 in) diameter hardwood tree positioned 7 m (22.9 ft) east of the road edge and 2.4 m (8 ft) north of a private driveway. The SCI inspection of the crash site identified 37.4 m (122.8 ft) of yaw marks through the grass indicative of the GMC’s trajectory. The yaw marks were diverging indicating the vehicle was rotating clockwise. Refer to **Figure 3**. The yaw marks led directly to

Figure 3: Trajectory view of the yaw marks leading to the point of impact.

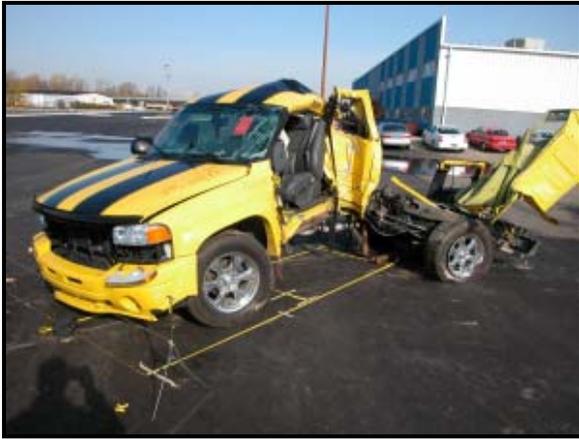
Figures 4 and 5 are the left front oblique and left side views of the exterior damage to the GMC. The vehicle sustained severe damage as a result of the impact with the tree. The direct contact damage consisted of the laterally deformed left sill, left front and rear doors, and the left roof rail. The tree pocketed at the C-pillar area resulting in a J-patterned crush profile, **Figure 6**. The combined length of the direct and induced damage measured 180 cm (71 in). The induced damage began 152 cm (60 in) rearward of the front of the vehicle at the leading edge of the left front door. The direct contact began 224 cm (88 in) rearward of the front of the vehicle of the aft aspect of the left front door. The length of the direct contact measured 109 cm (43 in). The residual crush profile was measured at the left sill and was as follows: C1 = 40 cm (15.5 in), C2 = 50 cm (19.8 in), C3 = 34 cm (13.2 in), C4 = 23 cm (8.9 in), C5 = 15 cm (5.9 in), C6 = 0. The maximum crush was located at C1 in the area of the pocketing 333 cm (131 in) rearward of the front of the vehicle. The windshield was cracked and separated at the lower left A-pillar as a result of the vehicle deformation. The left windows and backlight disintegrated. The force of the crush resulted in severe induced damage to the frame of the truck aft of the cab. The sheet metal, side cladding and bed of the pick-up separated. The non-metallic fuel tank was deformed from the bending of the frame. This resulted in a partial separation of the sending unit and fuel leakage from the tank. The Collision Deformation Classification (CDC) for this impact was 10-LPAW3.

Figure 4: Left front view of the GMC.

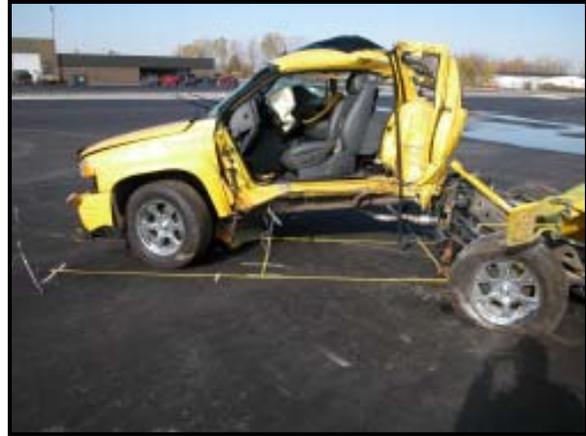
Figure 5: Left side view.

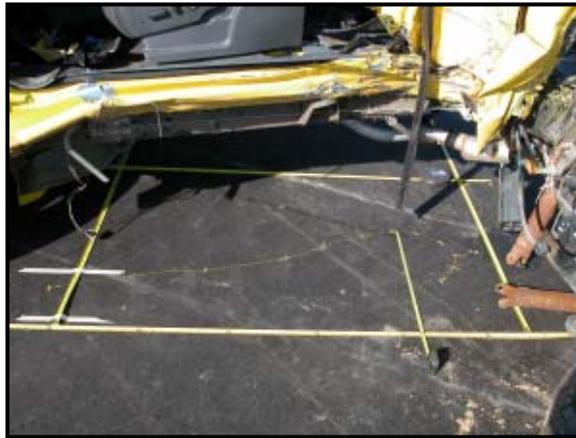
Figure 6: View of the crush profile of the left sill.

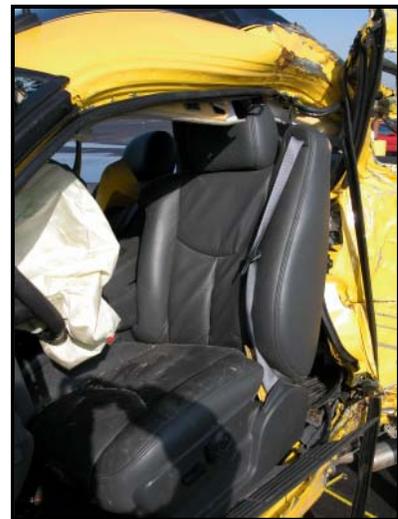
The interior damage to the GMC consisted of moderate intrusion, deployment of the driver air bag and the driver's interior contacts. The left roof rail deformed laterally inboard and was in close proximity to the head restraint. The intrusion at the mid-aspect of the roof rail was 38 cm (15 in.) and increased to 50 cm (19.5 in.) at the C-pillar location. The left rear door intruded into the left rear interior space due to the pocketing of the tree. The left rear door intrusion measured 72 cm (28.5 in) at the leading edge of the bench seat. The roof deformed downward intruding 41 cm (16 in) the left rear position.

Figure 7: Left interior view.

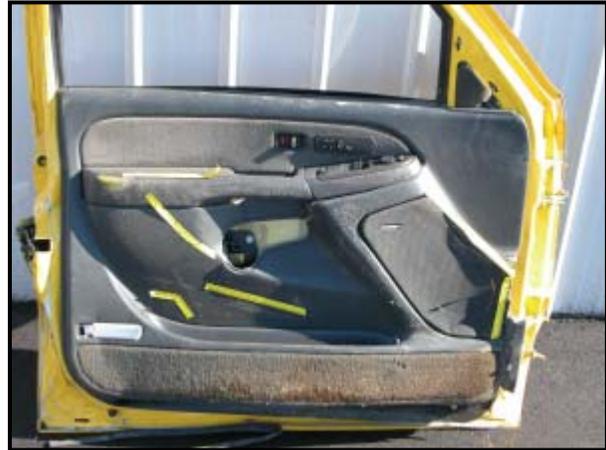
The interior occupant contacts consisted of the driver's lower extremity contact to the knee bolster and his left flank contact to the left front door panel. The left lower aspect of the knee bolster was fractured over an 8 cm (3 in) area. The parking brake lever was bent to the left. The left door panel was heavily scuffed during the ejection sequence, **Figure 8**. The lower forward aspect of the door panel exhibited a 25 cm x 10 cm (10 in x 4 in) contact area from the left lower extremity. There was a 36 cm (14 in) linear abrasion to the lower center aspect of the panel above the map pocket. A 13 cm x 13 cm (6 in x 6 in) triangular shaped pattern was located on the arm rest. The flow of these contact patterns was rearward and upward consistent with the driver's ejection path.

Figure 8: View of the driver contact to the left door panel.
