**GENERAL DYNAMICS ON-SITE CERTIFIED 208-ADVANCED COMPLIANT
VEHICLE CRASH INVESTIGATION**

GENERAL DYNAMICS CASE NO: CA03-065

VEHICLE: 2004 GMC YUKON

CRASH DATE: OCTOBER 2003

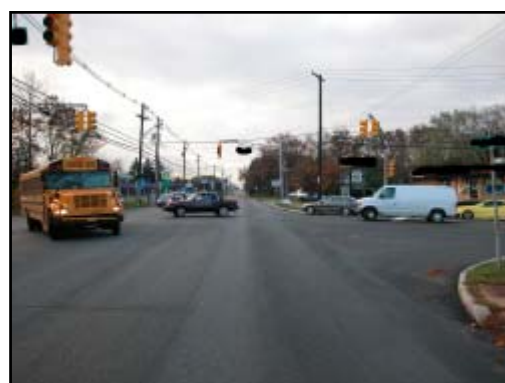
The driver of the Toyota initiated a left turn across the path of the oncoming GMC. The frontal aspect of the GMC impacted the right side of the Toyota in the intersection (**Figure 4**). The resultant directions of force were with the 11 o'clock sector for the GMC and 2 o'clock sector for the Toyota. The GMC's EDR recorded a maximum delta V of -16.2 km/h (-10.1 mph). A WinSmash missing vehicle algorithm computed a total delta V for the GMC of 17.0 km/h (10.6 mph). The longitudinal and lateral components for the GMC were -16.0 km/h (-9.9 mph) and 5.8 km/h (3.6 mph) respectively. The total delta V calculated by the missing vehicle algorithm for the Toyota was 36.0 km/h (22.4 mph). The calculated longitudinal and lateral components for the Toyota were -23.1 km/h (-14.4 mph) and -27.6 km/h (-17.1 mph) respectively.

Figure 4. Area of impact from southbound approach.

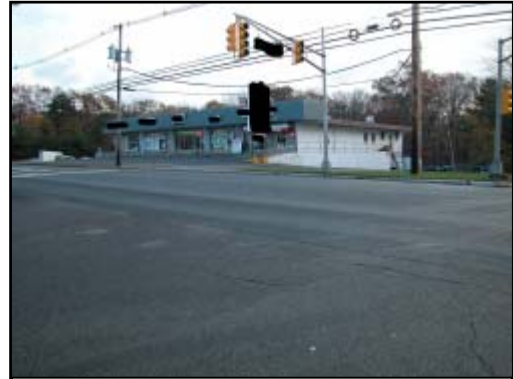
The GMC was deflected laterally right as its center of gravity continued forward. The Toyota was rotated counterclockwise. The frontal aspect of the Toyota sideswiped the left side of the GMC. The resultant direction of force for the secondary impact was within the 12 o'clock sector for the GMC. The GMC continued its trajectory and entered the westbound lane. The front right corner area of the GMC impacted the frontal aspect of the stopped Ford Taurus (**Figure 5**). All three vehicles came to rest in the southeast quadrant of the intersection.

Figure 5. Area of impact between GMC and stopped Ford.

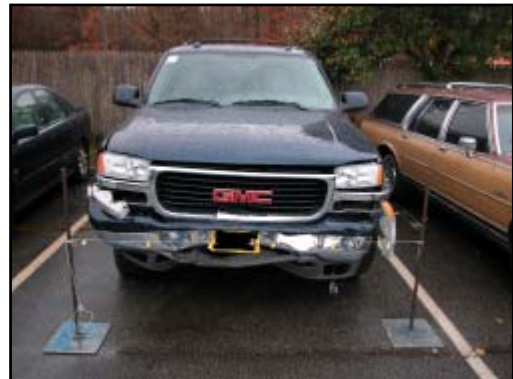
The 2004 GMC Yukon sustained moderate damage as a result of the multiple impacts (**Figure 6**). The damage for the impact with the Toyota consisted of a longitudinally displaced bumper, fractured grille, and displaced left and right turn signal lenses. The direct contact damage began on the front left bumper corner and extended 150.0 cm (59.4”) to the right. Maximum crush was located 17.0cm (6.7”) right of the vehicle’s centerline and measured 6.0 cm (6.3”). Six crush measurements were documented at the bumper level using a combined direct and induced damage width of 173.0 cm (68.1”) and were as follows: C1=10.0 cm (3.9”), C2=9.0 cm (3.5”), C3= 10.0 cm (3.9”), C4= 16.0 cm (6.3”), C5= 8.0 cm (3.1”), C6= 7.0 cm (2.8”). The Collision Deformation Classification (CDC) for this impact was 11-FDEW-1.

Figure 6. Frontal view of damaged 2004 GMC Yukon.

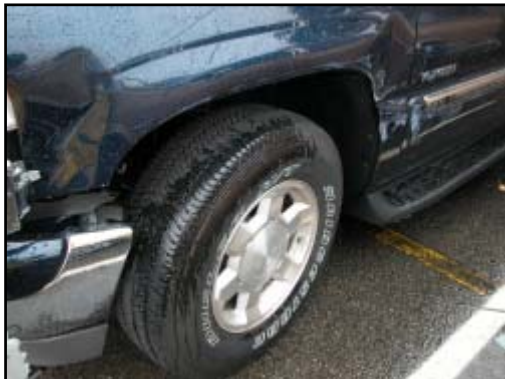
The damage from the second impact with the Toyota consisted of a large scuffmark and a minor dent from sideswipe-type damage on the front left side (**Figure 7**). The direct damage width was 168.0 cm (66.1”) and began 177.0 cm (69.7”) forward of the left rear axle and extended forward. Maximum crush was located at the rear aspect of the front left fender and was approximately 2.5 cm (1.0”). No crush measurements were obtained for this impact. The CDC for this impact was 12-LYES-1

Figure 7. Sideswipe damage from second impact with the Toyota.

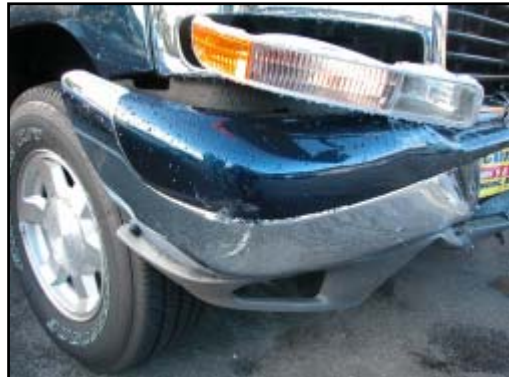
The damage from the impact with the Ford consisted of a 9.0 cm (3.5”) scuffmark on the right front bumper corner (**Figure 8**). No residual crush was present from this impact. The CDC for this impact was 12-FRLS-1.

Figure 8. Damage from impact with Ford.

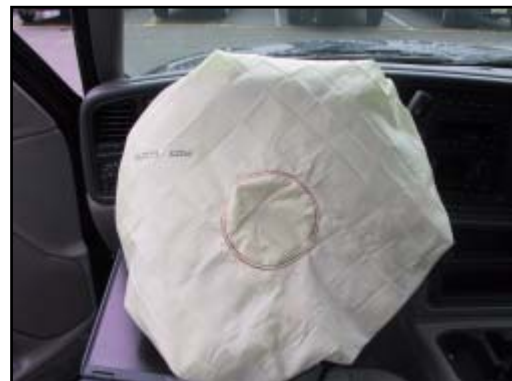
The 2004 GMC Yukon was equipped with a Certified Advanced 208-Compliant safety system. The system consisted of dual-stage frontal air bags, a passenger presence sensor for the front right seat and seat track positioning sensors for the front left and front right seats. The system was monitored and controlled by a Sensing and Diagnostic control Module (SDM) that was located on the floor under the driver’s seat. The SDM deployed the appropriate safety component(s) dependant on occupant presence, belt usage, seat track position and crash severity. In this crash, the SDM commanded a stage one deployment of the driver’s air bag at 40 milliseconds. The driver’s air bag module was located in the center of the steering wheel hub (**Figure 9**).

Figure 9. Deployed driver's frontal air bag.

The air bag was 61.0 cm (24.0”) in diameter and contained two tethers and was vented by two vent ports at the 11 and 1 o’clock positions on the rear aspect of the air bag. The front right seat was not occupied during the crash; therefore the system did not deploy the front right air bag. The GMC was also equipped seatback mounted side impact air bags for the front seating positions. The side impact air bags did not deploy in this crash.

Algorithm Enable (AE). The EDR also indicates that the driver applied the brakes and slowed the vehicle to 45.1 km/h (28.0 mph) one-second prior to AE. The maximum delta V recorded by the EDR was of -16.2 km/h (-10.1 mph) at 180 milliseconds. The SDM commanded a stage one deployment of the driver's air bag at 40 milliseconds, in this crash. The EDR recorded one event for this crash, although two others occurred. The front right air bag did not deploy, as the front right seat was not occupied. The EDR data is included as **Attachment A** of this report.

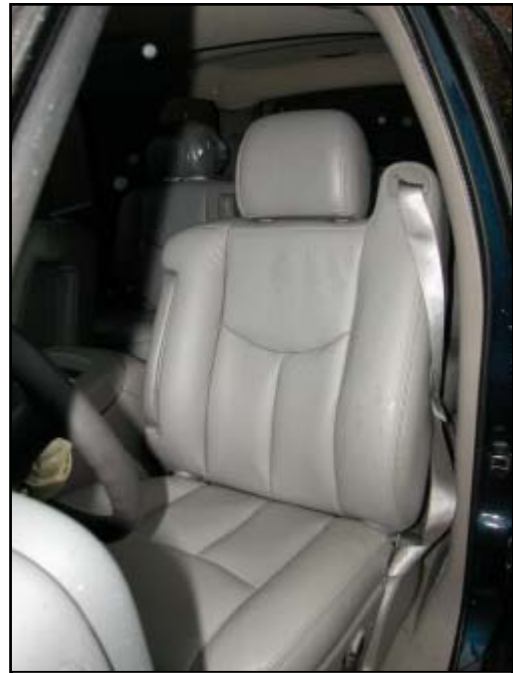
The 2004 GMC Yukon was equipped with integrated manual 3-point lap and shoulder safety belts for the front left (**Figure 10**) and front right seating positions. The front left safety belt was configured with a sliding latch plate and a belt sensitive emergency locking retractor (ELR). The driver utilized the safety belt during this crash. However, no loading evidence was present on the safety belt. The front right safety belt was configured with a sliding latch plate and switchable ELR/Automatic Locking Retractor (ALR). The second row was equipped with manual 3-point manual lap and shoulder belts that were configured with sliding latch plates and switchable ELR/ALR retractors. The third row was equipped with integrated manual 3-point lap and shoulder belts for the outboard seats and a manual 2-point lap belt for the center position. The outboard safety belts were configured with sliding latch plates and switchable ELR/ALR retractors and the center belt was configured with a locking latch plate and no retractor.

Figure 10. Driver's integrated safety belt.

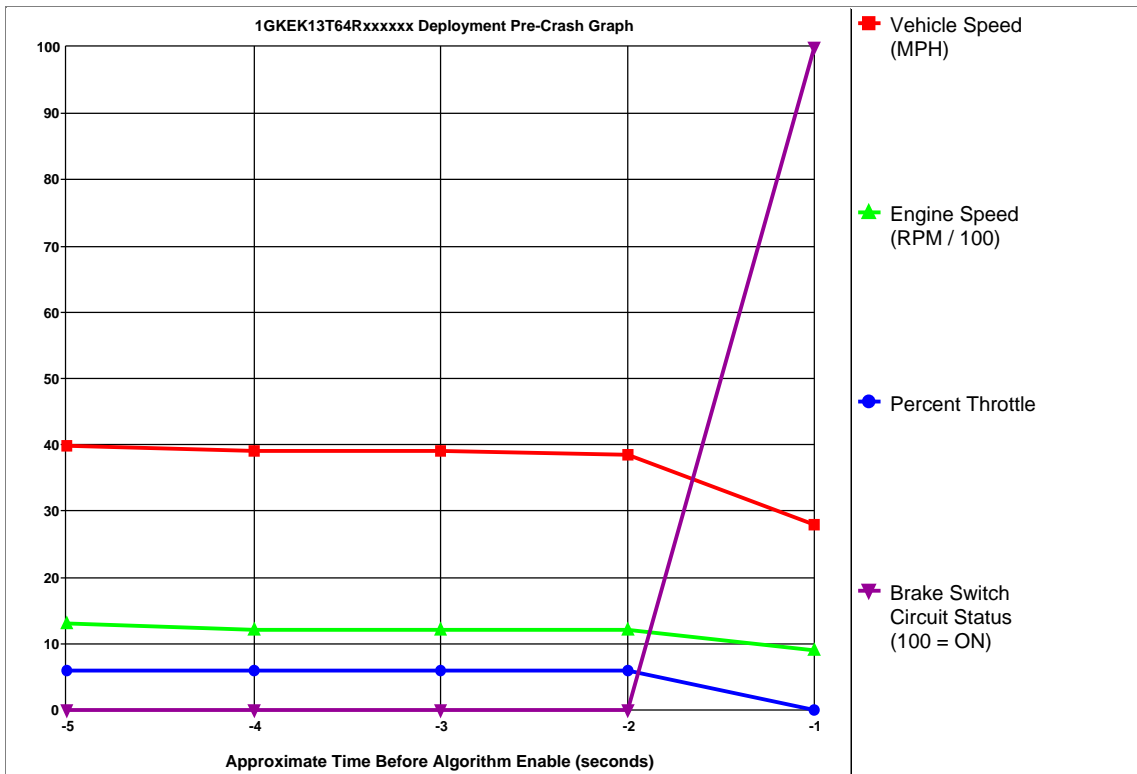
Seconds Before AE	Vehicle Speed (MPH)	Engine Speed (RPM)	Percent Throttle	Brake Switch Circuit Status
-5	40	1280	6	OFF
-4	39	1216	6	OFF
-3	39	1216	6	OFF
-2	39	1216	6	OFF
-1	28	896	0	ON

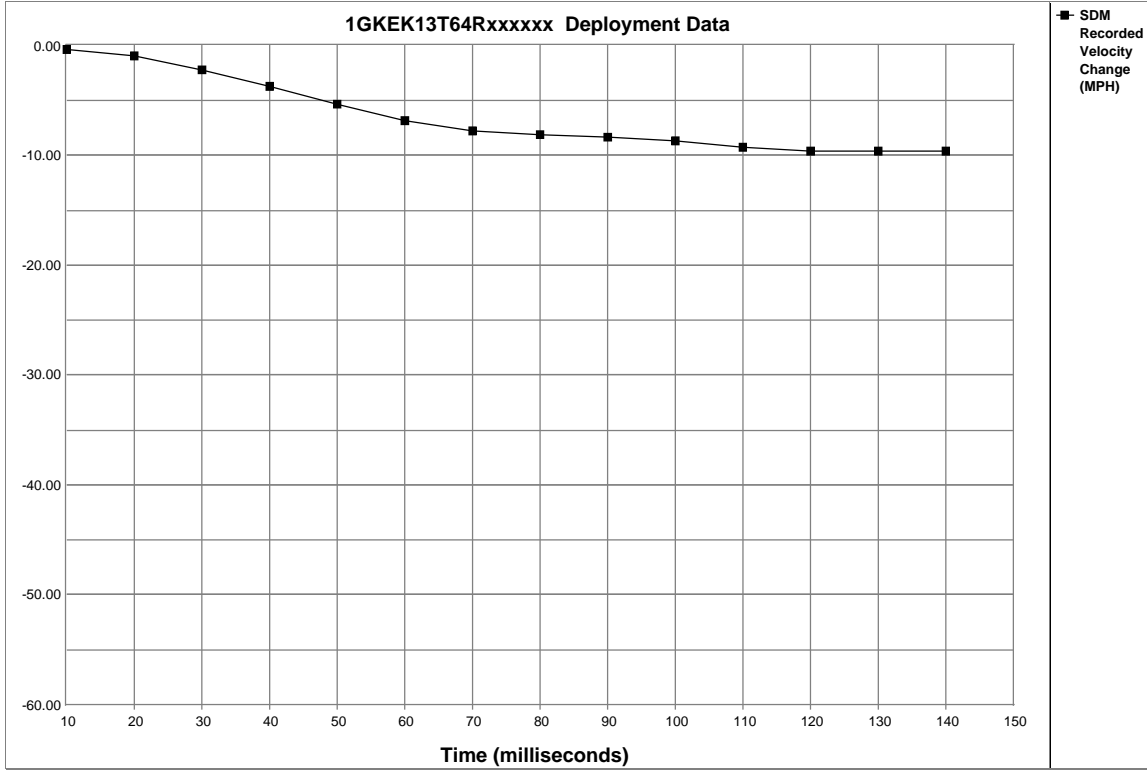
Time (milliseconds)	10	20	30	40	50	60	70	80	90	100	110	120	130	140	150
Recorded Velocity Change (MPH)	-0.31	-0.93	-2.17	-3.72	-5.27	-6.82	-7.75	-8.06	-8.37	-8.68	-9.30	-9.61	-9.61	-9.61	N/A
