**TRANSPORTATION SCIENCES
CRASH DATA RESEARCH CENTER**

SCI TECHNICAL SUMMARY REPORT

NASS/SCI COMBO CASE NO. 2004-47-013C

VEHICLE – 2004 FORD F-150

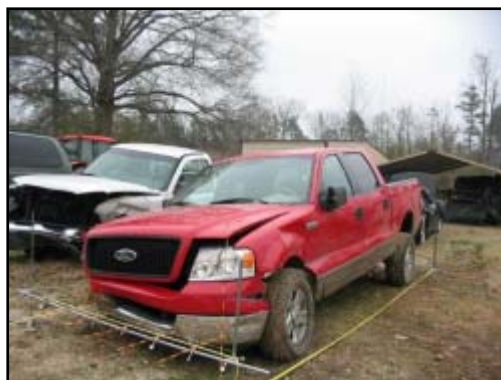
Figure 1. Subject vehicle 2004 Ford F-150.

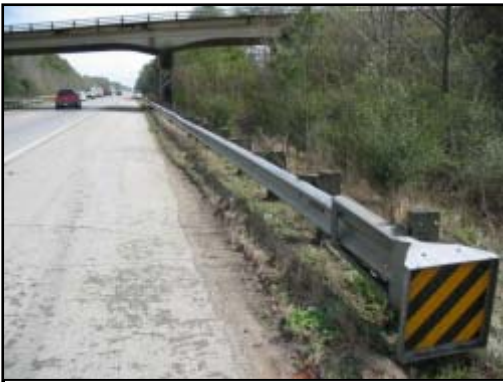
The front right aspect of the Ford impacted the W-beam guardrail (**Figure 3**) in a swiping impact configuration. The resulting direction of force was within the 12 o'clock sector. The WINSMASH program was not used to calculate a delta V for this impact due to the Ford sustaining multiple overlapping frontal impacts.

Figure 3. Impact to the first W-beam guardrail.

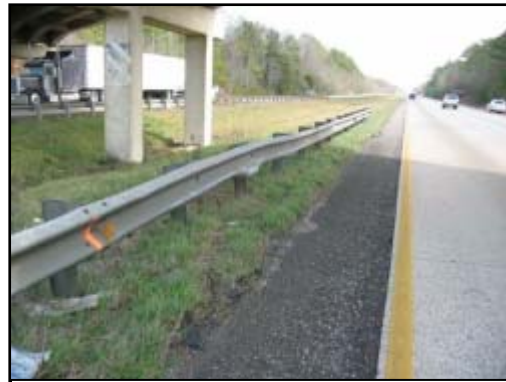
The Ford was subsequently redirected and began to travel in a northeast direction. The Ford departed the left (north) road edge and the front left bumper corner of the Ford impacted a second W-beam guardrail (**Figure 4**). The resultant direction of force was 12 o'clock for this impact. The residual damage was of a sideswiping pattern that began at the front left bumper corner and extended down the left side plane of the vehicle. Due to the damage type and the multiple overlapping frontal impacts, the WINSMASH program was not used to calculate a delta V for this event.

Figure 4. Impact to the second W-beam guardrail.

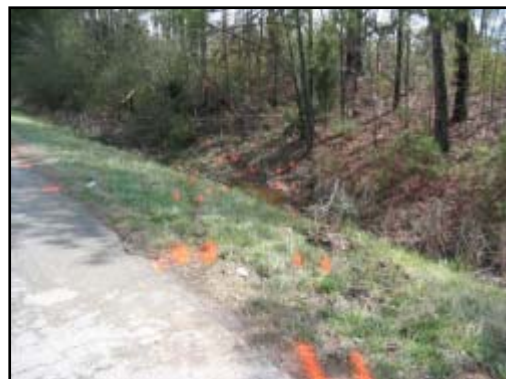
The second guardrail impact redirected the Ford back onto the travel lanes. The Ford departed the left (south) road edge and impacted a ditch (**Figure 5**) with its frontal plane. The resultant direction of force for this impact was 12 o'clock. The SCI investigator used the WINSMASH barrier equivalent algorithm to calculate a delta V for this event since the impact involved the full frontal

Figure 5. Area of ditch impact.

width of the vehicle. The total delta V was 20.0 km/h (12.4 mph). The longitudinal and lateral components were -20.0 km/h (-12.4 mph) and 0.0 km/h, respectively. The NASS researcher did not calculate a delta V due to multiple overlapping frontal impacts.

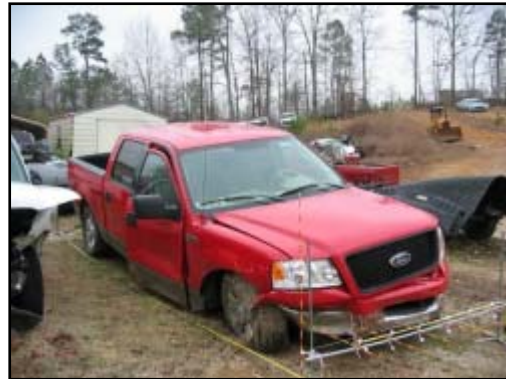
The 2004 Ford F-150 sustained moderate severity damage as a result of the initial impact with the W-beam guardrail (**Figure 6**). The direct damage began at the front right bumper corner and extended down the right side to the right rear bumper corner. The NASS researcher did not document a crush profile or direct damage length due to the multiple overlapping impacts. The damage consisted of longitudinal deformation of the front bumper and the rear right bumper was displaced longitudinally rearward. The Collision Deformation Classification (CDC) for this impact was 12-FREE-9.

Figure 6. Front right damage from the first W-beam guardrail impact.

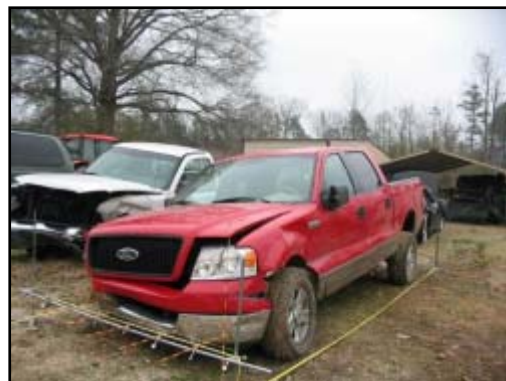
The Ford sustained minor severity damage as a result of the second W-beam guardrail impact (**Figure 7**). The NASS researcher did not document direct damage width or a crush profile. The damage consisted of longitudinally oriented abrasions on the front left bumper corner and the left side plane of the Ford. The lower aspect of the bumper fascia was comprised of metal and the upper aspect was plastic. The front left corner of the plastic was fractured from this impact. The left side sustained lateral deformation that began at the leading edge of the front left fender and extended the length of the vehicle. The CDC for this impact was 12-FLES-9.

Figure 7. Front left and left side damage from the second W-beam guardrail impact.

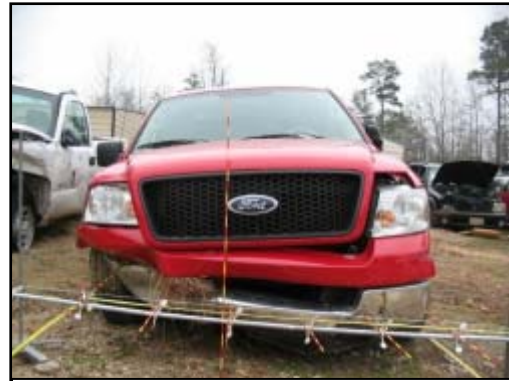
The Ford sustained moderate severity frontal damage as a result of the impact with the ditch (**Figure 8**). The direct damage began at the front right bumper corner and extended left 153.0 cm (60.2"). The maximum crush was located at the front right bumper corner and measured 25.0 cm (9.8"). It should be noted that this damage resulted from the initial W-beam guardrail impact and the subsequent ditch impact. The damage consisted of longitudinal deformation of the front bumper which was displaced rearward and punctured the front right tire. The NASS researcher noted that the right wheelbase was elongated 7.0 cm (2.8") from damaged suspension components. Six equidistant measurement were documented along the front bumper using a combined direct and induced damage width of 196.0 cm (77.2") and were as follows: C1 = 9.0 cm (3.5"), C2 = 6.0 cm (2.4"), C3 = 14.0 cm (5.5"), C4 = 16.0 cm (6.3"), C5 = 11.0 cm (4.3"), C6 = 25.0 cm (9.8"). The NASS researcher documented CDC for this impact was 12-FDLW-2. Based on the SCI evaluation of the damage, the CDC was revised to 12-FDLW-1 to reflect the maximum crush of 25.0 cm (9.8").

Figure 8. Frontal damage from the ditch impact.

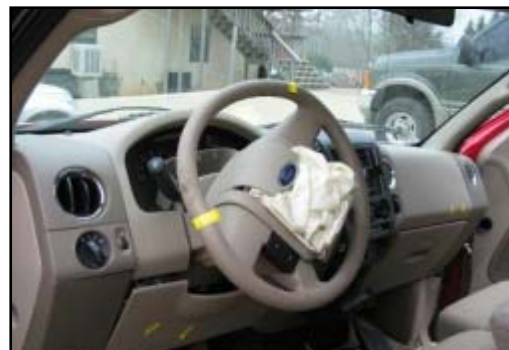
The 2004 Ford F-150 sustained minor damage as a result of occupant contacts (**Figure 9**). There was no intrusion of the passenger compartment. The NASS researcher noted steering wheel deformation as a result of loading from the driver's chest. Due to the driver's belted status and frontal air bag deployment, it was unlikely that he engaged the steering wheel with his chest. The steering wheel deformation was probably a result of the driver bracing. The driver's left knee contacted the knee bolster which was evidenced by a scuffmark. The driver contacted the roof with his right hand as a scuffmark was noted to the area of contact. The front right occupant contacted the right knee bolster with her knees. The right knee contact was evidenced by a scuffmark. The NASS researcher noted two occupant contact points to the rear roof area from the two unrestrained rear occupants. The occupant contacts to the rear roof were evidenced by hair.

Figure 9. Left knee bolster contacts.

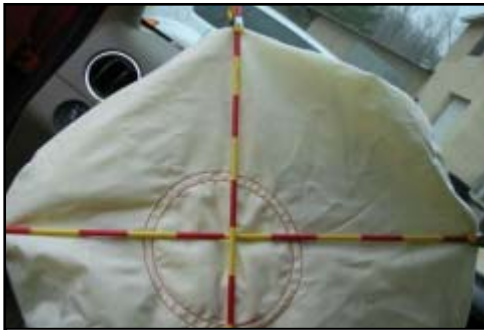
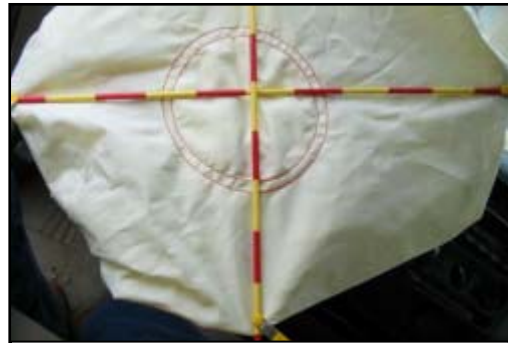
The driver's frontal air bag deployed from the center of the steering wheel hub (**Figures 10 and 11**). The air bag was configured with H-configuration cover flaps. The top flap measured 11.0 cm (4.3") in width and 7.0 cm (2.8") in height at the ends and 10.0 cm (3.9") in height at the center. The bottom flap measured 11.0 cm (4.3") in width and 12.0 cm (4.7") in height at the ends and 10.0 cm (3.9") in height at the center. The NASS researcher measured the air bag at 50.0 cm (19.7") in diameter in its deflated state. The air bag contained two tethers and two vent ports. The vent ports were located at the 11 and 1 o'clock positions on the rear aspect of the air bag. No occupant contacts were noted to the air bag.

Figure 10. Upper aspect of the deployed driver's air bag.

Figure 11. Lower aspect of the deployed driver's air bag.

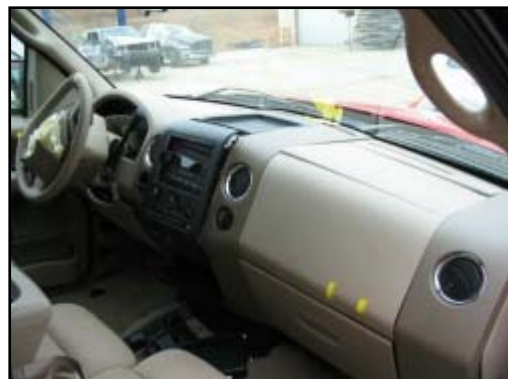
The front right air bag was a top-mount design on the instrument panel. The RCM did not deploy the front right air bag (**Figure 12**). It was unknown why the front right air bag was suppressed.

Figure 12. Non-deployed front right air bag.

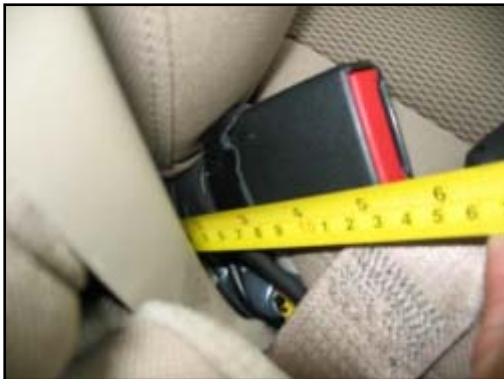
Figure 13. Fired driver's safety belt pretensioner.

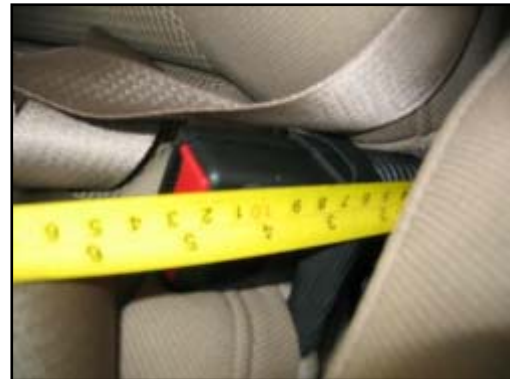
Figure 14. Fired passenger's safety belt pretensioner.
