SCI/NASS COMBINATION 208-COMPLIANT INVESTIGATION

CASE NUMBER - NASS-2004-49-253A

VEHICLE - 2004 FORD TAURUS

CRASH DATE - October 2004

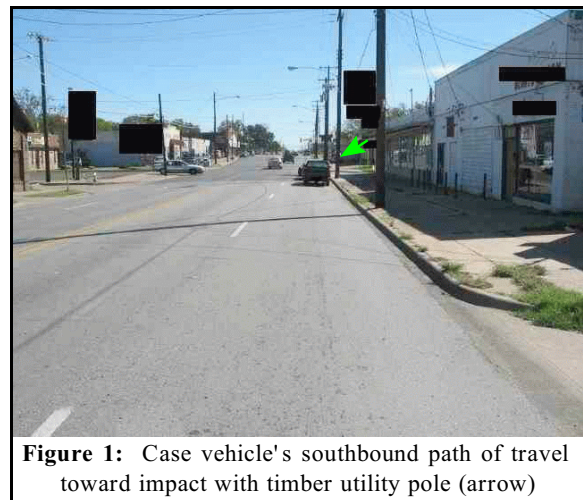
The case vehicle was traveling southward in an unknown lane of an undivided four-lane city street. It was dark but lighted, the weather was clear, the speed limit was 56 km.p.h. [35 m.p.h.] and the asphalt road surface was dry and free of defects (**Figure 1**). For some unknown reason, the case vehicle veered to the right (west). The autopsy toxicology testing revealed that the driver's blood alcohol concentration (BAC) was 0.18 mg/dl. It should be noted that there was fresh, swiping-type damage on the case vehicle's left side. The case vehicle's owner (husband of the deceased driver) indicated that there was no damage on the case vehicle prior to the crash. It is not known if this damage was related to the crash or, perhaps, occurred during post-crash handling of the case vehicle. The case vehicle departed the roadway to the right (west) and the right front wheel mounted the curb onto the sidewalk. The police report indicates that there were no skid marks and no witnesses.

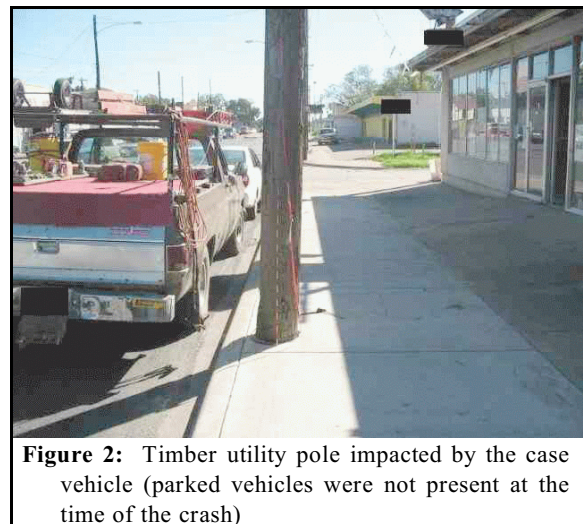
The crash occurred off the right (west) road edge. The case vehicle's front impacted a timber utility pole (**Figure 2**), causing the case vehicle driver's frontal air bag to deploy. The police crash report scene diagram indicates that, at final rest, the case vehicle was heading southwest with its front against the pole and its back wheels in the roadway. The police crash report indicates that electric service to an entire city block was disrupted, but this must have been a result of the wires and/or wire-bearing structures being damaged by vibrations because the pole had only surface damage.

The case vehicle's front center-right area impacted a timber utility pole that had a diameter of approximately 35 centimeters [14 inches] and which was set in the concrete sidewalk. The pole sustained minor surface scraping, with no fracture and no movement of its foundation (**Figure 2**).

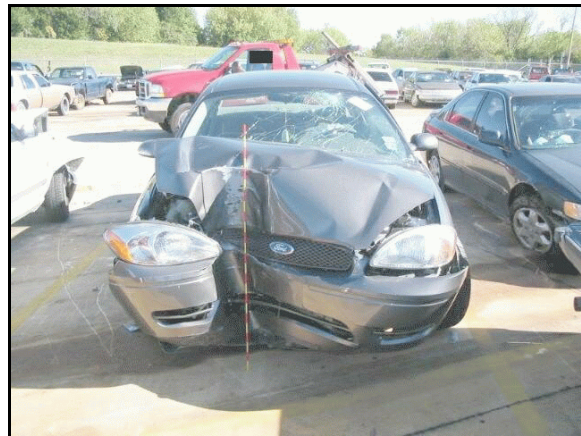
Figure 3: Case vehicle's entire front

The case vehicle sustained narrow direct contact on the bumper, grille and hood, beginning just right of center (**Figure 3**) and penetrating rearward and slightly rightward, creating a pocket behind the right headlamp/turn signal assembly (**Figure 4**). The hood was crushed rearward, folded upward and displaced to the right (**Figure 5**). Maximum crush was measured as 55 centimeters [21.7 inches] just inboard of the right headlamp/turn signal assembly. The right fender sustained induced damage and the right front tire was restricted due to its being pressed against the trailing edge of the wheel well. There was no other wheel/tire damage. The wheelbase was shortened by 12 centimeters [4.7 inches] on the right and lengthened by 2 centimeters [0.8 inches] on the left. The windshield was cracked across its entire width along the bottom edge with an area of spider web cracking directly above the steering wheel, and there was no other glazing damage.

The case vehicle's CDC for the pole impact was determined to be **12-FZEN-3 (0)**. The WinSMASH reconstruction program, damage-only algorithm based on the case vehicle's measured crush profile, was used on the case vehicle's impact with the utility pole. The total, longitudinal and lateral delta Vs are, respectively: 37 km.p.h. [23 m.p.h.], -37 km.p.h. [-23 m.p.h.] and 0 km.p.h. [0 m.p.h.]. The pole impact was the most severe and this was a crash of moderate severity (24-40 km.p.h. [15-25 m.p.h.]) for the case vehicle.

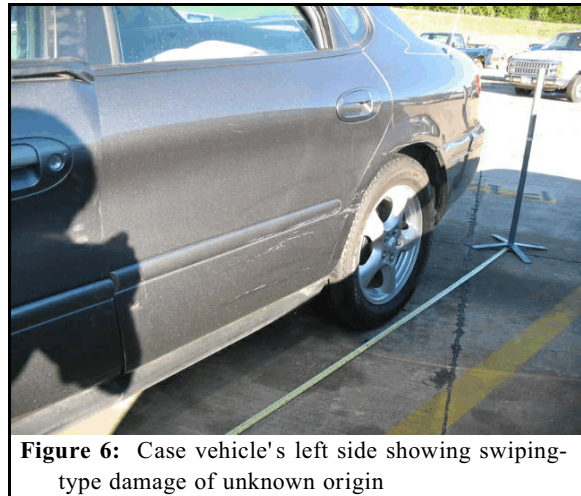
Because the case vehicle had fresh swiping-type damage on the left side, the NASS investigator included an event coded as "unknown event or object" in the case structure. The CDC for this event was determined to be **06-LZES-1 (190)**. If this unknown event was part of the collision sequence, it was of very minor severity (**Figure 6**).

Figure 6: Case vehicle's left side showing swiping-type damage of unknown origin

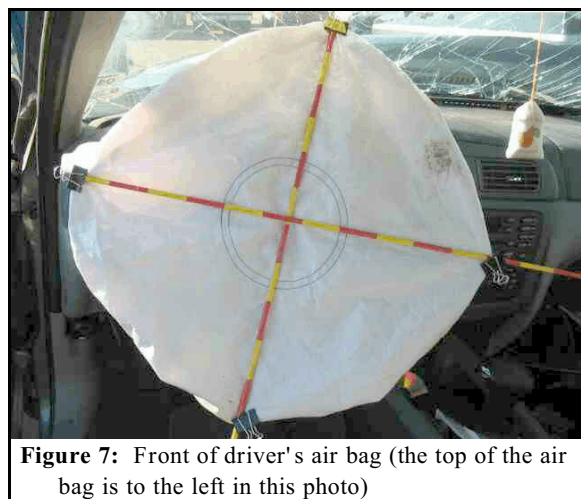
Figure 7: Front of driver's air bag (the top of the air bag is to the left in this photo)

was a small smudge of dirt on the front of the air bag fabric, at approximately the 5:00 position, and the driver's air bag was otherwise not damaged (**Figure 7**). There was no evidence of occupant contact on the driver's air bag.

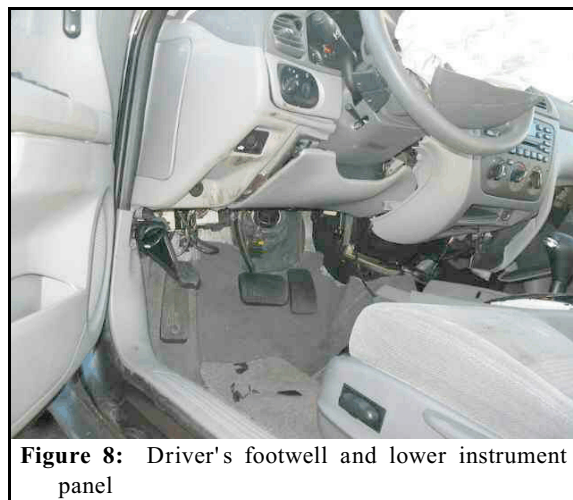
Figure 8: Driver's footwell and lower instrument panel

The driver's pre-crash actions are not known. It appears that the case vehicle simply drifted to the right and this gradual motion probably did not affect the driver's posture. The right front wheel mounted the barrier curb while the left front wheel remained in the roadway and the driver probably leaned slightly to the left. The case vehicle's front impacted the timber utility pole, slightly off center to the right, causing the driver's steering wheel-mounted air bag to deploy. The driver moved forward in response to the impact deceleration. Because she was not restrained by the safety belt system, she loaded and then rode down the air bag and her chest impacted the steering assembly. She sustained a fracture of the sternum, a laceration and contusion of the heart, contusions of the lungs bilaterally, fractures of four ribs on the left, a laceration of the spleen, a laceration of the liver, plus contusions and abrasions on her chest and left breast. As she moved forward, her knees impacted the knee bolster and she sustained lacerations on both knees. She also sustained an open fracture of the right ankle, with further details not specified, probably from her foot impacting and flexing against the floor. Her posture at final rest is not known.
