## TRANSPORTATION RESEARCH CENTER

## SCI/NASS COMBINATION 208-COMPLIANT VEHICLE INVESTIGATION

CASE NUMBER - NASS-2004-74-280J  
LOCATION - Nebraska  
VEHICLE - 2005 Ford Escape  
CRASH DATE - December 2004

Submitted:  
August 24, 2005  
Revised;  
November 1, 2006

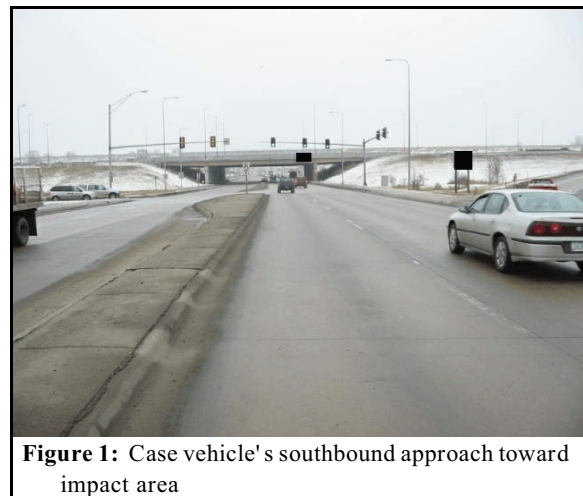
The case vehicle had been traveling southward and was stopped for an automatic traffic signal, heading southward, in heavy traffic, in the inside southbound lane of a three-lane roadway that was part of a divided local trafficway, within an interchange area, intending to continue south (**Figure 1**). The other vehicle (Windstar) was traveling generally northwestward down a one-lane, one-way entrance ramp that curved to the right and merged into the northbound lanes of the same divided trafficway where the case vehicle was traveling. It was daylight, the weather was clear, the concrete road surface was dry and with no apparent defects, and the speed limit for both vehicles was 64 km.p.h. [40 m.p.h.]. The Windstar's driver failed to negotiate the right curve and continued essentially straight, off the left edge of the ramp, across the gore and the northbound travel lanes (**Figure 2**). The case vehicle's driver did not attempt any avoidance actions.

**Figure 1:** Case vehicle's southbound approach toward impact area

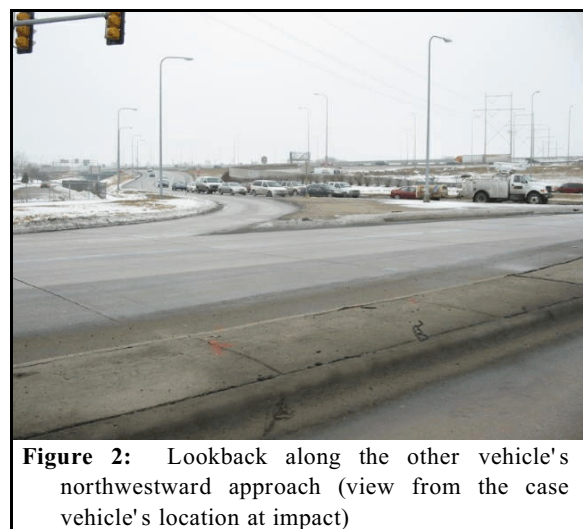
**Figure 2:** Lookback along the other vehicle's northwestward approach (view from the case vehicle's location at impact)

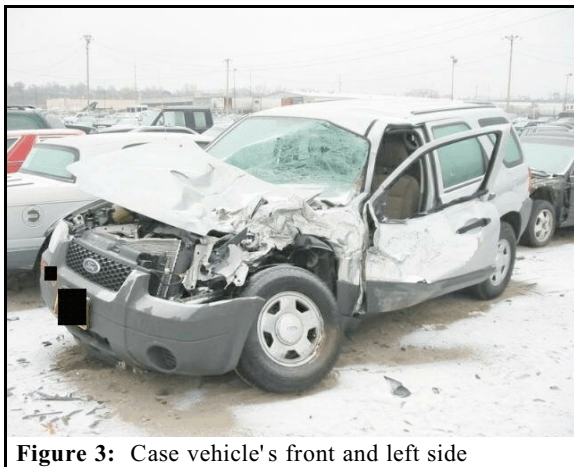
Figure 3: Case vehicle's front and left side

The case vehicle sustained direct contact damage extending from the left front corner nearly to the left B-pillar (**Figures 3 and 4**). The Windstar had impacted and vaulted over the curbed median and its front was up, off the ground, such that its bumper contacted the case vehicle at approximately the level of the top of the left front tire. The Windstar's frontal structures above the bumper engaged the case vehicle along the midline and above on the left side, including direct contact to the case vehicle's left upper A-pillar, windshield and driver's door window. The case vehicle's left fender and hood were crushed inward, downward and slightly rearward. The upper left A-pillar and driver's door window frame were bent inward and rearward with a sharp crease a short distance above the belt line (**Figures 4 and 5**). The left side of the windshield was heavily cracked and crushed inward due to direct contact with the Windstar, and the trailing edge of the hood contacted the lower portion of the windshield across its entire width, with additional heavy cracking on the right (**Figure 6**). The left roof rail over the driver's door was buckled upward due to rearward displacement of the left A-pillar, and the driver's door opening was distorted. In

The CDC for the case vehicle's single impact was determined to be **11-LYAW-3 (320 degrees)**. The WinSMASH reconstruction program, damage-only algorithm based on the measured crush profile for both vehicles, was used. The total, longitudinal and lateral delta-Vs are, respectively: 28 km.p.h. [17.4 m.p.h.], -21 km.p.h. [-13.0 m.p.h.] and + 18 km.p.h. [+ 11.2 m.p.h.]. These results are somewhat low due to the impact configuration, with the Windstar vaulting and engaging the case vehicle above the frame. This was a crash of moderate severity (24-40 km.p.h. [15-25 m.p.h.]) for the case vehicle.

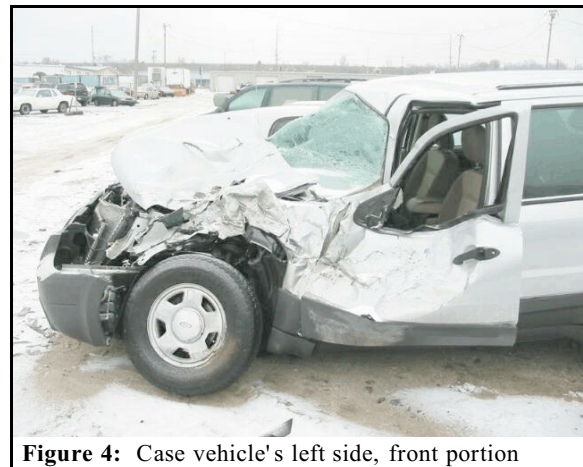
Figure 4: Case vehicle's left side, front portion

The driver's seat area sustained numerous specific intrusions, including: the windshield (44 cms. [17.3 inches] longitudinal); the left upper A-pillar (35 cms. [13.8 inches] longitudinal); the driver's door panel (14 cms. [5.5 inches] lateral); and the roof side rail above the driver's door opening (4 cms. [1.6 inches] lateral). The most significant intrusion, however, was from the Windstar's grille and hood, which penetrated into the case vehicle driver's seat area through the shattered driver's door window as it crushed the A-pillar and door structures inward. The magnitude of the lateral intrusion by the Windstar could not be measured. The Windstar's intruding frontal structures impacted the left side of the case vehicle driver's head.

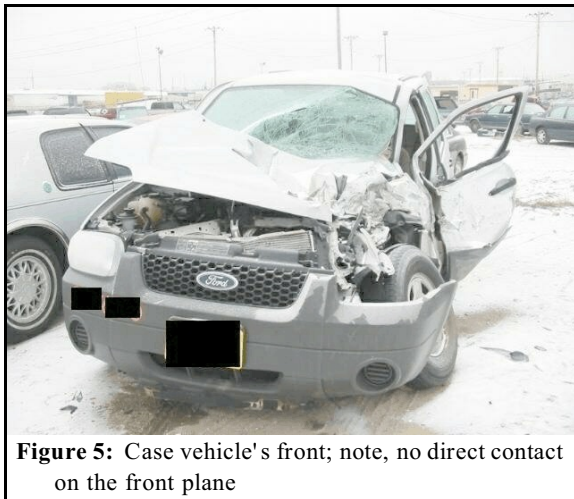
**Figure 5:** Case vehicle's front; note, no direct contact on the front plane

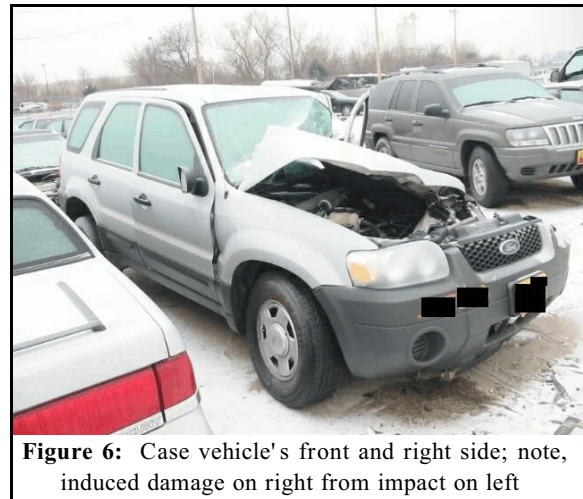
addition to the heavy damage to the windshield, the driver's door window glazing was completely shattered, and there was no other glazing damage. The front left axle/suspension was damaged, with the left front wheel visibly displaced inward at the top and restricted due to being pressed against the deformed body panels (**Figure 5**), but the tire was not damaged or deflated. The left rear wheel rim was dented but the tire was not damaged, and there was no other wheel/tire damage. The wheelbase was shortened by 13 centimeters [5.1 inches] on the left and stretched by 2 centimeters [0.8 inches] on the right. The force of the impact on the left side caused induced damage on the right side, with the right front door and/or door opening distorted (**Figure 6**).

**Figure 6:** Case vehicle's front and right side; note, induced damage on right from impact on left

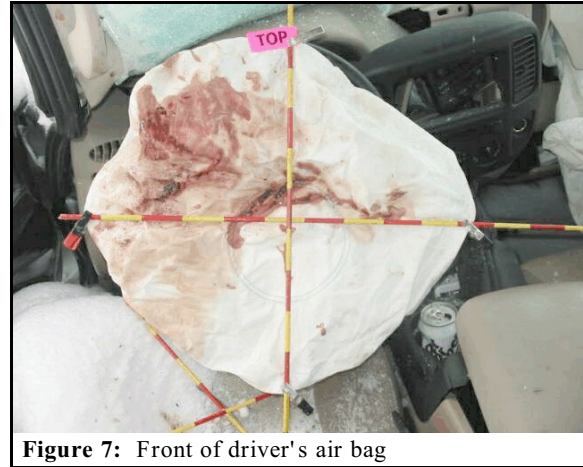
The driver's air bag was mounted in the steering wheel hub with the module cover flaps in the H-configuration. The cover flaps opened at the tear points and there was no evidence of damage to the cover flaps or the adjacent structures. The upper flap measured 15 cms. [5.9 inches] horizontally and 7 cms. [2.8 inches] vertically and the lower flap measured 13 cms. [5.1 inches] horizontally and 5 cms. [2.0 inches] vertically. The driver's air bag was round with a diameter of 50 cms. [19.7 inches]. There were two vent ports on the back surface of the fabric, of unknown diameter, at the 10:00 and 2:00 o'clock positions. There was no evidence of damage to the air bag. The driver's air bag fabric was smeared with copious amounts of blood on both the front and the back surfaces (**Figure 7**).

Figure 7: Front of driver's air bag

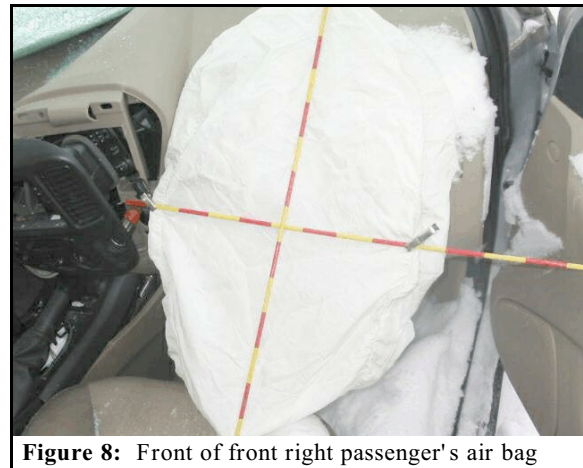
The front right passenger's air bag was mounted in the middle of the instrument panel on the right. The single cover flap opened at the tear points and there was no evidence of damage to the cover flap or the adjacent structures. The cover flap measured 33 cms. [13.0 inches] horizontally and 22 cms. [8.7 inches] vertically. The front right passenger's air bag was rectangular, measuring 70 cms. [27.6 inches] vertically and 36 cms. [14.2 inches] horizontally. There were two vent ports of unknown diameter, located in the left and right side panels of the air bag fabric. There was no evidence of occupant contact or damage on the front right passenger's air bag fabric (**Figure 8**).

Figure 8: Front of front right passenger's air bag

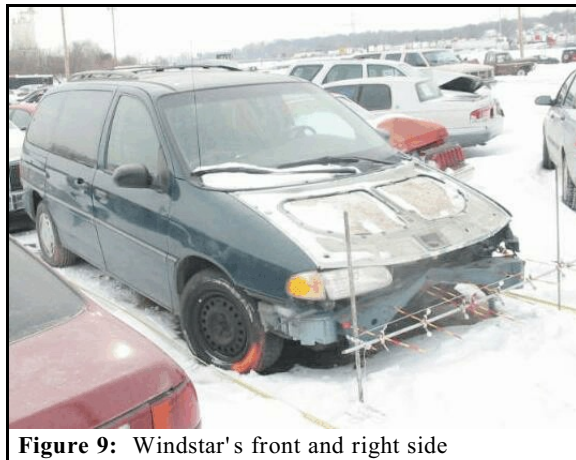
**Figure 9:** Windstar's front and right side

The Windstar sustained moderate direct contact damage across the lower portion of the front plane, with lesser direct and induced damage over almost the entire front (**Figures 9 and 10**). The bumper cover was torn off and the steel bumper was crushed rearward. The grille and the left headlamp/turn signal assembly were broken away, but the right headlamp/turn signal was intact. The finish panel was torn off the hood. There was no glazing damage. The wheel base was shortened by 16 centimeters [6.3 inches] on the left and stretched 5 centimeters [2.0 inches] on the right. The left front wheel rim was damaged and displaced rearward and the tire was torn and deflated. The investigator indicated that it was not possible to separate left front wheel damage due to the curb impact from the frontal impact. The left rear wheel rim was dented, with no damage to the tire, and there was no other wheel/tire damage.

Windstar's most severe impact, with the case vehicle, was determined to be **12-FDEW-2 (0 degrees)**. The WinSMASH reconstruction program, damage only algorithm based on the measured crush profile of both vehicles, was used on the Windstar's most severe impact. The total, longitudinal and lateral delta-Vs are, respectively: 26 km.p.h. [16.2 m.p.h.], -26 km.p.h. [-16.2 m.p.h.] and 0 km.p.h. [0 m.p.h.]. These results are somewhat low, due to the configuration of the two vehicles at impact. This was a crash of moderate severity (24-40 km.p.h. [15-25 m.p.h.]) for the Windstar.

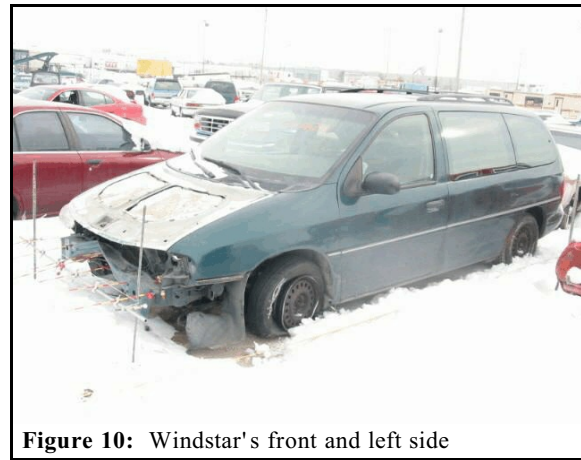
**Figure 10:** Windstar's front and left side
