Child Safety Seat Investigation / Vehicle to Vehicle
Dynamic Science, Inc. / Case Number: DS04001
2003 Toyota Corolla
California
January, 2004

1. Report No. DS04001		2. Government Accession No.		3. Recipient Catalog No.	
4. Title and Subtitle Child Safety Seat Investigation				5. Report Date October 28, 2004

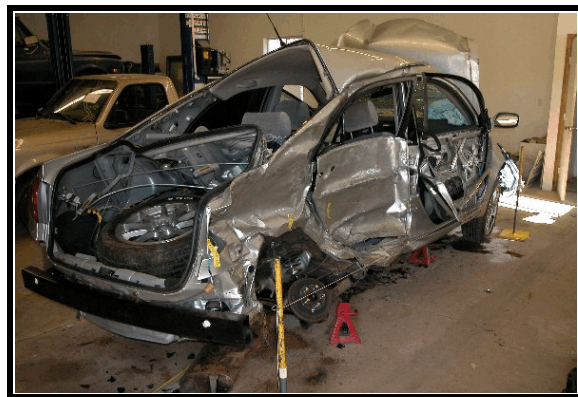
Direct damage from Impact 1 (Ford van) began 153.0 cm (60.2 in) rearward from the front axle. It measured 180.0 cm (70.8 in) and extended to the rear of the vehicle. A crush profile was taken above the sill which measured: C1= 25.0 cm (9.8 in), C2= 46.0 cm (18.1 in), C3=51.0 cm (20.0 in), C4=27.0 cm (10.6 in), C5=0 cm (0 in), C6=1.5 cm (0.6 in).

Figure 7. Right rear, Toyota Corolla

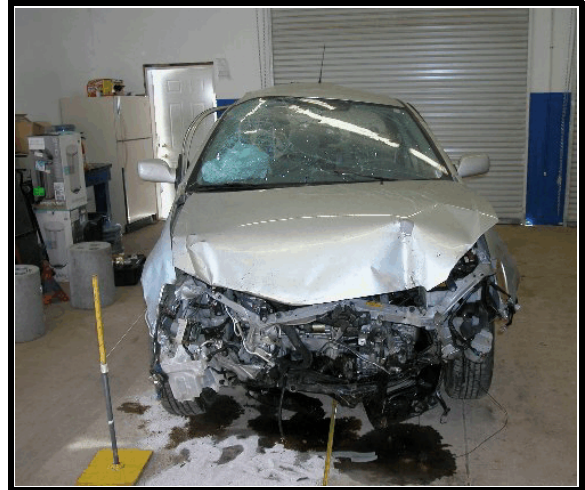
Direct damage from Impact 3 (Buick LeSabre) began and the front left corner of the vehicle and extended across the entire front end. The bumper, bumper fascia, bumper backing bar, and radiator had been removed prior to the vehicle inspection.

Figure 8. Front, Toyota Corolla

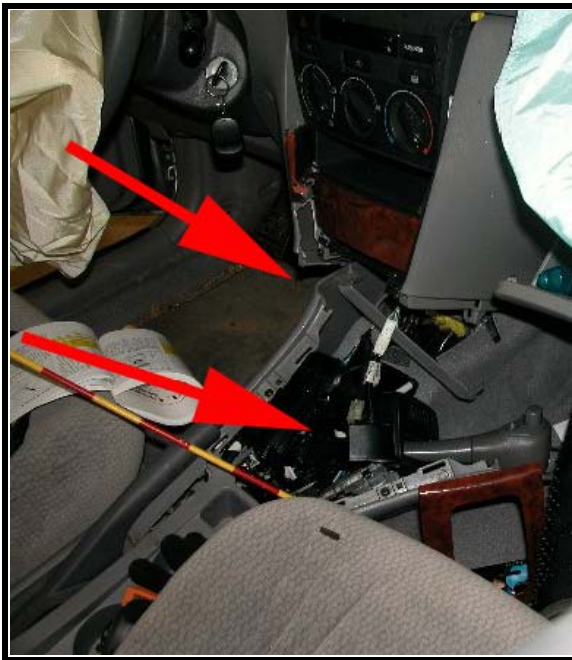
Interior damage to the Toyota Corolla was significant and was attributed to occupant contact and passenger compartment intrusion. The windshield sustained fracture damage from impact forces and the front right passenger's air bag. The back light and all the glass on the right side was disintegrated by impact forces. There was extensive right side intrusion, including intrusion through both right side doors, the sill, and the B/C pillars. The maximum intrusion was the sill into the right rear seating position and measured 39.0 cm (15.3 in) laterally. The rear right door intruded 32.0 cm (12.6 in) laterally into this same area. There was loading damage to the right rear door arm rest from contact with the child seat in this location. There was loading damage to center console and center mounted shifter from contact with the driver.

Figure 9. Center console driver contacts

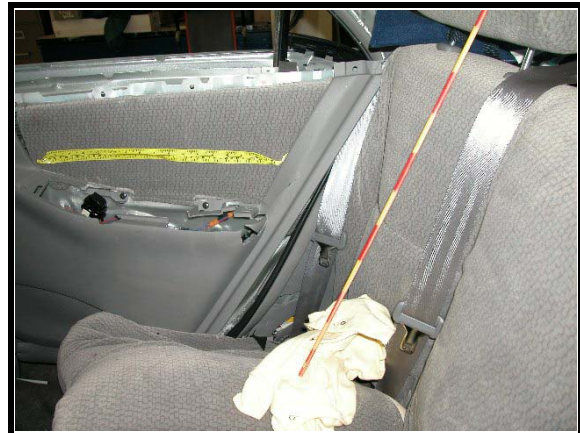
Figure 10. Right rear door intrusion

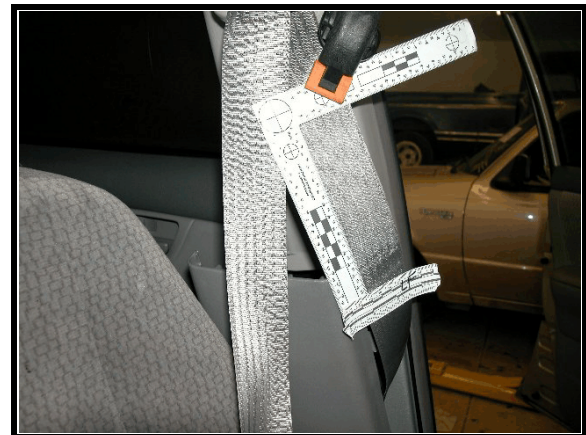
Figure 12. Load marks to driver's seat belt

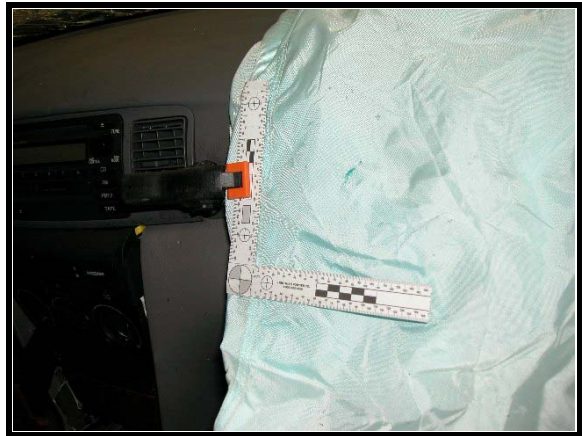
The front right passenger's air bag deployed from a top mount module with a single cover flap. The flap measured 23.0 cm (9.0 in) wide by 6.0 cm (2.4 in) high. The air bag measured 42.0 cm (16.5 in) in width and 54.0 cm (21.2 in) in height. The air bag was not tethered and was vented by two circular ports that were located at the 9 and 3 o'clock positions. There were no occupant contacts to the air bag or the cover flap. The air bag sustained a 3.0 cm (1.2 in) cut that was 8.0 cm (3.1 in) from the left edge and 29.0 cm (11.4 in) from the top of the air bag face. The cut was as a result of contact to the windshield during deployment.

Figure 14. Cut on upper left portion of front right passenger's air bag

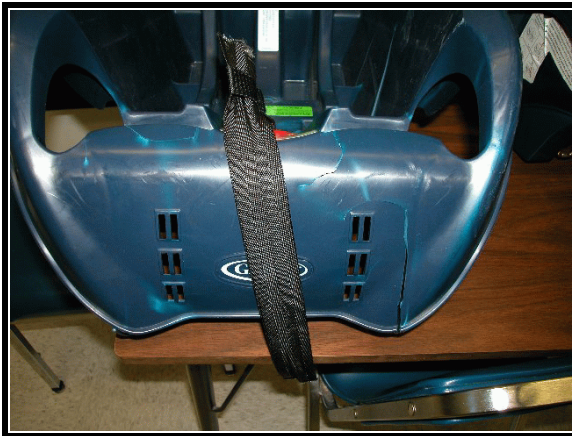
The right and left sides, as well as the front, of the base was cracked and deformed from the impact with the Ford and the resultant interior intrusion. The seat itself did not appear to have sustained any damage. There were no indications of any occupant contact to the inner seat shell.

Figure 20. Fractures to front of child seat base.

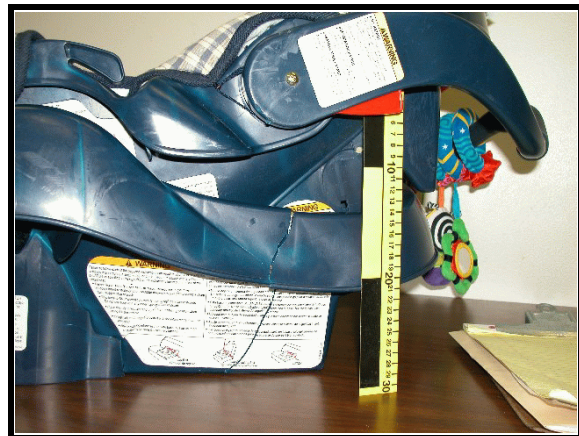
Figure 21. Left side of seat (nearest impact).
Seat attached to base.

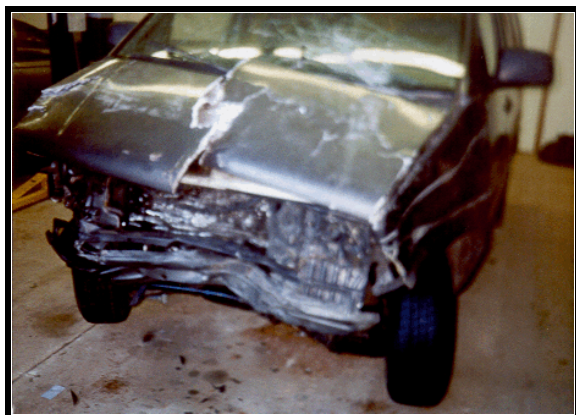
Figure 23. Front left, Ford Aerostar

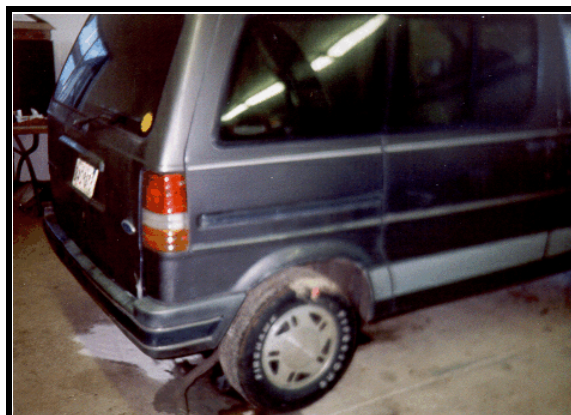
Figure 22. Right rear, Ford Aerostar

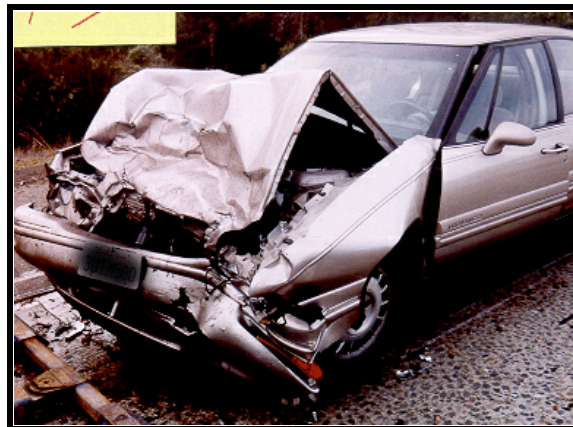
Figure 24. Front left, Buick LeSabre

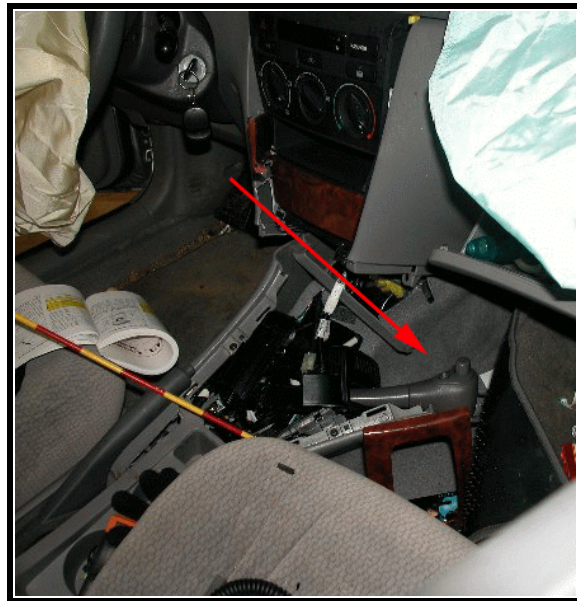
The 28-year-old female driver of the case vehicle was seated in a normal, upright fashion in a fabric covered bucket seat. The seat was found adjusted to the rear most track position but given the driver's height (173 cm/68 in) it is more likely that the seat had been moved prior to the vehicle inspection. The seat back was slightly reclined. The driver was using the available lap and shoulder belt. The shoulder belt anchorage was adjusted to the mid position. Prior to impact, the case vehicle had been involved in an evasive maneuver. Both hands were on the steering wheel actively involved in efforts to steer out of the counterclockwise vehicle rotation. The right foot was on the brake, the left on the floorboard. At impact with the Aerostar, the driver responded to the 3 o'clock direction of force by pitching sharply to the right. While the restraint system kept her generally in place, her hips went to the right and engaged the shifter and center console—causing the bilateral pelvic fractures—and her lower legs pitched to the right and engaged the foot controls—causing the medial malleolus fracture. The case vehicle was redirected in a clockwise direction before being struck in the front by the Buick LeSabre. The driver responded to the 1 o'clock direction of force by moving forward and to the right. At impact, the driver's air bag deployed and the driver's seat belt pretensioner actuated. The driver pitched forward and engaged the locked seat belt system—causing abrasions to her shoulder and hip. Her face engaged the deployed air bag—causing abrasions and contusions to her face/head and also caused her to bite her lip.

Figure 26. Contact to shifter and center console

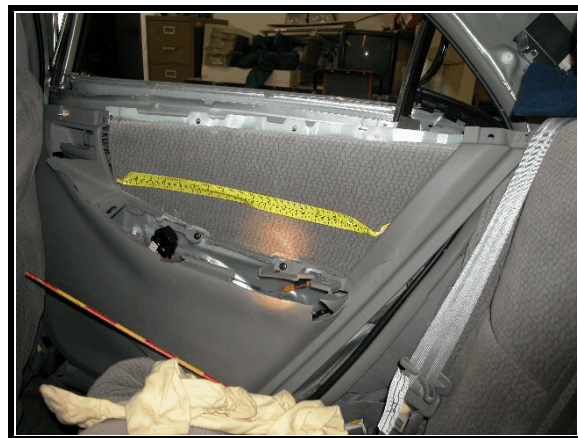
Figure 27. Damage to right rear door side panel due to impact, intrusion, and contact with infant safety seat

child seat interior with essentially the whole left side of her body. As the impact progressed, the right rear door intruded into and fractured the child seat exacerbating the left side injuries, including the clavicle and skull fractures. This occupant also sustained right side skull and rib fractures and lacerations to the spleen and liver. Given the amount of intrusion and the fact that the restraint remained in place, the injuries were a combination of impact and compression as the child safety seat was intruded on by the right door panel. At impact with the Buick, this occupant would have responded to the 1 o'clock direction of force by moving forward (with her back) and to the right.
