INDIANA UNIVERSITY

ON-SITE CERTIFIED ADVANCED 208- COMPLIANT VEHICLE INVESTIGATION

CASE NUMBER - IN-04-001
LOCATION - TEXAS
VEHICLE - 2003 CHEVROLET C1500 TAHOE
CRASH DATE - December 2003

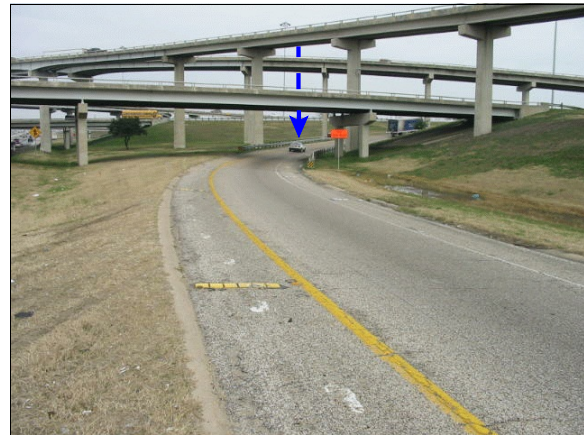
Figure 1: Case vehicle's north-northeastern travel path on exit/entrance ramp; Note: arrow indicates impact area (1st event) with guardrail (case photo #01)

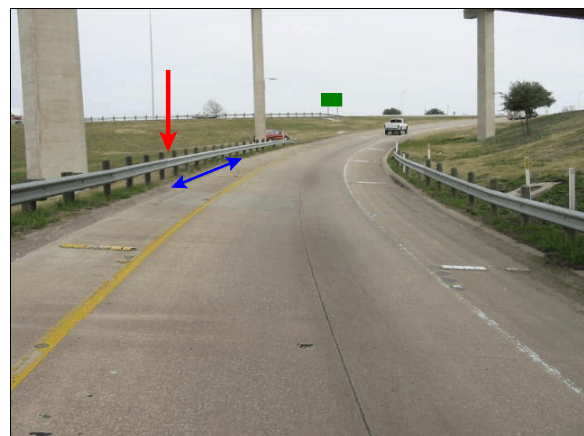
Figure 2: Case vehicle's northeastward travel path in rightward curving exit/entrance ramp; Note: oblique arrow indicates approximate point of impact and vertical arrow shows beginning of replacement guardrail (case photo #03)

Crash: The front (**Figure 3**) of the case vehicle impacted a metal longitudinal barrier [i.e., a “W” beam guard rail (1st event–**Figure 2** above)] on the northwestern roadside. The case vehicle's driver and front right passenger supplemental restraints (advanced air bags) did not deploy. The case vehicle vaulted over the guardrail in a tangential fashion.

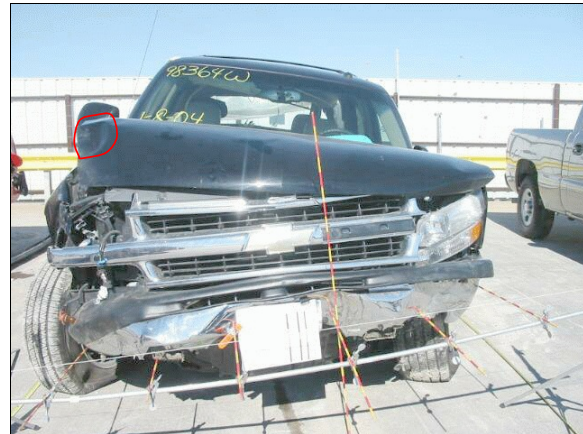
Figure 3: Case vehicle frontal damage from impact with “W” beam guardrail with contour gauge set at bumper level; Note: highlighted area on front right hood most likely from impact with guardrail support post (case photo #12)

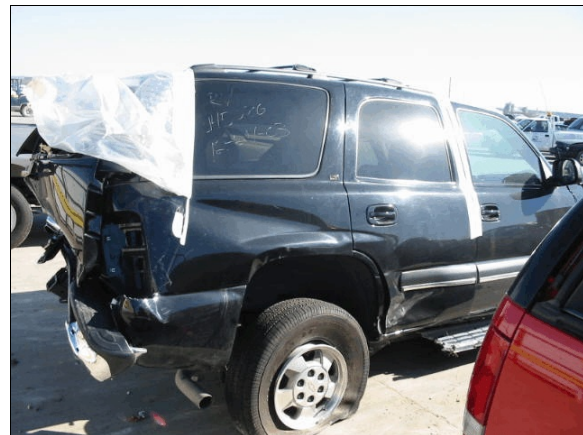
Post-Crash: While overriding the guardrail, the guardrail snagged and broke off a portion of the right running board and damaged the lower right rear door (2nd event–**Figures 4 and 5**). Furthermore, while overriding the guardrail, the left side

Figure 4: Damage to case vehicle's right rear door and running board most likely from sustained contact with deformed “W” beam (case photo #25)

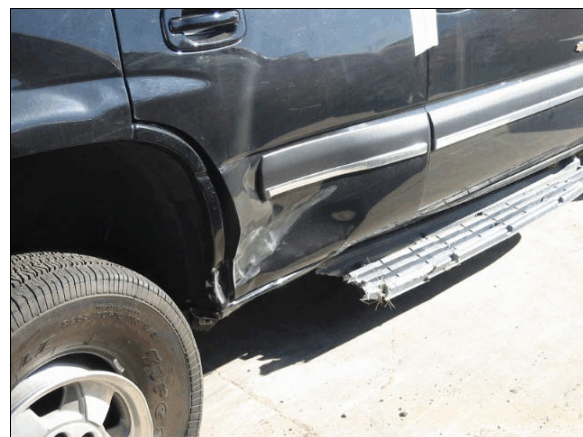
Figure 5: Close-up of damage to case vehicle's right rear door and running board most likely from sustained contact with deformed “W” beam guardrail (case photo #27)

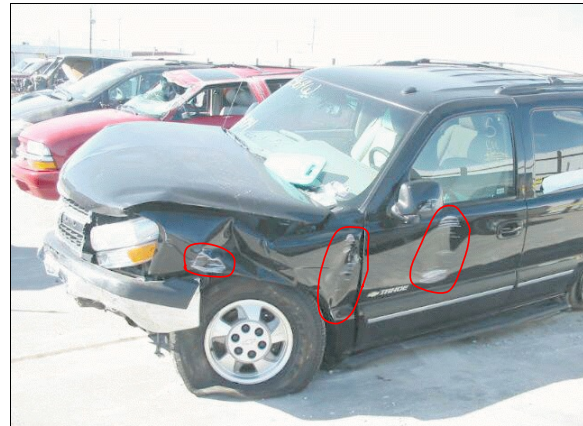
of case vehicle struck one or more delineator posts, depositing white vertically oriented marks along the case vehicle's left fender and left front door; the posts also knocked the left outside rearview mirror inward (3rd event–**Figure 6**). Eventually because of gravity, the front of the case vehicle dipped downward and contacted the guardrail again. In addition, the front right corner—especially the front right hood area (**Figures 7 and 8** below), most likely contacted one of the guardrail support posts (4th event–**Figure 9** below) enabling the case vehicle to begin flipping end-over-end (i.e., rollover initiation– 5th event).

Figure 6: Case vehicle's left fender and left front door areas showing white, vertically oriented, contact evidence most likely from contact with delineator post(s) originally positioned behind guardrail; Note: left outside rearview mirror contacted front-to-back (case photo #16)

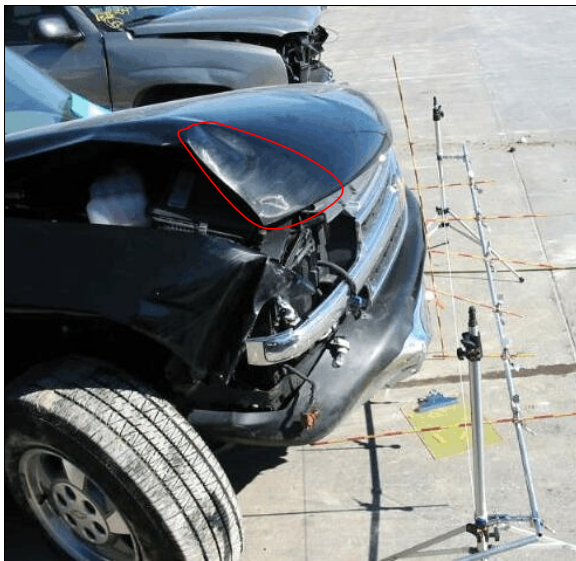
Figure 7: Case vehicle's frontal damage viewed from right along reference line; Note: damage area on front right hood possibly from contact with guardrail support post (case photo #27a)

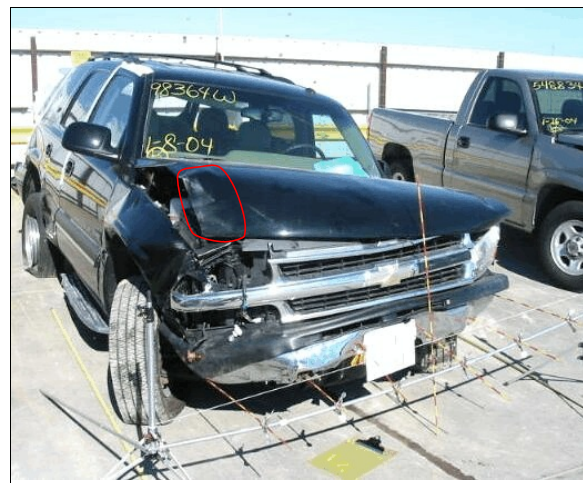
Figure 8: Case vehicle's frontal damage from impact with longitudinal barrier (i.e., "W" beam guardrail) viewed from right of front; Note: damage area on front right hood possibly from contact with guardrail support post (case photo #27b)

Exterior Damage: The case vehicle's initial contact with the longitudinal barrier (i.e., "W" beam guard rail) involved its front (**Figures 2 and 8** above). Direct damage extended across the entire front bumper, a measured distance of 159

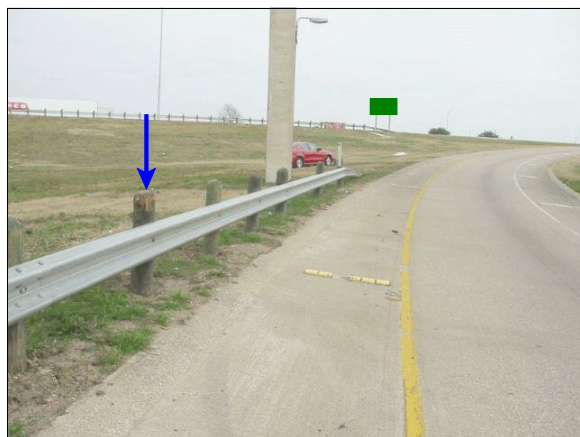
Figure 9: Case vehicle's area of roadway departure and contact with longitudinal barrier (i.e., "W" beam guardrail) located on northwest roadside of exit/entrance ramp; Note: unidentified tire mark on shoulder and arrow indicates suspected contact with guardrail support post (case photo #05)

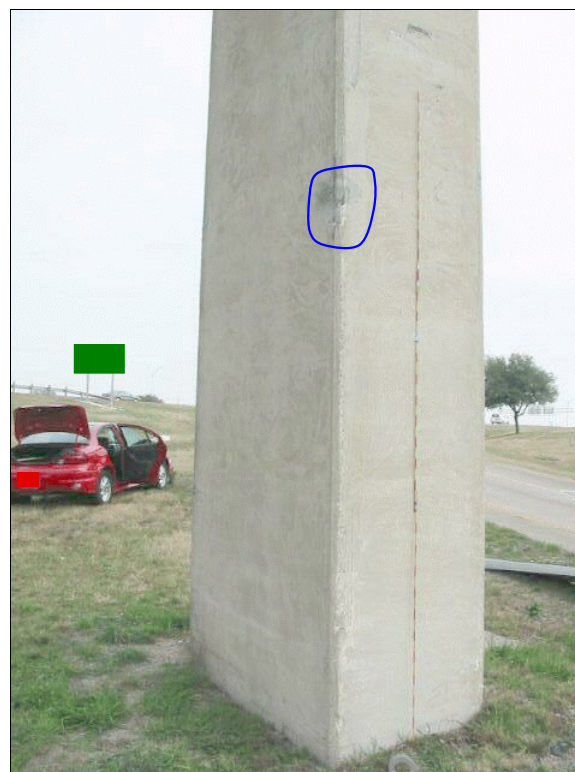
Figure 10: Case vehicle's contact area with bridge pillar; Note: height of contact area above ground and highlighted tire scuff mark (case photo #07)

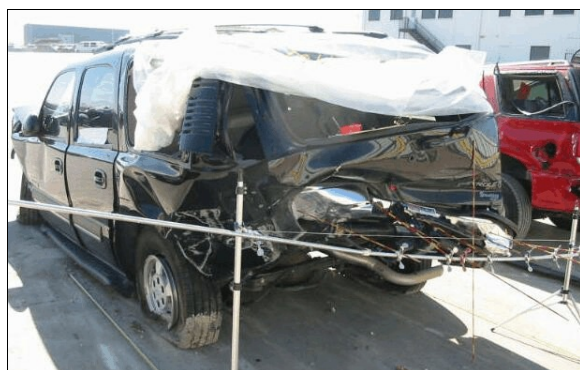
Figure 11: Non-horizontal damage to case vehicle's back from contact with bridge pillar, viewed from left of back with contour gauge set at bumper level; Note: vehicle was airborne and upside down at time of impact (case photo #19)

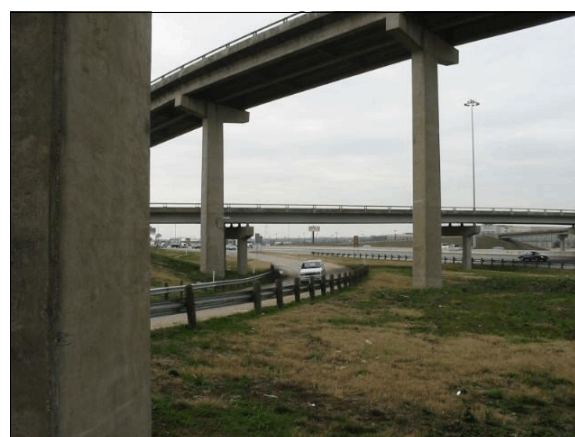
while still rotating clockwise about its vertical axis. The case vehicle struck the ground, most likely with its right side leading, depositing grass and dirt near the right rear door when the vehicle impacted the ground. The case vehicle's impact with the ground deflated all four tires. The case vehicle came to rest on its four wheels heading westward. The bridge pillar was located approximately 18.3 meters (60 feet) from the case vehicle's point of departure on the ramp's road edge (Figure 12).

Figure 12: Southwesterly view from case vehicle's approximate final rest position of vehicle's north-easterly pre-crash travel path in right-hand curve in exit/entrance ramp; Note: distance from "W" beam guardrail to bridge pillar (case photo #10)

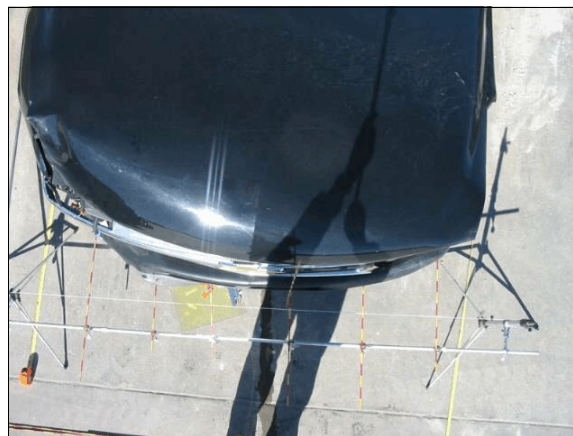
Figure 13: Overhead view of case vehicle's front damage from impact with longitudinal barrier (i.e., "W" beam guardrail); Note: crush greatest at front right corner (case photo #27d)

centimeters (62.6 inches). The undeformed end width was determined to be: 180 centimeters (70.9 inches). Residual maximum crush was measured as 25 centimeters (9.8 inches) at C₆ (Figure 13 above). The table below shows the case vehicle’s crush profile.

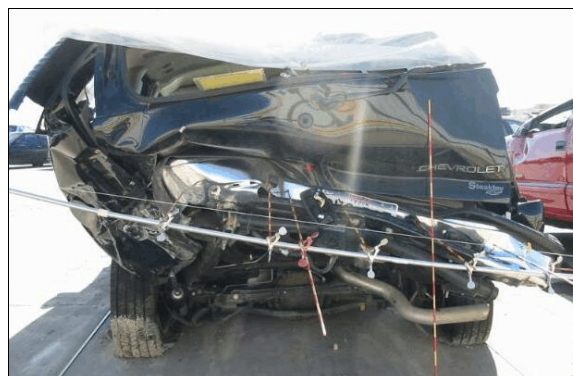
Figure 14: Non-horizontal damage to case vehicle’s back from impact with bridge pillar; Note: vehicle was airborne and upside down at time of impact and trunk was closer to the ground than the engine compartment (case photo #21a)

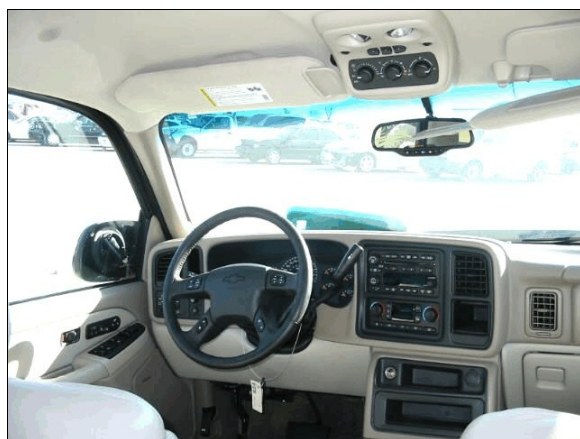
Interior Damage: Inspection of the case vehicle's interior revealed no evidence of occupant contact on the interior surfaces (Figures 15 and 16 and Figure 17 below). There was longitudinal intrusion from the lift gate into the truck/storage area behind the back seats. Finally, there was no evidence of compression to the energy absorbing shear capsules in the steering column and no deformation to the steering wheel rim.

Figure 15: Case vehicle's driver seating area showing non-deployed driver air bag and no apparent evidence of occupant contact to steering wheel, instrument panel, or greenhouse areas (case photo #31)

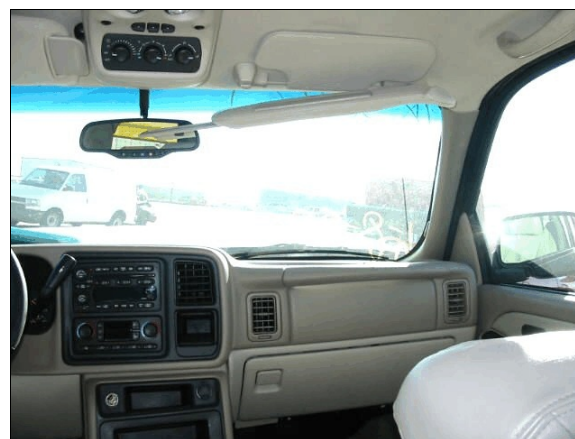
Figure 16: Case vehicle's front right seating area showing non-deployed front right air bag and no apparent evidence of occupant contact to center and right instrument panels and greenhouse area (case photo #33)

The case vehicle was equipped with a Supplemental Restraint System (SRS) that contained dual stage frontal air bags at the driver and front right passenger positions. Neither frontal air bag deployed as a result of the frontal impact with the longitudinal barrier. The case vehicle’s driver air bag was located in the steering wheel hub (**Figure 15** above) and the front right passenger’s air bag was located in the middle of the instrument panel (**Figure 16** above).

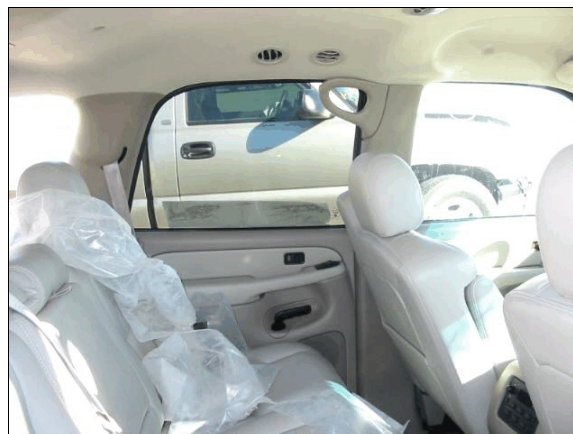
Figure 17: Case vehicle’s second seating area viewed from right showing no apparent evidence of occupant contact to roof above driver’s head and no indication of distortion or damage to driver’s seat back (case photo #34)

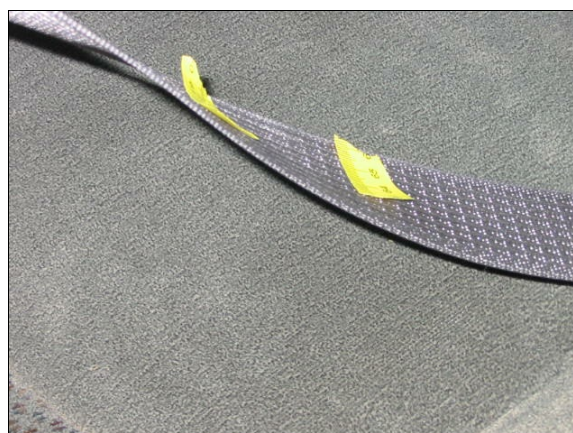
Based on this contractor's vehicle inspection and substantiated by the **EDR** data, the case vehicle's driver was restrained by her available, active, three-point, integral lap-and-shoulder, safety belt system; however, the belt system was not equipped with a pretensioner. Furthermore, there was no evidence of belt pattern bruising and/or abrasions to the driver's body, but the inspection of the driver's seat belt webbing and latch plate showed trace evidence of loading (**Figure 18**).

Figure 18: Loading evidence (i.e., slight waving and wear mark) on webbing of case vehicle's driver safety belt (case photo #31a)

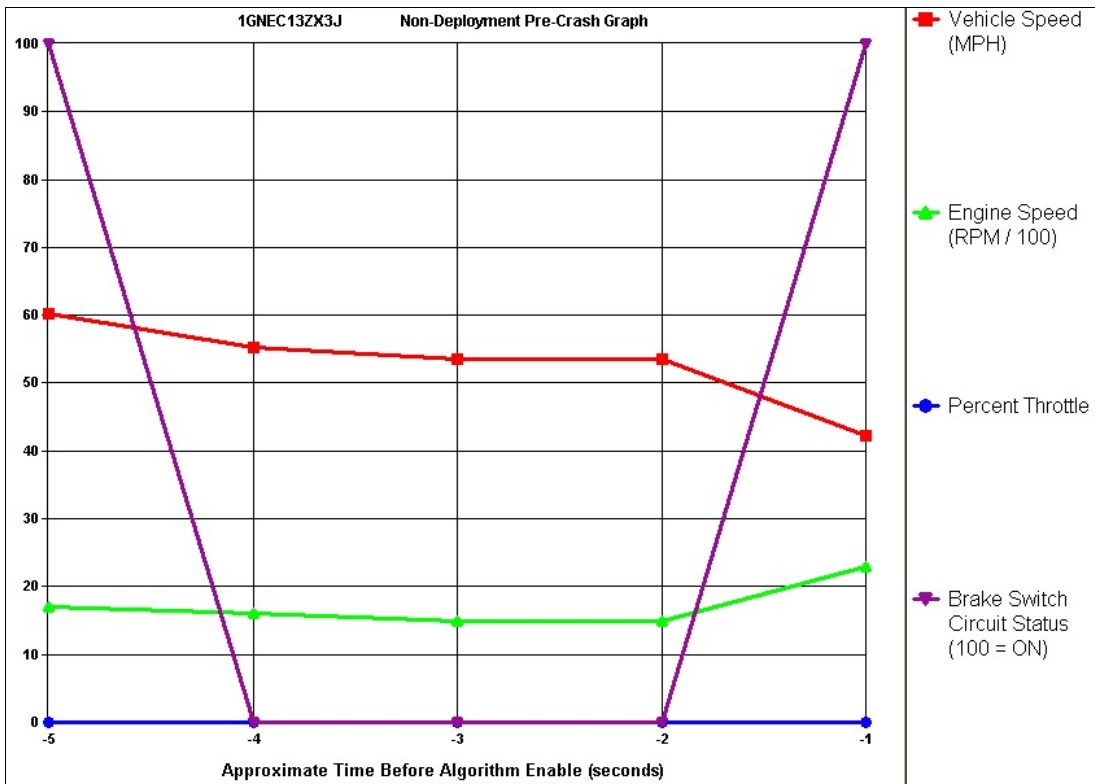
Figure 20: Case vehicle’s pre-crash speed and brake switch circuit status showing that the vehicle’s speed was recorded at 68 km.p.h. (42 m.p.h.) when the brake was reactivated approximately 1 second prior to algorithm enable, and that the brake switch had been activated, deactivated, and reactivated during the five recorded sample periods.

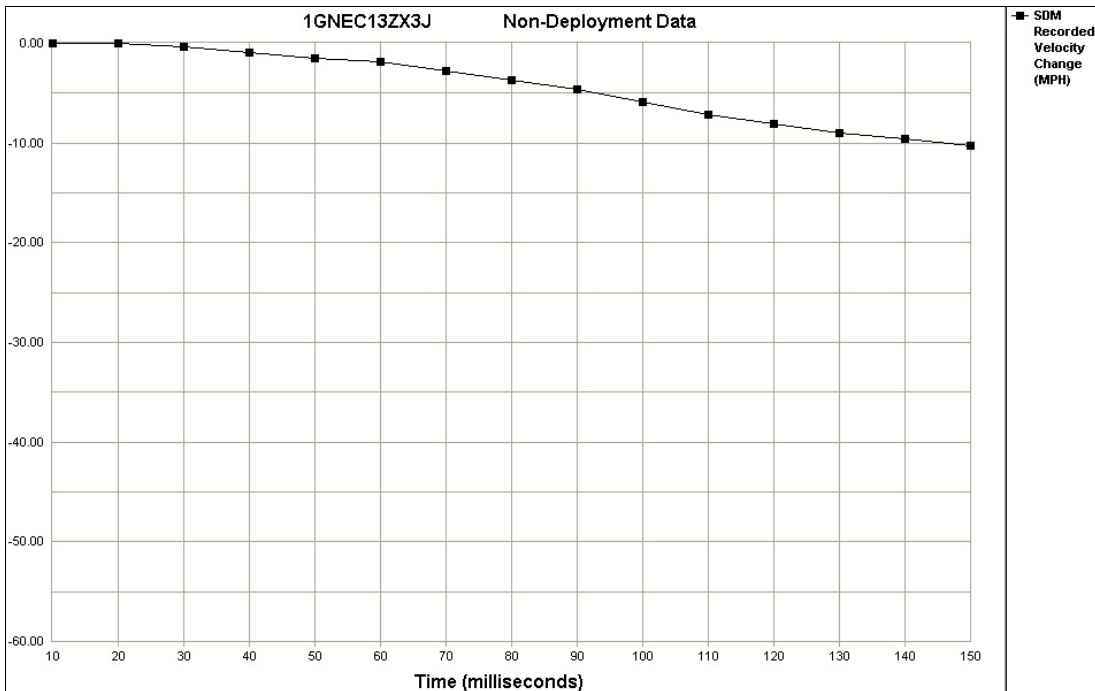
Figure 21: The case vehicle sustained a velocity change of approximately 16.4 km.p.h. (10.2 m.p.h.) during the first 150 milliseconds after the algorithm was enabled
