INDIANA UNIVERSITY

TRANSPORTATION RESEARCH CENTER

ON-SITE CERTIFIED ADVANCED 208- COMPLIANT VEHICLE INVESTIGATION

CASE NUMBER - IN-04-002
LOCATION - TEXAS
VEHICLE - 2003 CHEVROLET C1500 SILVERADO
CRASH DATE - January 2004

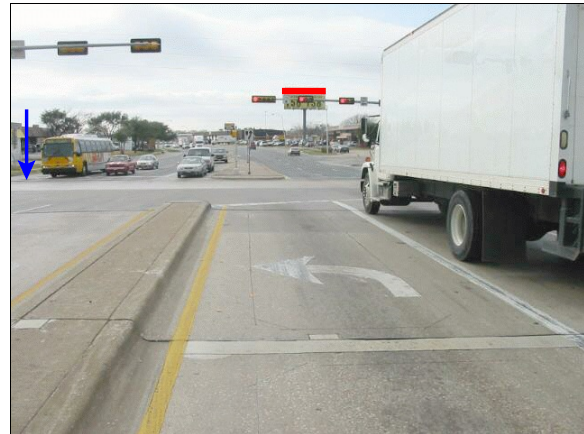
Figure 1: Case vehicle's westbound travel path in left-hand turn lane prior to making left turn; Note: arrow indicates approximate location of impact (case photo #01)

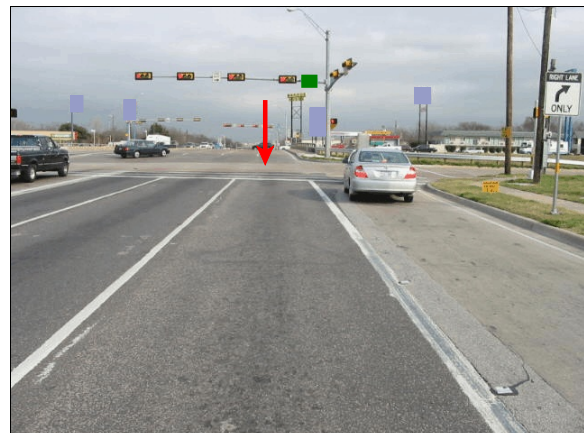
Figure 2: BMW's eastward travel path in outside through lane; Note: arrow indicates approximate location of impact (case photo #07a)

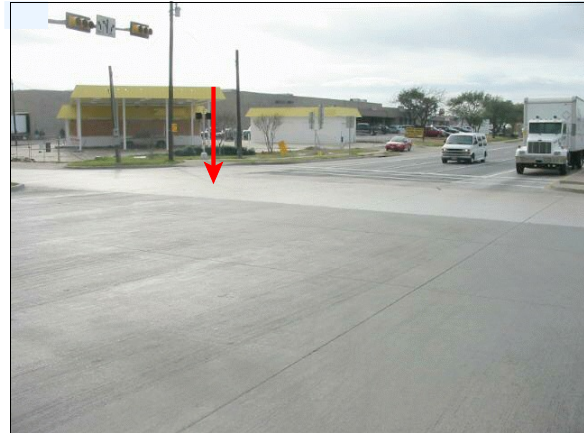
Figure 3: Case vehicle's travel path, west-to-south, during left-hand turn; Note: arrow indicates approximate area of impact (case photo #02)

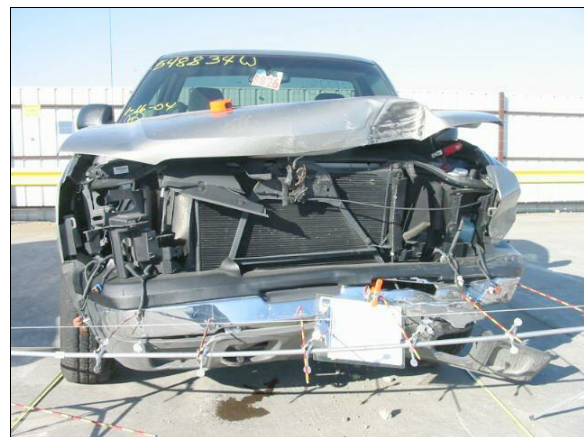
Figure 4: Case vehicle's frontal damage with contour gauge set at bumper level (case photo #11)

Exterior Damage: The case vehicle’s contact with BMW involved the entire frontal plane (**Figure 4** above and **Figure 11**). Direct damage began at the front left bumper corner and extended 162 centimeters (63.8 inches), along the front bumper. The Field L was determined to be 176 centimeters (69.3 inches). Residual maximum crush was measured as 50 centimeters (19.7 inches) at C₁ (**Figure 12**). The table below shows the case vehicle’s crush profile.

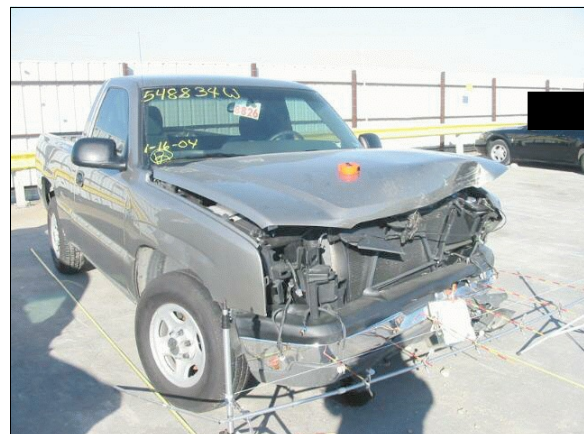
Crash: The front (**Figures 4** and **5**) of the case vehicle impacted the left front half of the BMW (**Figures 6** and **7** below), causing the case vehicle's driver supplemental restraint (air bag) to deploy. Based on the downloaded **EDR** data, only one stage of the driver's multi-stage air bag was activated. The case vehicle was equipped with a switchable (i.e., a cutoff switch) front right passenger supplemental restraint (air bag) that was set to the "auto" position (**Figure 8** below). This air bag did not deploy during the crash sequence.

Figure 5: Case vehicle's frontal damage viewed from right of front showing direct damage extending across entire front (case photo #22)

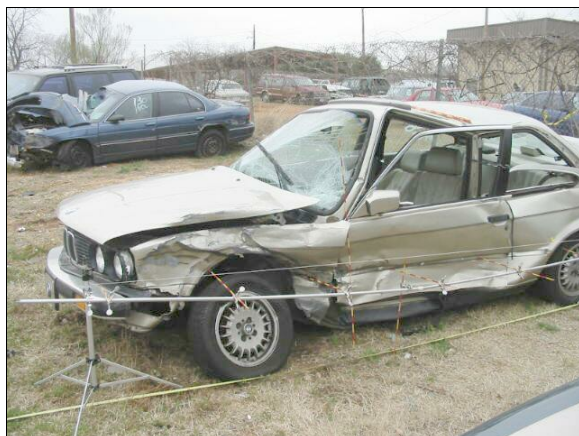
Figure 6 BMW's damaged left front half with contour gauge set above sill level; Note: damaged left front wheel assembly and direct contact to left "A"-pillar (case photo #45)

Exterior Damage: The BMW's contact with the case vehicle involved its left side (**Figures 6 and 7** above). Direct damage began 28 centimeters (11.0 inches) forward of the left rear axle and extended 283 centimeters (111.4 inches) forward, along the left side. The Field "L" began 23 centimeters (9.1 inches) forward of the left rear axle and extend 288 centimeters (113.4 inches) towards the vehicle's front. Residual maximum crush was measured as 40 centimeters (15.7 inches) at C₄ (**Figures 17 and 18** below). The table below shows the BMW's crush profile.

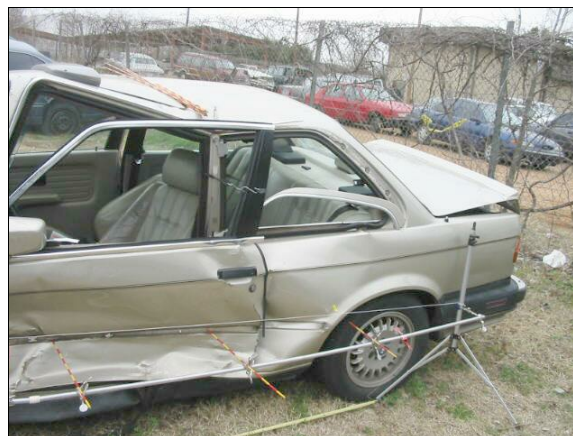
Figure 7: BMW's damaged left front door with crush extending onto left quarter panel; Note: door's window frame secured to left "B"-pillar for crush measurement purposes (case photo #46)

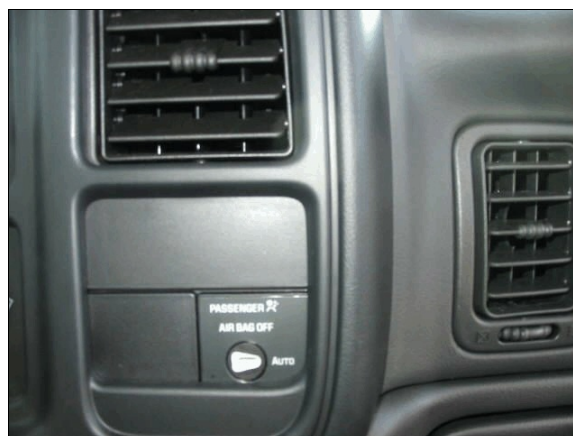
Figure 8: Case vehicle's front right passenger air bag cutoff switch showing switch located in "automatic" position; Note: with no front right passenger the seat's sensor correctly indicated that no deployment was required (case photo #33)

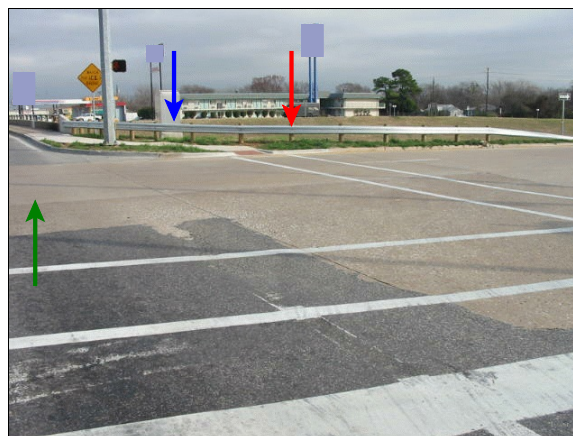
Post-Crash: As a result of the impact (**Figure 9**), the case vehicle rotated approximately 70 degrees counter-clockwise and was redirected to its left. The case vehicle came to rest partially off the roadway, straddling the curb on the southeast corner of the intersection, heading in an east-southeasterly direction (**Figure 10** below). The BMW was redirected to its right (southeast) and rotated approximately 45 degrees clockwise. The BMW is estimated to have come to final rest partially off the southern leg of the intersection, straddling the east curb, heading southeast (**Figure 9** and **Figure 10** below).

Figure 9: Arrows indicate areas of impact (green), and final rest for case vehicle (blue) and BMW (red); post-impact, case vehicle rotated counter-clockwise and BMW clockwise (case photo #09)

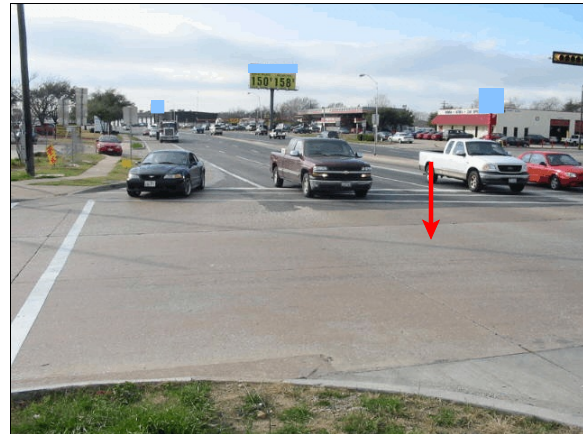
Figure 10: Westward view from beyond case vehicle's final rest position on southeast corner of four-leg intersection; Note: maroon pickup shows BMW's travel path and arrow indicates approximate location of impact (case photo #10)

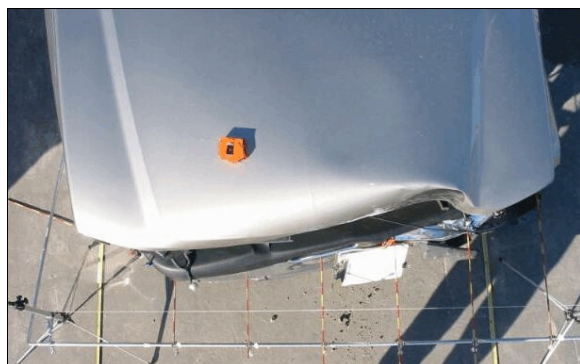
Figure 11: Overhead view of case vehicle’s frontal damage with contour gauge positioned at bumper level (case photo #23a)

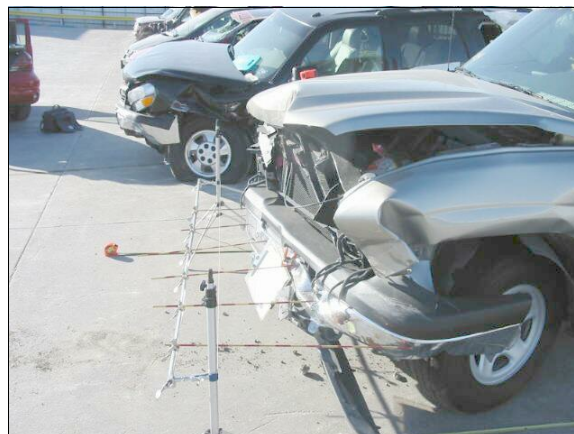
Figure 12: Case vehicle’s frontal damage viewed along reference line from left; Note: greater crush at C₁, indicating oblique nature of case vehicle’s interaction with BMW’s left side (case photo #14)

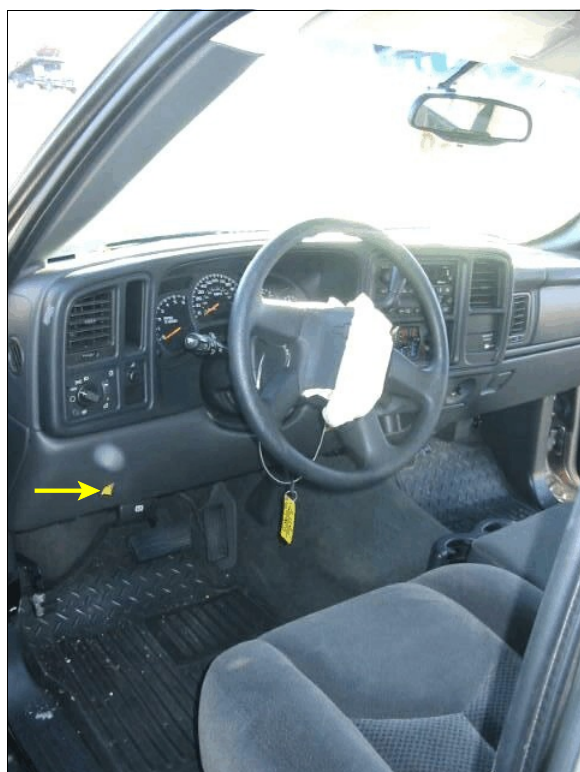
Interior Damage: Inspection of the case vehicle’s interior revealed only minor evidence (i.e., faint scuffs) of occupant contact. Scuffs were noted on the driver’s knee bolster, on both the left and right sides of the steering column (Figures 13 and 14). Finally, there was no evidence of intrusion to the case vehicle’s interior, no evidence of compression to the energy absorbing shear capsules in the steering column, and no deformation to the steering wheel rim.

Figure 13: Vertical view of case vehicle’s driver seating area showing deployed driver air bag and only possible contact evidence on left side of driver’s knee bolster (case photo #26)

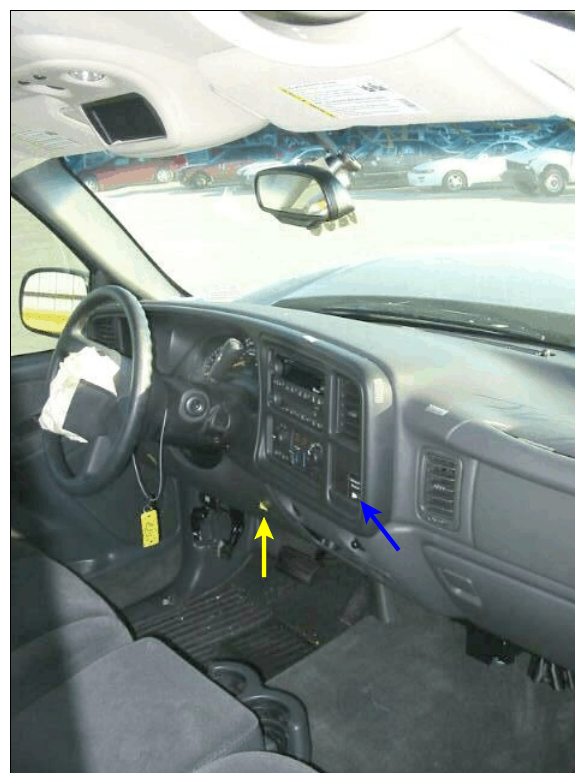
Figure 14: Vertical view of case vehicle’s front seating area showing deployed driver air bag, non-deployed front right passenger air bag, possible contact evidence on right side of driver’s knee bolster, and air bag cutoff switch (case photo #29)

The front right passenger's advanced air bag was located in the middle of the instrument panel. This air bag did not deploy in this crash (Figures 13 and 14 above).

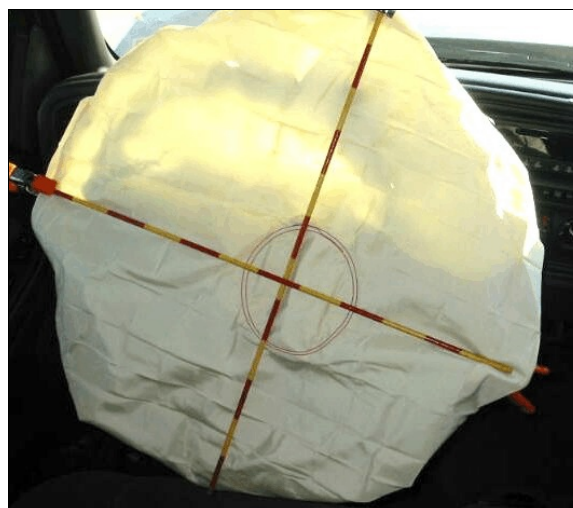
The case vehicle was equipped with a Supplemental Restraint System (SRS) that contained dual stage frontal air bags at the driver and front right passenger positions. Only the driver's frontal air bag deployed as a result of the frontal impact with the BMW. Only one stage of the multi-stage air bag was activated. The case vehicle's driver air bag was located in the steering wheel hub. The module cover consisted of asymmetrical, essentially, "I"-configuration cover flaps made of thick vinyl. Both the left and right flaps were trapezoidal in shape with overall dimensions of 14 centimeters (5.5 inches) along the top horizontal seam, 11 centimeters (4.3 inches) along the bottom horizontal seam, and 11.5 centimeters (4.5 inches) vertically along the seam that separated the two flaps. An inspection of the air bag module's cover flaps and the air bag's fabric revealed that the cover flaps opened at the designated tear points, and there was no evidence of damage during the deployment to the air bag or the cover flaps. The driver's air bag was designed with two tethers, each approximately 11 centimeters (4.3 inches) in width. The driver's air bag had two vent ports, approximately 3 centimeters (1.2 inches) in diameter, located at the 1 and 11 o'clock positions. The deployed driver's air bag was round with a diameter of 66 centimeters (26.0 inches). The distance between the mid-center of the driver's seat back, as positioned at the time of the vehicle inspection, and the front surface of the air bag's fabric at full excursion was not determined. An inspection of the driver's air bag fabric revealed no contact evidence readily apparent on the air bag's fabric (Figure 15).

Figure 15: Case vehicle's deployed driver air bag showing no obvious evidence of occupant contact (case photo #38)

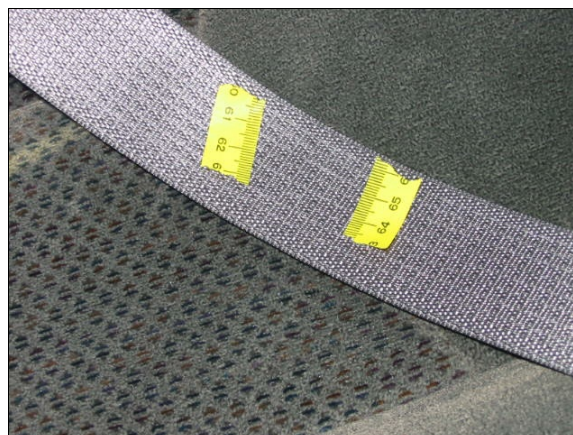
Based on this contractor's vehicle inspection and substantiated by the EDR data, the case vehicle's driver was restrained by his available, active, three-point, integral lap-and-shoulder, safety belt system; the belt system was not equipped with a pretensioner. Furthermore, according to the driver, there was evidence of belt pattern bruising and/or abrasions to the driver's torso, and the inspection of the driver's seat belt webbing and latch plate showed trace evidence (i.e., minor stretch marks) of loading on the belt's webbing (**Figure 16**).

Figure 16: Loading evidence (i.e., wear mark) on webbing of case vehicle's drivers seat belt (case photo #34)

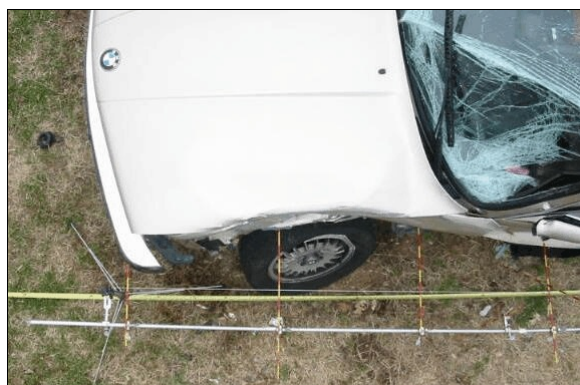
Figure 17: Overhead view of frontal portion of BMW’s left side damage with contour gauge positioned above the sill (case photo #47)

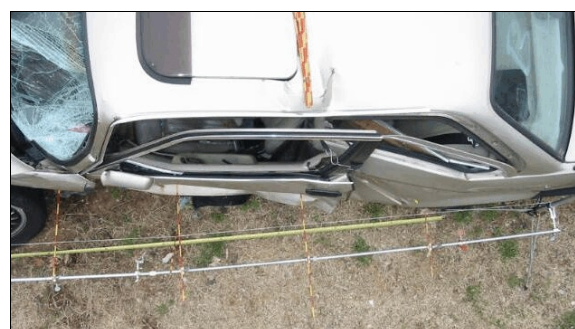
Figure 18: Overhead view of middle portion of BMW’s left side impact with contour gauge positioned above the sill (case photo #48)

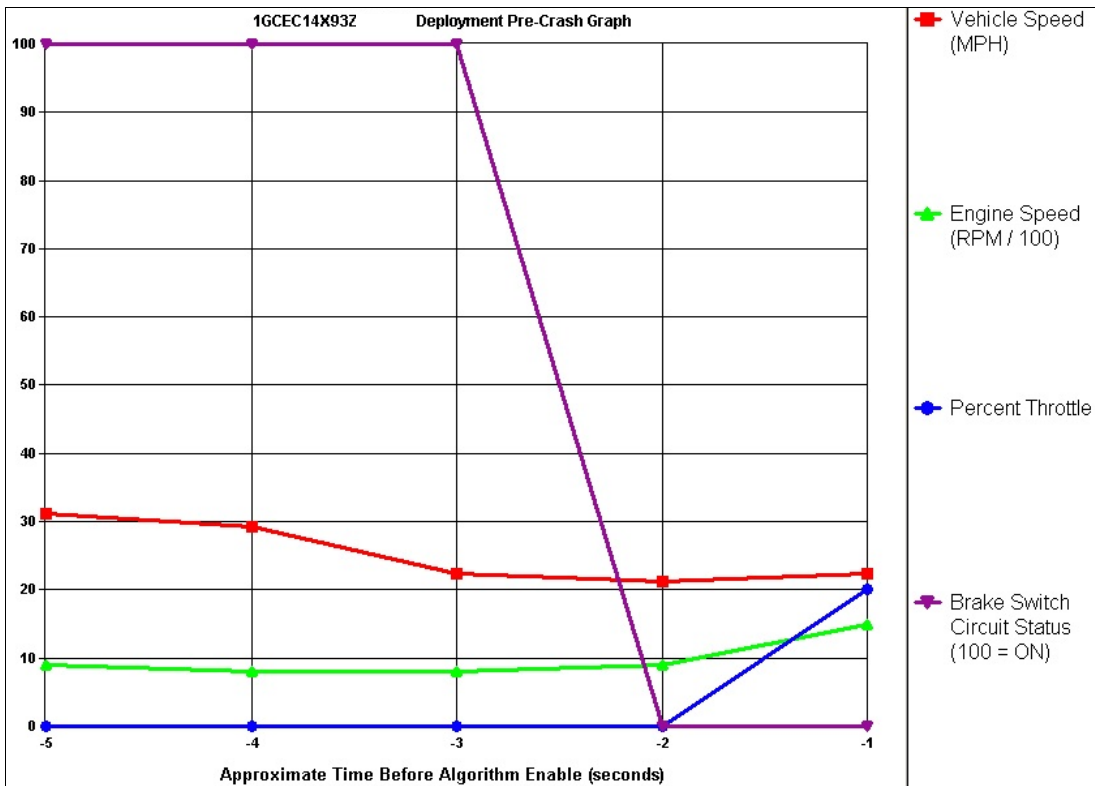
Figure 20: Case vehicle's pre-crash speed and brake switch circuit status showing that the vehicle's speed was recorded at 50 km.p.h. (31 m.p.h.) with the brake activated at approximately 5 seconds prior to algorithm enable and that the brake switch had been deactivated between the third and second recorded sample periods prior to algorithm enable.

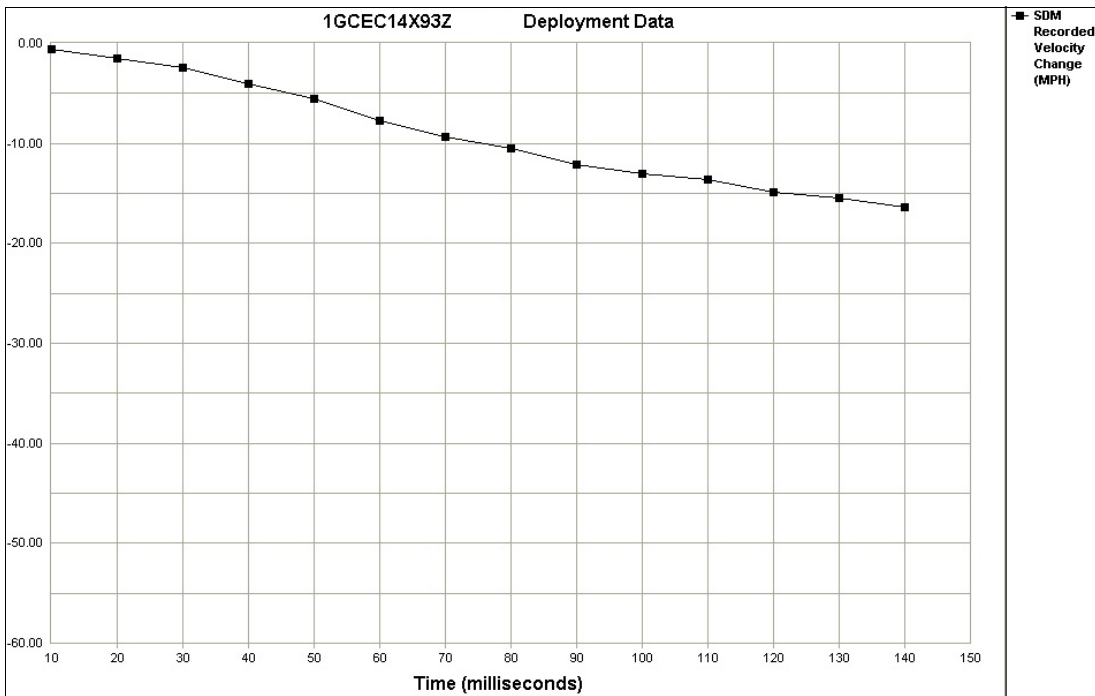
Figure 21: The case vehicle sustained a velocity change of approximately 26.4 km.p.h. (16.4 m.p.h.) during the first 140 milliseconds after the algorithm was enabled; maximum velocity change was recorded as 27.1 km.p.h. (16.8 m.p.h.) at 185 milliseconds

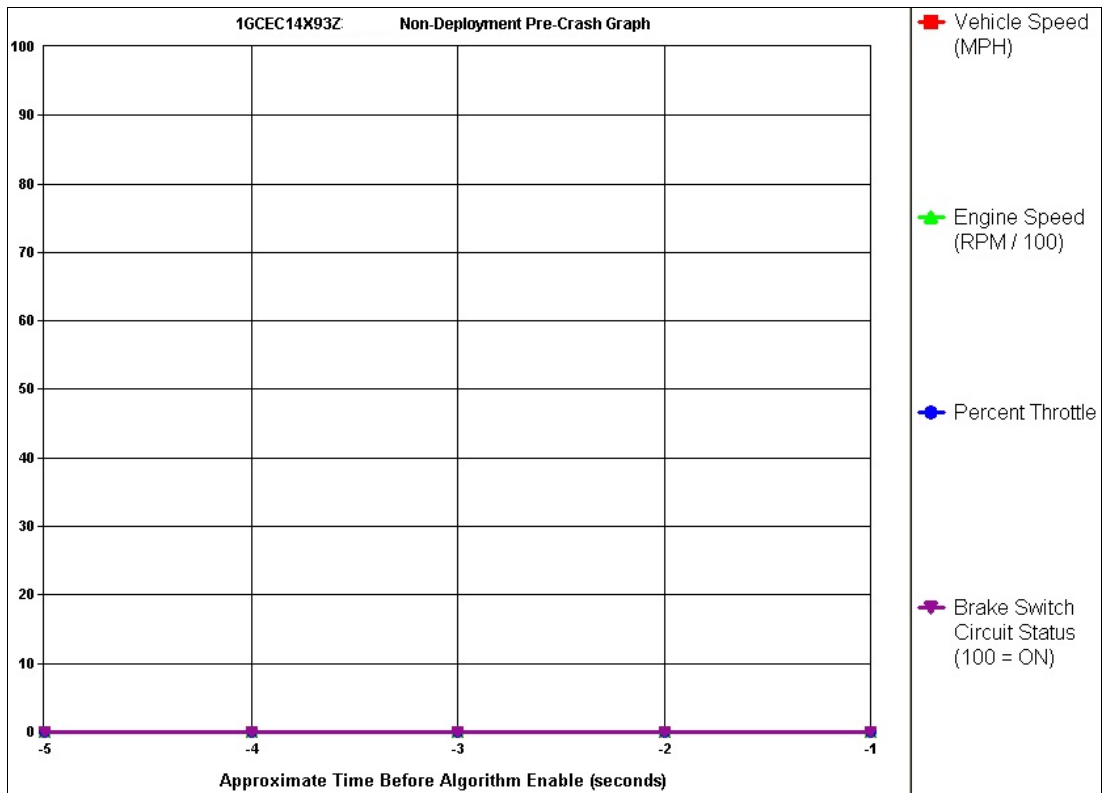
Figure 23: Case vehicle’s pre-crash speed and brake switch circuit status showing that the vehicle’s speed was recorded at 0 km.p.h. (0 m.p.h.) and that the brake switch had not been activated during the five recorded sample periods.

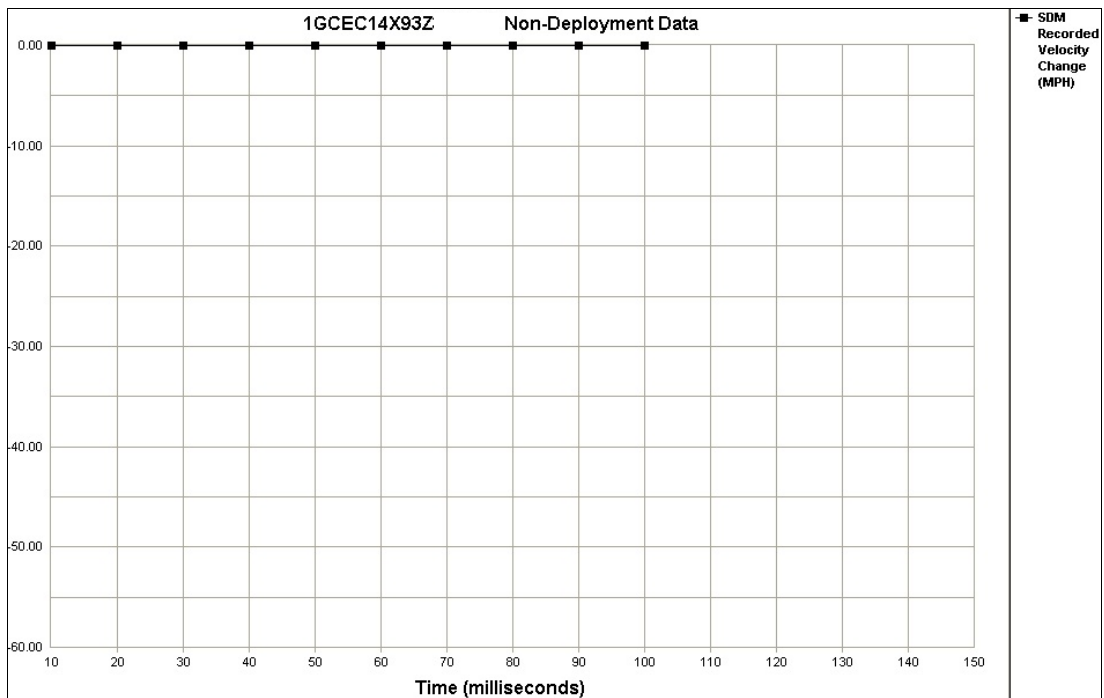
Figure 24: The case vehicle sustained a velocity change of approximately 0.0 km.p.h. (0.0 m.p.h.) during the first 100 milliseconds after the algorithm was enabled; maximum velocity change was recorded as 0.0 km.p.h. (0.0 m.p.h.) at algorithm enable (i.e., 0 milliseconds)
