Advanced Occupant Protection System Investigation/ Vehicle to Vehicle
Dynamic Science, Inc. / Case Number: DS04003
2004 Chevrolet Silverado
Colorado
February 2004

| 4. Title and Subtitle Advanced Occupant Protection System Investigation | | 5. Report Date March 12, 2006 | |
| 16. Abstract This on-site investigation focused on the performance of the advanced occupant protection system that was installed in a 2004 Chevrolet Silverado pickup. The Chevrolet pickup was occupied by a 28-year-old male driver and a 31-year-old male front right passenger. This two vehicle angle/broadside type crash occurred within the confines of a four-leg intersection. The Chevrolet pickup was struck in the front right by a 1995 International 4900 three axle garbage truck. The impact resulted in sufficient longitudinal deceleration of the Chevrolet pickup to command the deployment of the frontal air bag system. The International truck continued forward, departed the roadway and struck a metal light pole. The Chevrolet pickup rotated in counterclockwise rotation and came to rest in the intersection. The driver and front right passenger in the Chevrolet pickup sustained neck strains. The front right passen

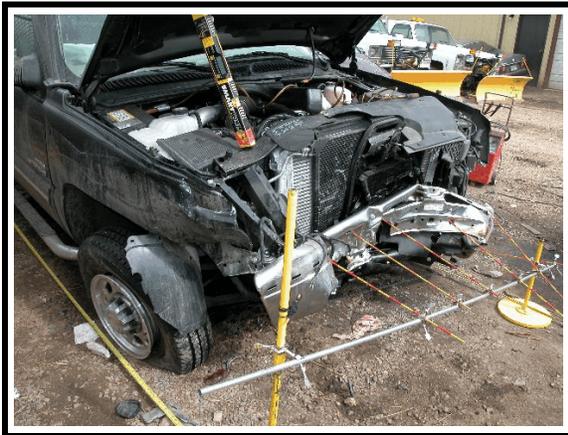
Damage Description: The 2004 Chevrolet Silverado sustained moderate front end and right side damage as a result of the two impacts with the garbage truck. For the frontal impact, the direct damage began on the front right bumper corner and extended laterally 160.0 cm (62.9 in). The maximum crush was located at C4 and measured 33.0 cm (12.9 in). There were white and green paint transfers across the entire front end. Six crush measurements were documented at the bumper level as follows: C1 = 0 cm (0 in), C2 = 0 cm (0 in), C3 = 3.0 cm (1.2 in), C4 = 21.0 cm (8.3 in), C5 = 13.0 cm (5.1 in), C6 = 0 cm (0 in). For the side impact, the direct damage began 23.0 cm (9.0 in) forward of the rear axle and extended forward 119.0 cm (46.8 in) along the right side plane. Both right side doors were jammed shut. The right rear door was bowed outward. The front right rim was damaged and the tire was flattened

CDC: Impact 1: 01FDEW2
Impact 2: 03RZEW3

Figure 5. Chevrolet Silverado, impact 1

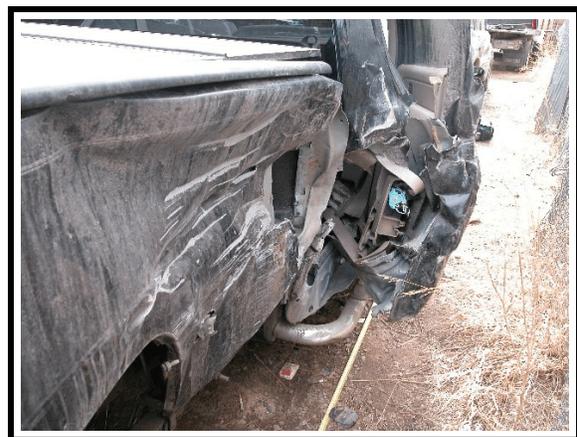
Figure 6. Chevrolet Silverado, impact 2

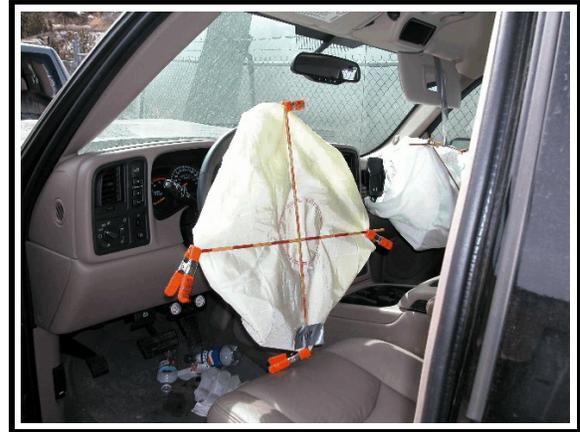
Figure 7. Driver's air bag

The driver's air bag deployed from the center of the steering wheel hub through symmetrical I-configuration module cover flaps. Each flap measured 8.0 cm (3.1 in) across the top, 12.0 cm (4.7 in) along the side, and 5.0 cm (2.0 in) at the bottom. The deployed driver's air bag measured 55.0 cm (21.7 in) in diameter in its deflated state. The maximum rearward excursion measured 25.0 cm (9.8 in). The distance from the module cover to the driver's seat back measured 70.0 cm (27.6 in). The air bag was equipped with two internal tethers. There were two vent ports located at the 11 and 1 o'clock aspects on the rear of the air bag. There was no damage to either the air bag or the module covers. There were marks to the front of the air bag from the module cover.

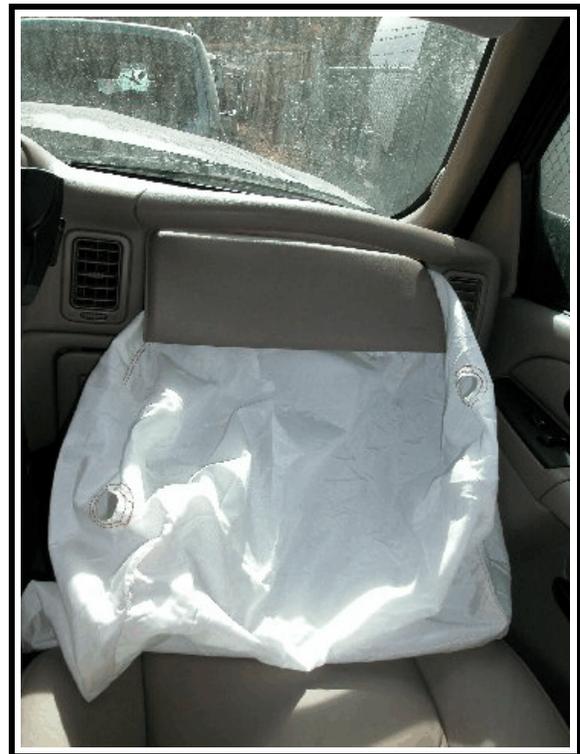
Figure 8. Front right passenger's air bag

The front right passenger's air bag deployed from a front mount module with a rectangular cover flap that was hinged at the top aspect. The module cover flap measured 39.0 cm (15.4 in) in

width and 14.0 cm (5.5 in) in height. The deployed front right passenger's air bag measured 46.0 cm (18.1in) in height and 48.0 cm (18.9 in) in width. There was a single tether. Two circular vent ports were located at the 10 and 2 o'clock aspects of each side panel of the air bag. There was no damage to either the air bag or the module cover.

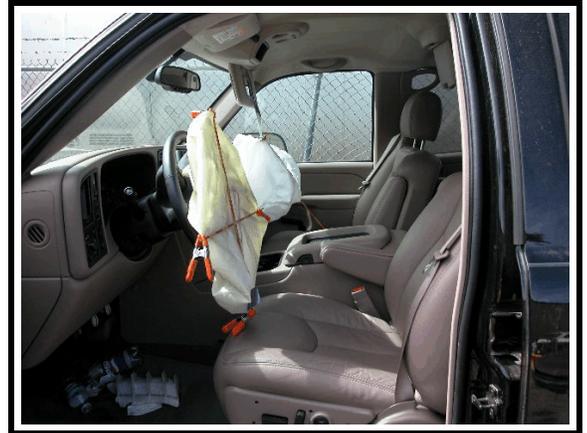
The 28-year-old driver was seated in an upright posture in the leather covered bucket seat and was restrained by the integral lap and shoulder belt. The driver's seat was located 10.0 cm (3.9 in) rear of the full forward track position (between middle and rear most track position). The seat back was adjusted to a 67 degree angle. Both hands were on the steering wheel. The right foot was on the accelerator and the left on the floorboard. At the first impact with the garbage truck, the frontal air bags deployed. The driver initiated a forward and slightly right trajectory. He was held in place by the lap and shoulder belt. He likely engaged the deployed air bag with his face and torso, but there were no residual injuries or contact evidence. The driver reported soreness to his right wrist and forearm that may have come from contact with the air bag; there were no resultant abrasions or contusions. At the second impact with the truck, the driver pitched to the right but was held in place by the lap belt. The driver sustained a neck strain from the impact forces. He was able to exit the vehicle on his own. He later visited his personal physician who recommended that he undergo some physical therapy to alleviate the neck pain.

Figure 9. Driver's seated area

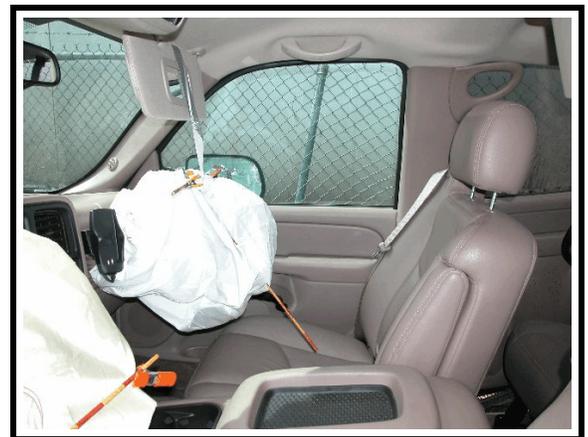
The 31-year-old male front right passenger was seated in an upright posture in the leather covered bucket seat and was restrained by the integral lap and shoulder belt. The front right passenger's seat was located 7.0 cm (2.8 in) rear of the full forward track position (middle track position). The seat back was adjusted to a 71 degree angle. This occupant had just finished completing a cell phone call. Both feet were on the floorboard. At the first impact with the garbage truck, the frontal air bags deployed. The front right passenger initiated a forward and slightly right trajectory. He was held in place by the lap and shoulder belt. He likely engaged the deployed air bag with his face and torso, but there were no residual injuries or contact evidence. His left knee struck the lower instrument panel but there was no resultant injury. At the second impact with the truck, this occupant pitched to the right and struck the right side of his head on the right window. He may have blacked out for a few seconds. He sustained a neck strain from the impact forces. He also reported soreness to his left knee and back. He was able to exit the vehicle on his own. He was transported to a local hospital where he was treated and released.

Figure 10. Front right passenger's seated area
