ON-SITE ADVANCED OCCUPANT PROTECTION SYSTEM INVESTIGATION

CASE NUMBER - IN-04-004
LOCATION - OKLAHOMA
VEHICLE - 2004 SATURN ION
CRASH DATE - January 2004

September 18, 2007

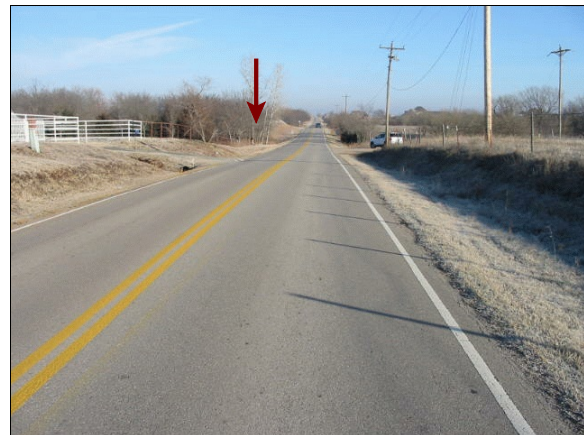
Figure 1: Case vehicle's northward path of travel in northbound lane after cresting hill; arrow indicates approximate area of impacts following roadside departure (case photo #03)

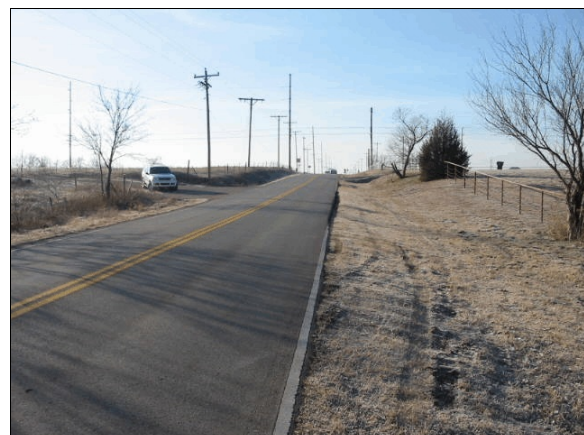
Figure 2: Southward view of case vehicle's northward travel path from hill crest across southbound lane and onto western roadside (case photo #11)

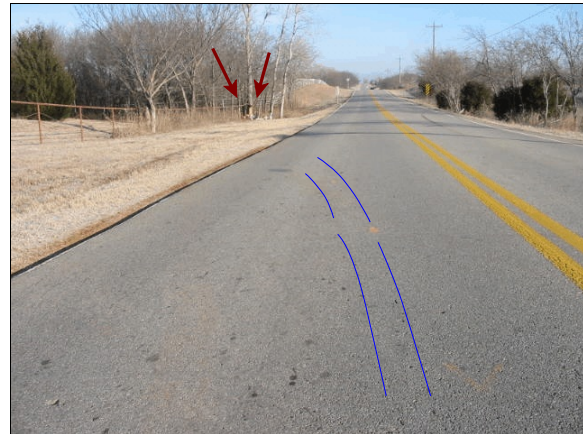
Figure 3: Curved marks (highlighted) from case vehicle's right side tires as vehicle travels northward in southbound lane heading off road onto west roadside and impact area (arrows) with fence rail and trees (case photo #03b)

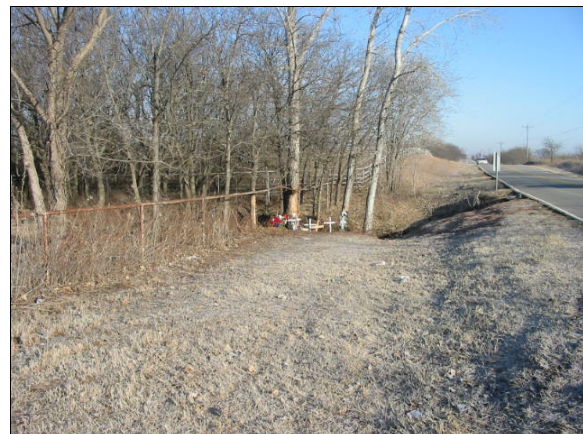
Figure 4: Case vehicle's northward travel path on west roadside toward area of impact with fence post and rail and trees (case photo #05)

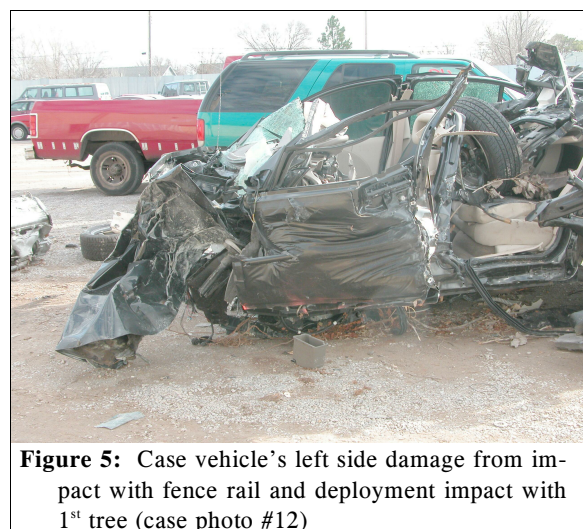
Crash: Based upon the Police Crash Report and our investigation, the crash sequence began when the front left (**Figure 5**) of the case vehicle impacted a vertical metal fence post (1st event—**Figure 6** below). The case vehicle continued through the post and almost immediately the left front fender impact a medium sized tree (2nd

Figure 5: Case vehicle's left side damage from impact with fence rail and deployment impact with 1st tree (case photo #12)

Because of the case vehicle’s severe damage, no attempt was made to estimate the crush from the impact with the 1st (small) tree (**Figure 5** above), which is believed to be the deployment event. The wheelbase on the case vehicle’s left side was shortened approximately 22 centimeters (8.7 inches) while the right side was shortened approximately 4 centimeters (1.6 inches). The case vehicle’s front bumper, bumper fascia, grille, radiator, hood, left and right headlight and turn signal assemblies, and left fender were directly damaged and crushed rearward. There was catastrophic damage to essentially the entire front end of the case vehicle, with few components remaining. Both front wheel assemblies were sheared off with the wheels continuing forward as discussed above. The engine block was separated from the engine compartment (**Figure 9** above). The contact to the fence rail directly damaged the left side of the roof (**Figure 9** above), left roof side rail, left “A”-pillar, and left windshield header (**Figure 5** above). There was induced damage to the hood, right fender, and right front and rear doors (**Figure 11**) as well as both the left front and rear window glazings. The roof also sustained induced damage and the windshield was heavily damaged and only slightly attached to the windshield frame, but this damage was likely because of the extrication and rescue efforts after the crash. The roof was cut off at the “A”, “B”, and “C”-pillars.

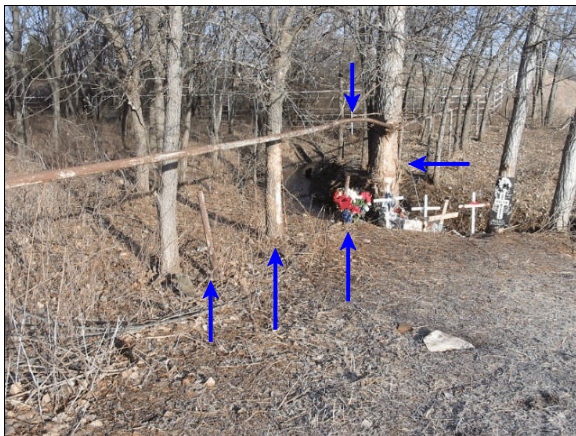
Figure 6: Case vehicle's area of impact with fence post and rail and trees; an arrow marks each of the five identified impacts (case photo #06)

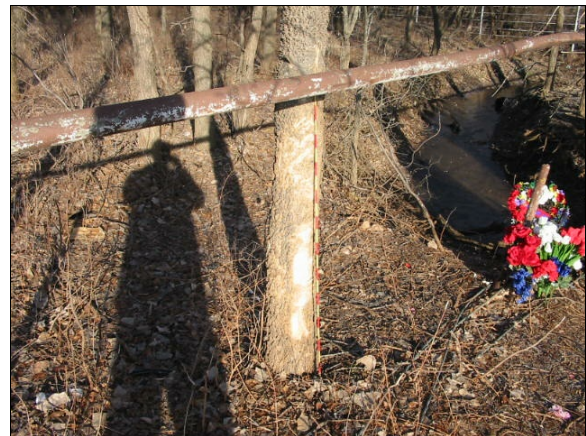
event—**Figures 6 and 7**), most likely causing the case vehicle's driver and front right passenger supplemental restraints (air bags) to deploy. Based on the downloaded **EDR** data, only one stage of the multi-stage air bags was activated. The case vehicle was redirected slightly to its right but struck another metal fence post (3rd event—**Figure 6**) before impacting a large tree with its front (4th event—**Figures 6 and 8**). The impact with the large tree was so severe that, according to the Police Crash Report, both front wheels were separated from the vehicle and continued forward a substantial distance. At this point, the case vehicle was still oriented in a north-northwesterly direction. After the collision with the second tree, the back end of the case vehicle elevated, but its upward movement was constricted by the top horizontal rail of the fence (5th event—**Figure 8**), causing damage to the roof (**Figure 9**).

Figure 7: Close-up of 1st tree impacted (2nd event) by case vehicle; this impact was most likely the deployment impact (case photo #07)

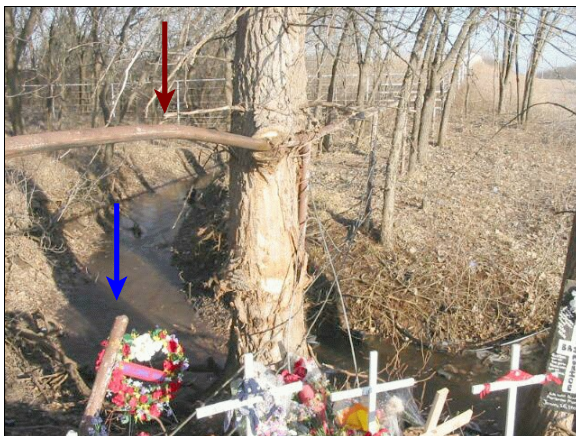
Figure 8: Close-up of 2nd tree impacted (4th event) by case vehicle; arrows show impact with fence post, blue arrow—3rd event, and fence rail, red arrow—5th event (case photo #09)

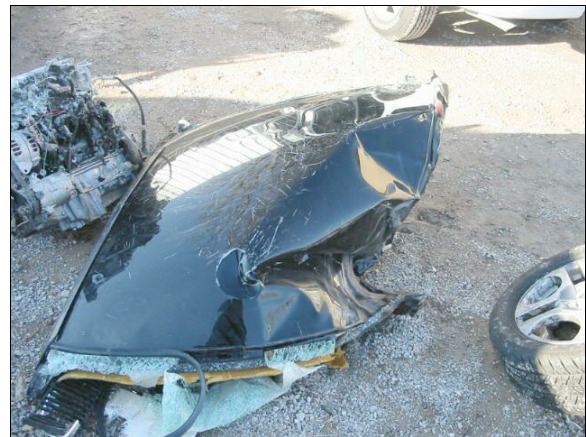
Figure 9: Damage to case vehicle's roof, removed by rescue personnel, showing indentation over driver's seating area from contact with horizontal portion of fence pole; Note: separated engine block in background (case photo #16)

Post-Crash: As a result of the impact sequence, the case vehicle came to rest against the second tree, heading in a north-northwesterly direction. According to the Police Crash Report, the case vehicle's two front wheels were found in a wooded area, approximately 27-37 meters (30-40 yards) further to the northwest. The engine block was also knocked out of the vehicle (**Figure 9**).

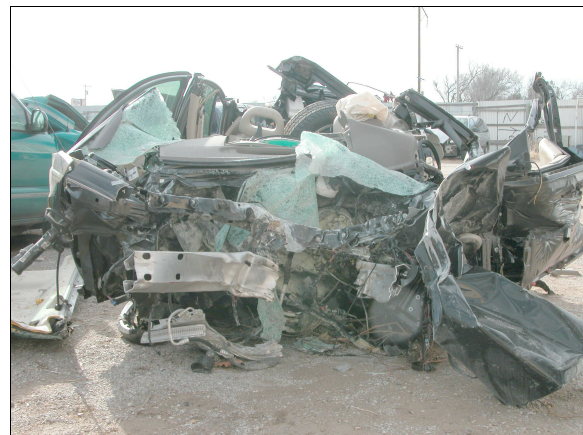
Figure 10: Frontal view of case vehicle's severely damaged front end; Note: engine was knocked out during impact with 2nd tree (case photo #14)

which components were involved and where damage began (**Figure 10** above). For the sake of this contractor’s reconstruction, our focus will be on the impact with the 2nd (large) tree. Crush measurements were taken at the actual metal bumper, which was split in the center from the 2nd tree impact. Direct damage is estimated to have started near the front left bumper corner and extended for 48 centimeters (18.9 inches) along the bumper to the right. Residual maximum crush at the bumper was measured as 159 centimeters (62.6 inches) at C₃. The table below shows the case vehicle’s crush profile.

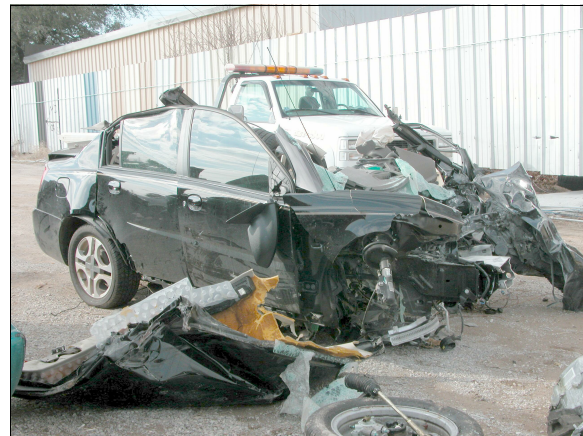
Figure 11: Case vehicle’s frontal damaged viewed from right of front; Note: engine missing and roof removed during extrication (case photo #15)

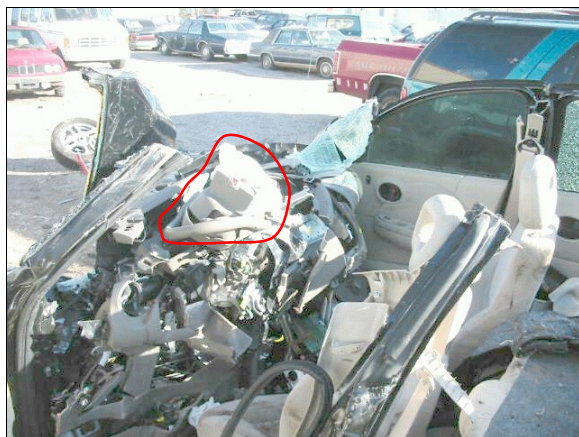
Figure 12: Elevated view from left of case vehicle's front seating area showing damage/intrusion; Note: deformed steering wheel rim and deployed driver air bag (case photo #18)

Interior Damage: Inspection of the case vehicle's interior revealed major interior damage and intrusion because of the severity of the crash (Figures 12 and 13 above). Numerous occupant contacts were found including the left front door panel, left door armrest (Figure 14 above), steering wheel rim, steering column, brake pedal, center instrument panel (Figure 15 above), glove box door (Figure 16), left front seat back (Figure 17) and driver's adjustable head rest (Figure 18).

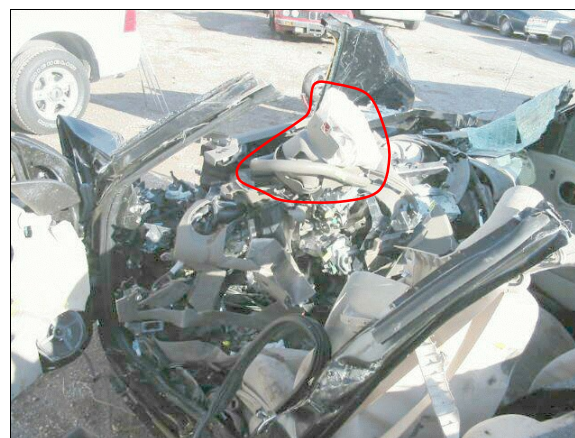
Figure 13: Case vehicle's driver seating area viewed from behind left "B"-pillar showing intrusions and contact evidence; Note: deformed steering wheel and deployed driver air bag (case photo #20)

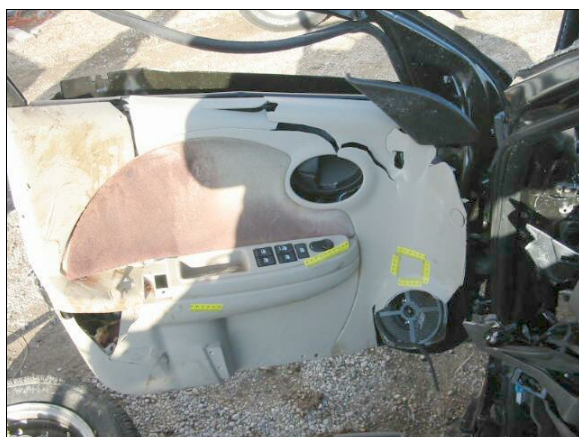
Figure 14: Interior surface of case vehicle's driver front door showing evidence of occupant contact (case photo #25)

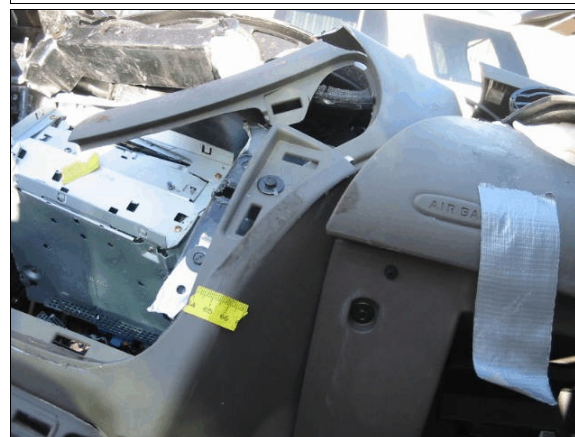
Figure 15: Contact evidence on case vehicle's center instrument panel area; Note: deployed front right passenger air bag (case photo #23)

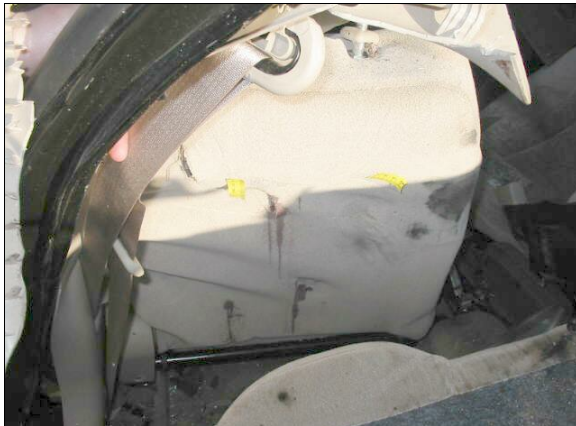
Figure 17: Back surface of case vehicle's driver seat back showing contact evidence from impact by back left occupant (case photo #27)

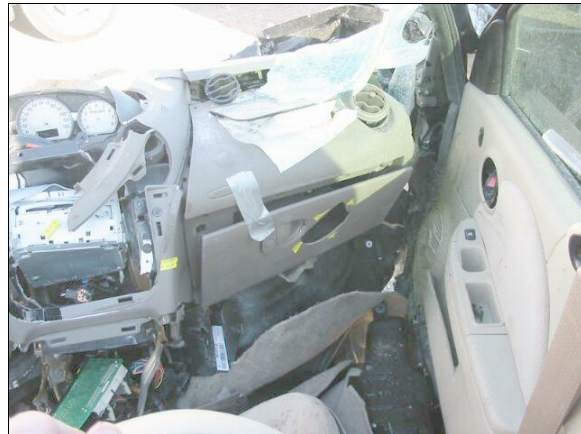
Figure 16: Case vehicle's front right passenger seating area showing deployed front right passenger air bag, intrusions, and contact evidence; Note: contacts to center instrument panel and "hole" in glove box door (case photo #24)

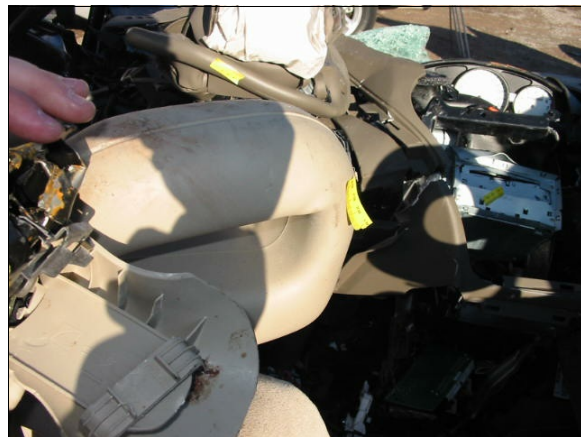
Figure 18: Close-up of back surface of adjustable head restraint for case vehicle's driver showing distortion and damage caused by contact from back left occupant; Note: distorted steering wheel rim in background (case photo #48)

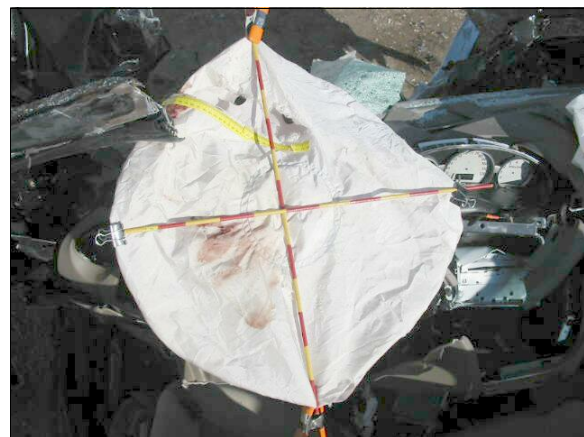
Figure 19: Front surface of case vehicle's deployed driver air bag showing contact evidence near center in lower left quadrant and tear in air bag's fabric in upper left quadrant (case photo #30)

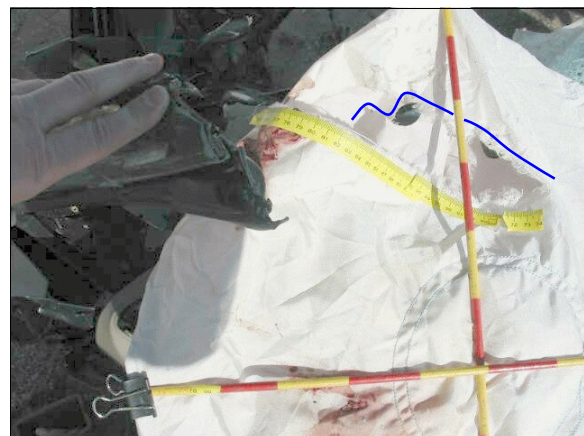
Figure 20: Close-up of obliquely oriented tear (i.e., yellow tape) and blood evidence on front surface of case vehicle's deployed driver air bag; tear exposes vent ports on air bag's back surface (case photo #32)

upper and lower right quadrants of the bag's front surface face and there were sizeable blood and tissue stains in the upper and lower left quadrants of the air bag's face. The back side of the air bag was free of damage except for a pair of 2.5 centimeter (1.0 inch) holes in the lower left and right quadrants near the 6 o'clock position.

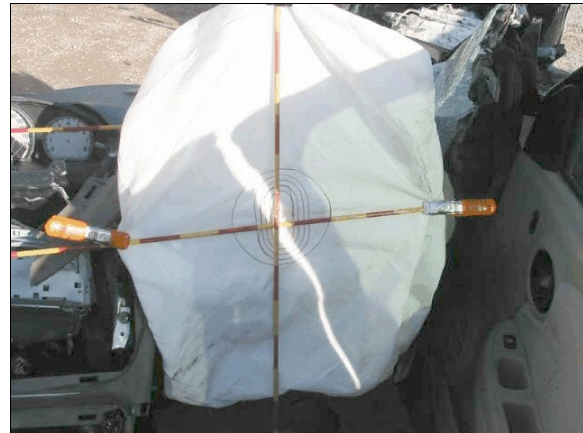
The front right passenger's air bag was located in the top of the instrument panel. There was a single, essentially rectangular, modular cover flap. The cover flap was made of thick semi-pliable vinyl, thicker than the vinyl on the driver's module. The flap's dimensions were not recorded nor was the profile of the case vehicle's instrument panel. An inspection of the front right air bag module's cover flap and the air bag's fabric revealed that the cover flap opened at the designated tear points, and there was no evidence of damage during the deployment to the air bag or the cover flap. The front right passenger's air bag was designed with two tethers, each approximately 11 centimeters (4.3 inches) in width. The front right air bag had two vent ports, approximately 5.5 centimeters (2.2 inches) in diameter, located at the 10 and 2 o'clock positions. The deployed front right air bag was rectangular with a height of approximately 60 centimeters (23.6 inches) and a width of approximately 43 centimeters (16.9 inches). An inspection of the front right passenger's air bag fabric revealed nothing more than dirt and grease scuffs routinely found in most deployments (**Figure 21**).

Figure 21: Front surface of case vehicle's deployed front right passenger air bag showing no obvious evidence of occupant contact (case photo #43)

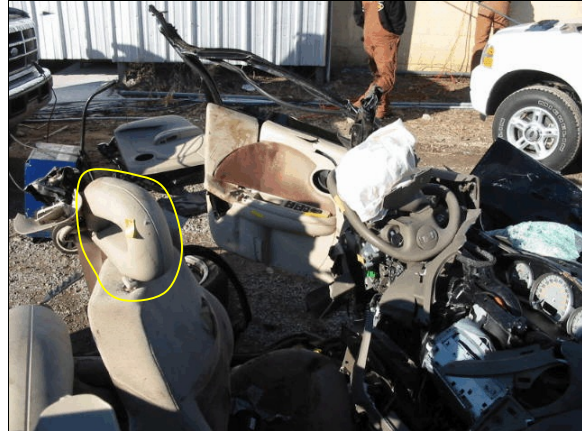
The case vehicle's back left passenger was not using his available, active, three-point, lap-and-shoulder, safety belt system; the belt system was not equipped with a pretensioner. Furthermore, the inspection of the back left passenger's seat belt webbing, "D"-ring, and latch plate showed no evidence of loading. In addition, the vehicle inspection indicates that the back left passenger contacted the back surface of the driver's seat back (**Figure 17** above) and deformed the driver's adjustable head restraint (**Figure 18** above and **Figure 22**).

Figure 22: Elevated view of case vehicle's driver seating area showing distorted steering wheel rim, deployed driver air bag, contact evidence on interior surface of driver's door, and distortion to driver's adjustable head restraint from contact by back left passenger (case photo #28)

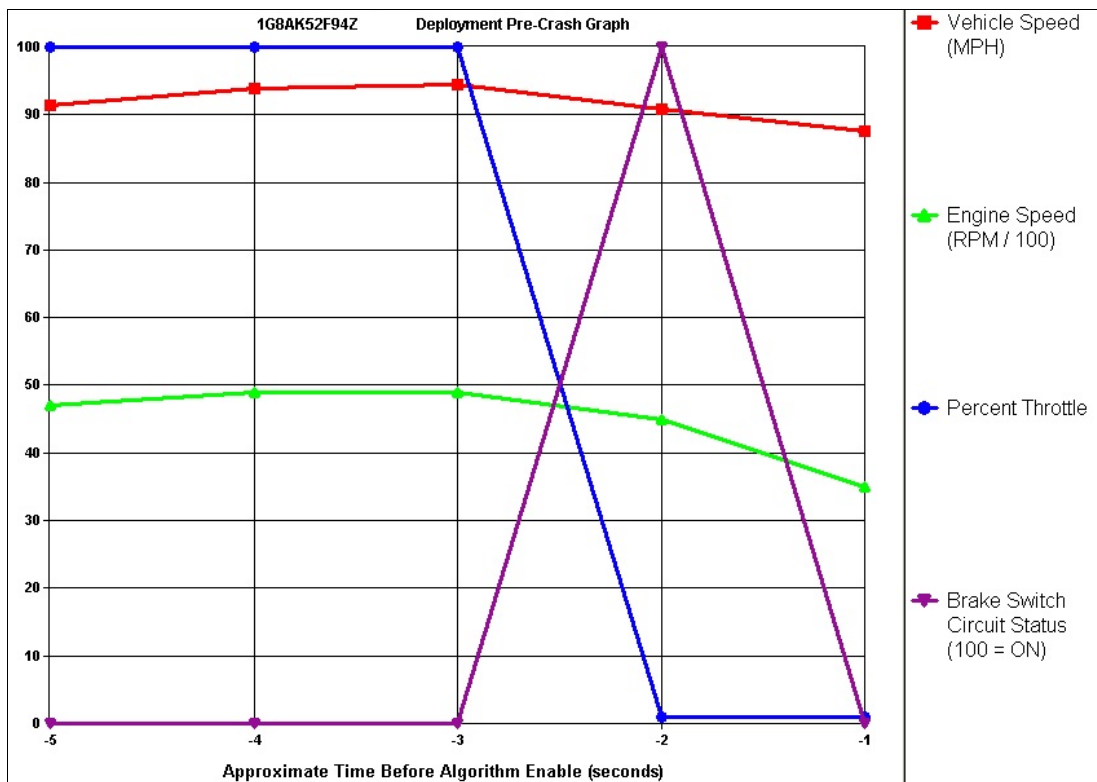
Figure 24: Case vehicle's pre-crash speed and brake switch circuit status showing that the vehicle's speed was recorded at 146 km.p.h. (91 m.p.h.), with the brake activated, at approximately 2 seconds prior to algorithm enable and that the brake switch had been deactivated between the 5th and 2nd recorded sample periods **and** during the last record sample prior to algorithm enable

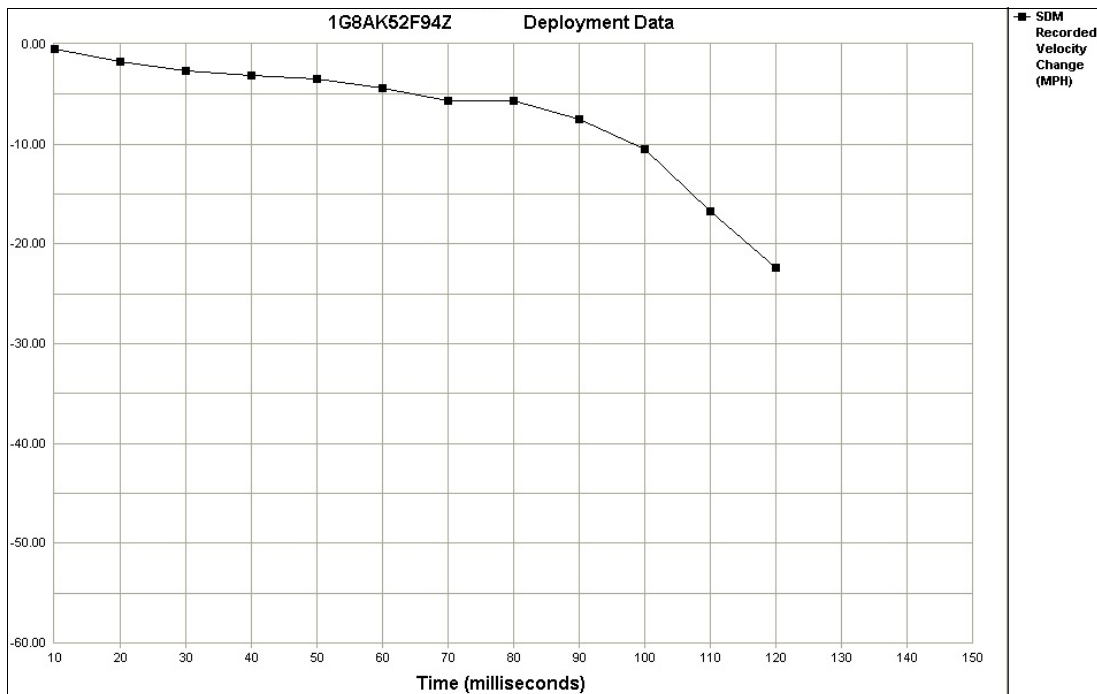
Figure 25: The case vehicle sustained a velocity change of approximately 36.0 km.p.h. (22.4 m.p.h.) during the first 120 milliseconds after the algorithm was enabled; maximum velocity change was recorded as 36.13 km.p.h. (22.45 m.p.h.) at 117.5 milliseconds

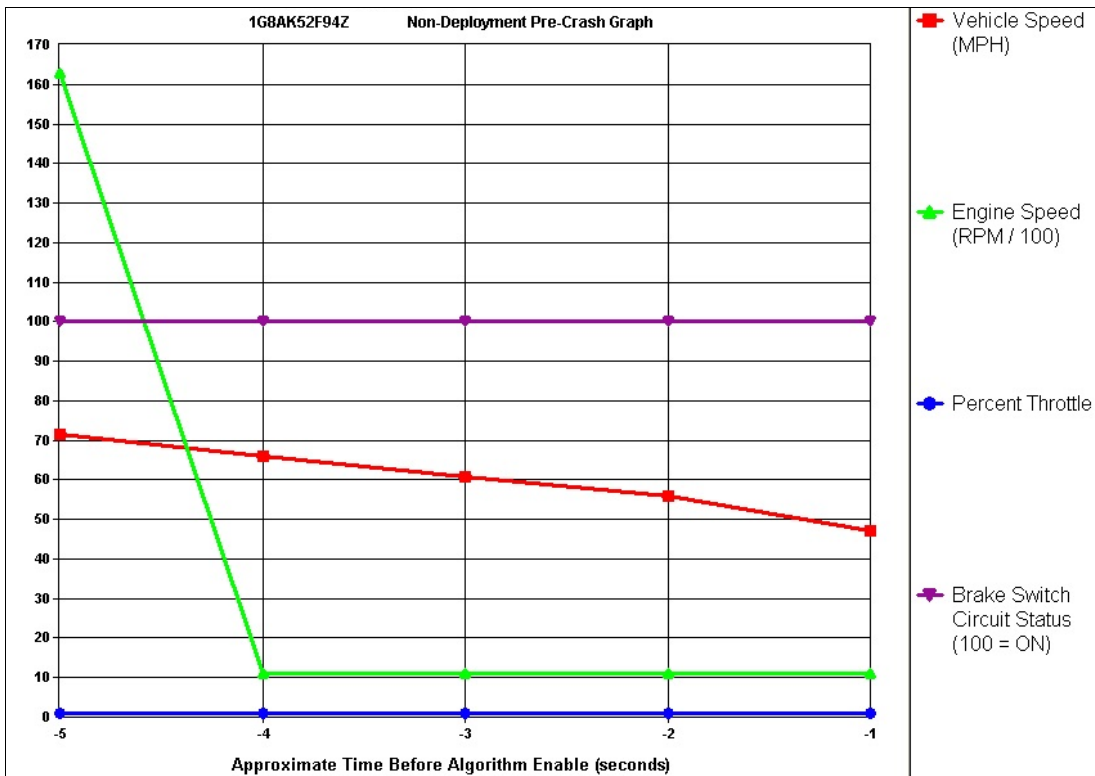
Figure 27: Case vehicle’s pre-crash speed and brake switch circuit status showing that the vehicle’s recorded speed decreased from 114 km.p.h. (71 m.p.h.) to 76 km.p.h. (47 m.p.h.) during the five recorded sample prior to algorithm enable and that the brake switch had been activated throughout the five recorded sample periods

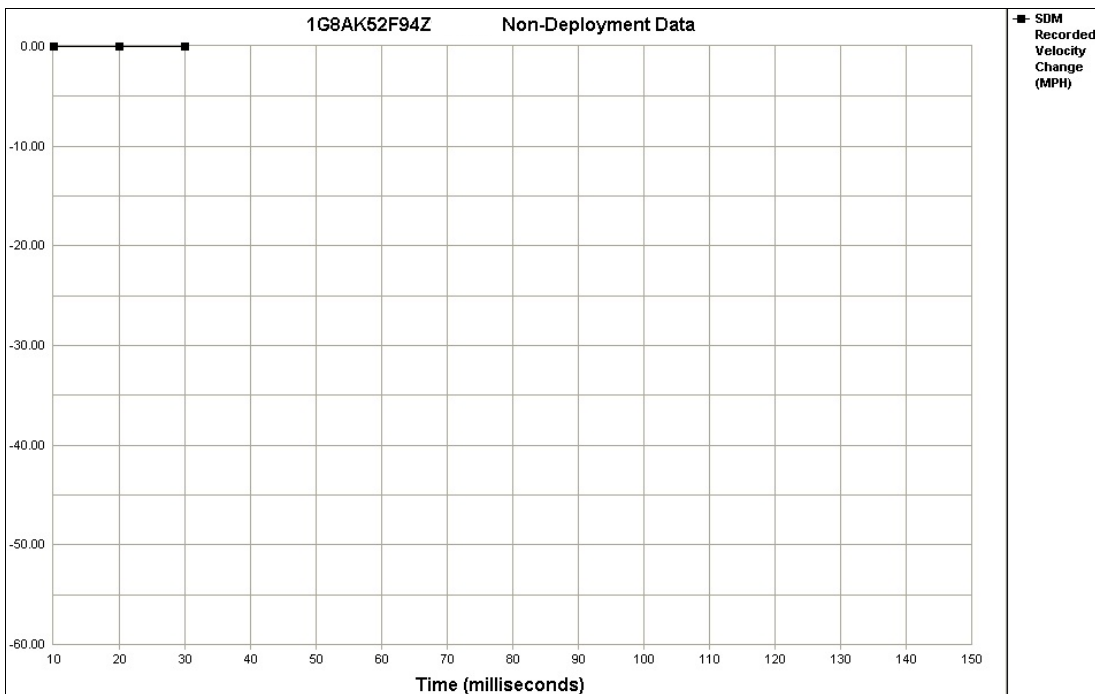
Figure 28: The case vehicle sustained an insignificant velocity change of approximately 0.0 km.p.h. (0.0 m.p.h.) during the first 30 milliseconds after the algorithm was enabled; maximum velocity change was recorded as 0.37 km.p.h. (0.23 m.p.h.) at 50 milliseconds
