**CALSPAN ON-SITE SCHOOL BUS CRASH INVESTIGATION**

**CASE NO.: CA04-006**

**VEHICLE: CHASSIS - 1997 INTERNATIONAL CONVENTIONAL  
BODY - 77 PASSENGER BLUEBIRD**

**CRASH DATE: FEBRUARY 2004**

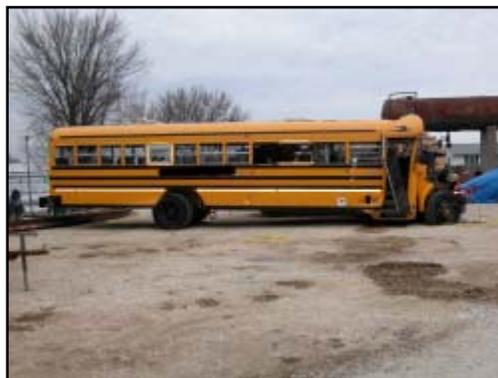
**Figure 1. Subject school bus.**

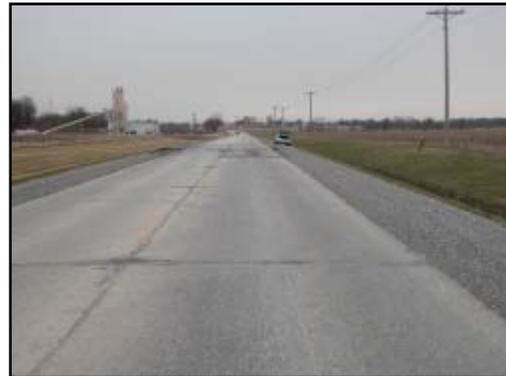
The crash occurred on a two-lane road in a rural area during daylight hours (**Figure 2**). The asphalt road surface was 7.5 m (24.6') in width and was delineated by a broken yellow center line. Both edges of the roadway were bordered by stone shoulders and shallow drainage ditches. In the vicinity of the crash site, the roadway was straight and level. A right curve for westbound traffic terminated 0.4 kilometers (0.3 mile) east of the crash site. A four-leg intersection with four-way stop signs was located 1.6 km (1 mile) east of the crash site. At the time of this on-site SCI investigation, an

**Figure 2. Westbound view of the crash site.**

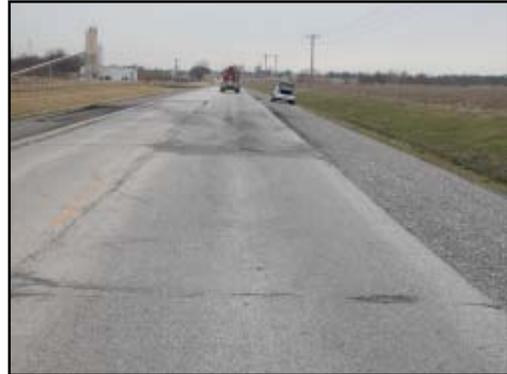
The road repair employee of the highway crew observed the approaching school bus as he was filling a pothole (**Figure 3**). At this point in time, the bus was a significant

**Figure 3. Location of the stopped dump truck and westbound approach of the school bus.**

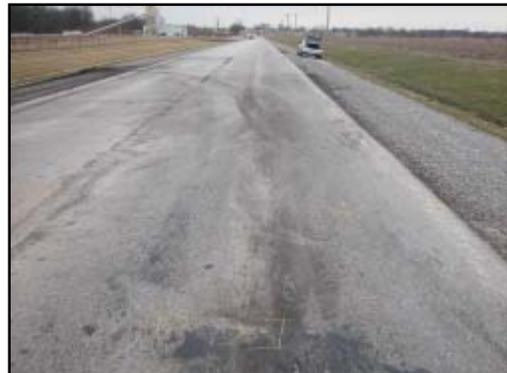
The dump truck was positioned within the westbound travel lane when struck by the frontal aspect of the school bus (**Figure 4**). Based on witness statements to the investigating police officers, the impact speed of the bus was within the 80-89 km/h (50-55 mph) speed range. The full frontal area of the bus impacted the rear of the dump truck in a 12/6 o'clock impact configuration. The initial contact against the back of the dump truck and the extended tailgate fractured the fiberglass cowl of the bus and displaced the cowl in a rearward direction. The front bumper of the bus was crushed from the impact with the rear trailer

**Figure 4. Area of impact between the dump truck and subject school bus.**

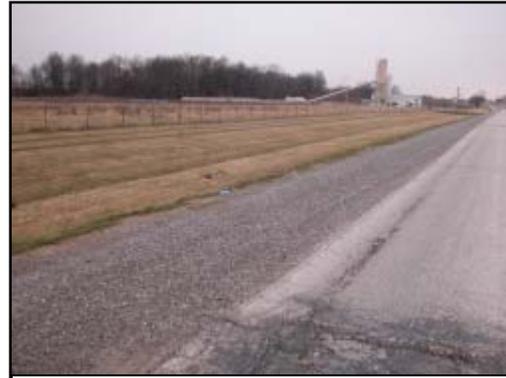
The dump truck was redirected forward and traveled in an arcing trajectory to its left due to the forward displacement of the rear axle. The left wheelbase was reduced in length, which induced a rear axle steering input to the truck. The truck traversed the westbound travel lane and the south shoulder, coming to rest off-road approximately 39.2 m (128.6') west of the point of impact (**Figure 5**). The front tires furrowed into the ground which identified the vehicle's trajectory and final rest position. At rest, the dump truck was facing in a southwesterly direction.

**Figure 5. Final rest of the struck dump truck.**

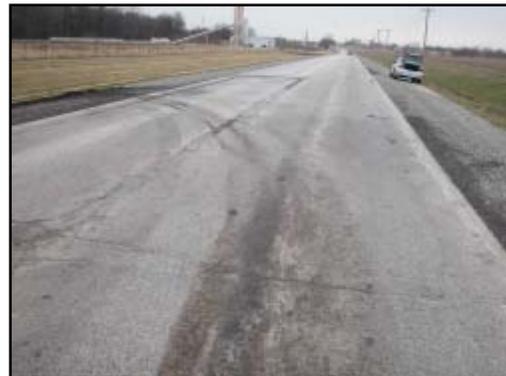
The front tires of the school bus were punctured by the engagement against the rear of the truck. A counterclockwise steering angle was induced to the front axle of the bus, which resulted in a left arcing trajectory of the bus as it traveled forward. The front tires marked on the asphalt road surface that identified the vehicle's trajectory to final rest (**Figure 6**). The two parallel arcing tire marks traversed the westbound travel lane, terminating at the south road edge. The tire marks on the stone shoulder were eroded by a road grader that was summoned to the scene to level out the displaced cold patch asphalt debris. The bus came to rest approximately 21.9 m (71.9') southwest of the initial point of impact. At rest, the bus was facing in a southwesterly direction, diagonal to and blocking the travel lanes.

**Figure 6. Path to final rest for the school bus.**

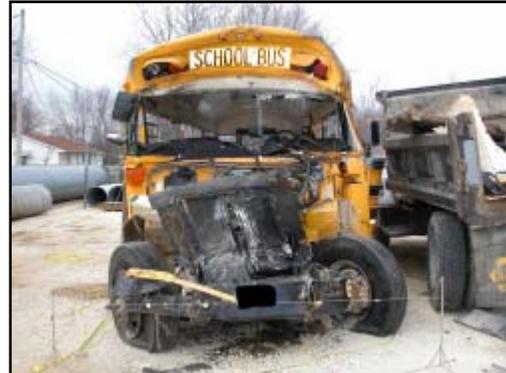
The frontal exterior of the school bus sustained severe damage as a result of the impact with the rear of the stopped dump truck (**Figure 7**). The direct damage involved the front bumper, engine cowl, frame, tires, suspension components, radiator and the radiator support. The fiberglass engine cowl was fractured and displaced rearward into the front cowl of the bus at the base of the windshield and the bulkhead area located above the windshield header.

**Figure 7. Frontal damage to subject school bus and bumper level crush profile.**

The direct contact damage on the front bumper began 100 cm (37.6") right of center and extended 192 cm (75.6") to the left corner. The impact deformed both ends of the bumper rearward resulting in a combined direct and induced damage length of 182 cm (71.5"). Maximum crush measured 57 cm (22.5") located at the left bumper corner. A crush profile was documented at bumper level and was as follows: C1 = 57 cm (22.5"), C2 = 16 cm (6.1"), C3 = 16 cm (6.4"), C4 = 8 cm (3.1"), C5 = (3"), C6 = 24 cm (9.5").

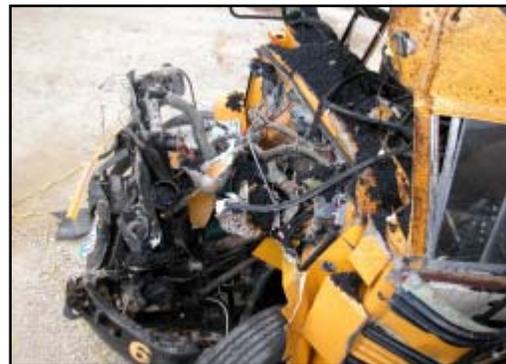
**Figure 8. Overhead view of cowl deformation.**

The wiper cowl area was crushed rearward by the rearward displacement of the engine cowl and the subsequent engagement against tailgate of the dump truck (**Figure 8**). The lateral width of the cowl area was 206 cm (81”) which extended from A-pillar-to-A-pillar. Maximum crush at the level of the cowl was 33 cm (12.8”) located 41 cm (16.2”) inboard of the left A-pillar. The crush profile at this level was as follows: C1 = 21 cm (8.3”), C2 = 33 cm (12.8”), C3 = 27 cm (10.8”), C4 = 22 cm (8.5”), C5 = 19 cm (7.3”), C6 = 2 cm (0.9”).

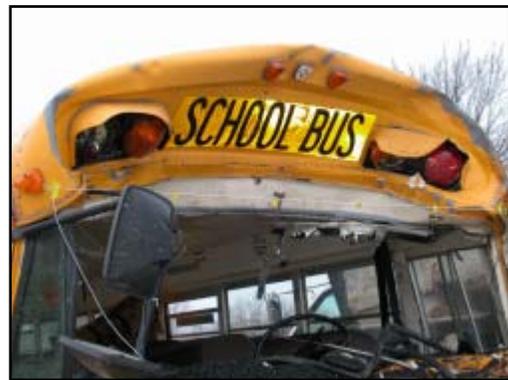
The above mentioned engine cowl was displaced vertically and rearward as it engaged the windshield/bulkhead area of the bus body. This area sustained a maximum crush value of 38 cm (15”). The width of the bulkhead area measured 196 cm (77”) that spanned A-pillar to A-pillar. The crush profile at this bulkhead (**Figure 9**) was as follows: C1 = 0 cm, C2 = 34 cm (13.4”), C3 = 38 cm (15”), C4 = 36 (14.3”), C5 = 27 cm (10.8”), C6 = 0 cm.

**Figure 9. Windshield header crush profile.**

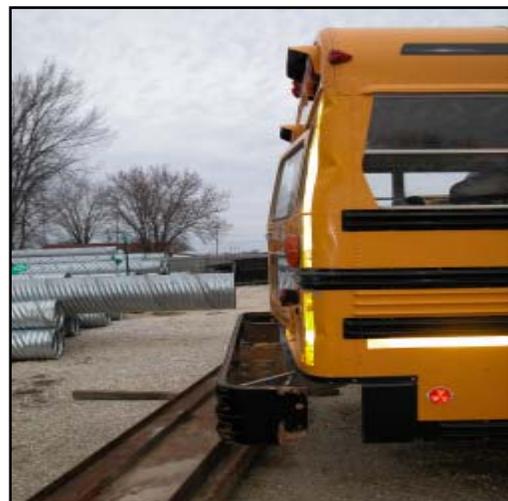
The impact displaced the body/chassis alignment of the school bus. The body of the bus continued forward as the chassis of the bus engaged the rear of the truck. This resulted in approximately 31 cm (12”) of forward displacement of the bus body as evidenced by the separation at the rear of the body/chassis, and by slide marks on the frame at the bracket locations that held the body to the frame (**Figure 10**).

**Figure 10. View of body chassis separation at the rear.**

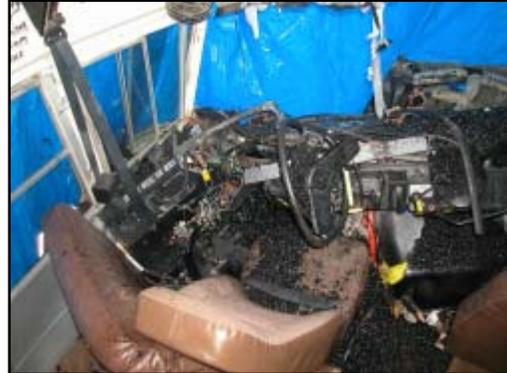
The driver loaded the manual belt system as he responded to the frontal crash forces. A subtle D-ring transfer was noted to the belt webbing that was subsequently cut by rescue personnel. He was subsequently engaged by the intruding steering wheel rim and the asphalt. The wheel rim was pulled forward by rescue personnel during the extensive extrication. The driver's seat back was deflected rearward by his loading from the intrusion. At the time of the SCI inspection, the seat back was deflected (bent) approximately 40 degrees aft of vertical. The driver's knees contacted the lower instrument panel as evidenced by two distinct areas of deformation to the steel component. **Figure 11** is an overall view of the driver's area deformation.

**Figure 11. View of driver's area deformation.**

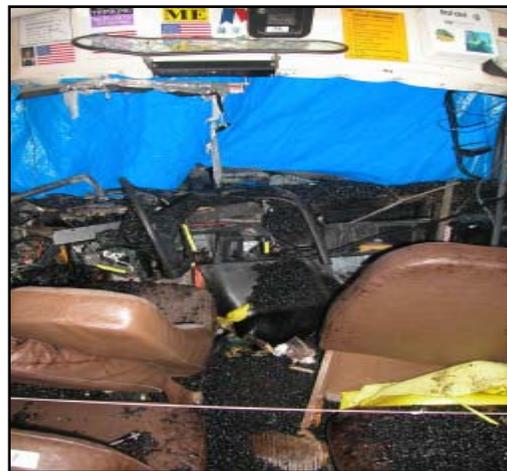
The T-handle to the center mounted transmission selector lever was fractured from probable contact by the upright female passenger. This passenger also loaded the center mounted door release lever/linkage arm. Body fluid (blood) was noted to the struck handle. Although not supported by contact evidence due to the severity of damage, the upright passenger probably engaged the intruding engine cowl. She was subsequently knocked to the floor and buried by the intruding asphalt material.

**Figure 12. Center instrument panel contacts from the 15-year-old female passenger and final rest area for this occupant.**

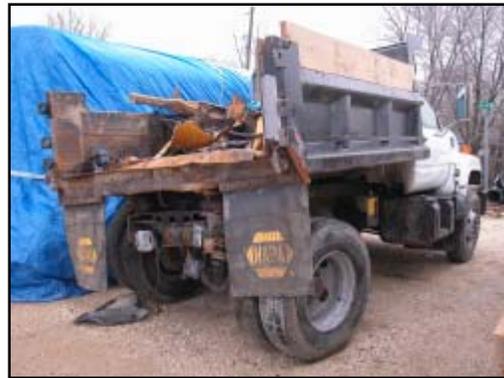
The bus impacted the rear plane of the stopped dump truck. The direct contact involved the rear tailgate of the truck that was extended to a near horizontal position, the rear axle, left rear tires, and the rear aspect of the dump body (**Figure 13**). Additionally, the bus impacted and fractured the fabricated trailer hitch and frame assembly that was welded to the rear truck frame rails. The impact deformed and separated the tailgate from the dump body and crushed the rear edge of the dump body at the right corner to a depth of 24 cm (9.5"). The frontal engagement to the tires and differential assembly displaced the rear axle of the truck forward. The right wheelbase was elongated to 436 cm (171.5") while the left wheelbase measured 391 cm (154").

**Figure 13. Damage area of the struck dump truck.**
