ON-SITE CERTIFIED ADVANCED 208- COMPLIANT VEHICLE INVESTIGATION

CASE NUMBER - IN-04-011
LOCATION - TEXAS
VEHICLE - 2003 CHEVROLET C1500 SILVERADO
CRASH DATE - April 2004

1. <i>Report No.</i> IN-04-011		2. <i>Government Accession No.</i>		3. <i>Recipient's Catalog No.</i>	
4. <i>Title and Subtitle</i> On-Site Certified Advanced 208-Compliant Vehicle Investigation Vehicle - 2003 Chevrolet C1500 Silverado Location - Texas			5. <i>Report Date:</i> August 16, 2007

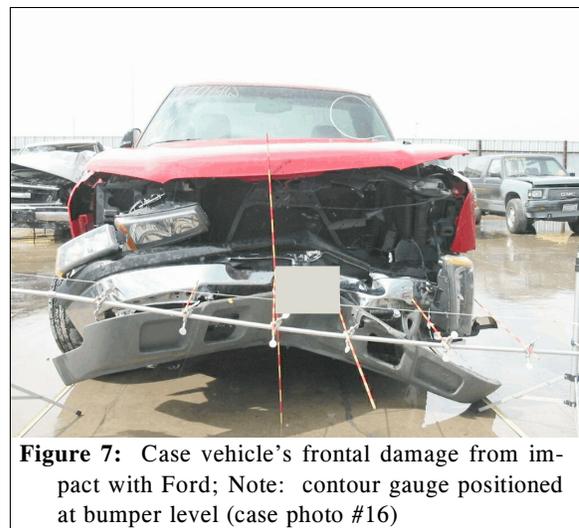
Crash: The front left half (**Figure 7** and **Figure 8** below) of the case vehicle impacted the front left corner of the Ford, causing only the case vehicle's driver supplemental restraint (air bag) to deploy. Based on the downloaded **EDR** data, only one stage of the driver's multi-stage air bag was activated. The case vehicle was equipped with a switchable (i.e., a cutoff switch) front right

Figure 7: Case vehicle's frontal damage from impact with Ford; Note: contour gauge positioned at bumper level (case photo #16)

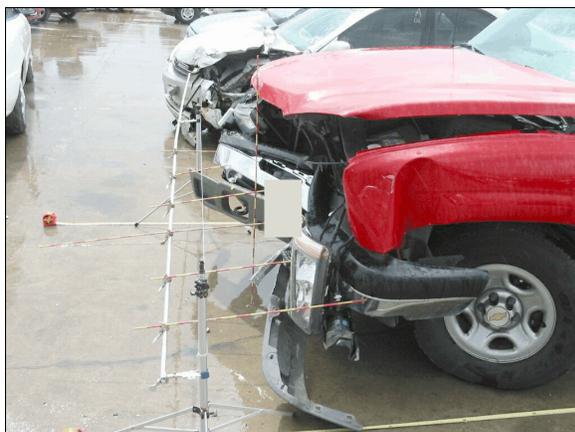
Figure 8: Reference line view of case vehicle’s frontal damage viewed from left; Note: case vehicle’s left front wheel is restricted by damage (case photo #19)

The wheelbase on the case vehicle’s left side was shortened 14 centimeters (5.5 inches) while the right side was extended 3 centimeters (1.2 inches). The case vehicle’s front bumper, bumper fascia, grille, radiator, hood, left headlight and turn signal assemblies, and left fender were directly damaged and crushed rearward. There was induced damage to the right headlight and turn signal assemblies as well as the hood and left fender. Remote buckling was also found on the truck bed (**Figure 11**). No obvious induced damage or remote buckling was noted to the remainder of the case vehicle’s exterior.

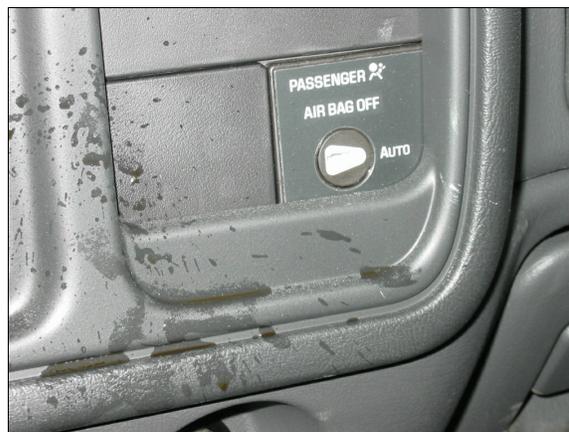
passenger supplemental restraint (air bag) that was set to the “auto” position (**Figure 9**). The case vehicle’s front right passenger air bag did not deploy during the crash sequence.

Figure 9: Close-up of case vehicle’s front right passenger air bag switch located in lower right portion of center instrument panel; Note: switch located in “Auto” position (case photo #41)

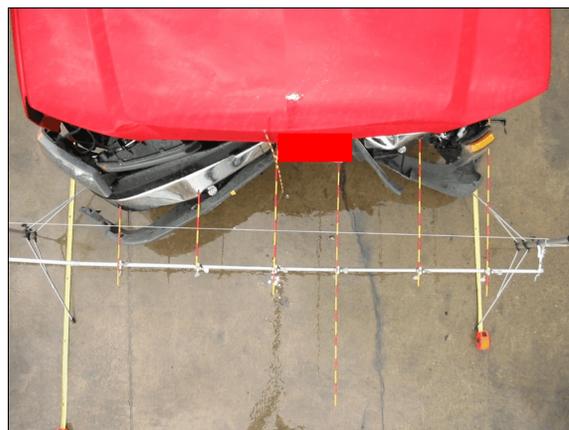
Exterior Damage: The case vehicle’s contact with Ford involved the entire front. Direct damage began at the front left bumper corner and extended 112 centimeters (44.1 inches), along the front bumper (**Figure 10**). The undeformed end width was determined to be 176 centimeters (69.3 inches). Residual maximum crush was measured as 39 centimeters (15.4 inches) at C₃. The table below shows the case vehicle’s crush profile.

Figure 10: Overhead view of case vehicle’s frontal damage showing contour gauge positioned at bumper level; Note: case vehicle was in counter-clockwise yaw at impact (case photo #27)

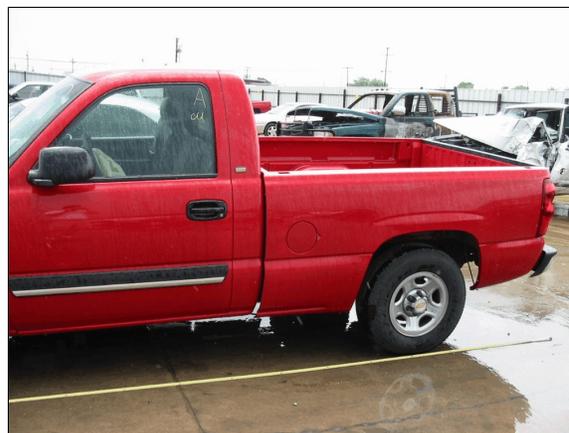
Figure 11: Induced damage to case vehicle’s truck bed (case photo #21)

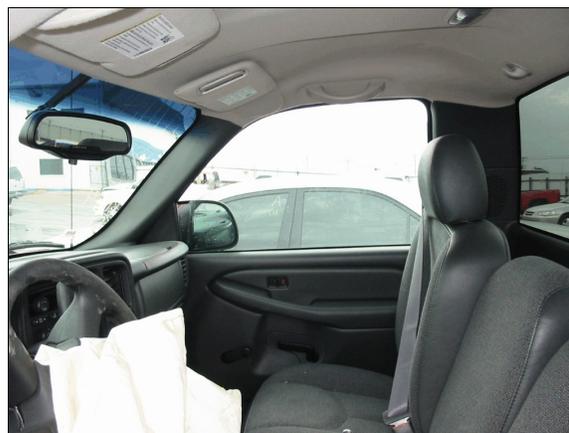
Vehicle Interior: Inspection of the case vehicle’s interior revealed that there was no evidence of occupant contact on the interior surfaces of the case vehicle (**Figure 12** and **Figures 13** and **14** below). Although the interviewee (case vehicle’s driver) stated the front center passenger struck her head on the center dash area, no evidence of occupant contact was found (**Figures 15** and **16** below). It should be noted that some sort of fluid was splayed over the center instrument panel (**Figure 9** above). It is possible that the front center passenger had a cup of some sort of liquid in her hands just prior to the crash; however, no confirmation of this hypothesis was obtained. Finally, there was no evidence of intrusion to the

Figure 12: Case vehicle’s front seating area showing deployed driver air bag and greenhouse area and rear view mirror above front center seat (case photo #28)

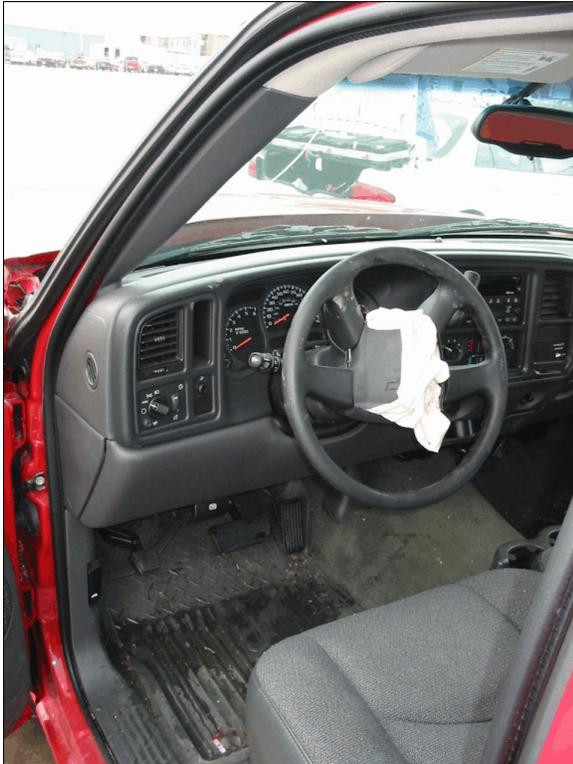
case vehicle's interior, no evidence of compression to the energy absorbing shear capsules in the steering column, and no deformation to the steering wheel rim.

Figure 13: Case vehicle's driver seating area showing deployed driver air bag, greenhouse, left instrumental panel and knee bolster left of steering column, and toe pan areas (case photo #30)

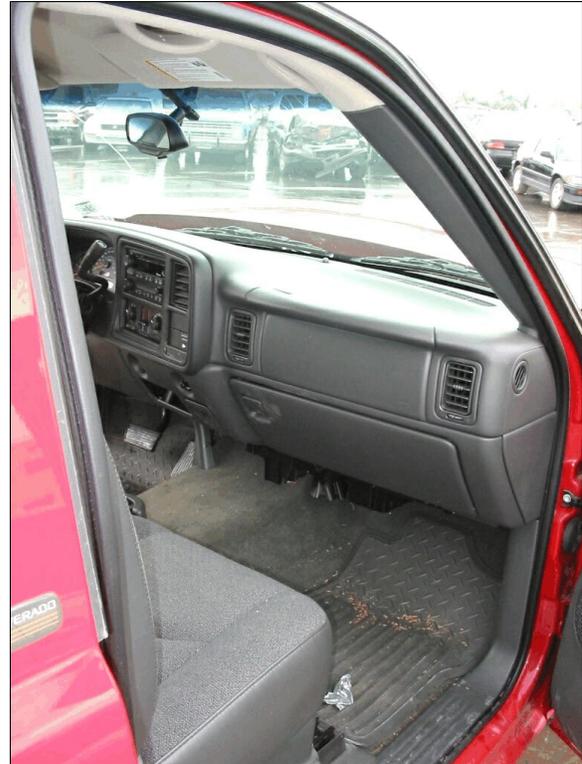
Figure 14: Case vehicle's front right seating area showing non-deployed front right passenger air bag, greenhouse, center and right instrument panel, and right toe pan areas (case photo #32)

The front right passenger's air bag was located in the middle of the instrument panel (**Figure 13** above). It should be noted that there was no occupant in the front right seat and that the air bag for this position did not deploy. In addition, there was an air bag cutoff switch on the center instrument panel, but the switch was turned to its "Auto" position (**Figures 9** and **16** above).

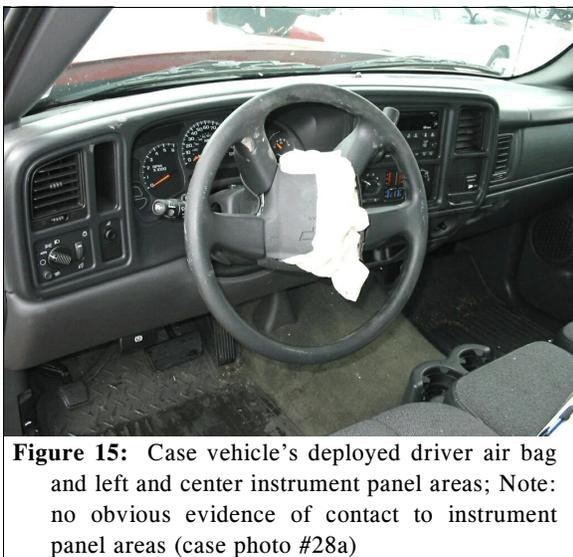
Figure 15: Case vehicle's deployed driver air bag and left and center instrument panel areas; Note: no obvious evidence of contact to instrument panel areas (case photo #28a)

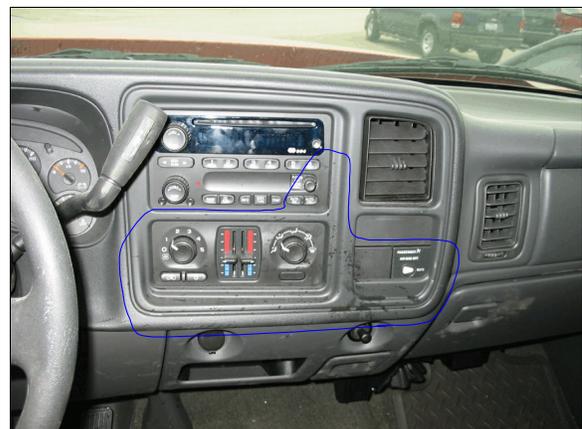
Figure 16: Case vehicle's center instrument panel area showing possible contact evidence; Note: splatters are not blood stains (case photo #40)

The front center occupant was transported by ambulance to the hospital. She sustained minor injuries and was treated and released. According to the interview with her father and her medical records, the injuries sustained by the case vehicle's front center passenger included: a laceration {cut} above her right eye and lacerations {cuts} to her gums, lower lip, and chin. This occupant’s facial injuries were most likely caused by her contact with the case vehicle’s center instrument panel.

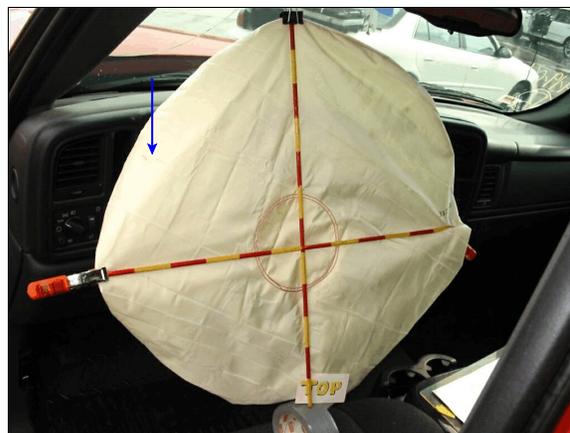
The case vehicle was equipped with a Supplemental Restraint System (SRS) that contained dual stage frontal air bags at the driver and front right passenger positions. Only the driver's frontal air bag deployed as a result of the frontal impact with the Ford. Only one stage of the multi-stage air bag was activated. The case vehicle's driver air bag was located in the steering wheel hub (**Figure 12** et al. above). The module cover consisted of symmetrical "I"-configuration cover flaps made of thick vinyl with overall dimensions of 5.5 centimeters (2.2 inches) at the left and right horizontal seams and 12 centimeters (4.7 inches) vertically. An inspection of the air bag module's cover flaps and the air bag's fabric revealed that the cover flaps opened at the designated tear points, and there was no evidence of damage during the deployment to the air bag or the cover flaps. The driver's air bag was designed with two tethers, each approximately 12 centimeters (4.7 inches) in width. The driver's air bag had two vent ports, approximately 3 centimeters (1.2 inches) in diameter, located slightly inward from the outer circumference at the 10:30 and 1:30 clock positions. The deployed driver's air bag was round with a diameter of 65 centimeters (25.6 inches). The distance between the mid-center of the driver's seat back, as positioned at the time of the vehicle inspection, and the front surface of the air bag's fabric at full excursion was 40 centimeters (15.7 inches). An inspection of the driver's air bag fabric revealed a faint blood stain on the air bag's fabric near its outer edge at approximately the 4 o'clock position (**Figure 17**). Because the front center passenger sustained facial lacerations, it is very likely that the "stain" is blood and it came from the front center passenger.

Figure 17: Case vehicle's deployed driver air bag showing possible blood evidence (arrow) on air bag's fabric near 4 o'clock area (case photo #33)

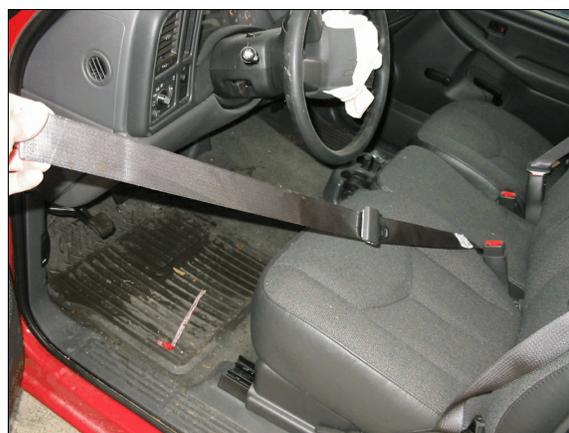
Based on this contractor's vehicle inspection and the interview with the case vehicle's driver, the case vehicle's front center passenger was restrained by her available, active, two-point, lap belt system. There was no mention by the driver of belt pattern bruising and/or abrasions to the front center passenger's torso, and the inspection of the front center passenger's seat belt webbing and latch plate showed minor blood stains on the

Figure 18: Webbing from case vehicle's lap only center seat belt showing blood on webbing (case photo #42)

belt’s webbing but no evidence of loading (**Figure 18** above and **Figure 19**).

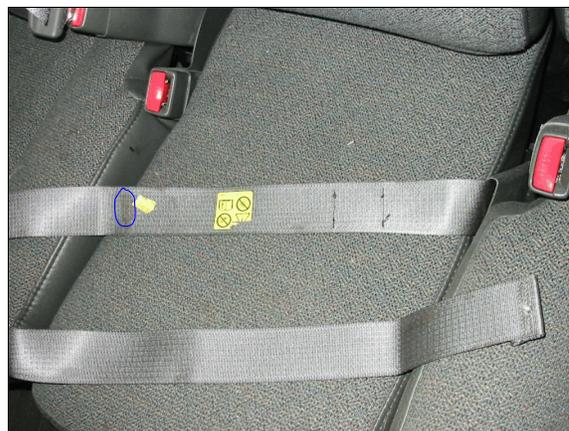
Figure 19: Overhead view of case vehicle’s front center seat cushion and seat belt webbing; Note: blood (circled) on belt’s webbing (case photo #45)

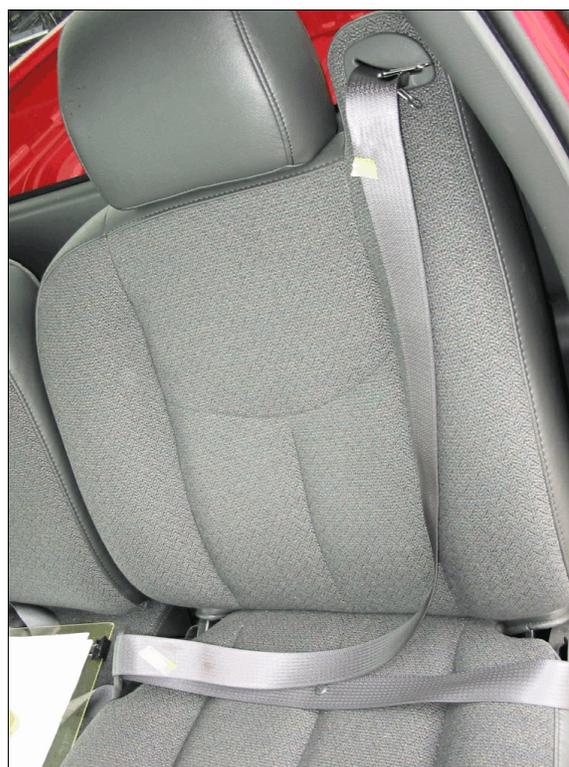
Figure 20: Elevated view of webbing from case vehicle's integrated driver seat belt showing loading evidence near retractor port (case photo #37)

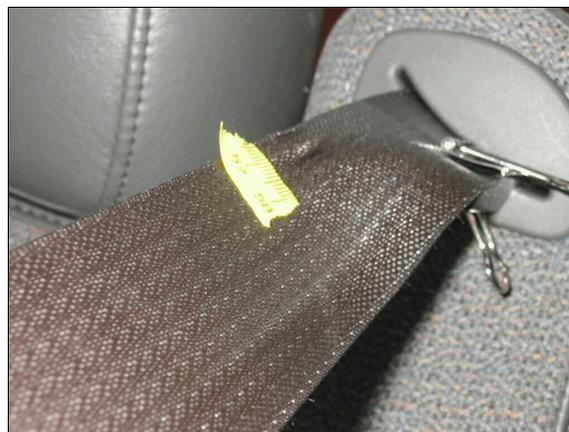
Figure 21: Close-up of loading evidence (i.e., “pinched” area) on webbing of case vehicle’s integrated driver seat belt near retractor port (case photo #39)

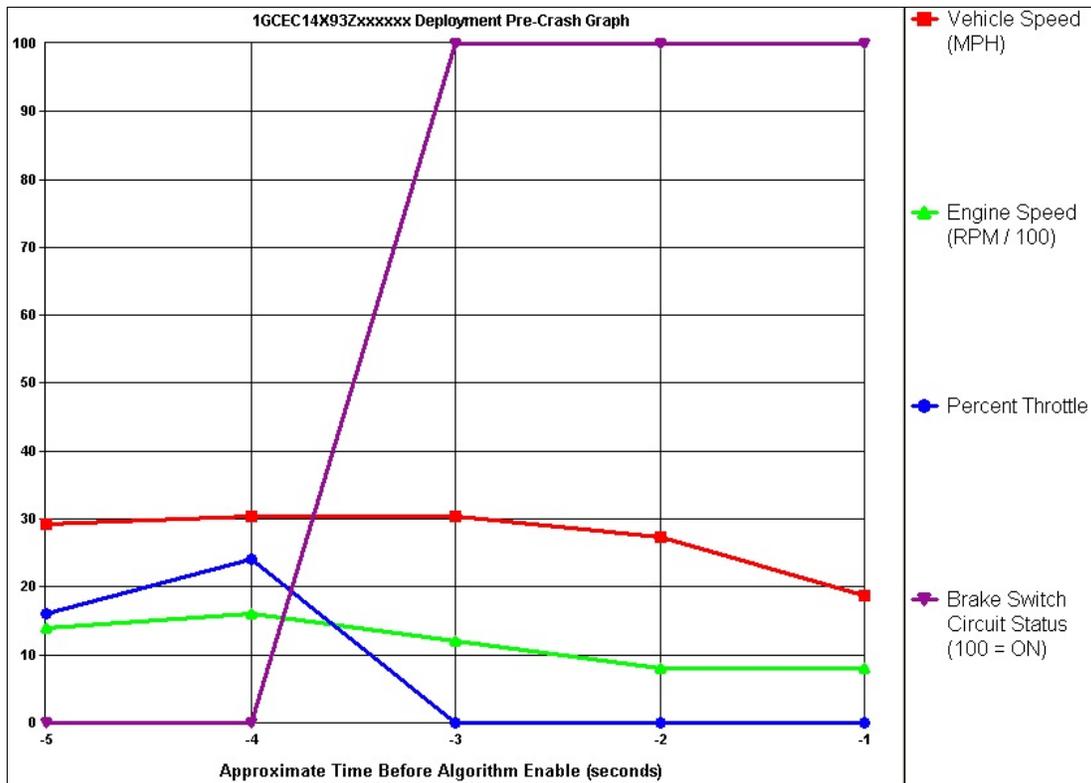
Figure 23: Case vehicle's pre-crash speed and brake switch circuit status showing that the vehicle's speed was recorded at 48 km.p.h. (30 m.p.h.) when the brake was activated approximately 3 seconds prior to algorithm enable.

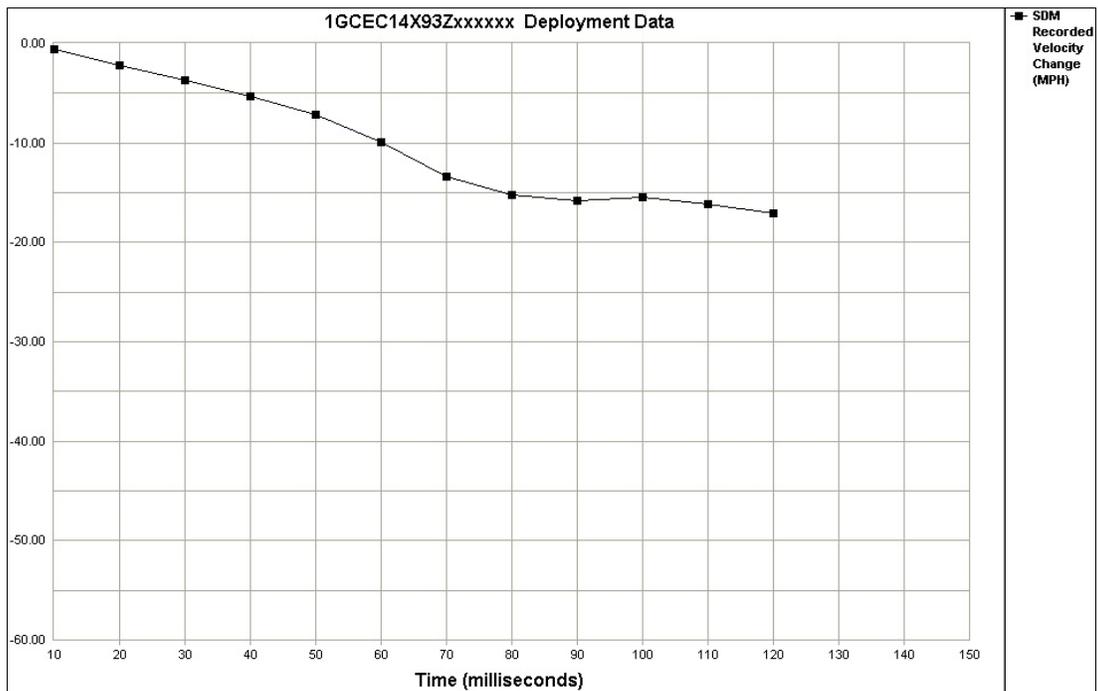
Figure 24: The case vehicle sustained a velocity change of approximately 27.4 km.p.h. (17.1 m.p.h.) during the first 120 milliseconds after the algorithm was enabled; maximum velocity change was recorded as 27.9 km.p.h. (17.4 m.p.h.) at 125 milliseconds.

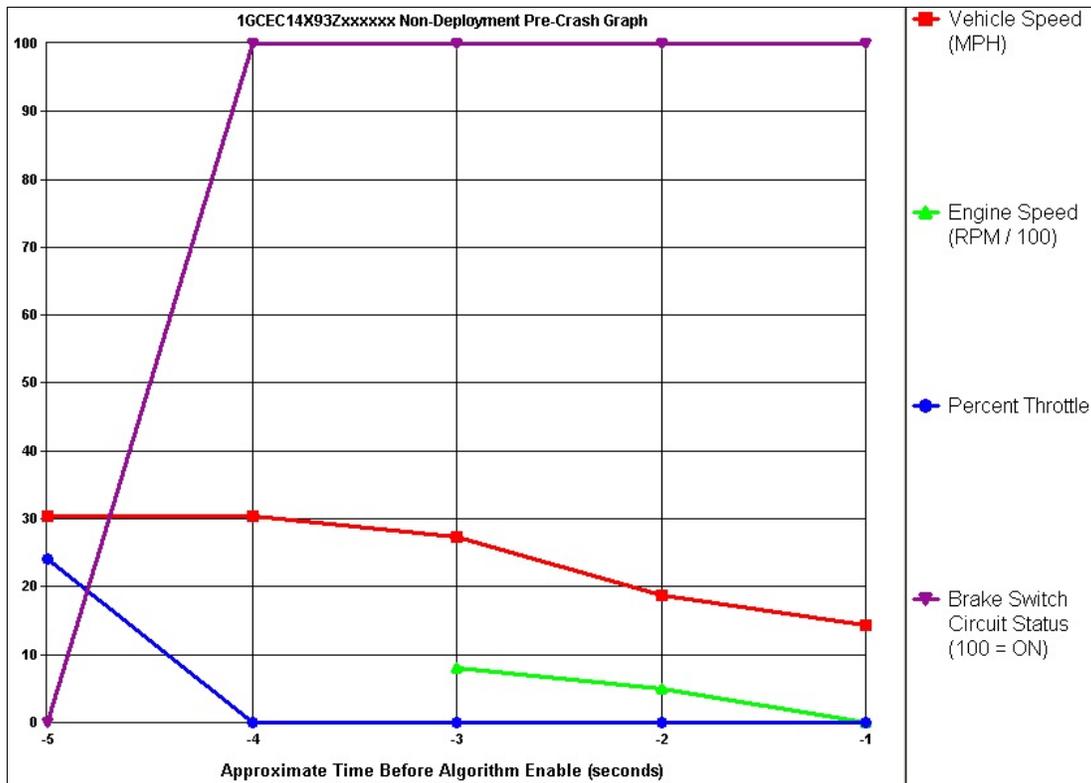
Figure 26: Case vehicle’s pre-crash speed and brake switch circuit status showing that the vehicle’s speed was recorded at 48 km.p.h. (30 m.p.h.) when the brake was activated approximately 4 seconds prior to algorithm enable.

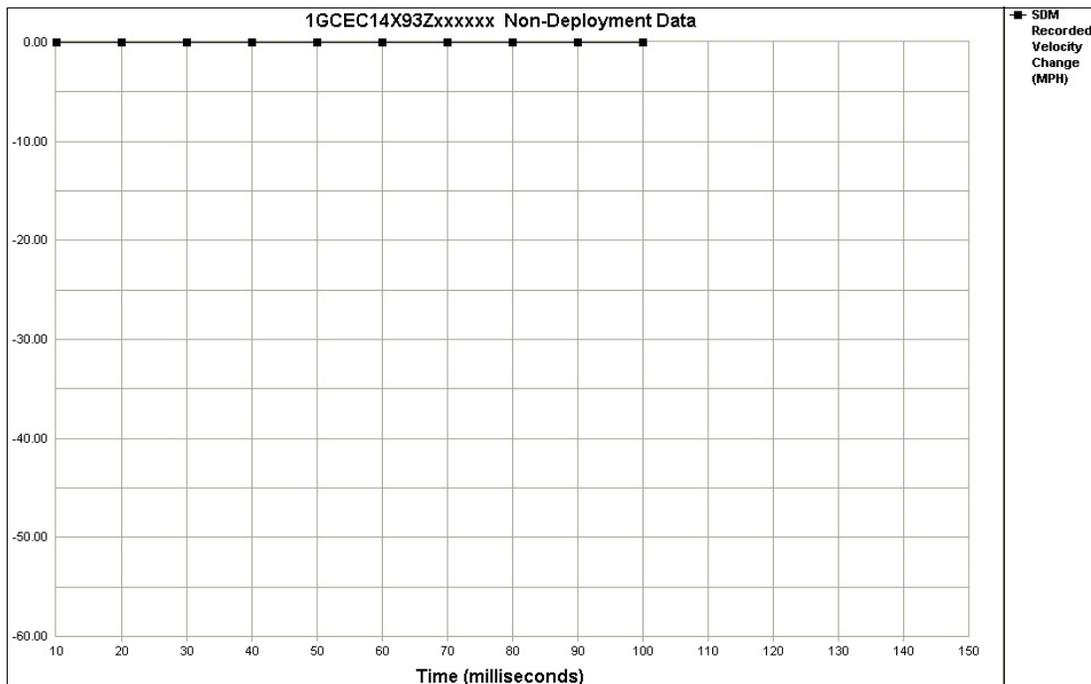
Figure 27: The case vehicle sustained a velocity change of approximately 0.0 km.p.h. (0.0 m.p.h.) during the first 100 milliseconds after the algorithm was enabled; maximum velocity change was recorded as 0.06 km.p.h. (0.04 m.p.h.) at 10 milliseconds
