ON-SITE CERTIFIED ADVANCED 208- COMPLIANT VEHICLE INVESTIGATION

CASE NUMBER - IN-04-012
LOCATION - Texas
VEHICLE - 2004 HONDA ACCORD EX
CRASH DATE - March 2004

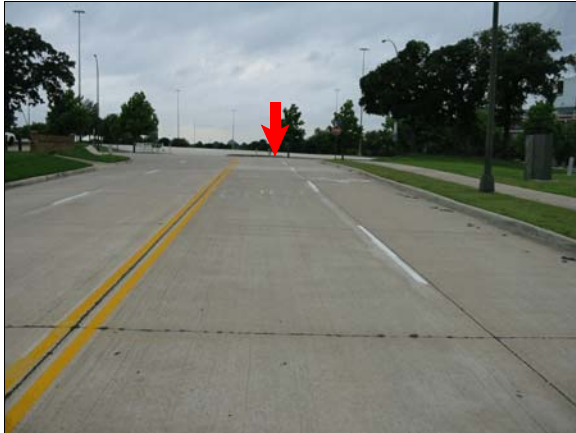
Pre-Crash: The case vehicle was northwest-bound and was stopped at the stop sign in the outside lane (**Figure 1**). The driver proceeded into the intersection intending to continue northwest, straight through the intersection into a sports stadium parking lot. The Chrysler was traveling southwest in the left inside lane (**Figure 2**), and the driver was intending to continue through the intersection and continue southwest. The case vehicle's driver stated he took no actions to avoid the crash. The crash occurred within the intersection of the two trafficways.

Figure 1: Overview of case vehicle's approach northwest-bound to intersection, arrow shows area of the crash, case vehicle stopped at stop sign

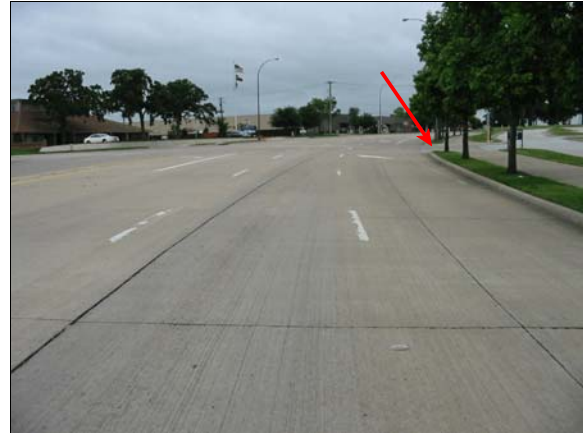
Figure 2: Approach of Chrysler's southwest-bound in inside through-lane, arrow shows location of driveway case vehicle was attempting to enter

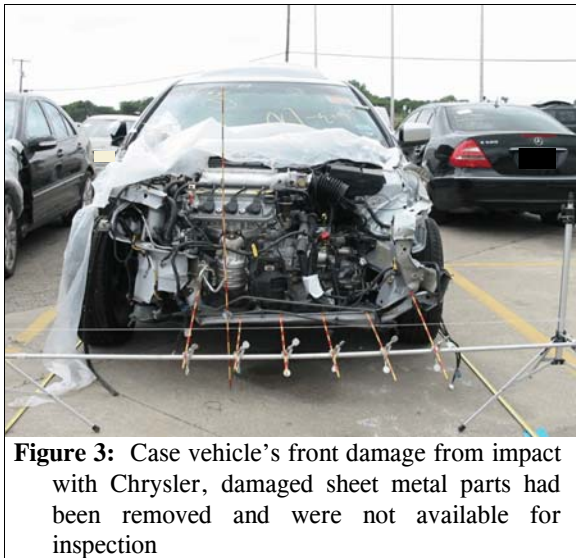
Figure 3: Case vehicle's front damage from impact with Chrysler, damaged sheet metal parts had been removed and were not available for inspection

Crash: The front of the case vehicle impacted the left fender and driver's door of the Chrysler (**Figures 3 and 4**), causing a first stage deployment of the case vehicle's driver air bag. The case vehicle's front right air bag did not deploy because there was no front right occupant in the case vehicle. The weight sensor in the front right seat properly determined the absence of an occupant and suppressed deployment of the front right air bag.

Exterior Damage: Based on the damaged parts that remained on the case vehicle and the damage to the Chrysler, it appears the case vehicle most likely sustained direct damage across the full width of its front bumper. Additionally, the grille, hood, and the front of both fenders were most likely directly damaged and crushed rearward and to the left. Crush measurements were taken at the lower radiator support, and maximum crush at this component was measured as 17 centimeters (6.6 inches) occurring at C₆. Based on the damage to the case vehicle and the Chrysler, the direct damage width was considered to be 154 centimeters (60.6 inches), the undeformed width of the front bumper. The table below shows the case vehicle’s crush profile.

Damage Classification: The front bumper, hood, and fenders had been removed from the case vehicle and were not present at the inspection; however, based on the damaged components remaining on the case vehicle and the damage profile on the Chrysler, this contractor determined that a CDC could be reasonably estimated. The CDC was estimated to be **82-FDEW-1 (50 degrees)**. The CDC force direction was incremented because both front unibody frame members were shifted to the left beyond the 10 centimeter (4 inch) threshold.

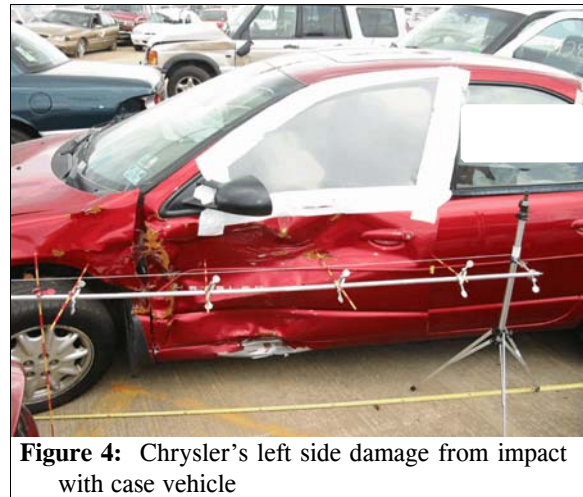
Figure 4: Chrysler's left side damage from impact with case vehicle

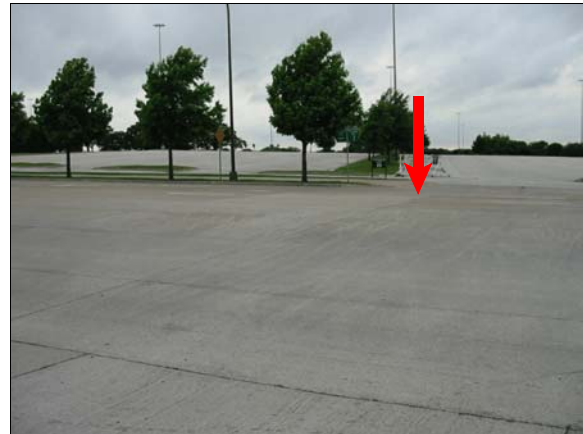
Post-Crash: As a result of the impact, the case vehicle rotated counterclockwise, traveled a short distance and came to final rest in the intersection facing west (**Figure 5** below). The impact likely

Figure 5: Overview of trees on southwest corner of intersection and parking lot driveway case vehicle was attempting to enter is on right, arrow shows case vehicle's area of final rest

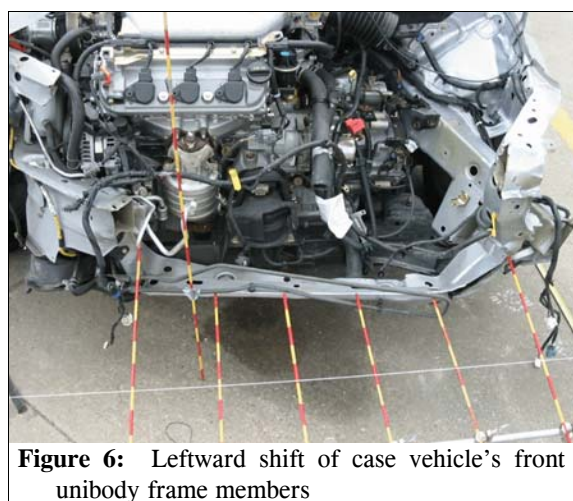
The case vehicle’s left side wheelbase was reduced 1 centimeter (0.4 inch) and the right side wheelbase was extended 2 centimeters (0.8 inch). Induced damage involved the hood and both front fenders as well as both front unibody frame members (**Figure 6**). Additionally, the right lower corner of the windshield was cracked.

Figure 6: Leftward shift of case vehicle’s front unibody frame members

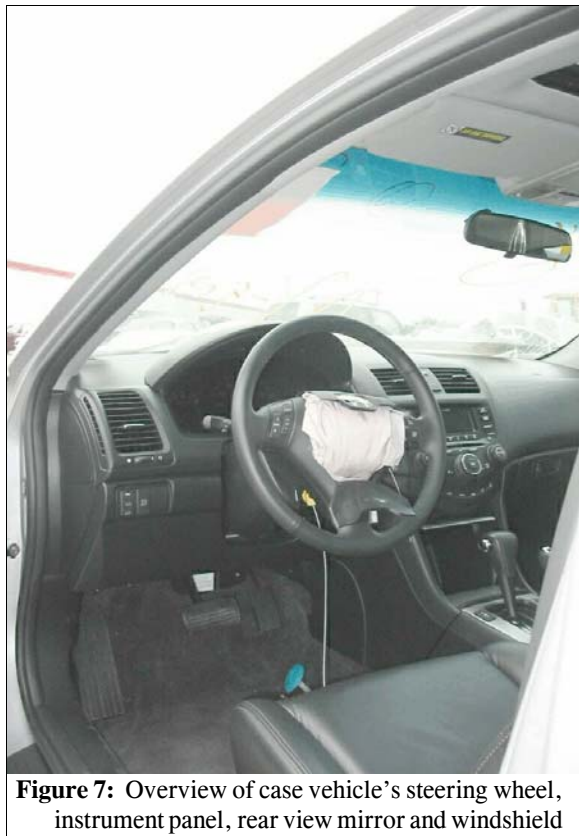
Vehicle Interior: Inspection of the case vehicle’s interior (**Figure 7** below) revealed a possible occupant contact to the rear view mirror (**Figure 8** below) and a small area of very light scuffing

Figure 7: Overview of case vehicle's steering wheel, instrument panel, rear view mirror and windshield

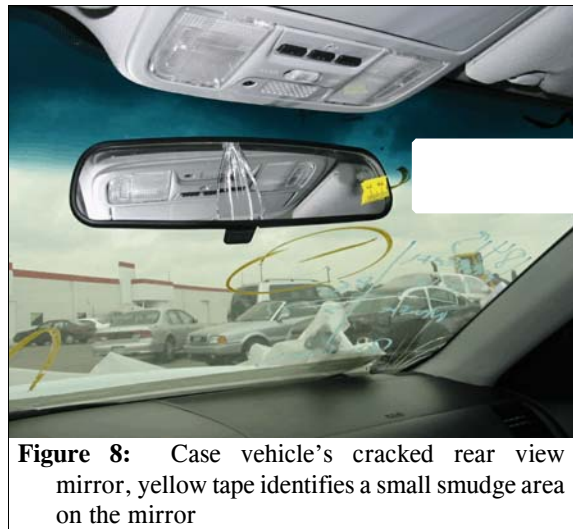
Figure 8: Case vehicle's cracked rear view mirror, yellow tape identifies a small smudge area on the mirror

chest impacted his deployed air bag, and his right hand most likely contacted the rear view mirror. The rear view mirror was cracked, and there appeared to be a small smudge on the lower right corner (**Figure 8** above). The driver then most likely rebounded off the air bag and back into his seat. The driver remained in his seat as the case vehicle rotated counterclockwise to its final rest position, and he exited the case vehicle without assistance.

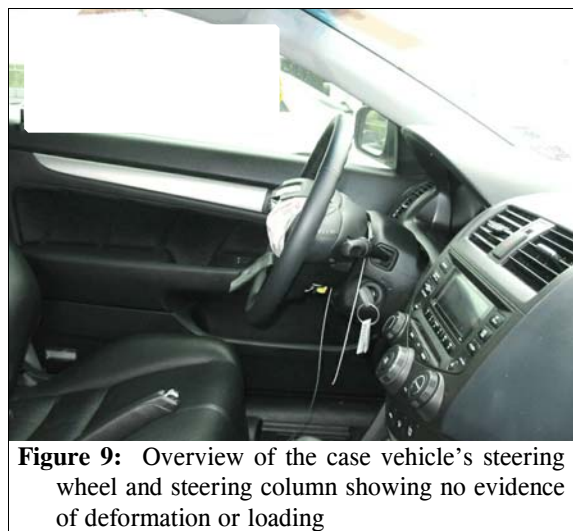
to the top right quadrant of the air bag. The scuffing appeared to be related to the deployment and not occupant contact. No other occupant contact evidence was found, and no intrusion of the passenger compartment was observed. Finally, there was no evidence of compression of the energy absorbing steering column, and no deformation of the steering wheel rim was observed (Figure 9).

Figure 9: Overview of the case vehicle's steering wheel and steering column showing no evidence of deformation or loading

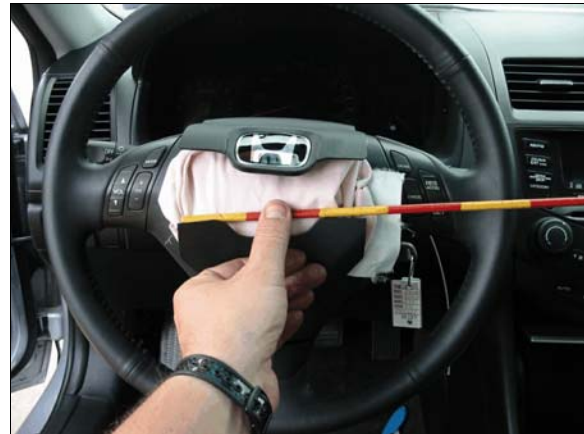
The case vehicle's driver air bag was located in the steering wheel hub. An inspection of the air bag module cover flaps and the air bag fabric revealed that the cover flaps opened at the designated tear points (**Figure 10**). There was no evidence of damage during the deployment to the air bag module cover flaps. The top module cover flap was approximately rectangular in shape with a rounded contour in the center of the flap that accommodated the Honda emblem. The top cover flap was 13.5 centimeters (5.3 inches) in width and 7 centimeters (2.8 inches) in height. The bottom module cover flap was approximately triangular in shape with a rounded concave contour in the center of the flap that accommodated the Honda emblem on the top flap. The bottom module cover flap was 13.5 centimeters (5.3 inches) in width at its widest point and 7 centimeters (2.8 inches) in height. The deployed driver's air bag (**Figure 11**) was round with a diameter of approximately 60 centimeters (23.6 inches). The air bag was designed with two tethers, each approximately 7 centimeters (2.8 inches) in width and had two vent ports, each approximately 5 centimeters (2.0 inches) in diameter, located at the 9 and 3 o'clock positions (**Figure 12**).

Figure 10: Case vehicle driver's air bag module cover flaps

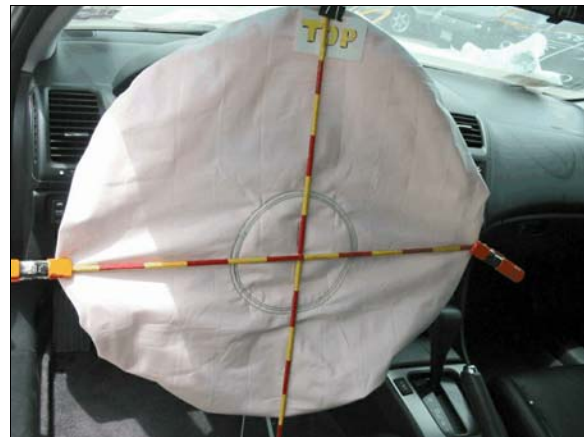
The distance between the mid-center of the driver's seat back, as positioned at the time of the inspection (i.e., approximately between the middle and rear-most track position), and the front surface of the air bag fabric at full excursion was 45 centimeters (17.7 inches). A small area of very light scuffing was found on the upper right quadrant of the air bag that appeared to be related to the interaction

Figure 11: Case vehicle driver's air bag

of the air bag with the back of the module cover flap.

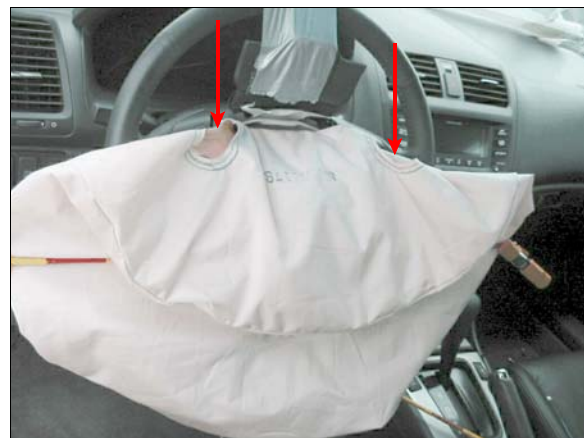
Figure 12: Case vehicle driver's air bag vent ports

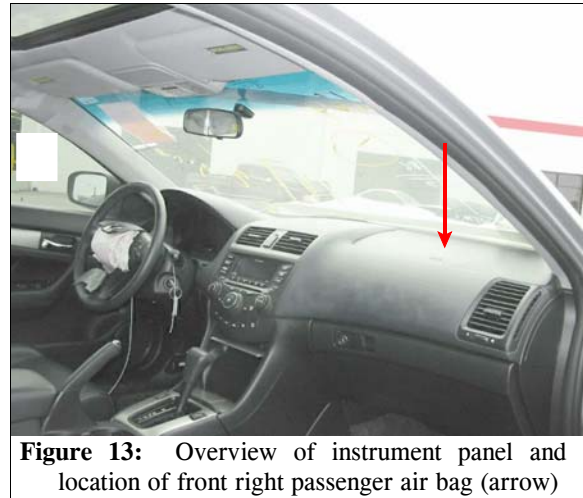
The front right passenger's air bag was located on the top of the instrument panel (**Figure 13**). The deployment of the front right passenger air bag was properly suppressed by the case vehicle's advanced occupant protection system because there was no front right passenger in the case vehicle at the time of the crash.

Figure 13: Overview of instrument panel and location of front right passenger air bag (arrow)

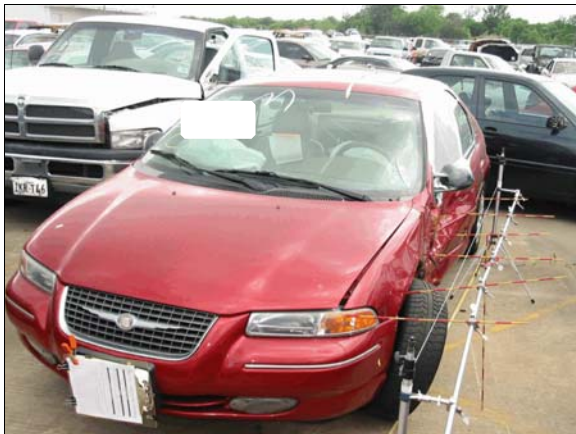
Figure 14: Left front corner view of damage to left side of Chrysler from impact with case vehicle

Exterior Damage: The Chrysler’s impact with the case vehicle involved the left fender, left front wheel and left front door (**Figures 14 and 15**). The direct damage began 118 centimeters (46.5 inches) forward of the left rear axle and extended 203 centimeters (80 inches) forward along the left side of the Chrysler. Crush measurements were taken at the mid-door level, and the maximum residual crush was measured as 10 centimeters (3.9 inches) occurring at C₂ and C₃. The table below shows the Chrysler’s left side crush profile.

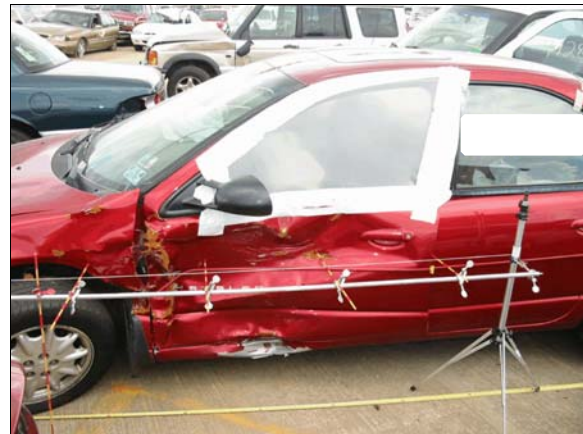
Figure 15: Chrysler's damaged left fender and left front door from impact with case vehicle

The Chrysler's left side wheelbase was reduced 6 centimeters (2.4 inches) while the right side wheelbase was extended 2 centimeters (0.8 inch). The Chrysler's left fender, left front door and left front wheel were directly damaged and crushed inward. Induced damage involved the front portion of the left fender and back portion of the left front door. In addition, the windshield the cracked.
