**CALSPAN ON-SITE CERTIFIED ADVANCED 208-COMPLIANT
VEHICLE CRASH INVESTIGATION**

SCI CASE NO: CA04-012

**VEHICLE: 2003 CADILLAC ESCALADE
LOCATION: PENNSYLVANIA
CRASH DATE: FEBRUARY 2004**

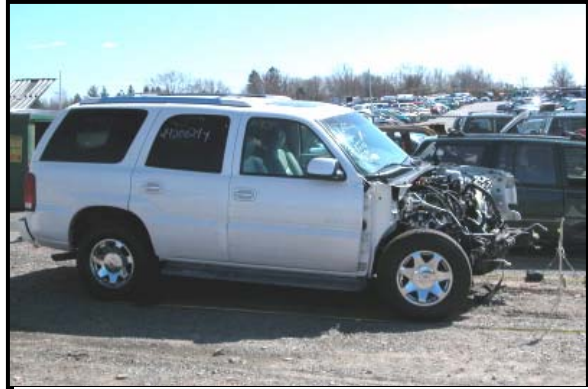
Figure 1: 2003 Cadillac Escalade.

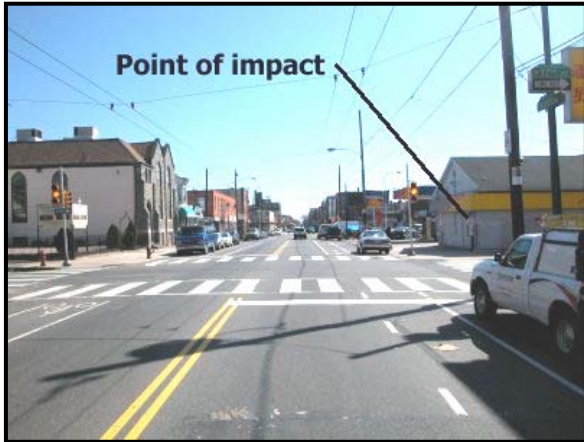
Figure 3: Eastbound trajectory view.

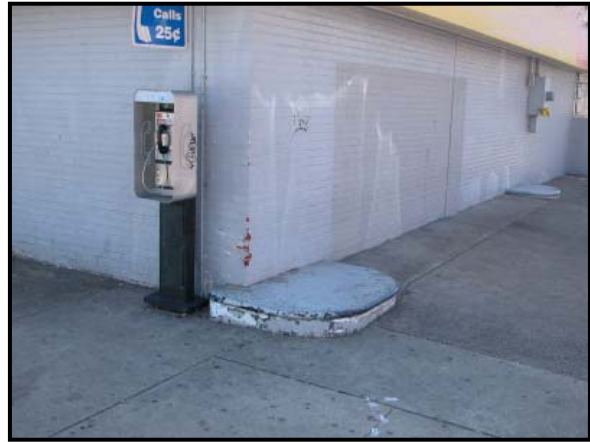
southbound road edge. A series of bricks 36 cm to 69 cm (14 in to 27 in) above the ground measuring 28 cm (11 in) in width on the north wall were freshly chipped and abraded. These bricks identified the point of impact. A public telephone was located 0.6 m (2 ft) east of building's corner and sustained minor damage from contact with the front fascia of the Cadillac. The pole-mounted traffic signal located in the intersection quadrant was contacted by the left rear quarterpanel of the Cadillac as the vehicle rotated to final rest. The pole and signal did not appear to have been damaged. A schematic of the crash is attached to the end of this report, **Figure 9**. The speed limit in the area of the crash was 48 km/h (30 mph). **Figure 2** is a trajectory view of the Cadillac approaching the point of impact. **Figure 3** is a view of the point of impact.

Figure 2: Point of impact.

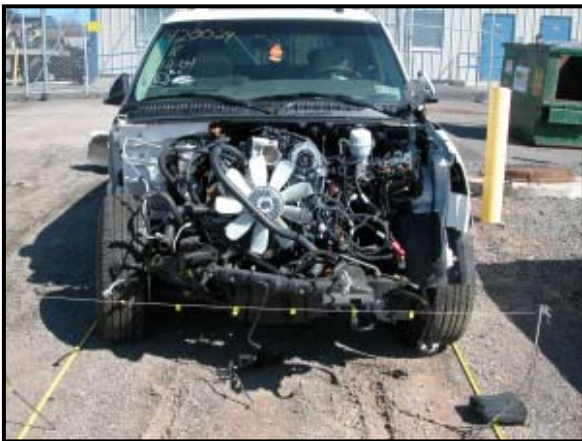
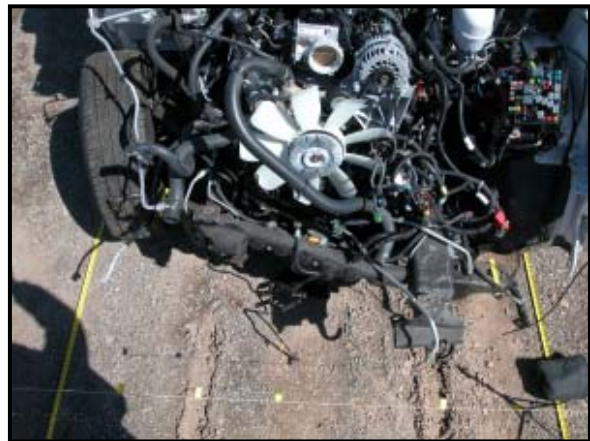
The Cadillac Escalade had been dismantled by a repair facility during the insurance estimating process. This hampered the documentation of the crush profile. Residual crush was measured directly to the vehicle's frame. For that reason, the residual damage profile used during the analysis was underestimated. In turn, the under reported damage severity resulted in an under reported delta V by the WINSMASH Damage Algorithm. **Figures 4 and 5** are frontal views of the damaged Cadillac.

Figure 4: Cadillac front view.

Figure 5: Cadillac overhead front view.

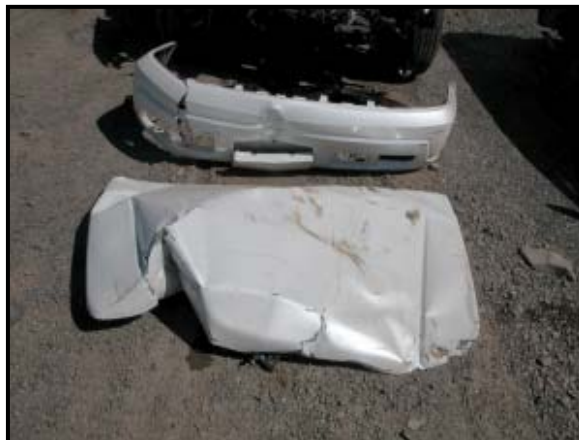
The front plane of the Cadillac sustained direct contact damage due its impact with the corner of the building that began 28 cm (11 in) right of center and extended 38 cm (15 in) to the right. As the vehicle crushed, the front plane contacted the vertical support for the public telephone. The contact to the telephone support occurred approximately on the vehicle's centerline. This contact pattern measured 8 cm (3 in) in width. The fascia and damaged hood are depicted in **Figure 6**.

Figure 6: Damaged bumper fascia and reinforcement.

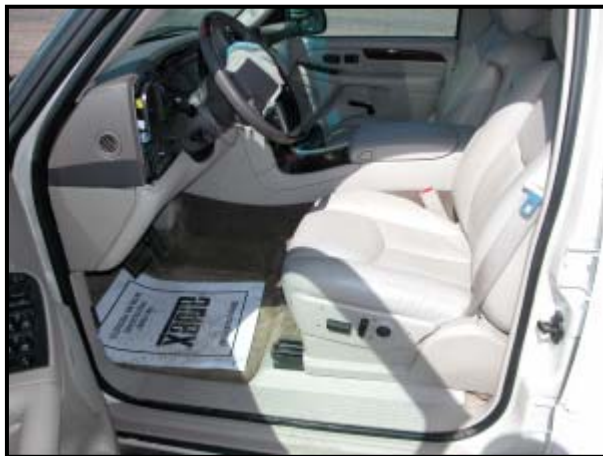
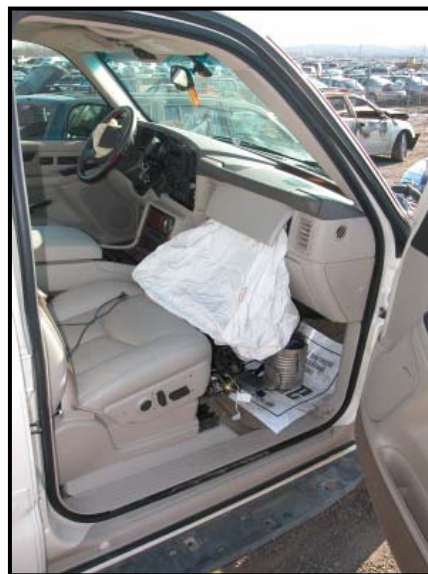
The interior damage to the Cadillac was limited to the deployment of the vehicle's frontal air bags and the minor occupant contacts to the front interior. There was no interior damage related to the exterior force of the crash. There was no reduction in the volume of the front occupant space. **Figures 7 and 8** are interior views of the Cadillac.

Figure 7: Left interior view.

Figure 8: Right interior view.
